Damage Survey of the Violent Tornado in Southeast Czechia on 24 June 2021

Tomáš Púčik David Rýva Miroslav Šinger Miloslav Staněk Pieter Groenemeijer

Tornado rated using 0.1 version of the IF-scale

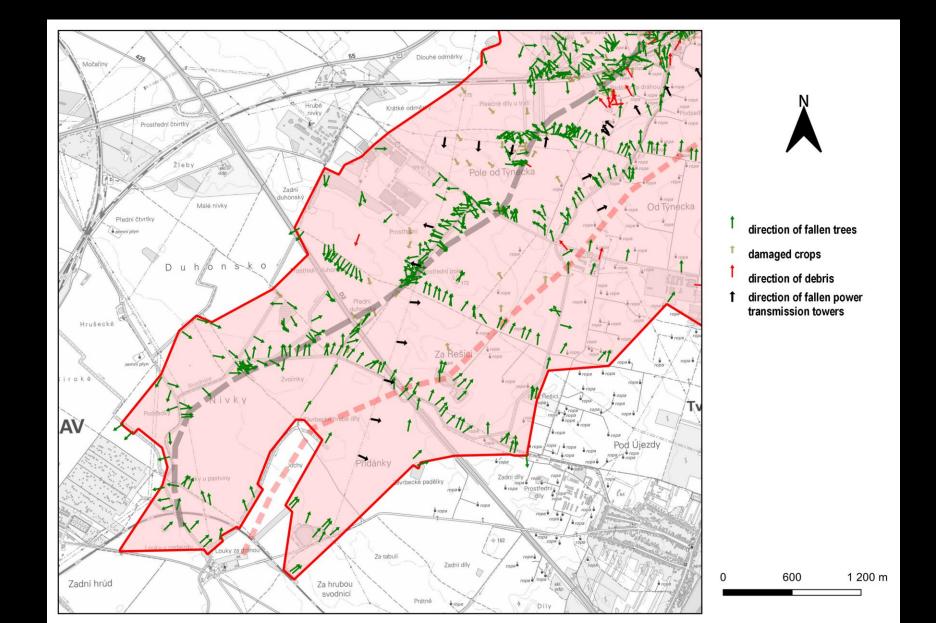
Beginning of the path: Tornado vs the RFD

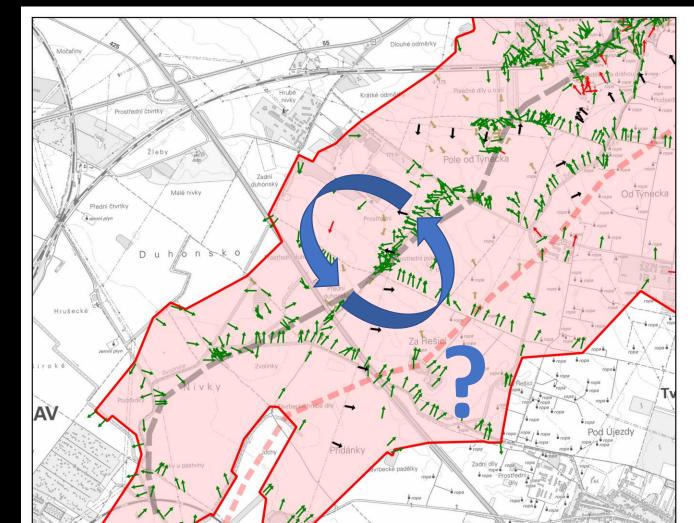
Beginning of the path: Tornado vs the RFD

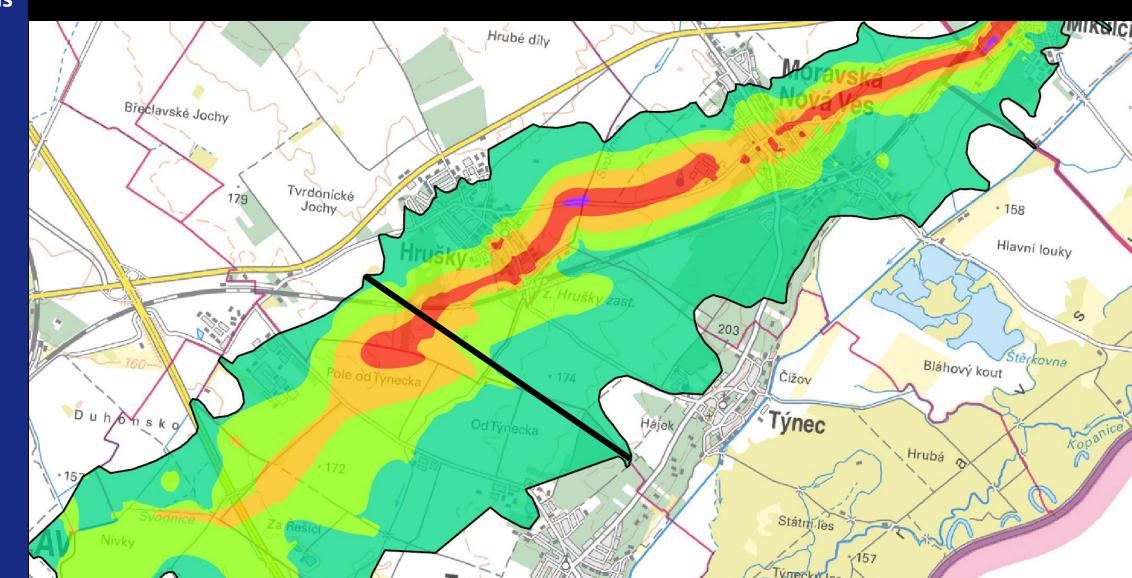
Width of the tornado

Maximum width up to around 3.5 km (tornado + RFD?)

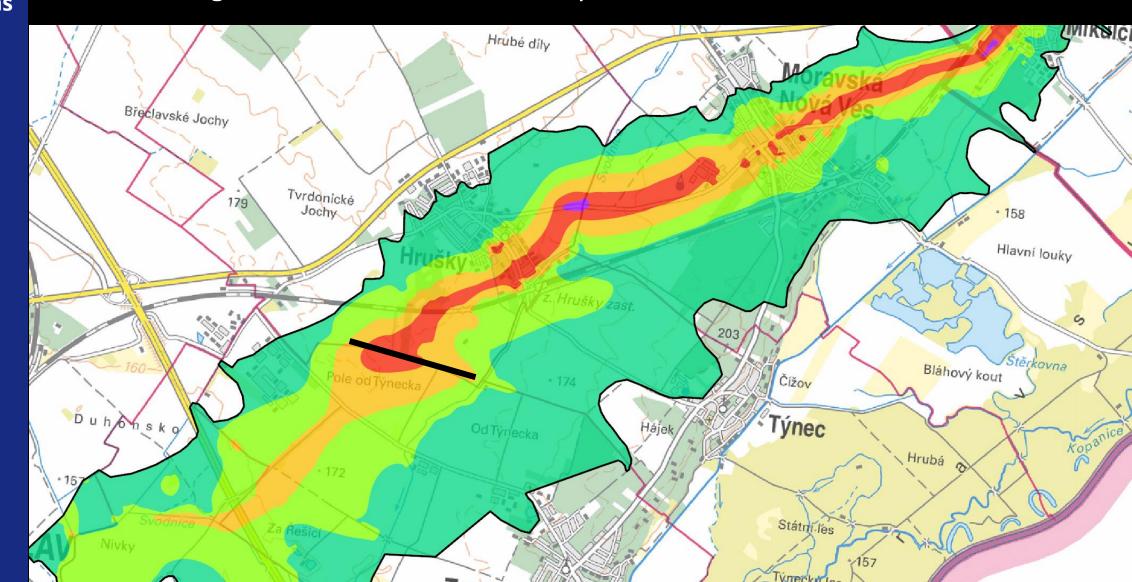
Width of the tornado

IF2 or stronger winds maximum width up to 1.3 km

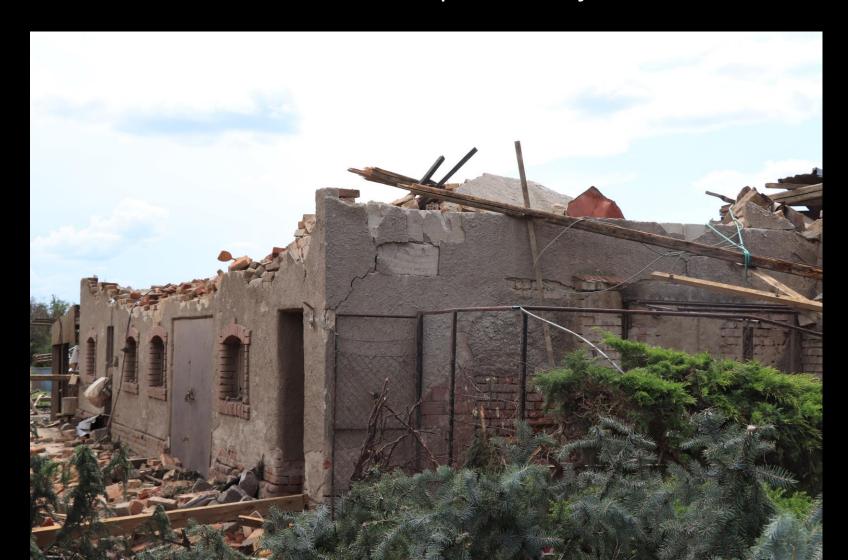
IF2 – IF3 damage to the buildings

Destruction of the roof construction and parts of adjacent walls.

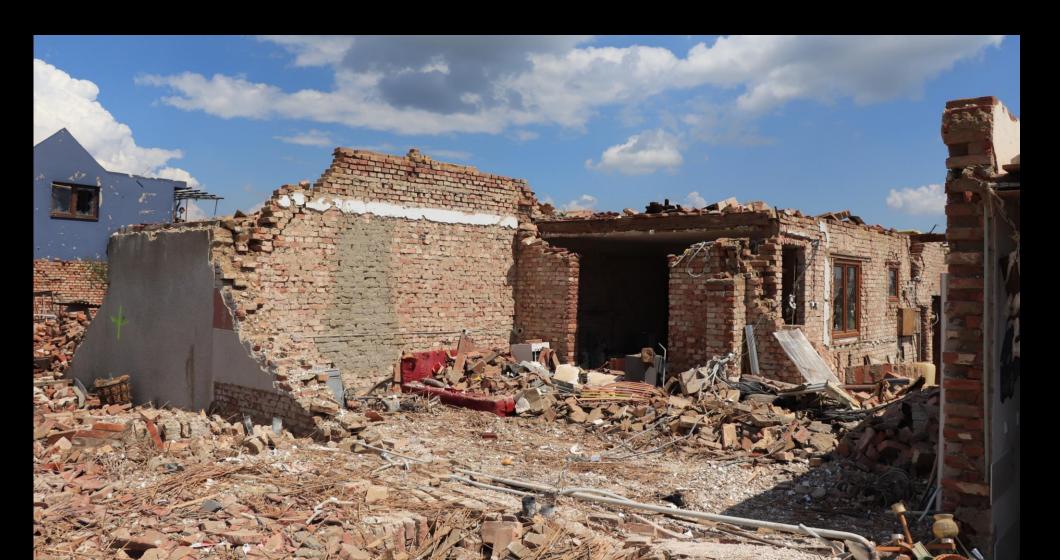
IF4 damage to the buildings

Awarded to 14 buildings out of approximately 3000 affected (0.5%)

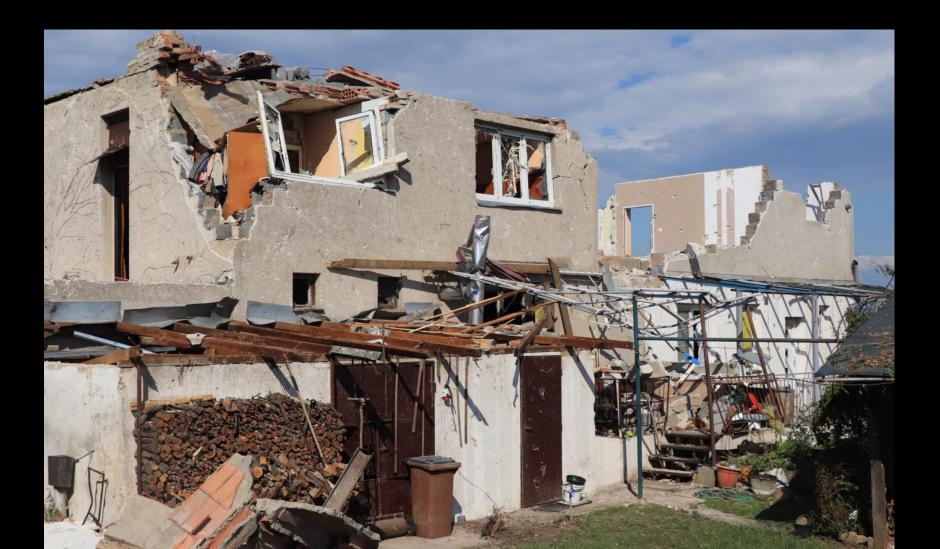
IF4 damage to the buildings

Destruction of the load-bearing brick walls with thickness of 15+ cm
