Severe wind damage in Córdoba, Spain, 9 March 2024 linked to a possible cold-frontal misocyclone

Delia Gutiérrez¹ (dgutierrezr@aemet.es), Juan de Dios Soriano¹

(1) AEMET, Agencia Estatal de Meteorología

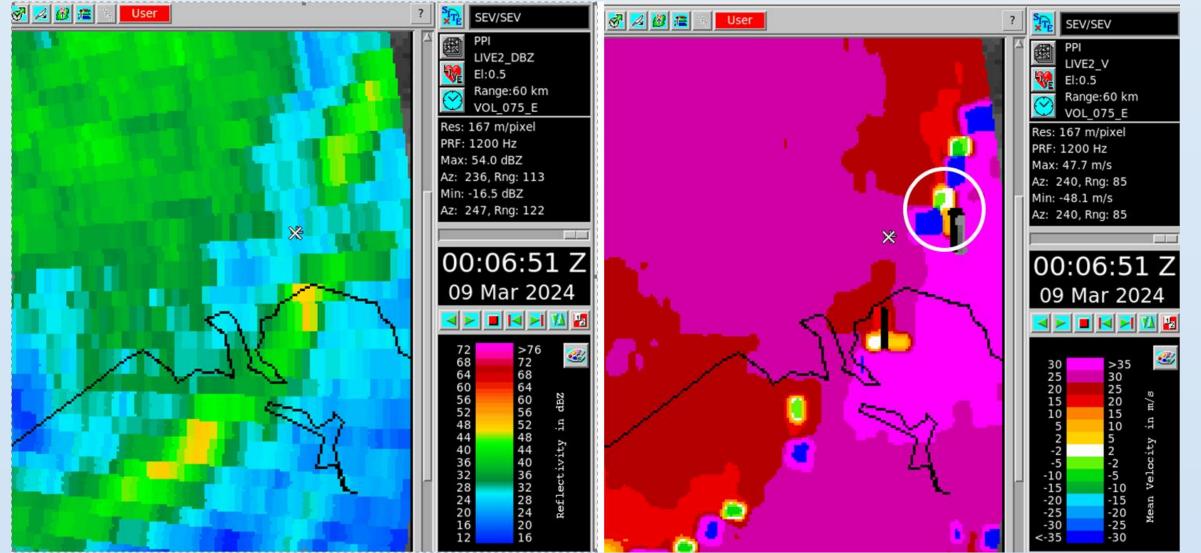
Reflectivity (left) and radial velocity (right), 00:06 UTC. White cross marks the location of the damaged power plant. A circle (right) surrounds the possible misocyclone that may have passed over the plant. The vortex coincides with the gap in the reflectivity pattern (left). The maximum exit velocity south of the vortex, after accounting for aliasing, is estimated to be ≥ 58 m/s. The radar beam elevation at this location is ~ 2,200 m

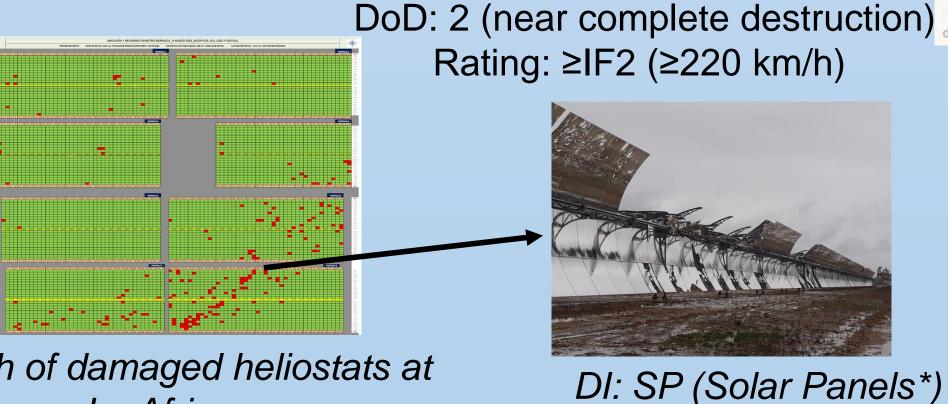
Path of damaged heliostats at La Africana.

AWS at the SW end recorded 96.48 km/h at 00:06 UTC

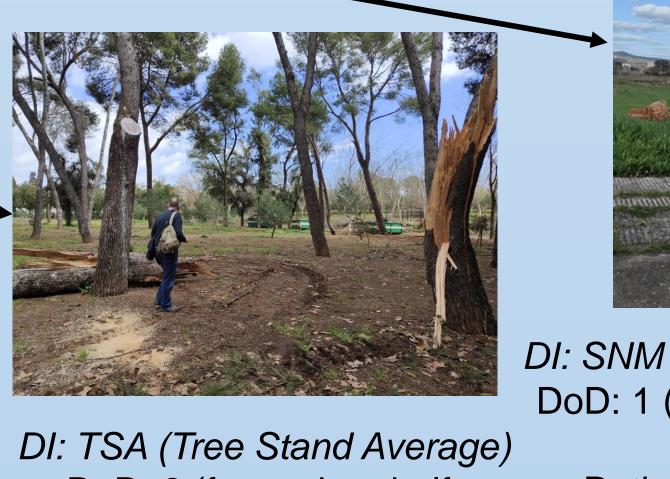
DI: TSA (Tree Stand Average DoD: 2 (fewer than half snapped or uprooted) Rating: IF1 (150 km/h)

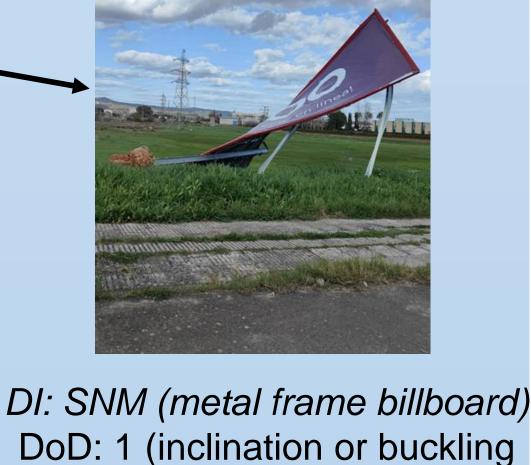
of pillars)
Rating: IF1.5 (180 km/h)
