INTRODUCTION

EFFECTS OF VERTICAL GROUND MOTION IN BUILDINGS IN THE 2016 AMATRICE EARTHQUAKE AFFECTED AREA (Figs. 9-16)

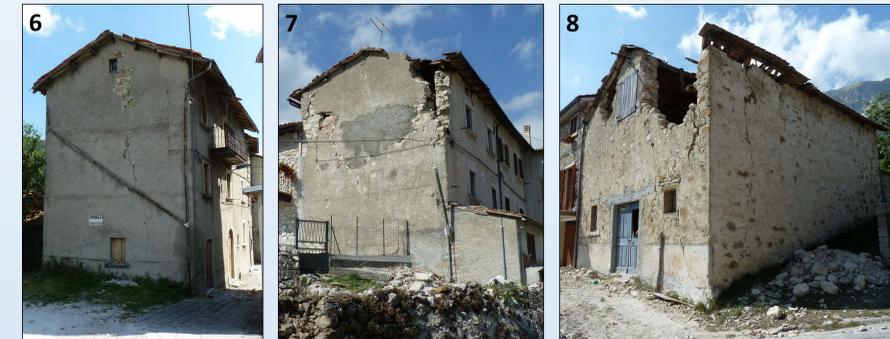
On 2016.08.25, after the main shock

On 2016.08.26 After an Mw 4.8 aftershock
