Evidence of natural hazards in the lower Yellow River: A close look at bank collapses

Lu Gao and Xiangzhou Xu*

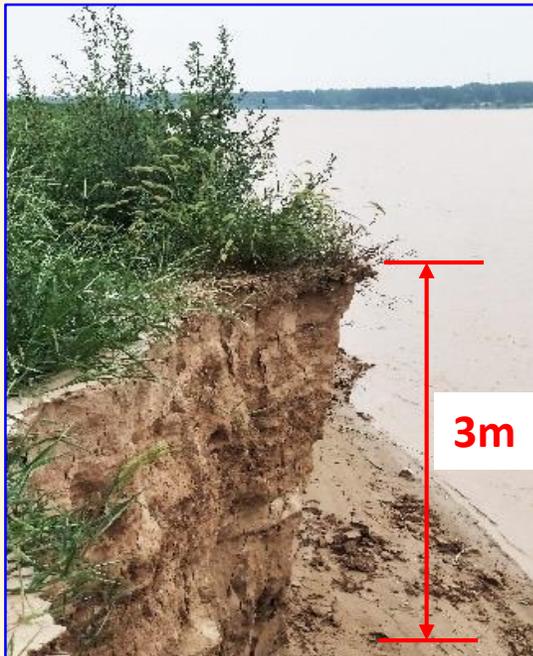
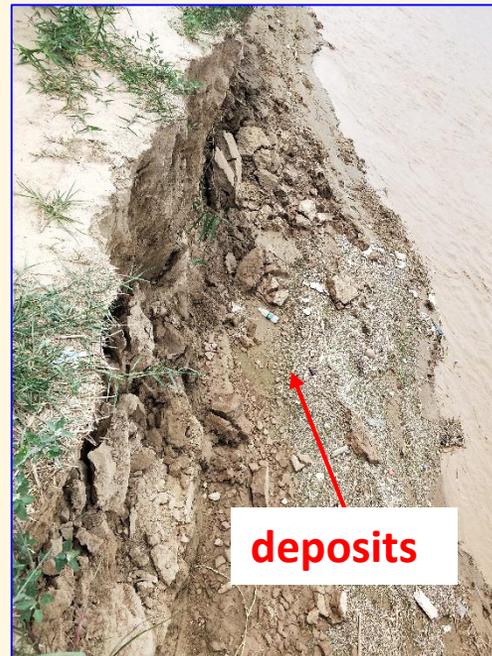
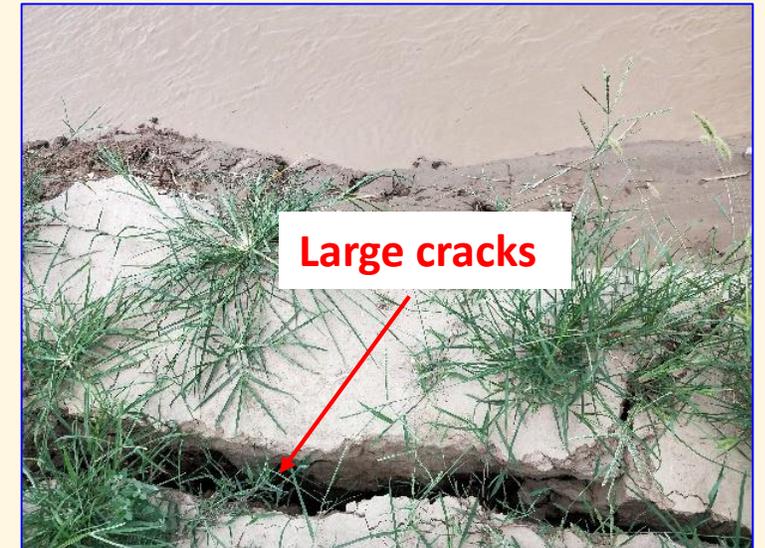
Figures show the Dongming Reach with **wandering characteristics**. **Planar failures** were probably the main types of riverbank failure that occurred in this reach. Some **deposits** were clearly observed at the foot of the slope, which could protect the near-shore riverbed. It is also found that **the riverbank was unstable** and the bank may collapse at any time due to the presence of **large cracks** in the riverbank.

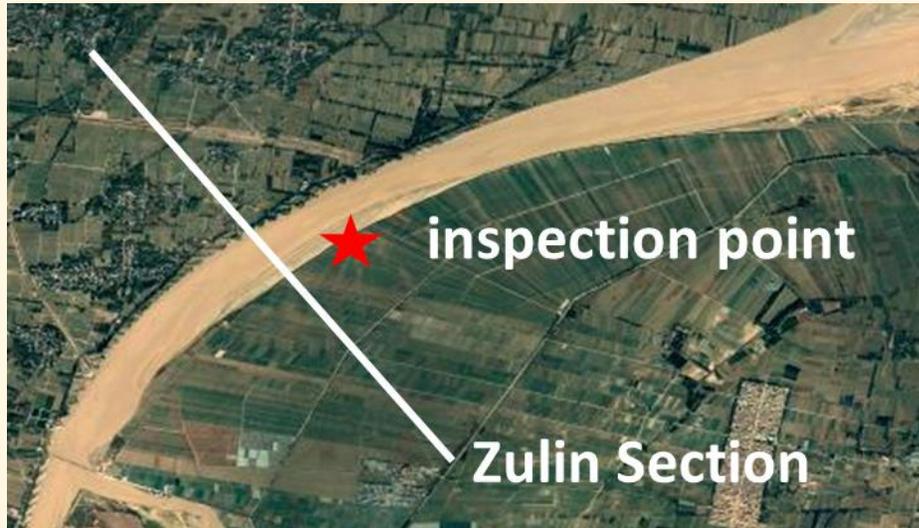
The shoreline is at an angle to the flow direction in the channels. Coincidentally, the bank collapse of Dongming section has been affected for this reason. In fact, **there are no protective measures on the riverbank** and the upstream water directly scours the riverbank, which causes serious problems.

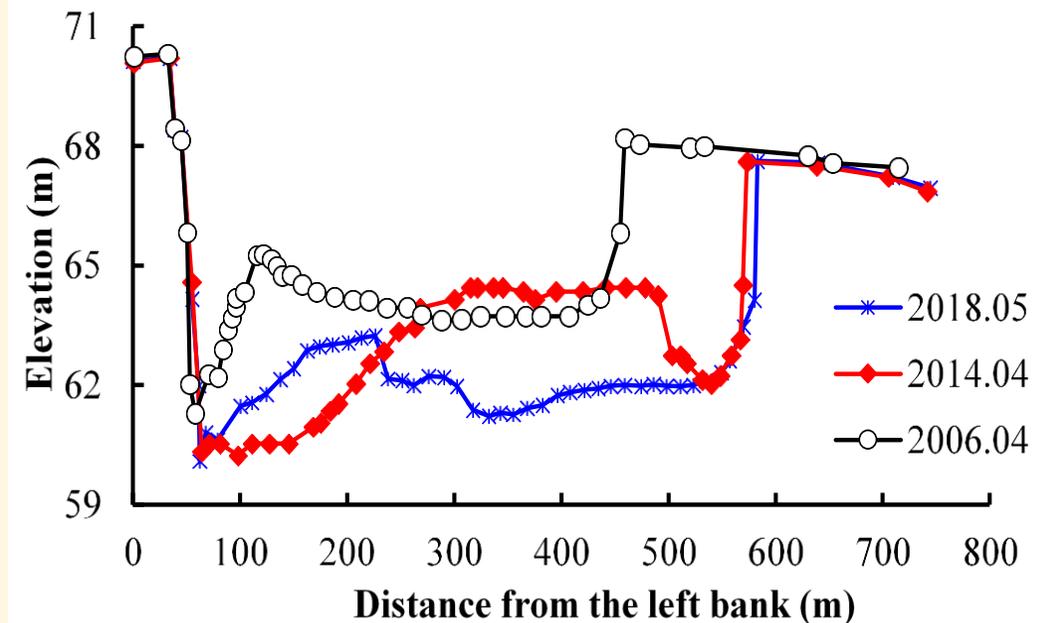
We obtained the changes of cross-sectional profiles at the **Zhulin section near the investigation** in Dongming Reach. During the period 2006-2018, the **right bank** has retreated **124 m** in the past 12 years, especially its lateral displacement reached **114 m during the period 2006-2014**, while the annual-lateral displacement was **10.3 m/a**.

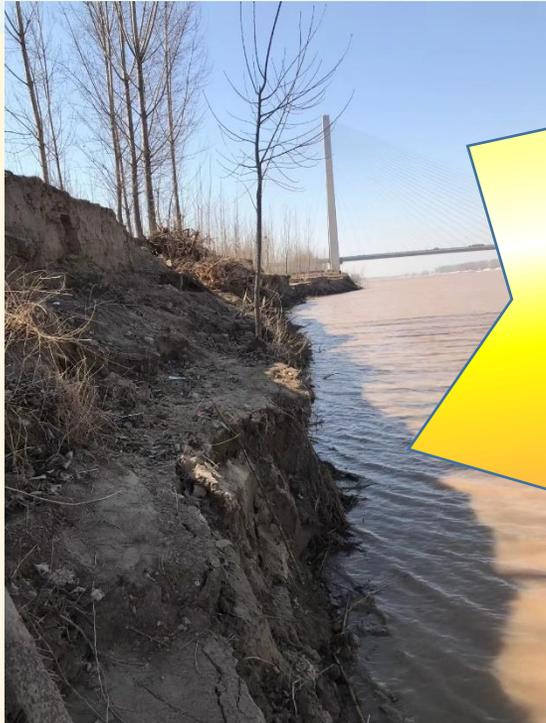
The Jiyang Reach is a **narrow reach**. In the river reach and adjacent downstream, the Daliudian river-control works were scoured extensively because of the significant changes in the local flow regime. Similarly, many cracks were also observed on the bank slope, and the failure type was the **upward-concave collapse**.

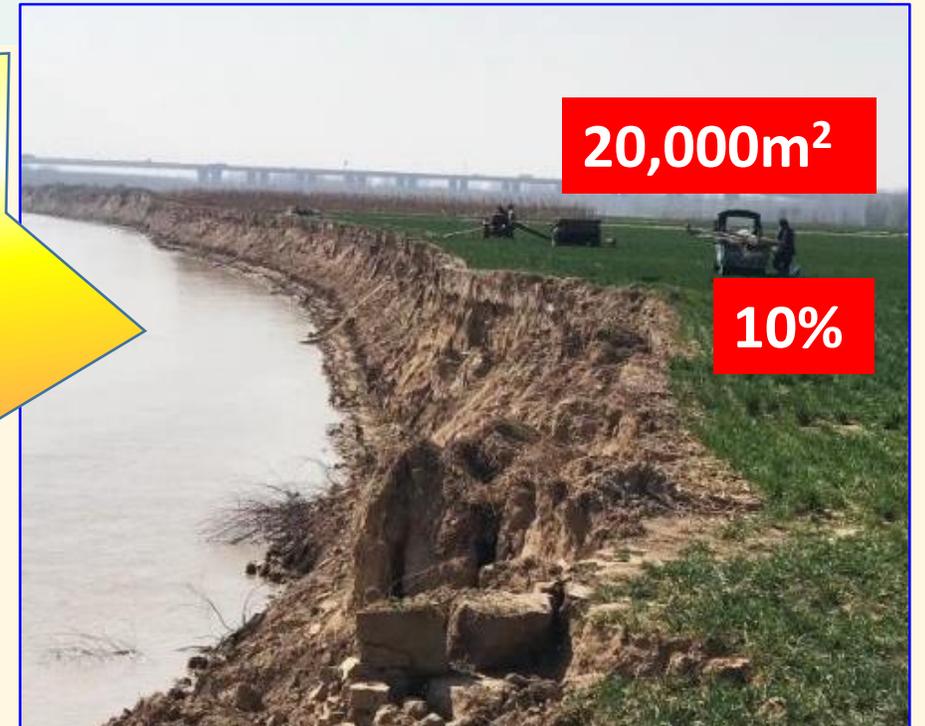
The erosional process still remains active to the present.

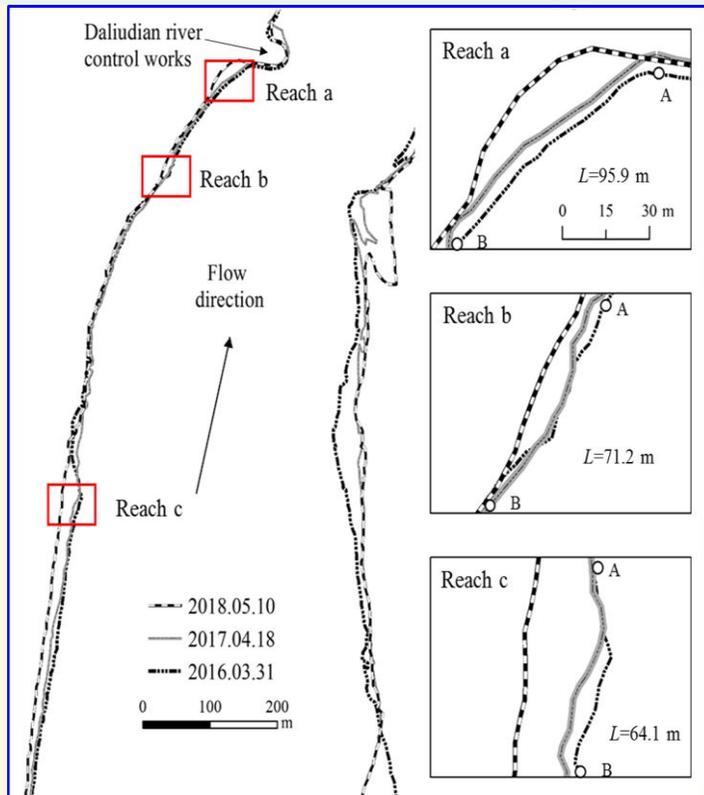
The bank lines we got from the satellite images show that the degrees of collapse on the left bank were different during the phase of 2016-2018. We further studied the bank collapses of the **Reaches a, b and c**.

Reach	Characteristic	Duration		
		3/31/2016-4/18/2017	4/18/2017-5/10/2018	3/31/2016-5/10/2018
Reach a	L (m)	95.9	95.9	95.9
	A_R (m ²)	419.0	801.3	1220.4
	A_D (m ²)	0.0	-13.8	-13.8
	\overline{B}_{La} (m)	4.4	8.2	12.6
	B_{pm} (m/a)	5.8	15.5	15.5
Reach b	L (m)	71.2	71.2	71.2
	A_R (m ²)	87.1	415.9	502.9
	A_D (m ²)	-52.8	0.0	-52.8
	\overline{B}_{La} (m)	0.5	5.8	6.3
	B_{pm} (m/a)	4.2	9.7	9.7
Reach c	L (m)	64.1	64.1	64.1
	A_R (m ²)	240.2	1287.9	1528.1
	A_D (m ²)	-4.8	0.0	-4.8
	\overline{B}_{La} (m)	3.7	20.1	23.8
	B_{pm} (m/a)	7.4	26.0	26.0
Average	L (m)	77.1	77.1	77.1
	A_R (m ²)	248.8	835.0	1083.8
	A_D (m ²)	-19.2	-4.6	-23.8
	\overline{B}_{La} (m)	2.8	11.4	14.2
Maximum	B_{pm} (m/a)	7.4	26.0	26.0

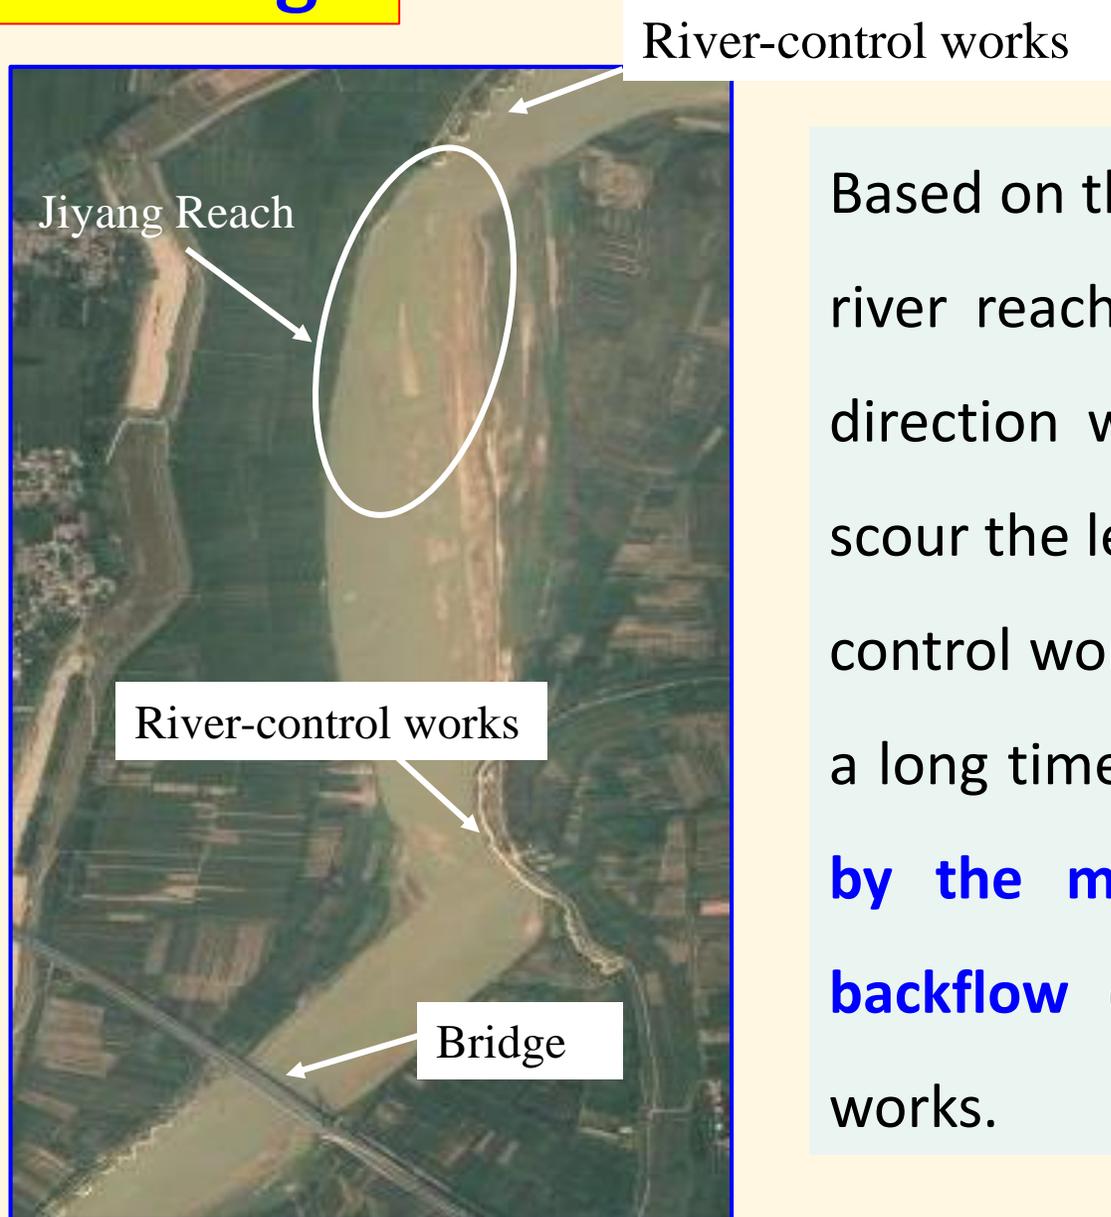
Based on the characteristics of the wandering river reach, a change of the upstream flow direction will make the mainstream directly scour the left bank due to the upstream river-control works and bridge piers. Therefore, for a long time, the riverbank has been **attacked by the mainstream** and **scoured by the backflow** due to the downstream control works.

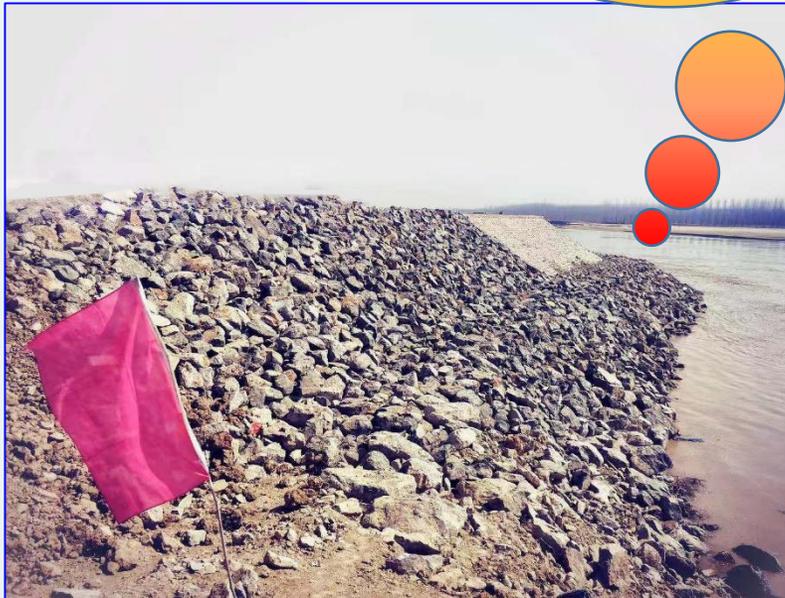
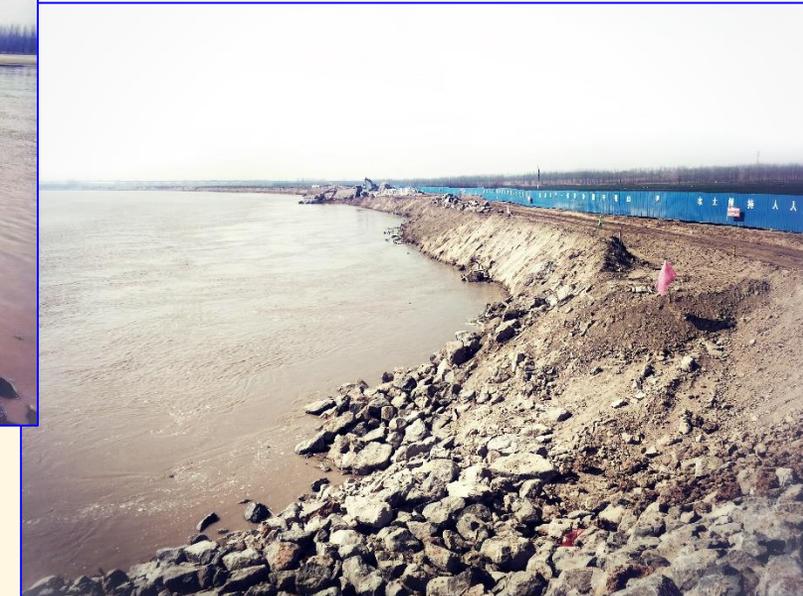
Presently, a combined management solution of riprap and gabions is popularly used in the bank-restoration projects in the lower Yellow River.

Shortcoming:

- High price
- An insufficient amount of material
- Low number of skillful stonemasons

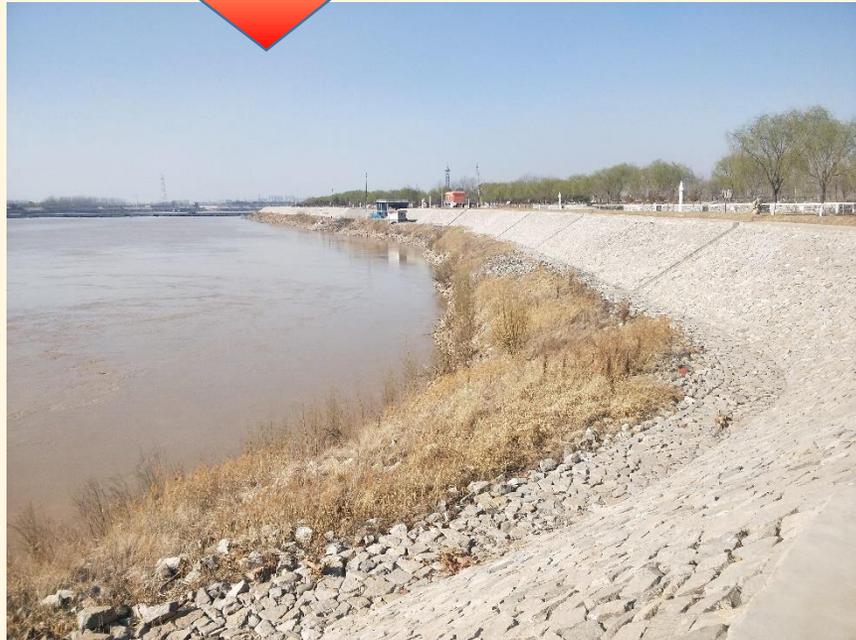
In the lower Yellow River, the **proportion of hard revetment is still high**. The hard revetment is not conducive to the development of an ecological environment and also undesirable as a basin-wide solution in the future.

A two-pronged approach is envisaged to **establish an ecological bank protection work**, which can realize the function of protecting the riverbank, improve the ecological environment, and even construct a waterside pavilion. **Looking for such ecological construction measures has become a hot topic in river management research.**
