# Durability of a ventilated stone facade: A case study of a limestone facade affected by the corrosion of the anchorage system

D728 | EGU2020-3755

The present study aims understanding causes of the **corrosion** of an anchorage system of a **ventilated stone façade** cladded with the Portuguese limestone "Lioz".

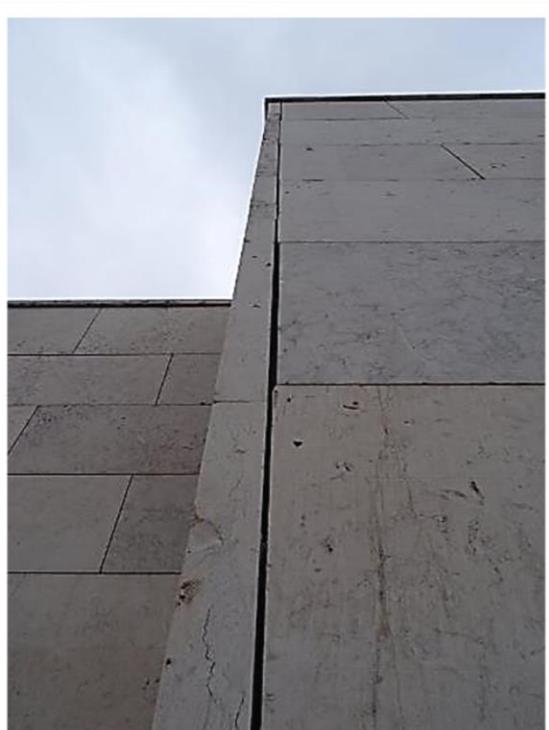
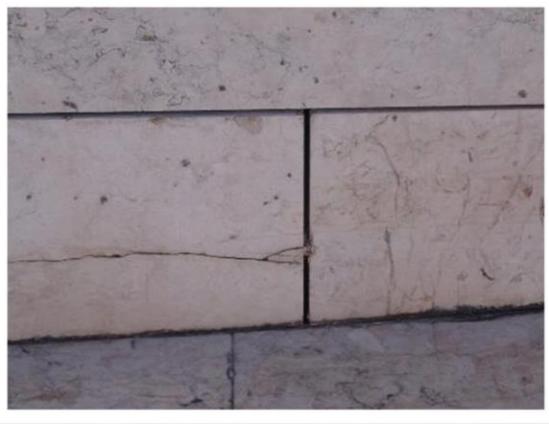
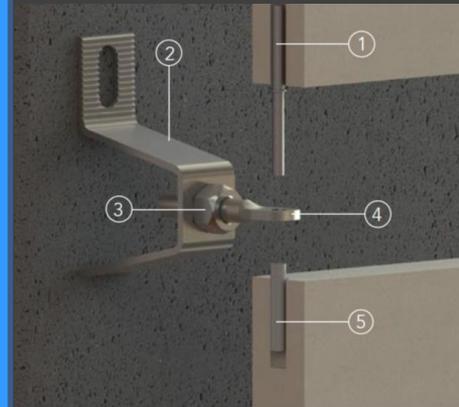
## Lioz limestone ventilated façade

- | 20 years in service
- | Public building
- | Low maintenance = light cleaning on year 10 and 20
- | Dowel-hole anchor stainless steel system
- | Enclosure support = concrete walls
- | Identification of fissures, ruptures, detachments

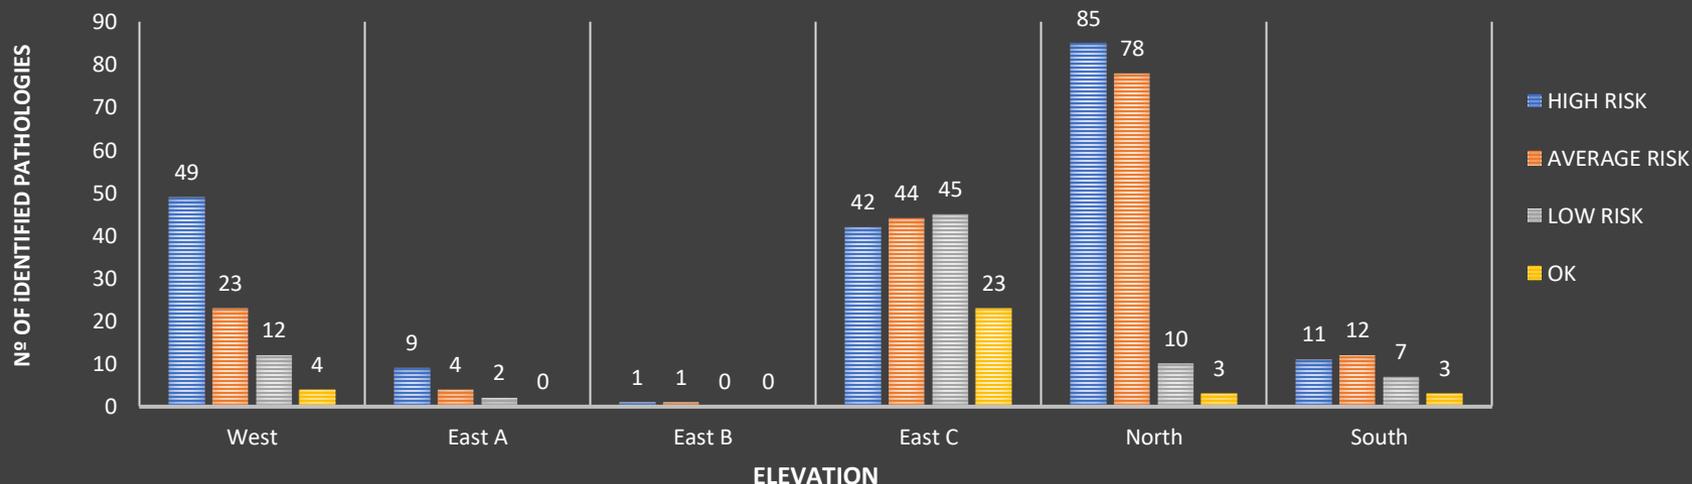
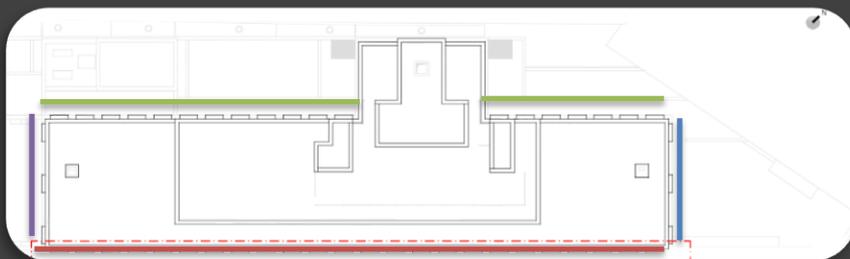
North  
South  
East  
West

- | 48% issues depicted high risk @ North elevation
- | 27% issues depicted high risk @ East elevation
- | High risk is linked to a higher probability of cladding failure
- | High risk = anchoring system with corrosion + stone slab with critical pathology

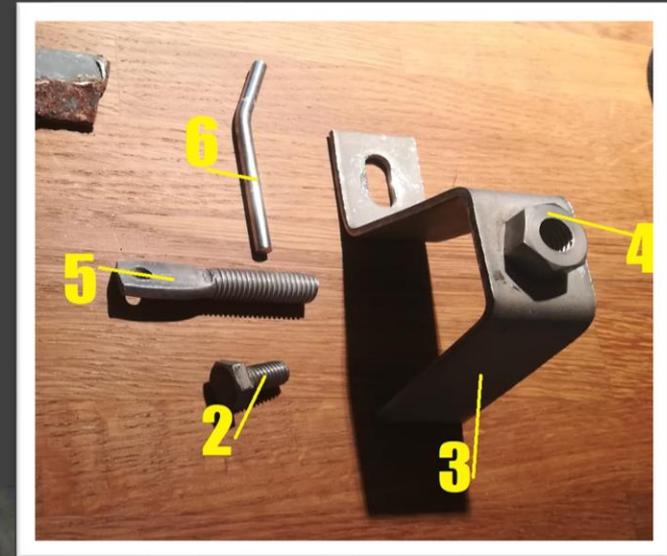
- | #6 – A2/304 steel suitable for standard environmental conditions
- | #5 – A4/316 steel improved composition for aggressive environmental conditions but not resistant to seawater.
- | #4 – A1/303 steel good workability but only suitable for mild environmental conditions
- | #3 & #2 – A3 similar to A2/304 with stabilized conditions

Anchor system item ref.	Elements (%)									Steel type	Corrosion resistance
	C	Si	Mn	P	S	Cr	Mo	Ni	Cu		
# 2	0.06	0.42	1.6	0.036	0.015	18.2	0.28	9.4	---	A3	++
# 3	0.05	0.38	1.7	0.028	<0.008	18.5	0.30	8.7	---	A3	++
# 4	0.04	----	1.6	----	0.33	17.3	0.44	8.7	0.42	A1	-
# 5	0.04	0.62	0.8 8	0.029	<0.008	17.3	2.2	10. 5	> 1.9	A4	+++
# 6	0.10	0.59	1.7	0.029	> 0.04	19.5	0.54	7.8	---	A2	+

- Anchor **item #4** is made of **A1 stainless steel** which is highly unsuitable for the load + slab size + environment.
- **60%** of **#4 anchor items** present severe **pitting corrosion** = environmental+ stress + poor installation combination.

- **Aprox. 60%** of the inspected **stone slabs** were classified has **high risk** for collapse. Replacement was recommended.
- All **anchor items** should at least made of **A4** stainless steel = better corrosion and mechanical performance.

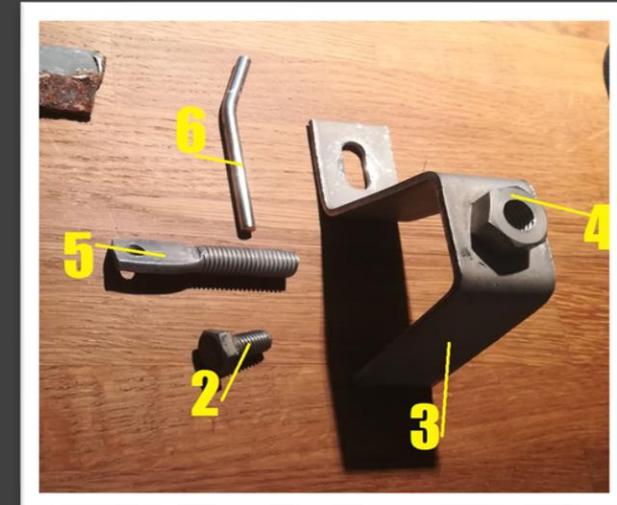
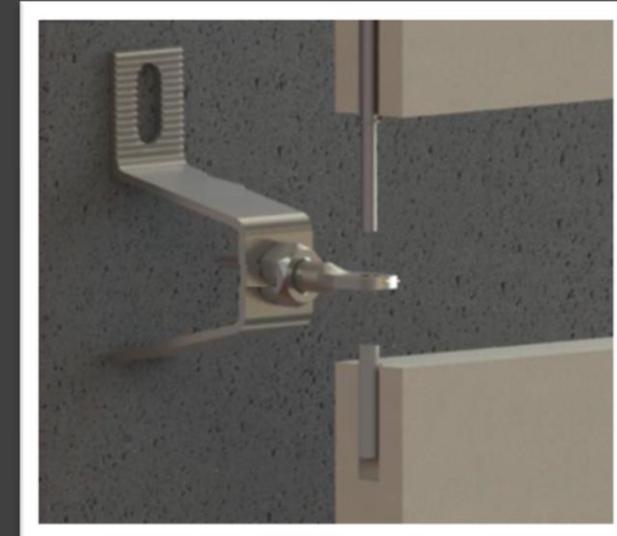
- Most stone drilling was made on site = poor work quality.
- **98%** of the inspected anchor items show corrosion at several levels between severe and mild.

- Corrosion of metals is a kinetic process, which occurs at a certain speed and which allows, once a critical degradation level is reached, failure at the anchor and consequent rupture of the Lioz slab. Failure of the anchor elements will occur by reducing the cross section of the most weakened item.
