A multi-disciplinary materials study as a contribution to evaluate degradation issues of monuments and archaeological sites towards their preservation.

HEritage Resilience Against CLimate Events on Site

Materials weathering state @ Knossos Palace, in Heraklion

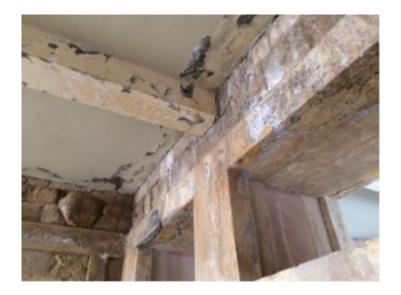
- ✓ the degradation of selenite (mineral gypsum).
- ✓ salt accumulation and efflorescence
- ✓ dark encrustations and other external accumulations

degradation of reinforced concrete (used by for restoration)

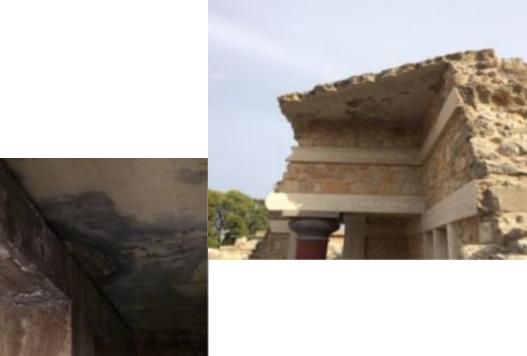
Deterioration of concrete is particularly visible and widespread at the positions where ancient architectural parts of gypsum are included in the concrete structure.

It is most likely due to moisture and possibly aggressive agents generally present in the atmosphere (e.g. carbon dioxide, sulfur dioxide), as well as to the excessive climate forcing (strong exposure to rainfalls and solar radiations). In these parts there is a diffused oxidation of rebars, due to the presence of humidity, efflorescence and local spalling of external layers of material.

Deterioration of concrete in reinforced concrete elements built during the restoration by Sir Arthur Evans .

Taking into account the diffused degradation of building, the restoration/maintenance action has to **include the removal of carbonated concrete in each portion, presenting cracking phenomena, swellings or delamination.**

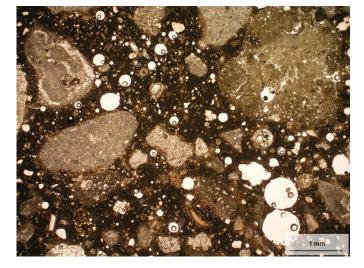
The aggregate is composed of lithic fragments, monocrystalline grains and diffuse calcium carbonate remains.

Sample D3 in plane-polarized light.

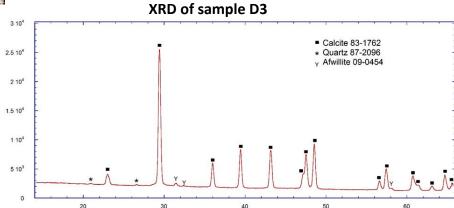
XRD revealed, in addition to the presence of calcite and quartz, **the diffraction pattern of** afwillite $(Ca_3Si_2O_4(OH)_6)$ a calcium silicate hydrate characteristics of Portland cement

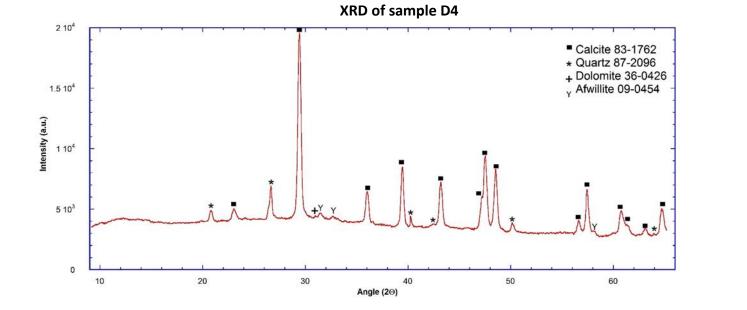
XRD analysis revealed, in addition to the presence of calcite and quartz, the

diffraction pattern of afwillite

(Ca3Si2O4(OH)6) and dolomite.

Sample D4 in plane-polarized light.

Concrete composed of a poorly sorted aggregate and it is is composed of lithic fragments, monocrystalline grains and diffuse calcium carbonate remains. The lithologies are predominantly carbonatic sedimentary rocks

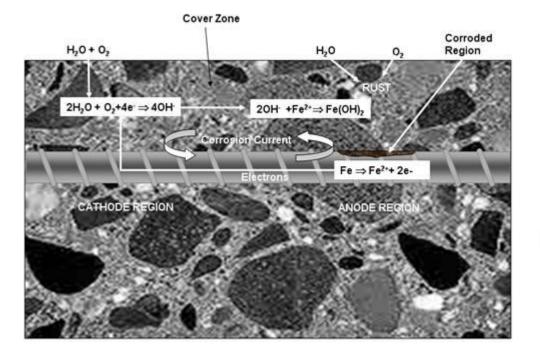
Iron bars Corrosion

Before Corrosion

Build-up of Corrosion Products

Surface Cracks,

Stains

Eventual Spalling, Corroded Bar Exposed

There is also the progressive oxidation of visible metal reinforcements that in some cases led to the bar section reduction. Integration of metal reinforcements should be provided to counterbalance the original damaged ones. The common structural and non-structural repair actions for reinforced concrete involve:

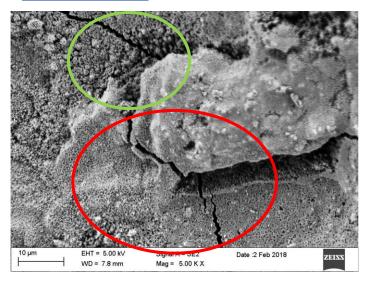
The SEM observation of the fracture surface **showed a crack propagation both transgranular and intergranular**, confirming the occurrence of a double mechanism exfoliation and stress corrosion.

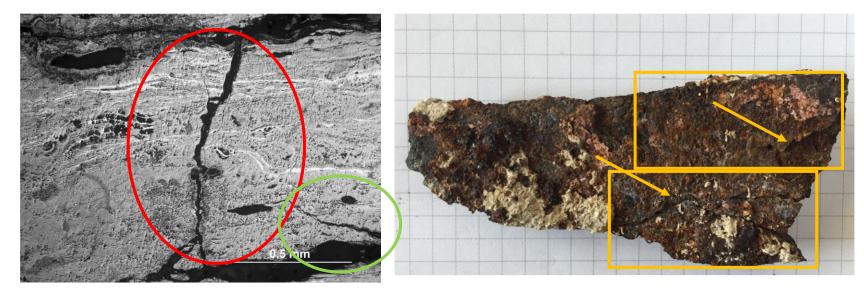
The observation at metallurgical microscope reported revealed cracks that propagated in two different directions: along the rolling axis and in a direction perpendicular to it. The corrosion propagated on layers parallel to the surface as in exfoliation corrosion. The corrosion product that formed had a greater volume than the volume of the parent metal. The increased volume forced the layers apart, and caused the metal to exfoliate. The presence of a strong exfoliation combined with the load, generated a stress corrosion attack (i.e. the result of the combined and synergistic interaction of mechanical stress and corrosion reactions). The stress corrosion produced vertical cracks.

Delamination of iron bars
