SLOPE STABILITY ANALYSIS OF EMBANKMENT DAM UNDER TOTAL AND EFFECTIVE STRESS

Tri Hartanto^{1,*}, Widjojo Adi Prakoso²

¹Department of Civil Engineering, University of Indonesia, Depok, Indonesia

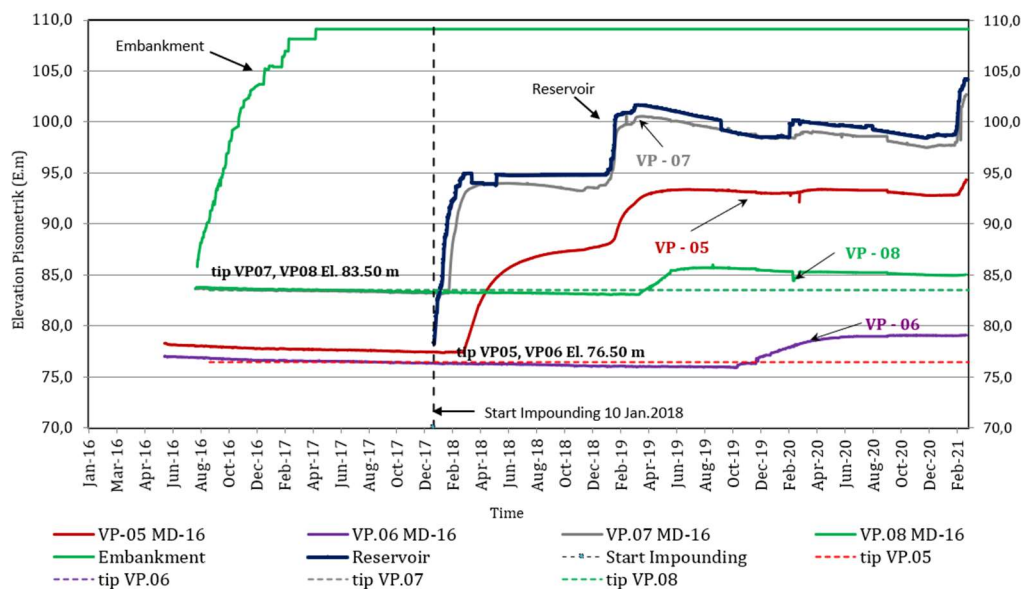
Fig 4. Piezometer reading of VP-05, VP-06, VP-07 and VP-08.

Fig 4 show time histories VP-05, VP-06, VP-07 and VP-08. Embankment started approximately on August 2016, same time with installed VP-5 and VP-6. Installed el. on 76.5 m, lowest part on clay core embankment. The embankment raising up until reaches el. 83.5 m, VP-07 and VP-08 were installed. Until el. 83.5m, VP-05 and VP-06 still no response regarding to raising the embankment. The overburden can't immediately be recorded by the instrument, probably because there is time-lag and the accuracy of the instrument itself, or some mistake when the instrumentation was installed. VP-05 and Vp-06 has response when first impounding started on January 10th, 2018. During first filling, VP-05 responding very well, correlated with raising the reservoir level. VP-06 responding very well too, because of the location of VP-06 little bit downstream from VP-05 and close from downstream filter, the response quite different

from VP-05. VP-06 started response at October 2019. VP-07 has higher reading from VP-05, reflect anomaly reading, probably caused by capacity of piezometer, the layer the piezometer was installed has moisture contents or the tip containing bubble air. Piezometer VP-5 reading should be > VP-07 reading,

After the reservoir at the steady level, approximately at el. 102 m, elevation level of VP-05, VP-06, VP-07 and VP-06 trend to decrease following time, the dissipation process happens and consolidation stages started.

However, there is an anomaly in reading VP-07, who has higher reading from VP-05, probably caused by capacity of piezometer, the layer the piezometer was installed has moisture contents or the tip containing bubble air. Piezometer VP-5 reading should be $>$ VP-07. This condition must be check very carefully and comprehensive later on.

The calibration constants for piezometer should be checked from installation details (if available) and necessary correction should be done accordingly. Continuous monitoring should be done regularly, visual observation and instrument analysis to checking dam safety of Raknamo dam. On MDE if $SF < 1$, still we need to calculate permanent deformation which is proposed by Makdisi & Seed, 1977.

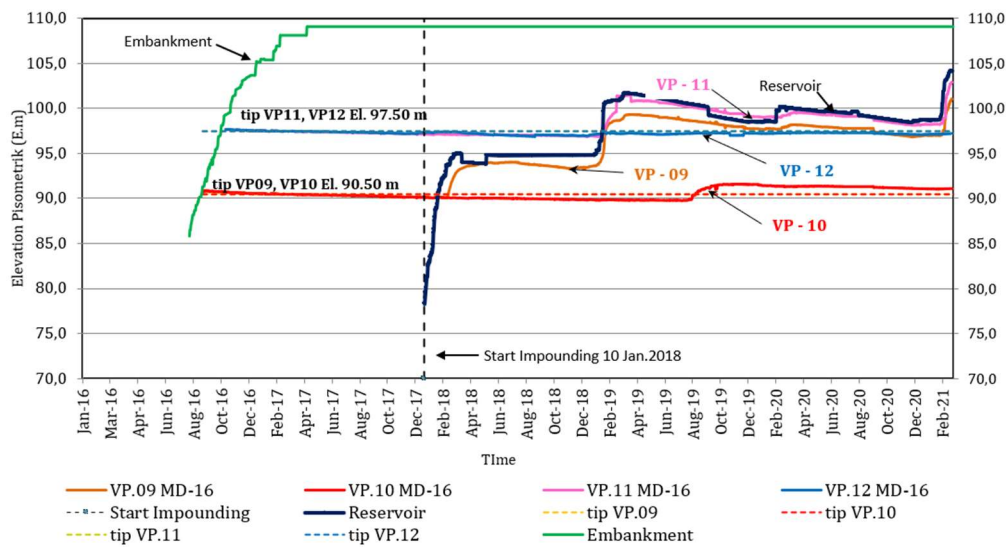
Fig 5. Piezometer reading of VP-09, VP-10, VP-11 and VP-12.

Fig 5 shows during the construction stages on VP-09, VP-10, VP-11 and VP-12 didn't response related to raising the embankment. VP-09 Soon after impounding was started, it's started to respond correspondent to reservoir level. These response same with other instruments below, reflected that the instruments doing good job to measure the pore pressure. VP-09 and VP-10 installed at el. 90.5 m, VP-11 and VP-12 installed at el. 97.5 m. VP-9 and VP11 has quick response regarding reservoir level, and VP-10 and VP 12 has slow response because its located downstream from VP-9 and VP-11.

For the same reasons, after consolidation, changes in piezometric heads are consistent with the change in the impounding level. As expected, the time lag is higher downstream and sensitivity to impounding changes is enhanced upstream.

At the end of the analysed period when the impounding level follows oscillating up to a nearly constant maximum value, stable piezometric heads seem to indicate the reaching of nearly steady state conditions, to be understood with respect to an average value of the impounding level.

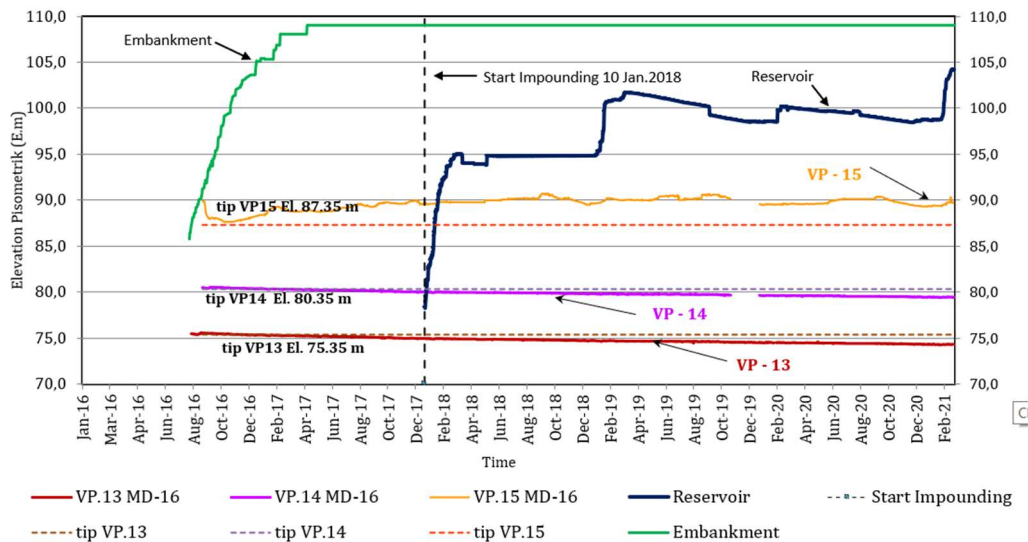
Fig 6. Piezometer reading of VP-13, VP-14, VP-15 and VP-16.

Because VP-13, VP-14, VP-15 and VP-16 installed higher elevation than other piezometer and close to crest of the dam, 10 m water head, until last monitoring (Feb 2021) still no significance response (Fig 6). This section should be placed lower than el. 80 m to read the phreatic line on random zone.
