NH3.13

Nature-based and bio-based solutions for geohazard mitigation on slopes and streambanks ▶

“Nature based Solutions and combined techniques in the immediate vicinity of infrastructure and residential areas - 5 case studies of steep bank stabilization in the Garonne water catchment area in France realized between 1999 and 2022

Klaus Peklo Dipl.-Ing., graduate engineer

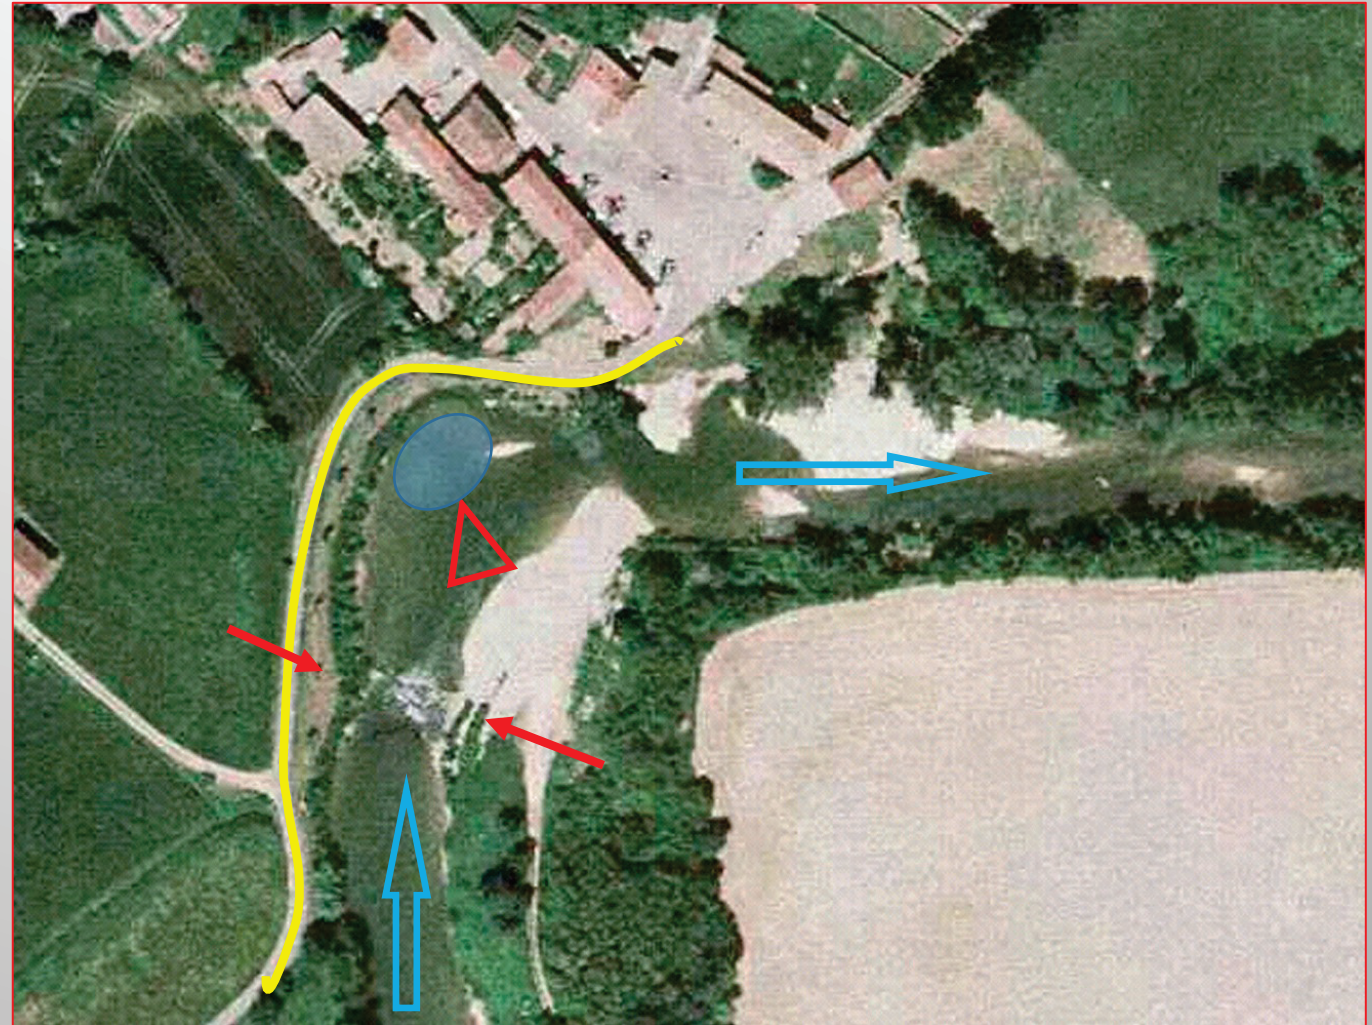
Damage case: Far advanced bed and bank erosion; imminent risk of undermined embankment collapse threatening public space and communal road

Geometric shape: Variable bed width 30/50m; bank height 6m, subvertical and variable slope gradient; 50 year design flood $Q_{50} \sim 600\text{m}^3/\text{s}$

Provided longitudinal construction: Horizontal willow fascine, live Log Cribwall, live Brush Mattress, Brush Layers, Log branch cutting

Provided transversal construction: 40 m wide 3D transversal Rough Ramp anchored in live RipRap

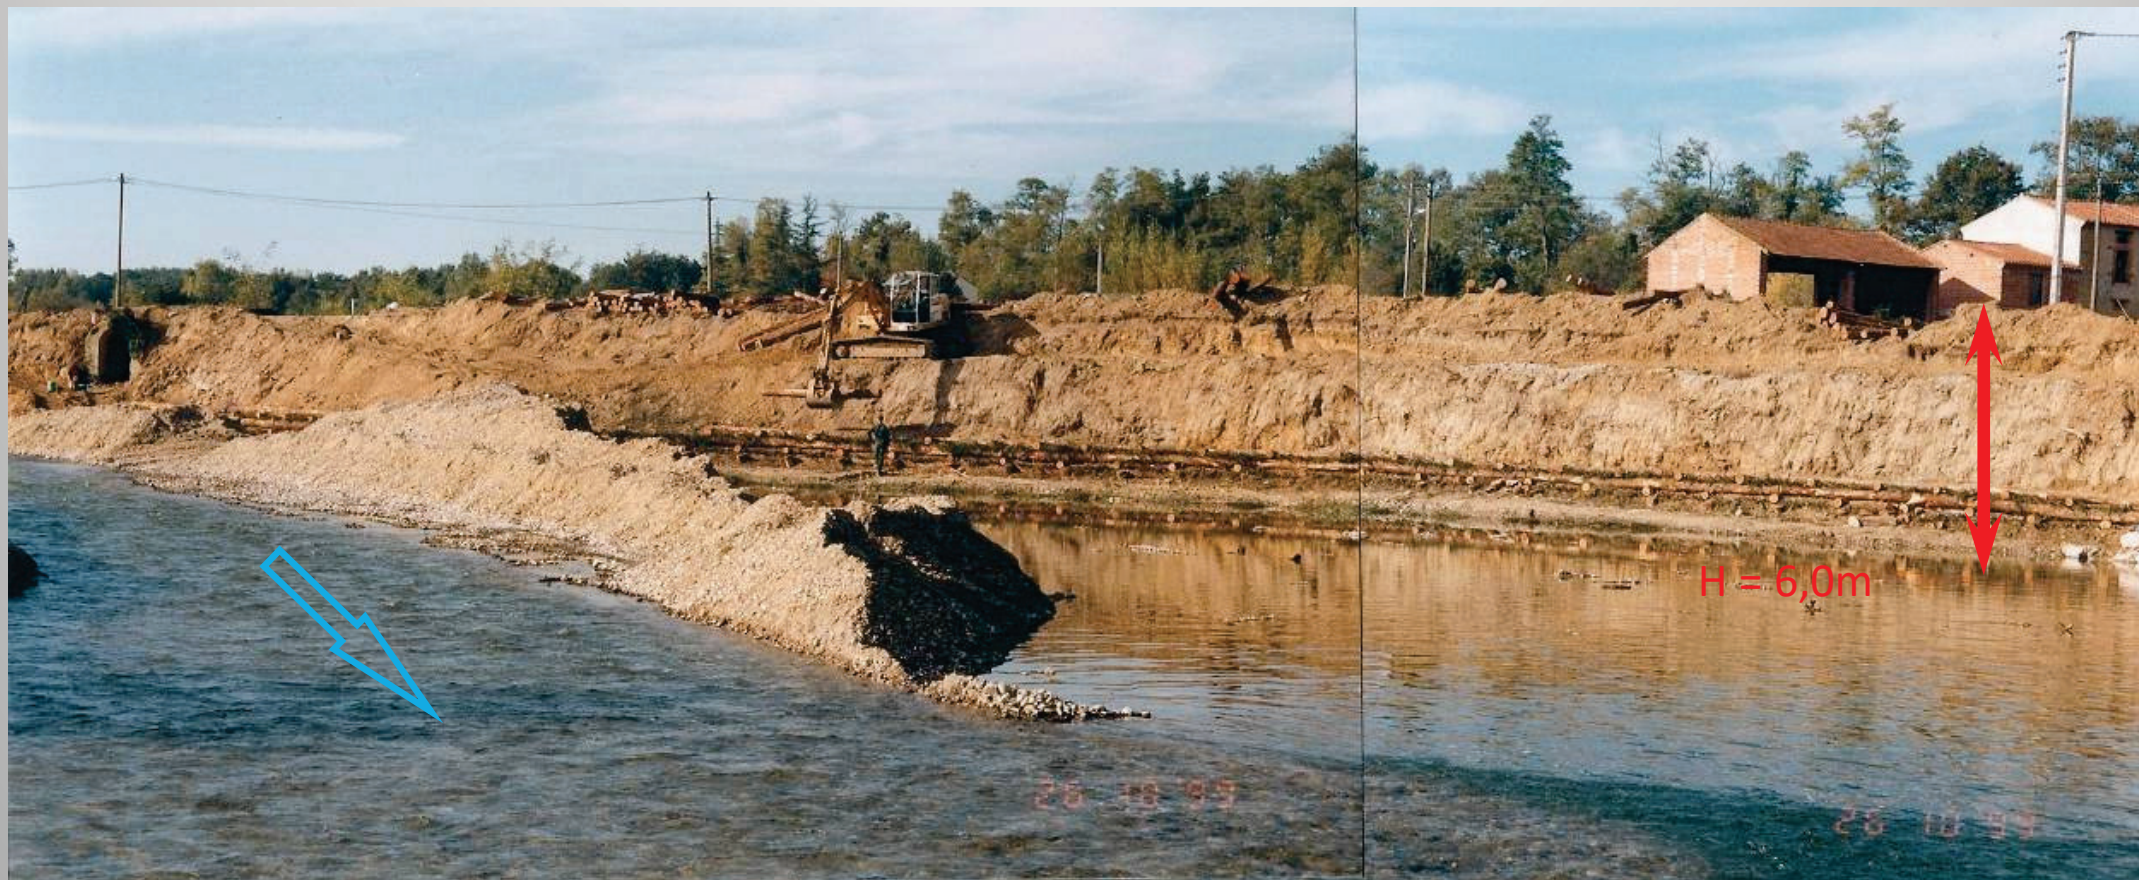
Construction stage this photo: during end of octobre 1999 on left bank

Construction aim: Permanent riverbed shifting to right riverbank and vegetated
Log Cribwall fastening

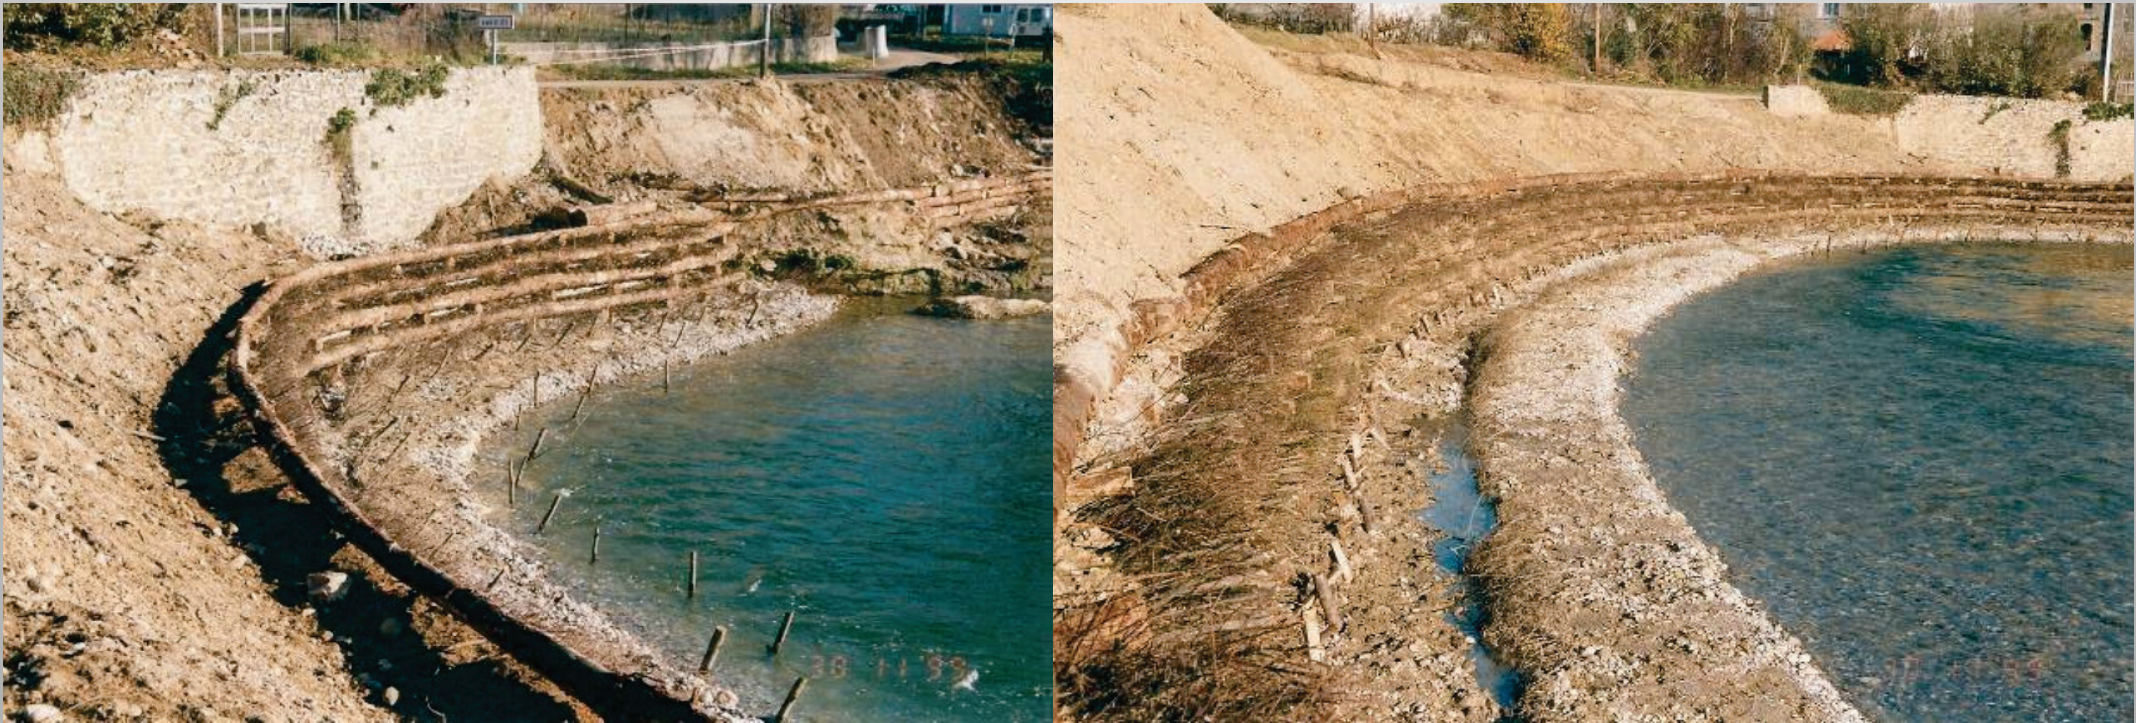
Construction stage during winter 1999: Longitudinal left bank protection ongoing as vegetated Log Cribwall

Anchoring depth = 2,50m strengthened with local plant cuttings in order to obtain a riparian stratum of Salix shrub

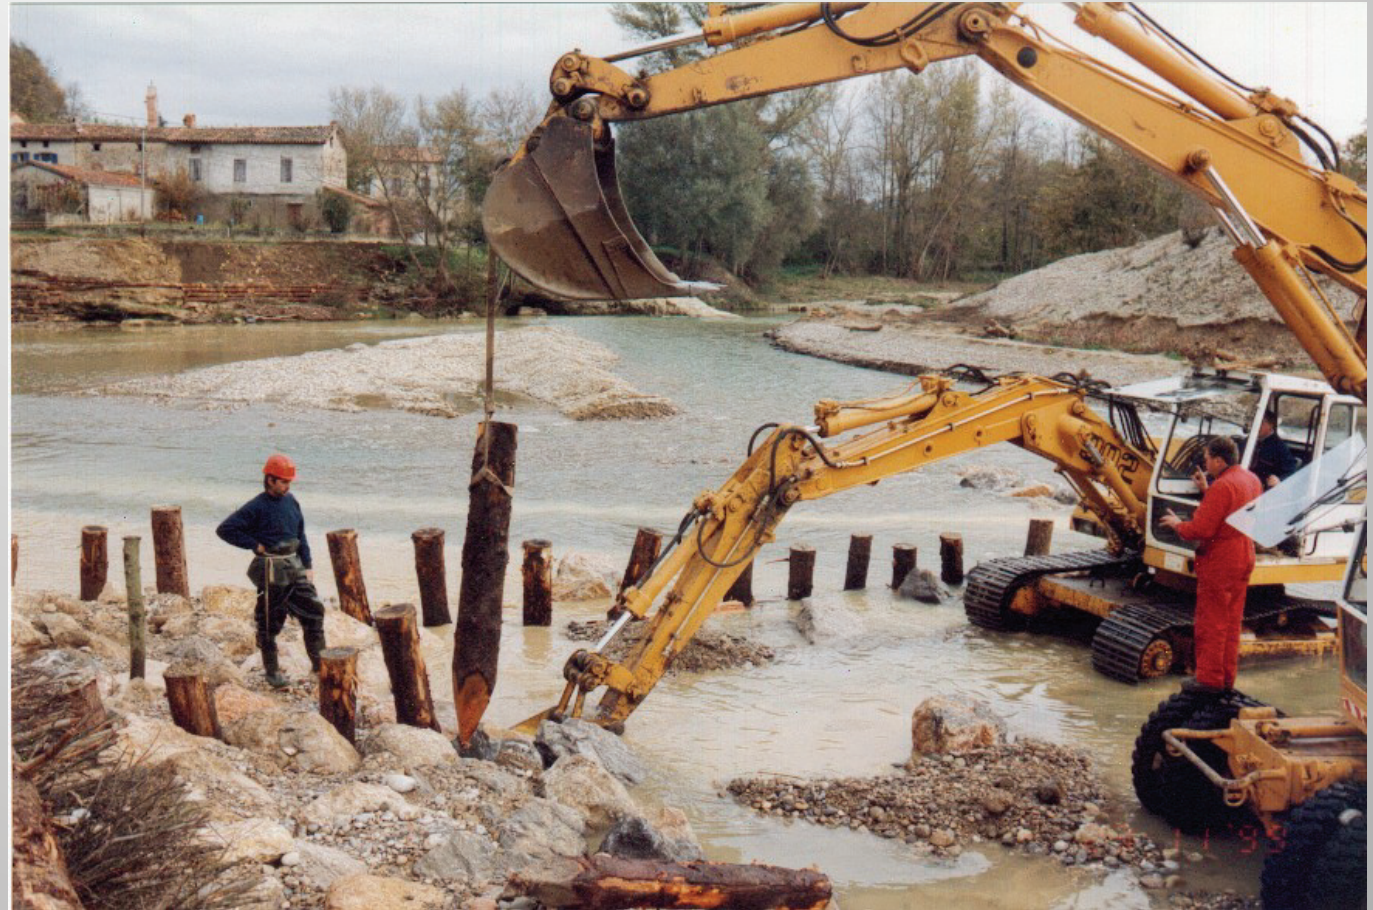
Construction stage during winter 1999: 3D transversal Rough Ramp construction ongoing

Larix decidua pile driving activity
into river alluvium in progress >>

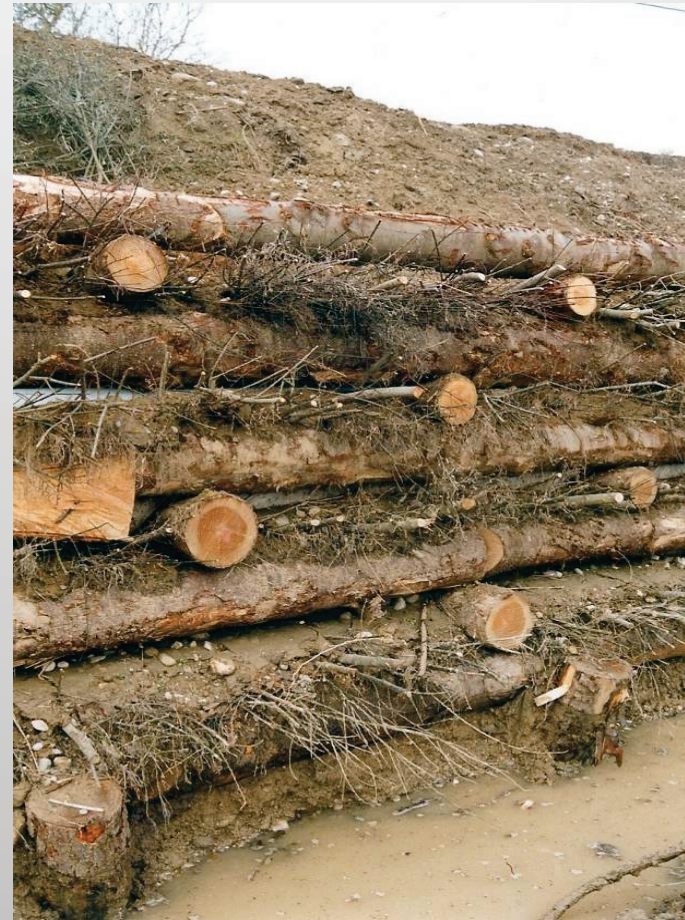
Lifetime cycle: Detail of Log Cribwall – notice the off-centered position of wooden cross pieces

Picture taken after 600m³/s flood event in April 2000

Front of vegetated reinforced
Log Cribwall constructed from
Larix decidua felled in the
highlands of the Pyrenees

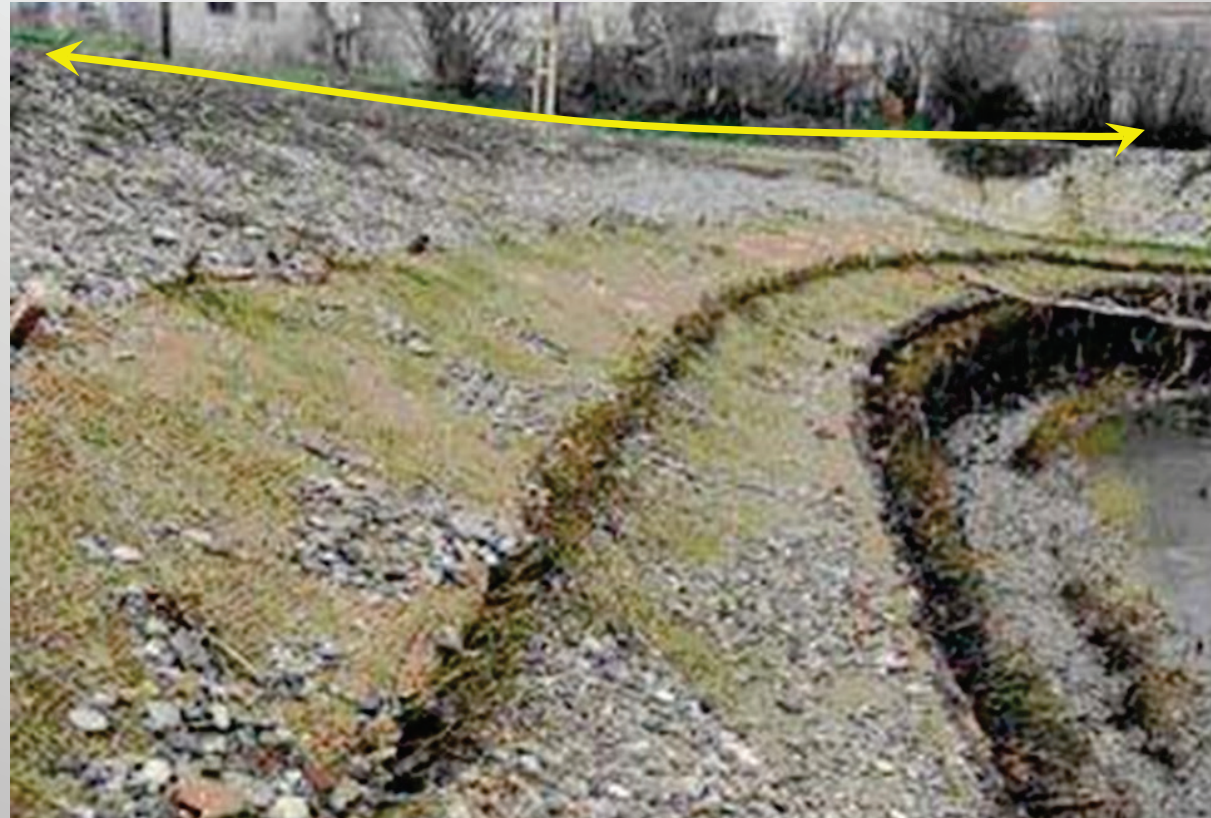
Lifetime cycle April 2000: State after the 1st stress-test

5 months after completion, a flood event occurring of ~ 6,50m height

The yellow line indicates the position of the communal road also the highest floodlevel

Bed and bank: No damage caused by the flood

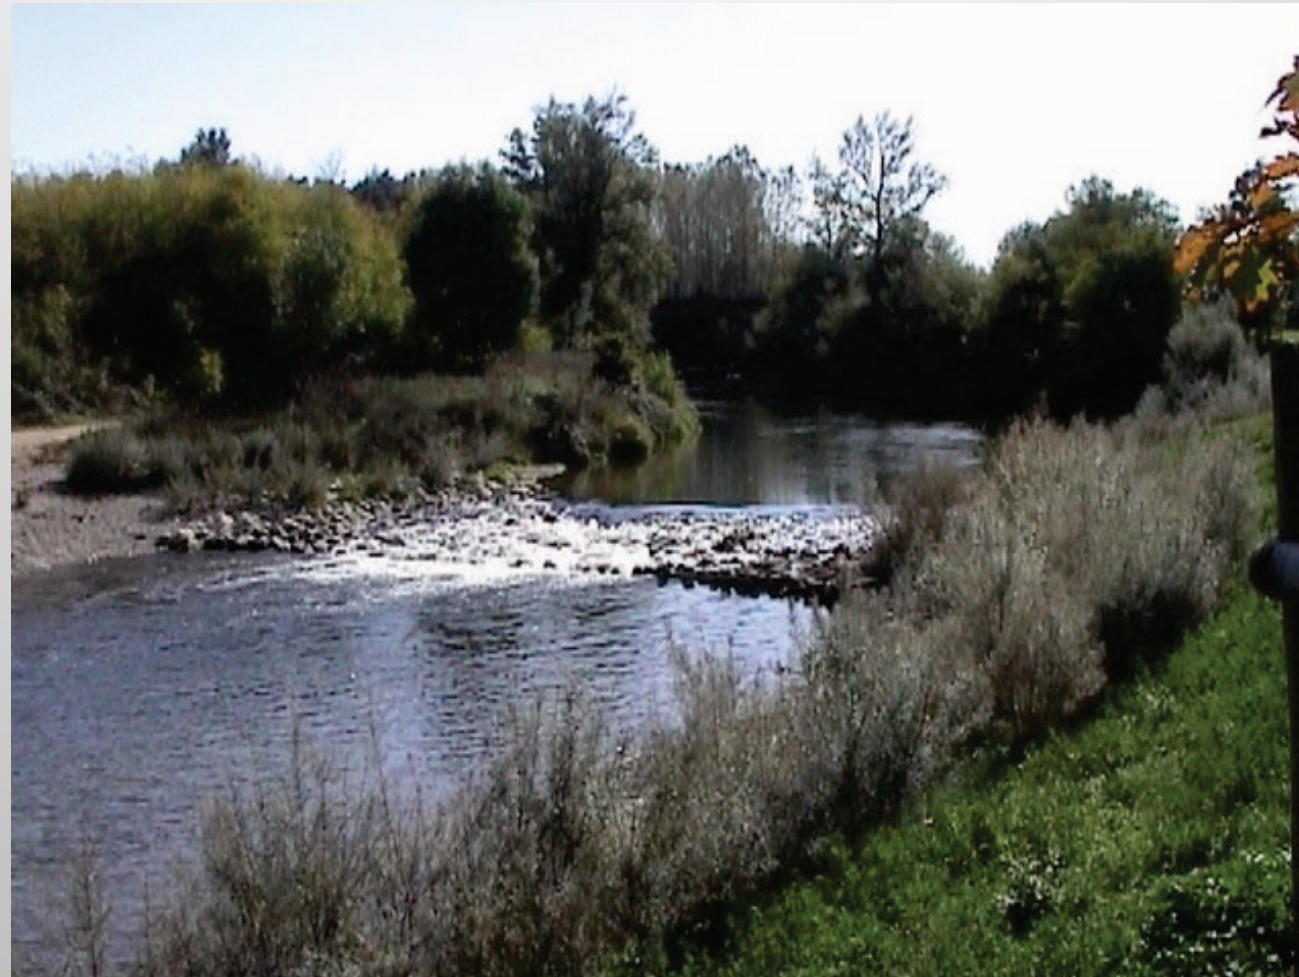
Lifetime cycle 2005: Upstream picture towards 3D Hydraulic Rough Ramp anchoring into right bank

Background: Vegetated RipRap integrating anchoring on both Riversides >>

View towards upstream in 2005 of the 3D rough boulder ramp and the flanking vegetatively reinforced bank. The intended river bottom elevation in upstream to obtain velocity reduction through sediment deposition is clearly visible.

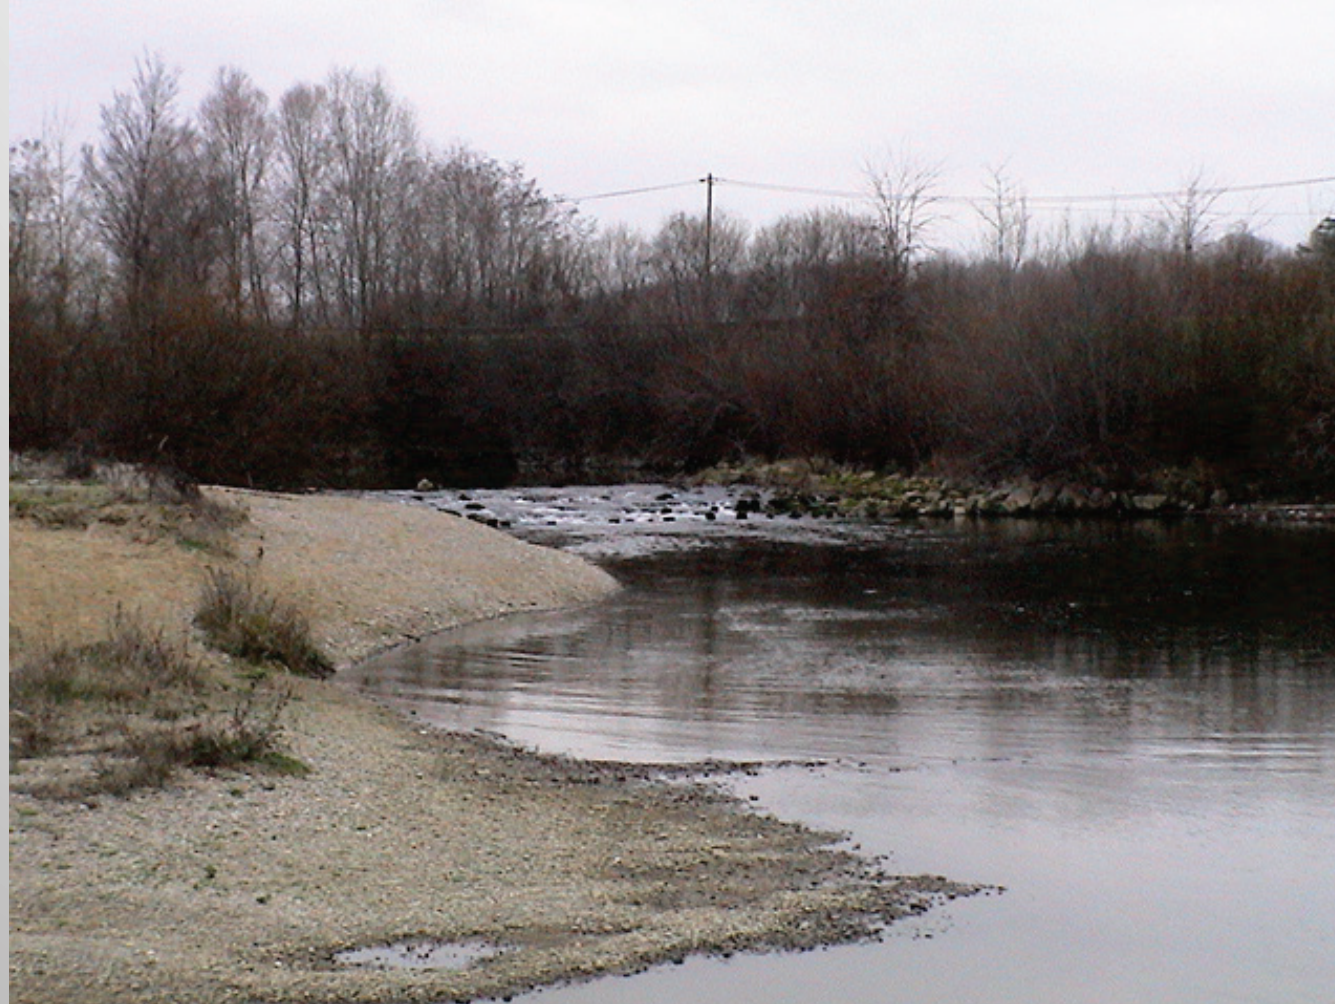
Lifetime cycle winter 2007: Upstream picture towards Rough Ramp anchoring into left bank

Always working in perfect condition, the Rough Ramp avoids erosion damage on LRB by deviating floods to RRB and provides free river oxygenation and enjoyment for bathers >>

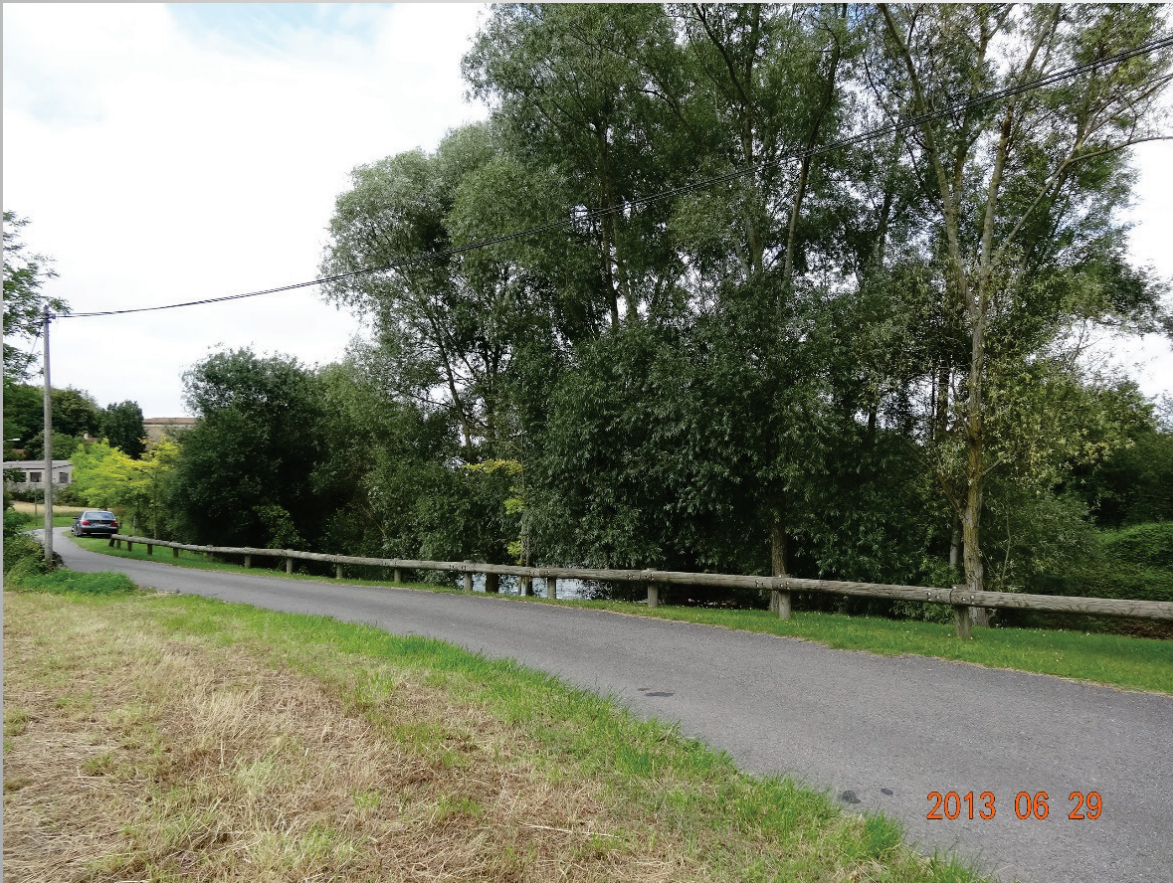
View to lower left bank

Lifetime cycle 2013: 4 years after completion date

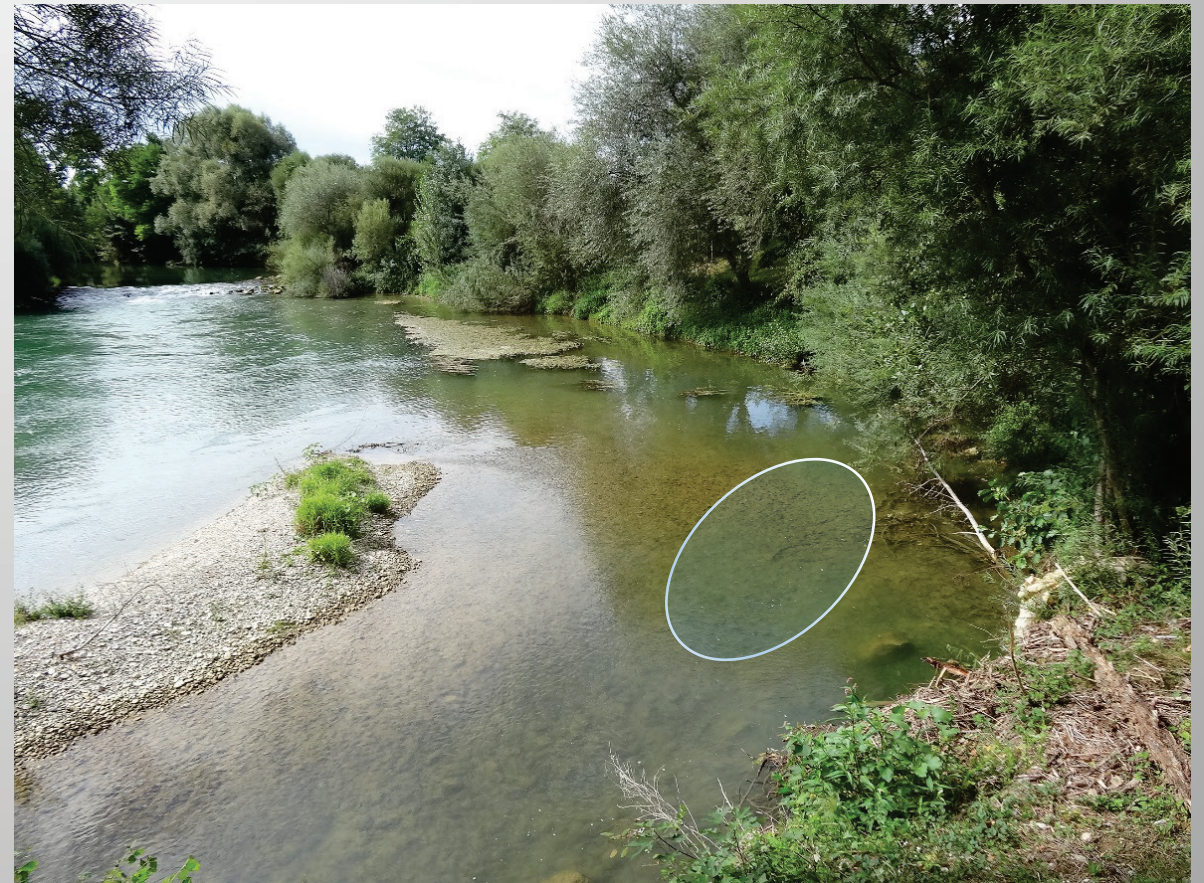
View to upper left bank: no more undermining!

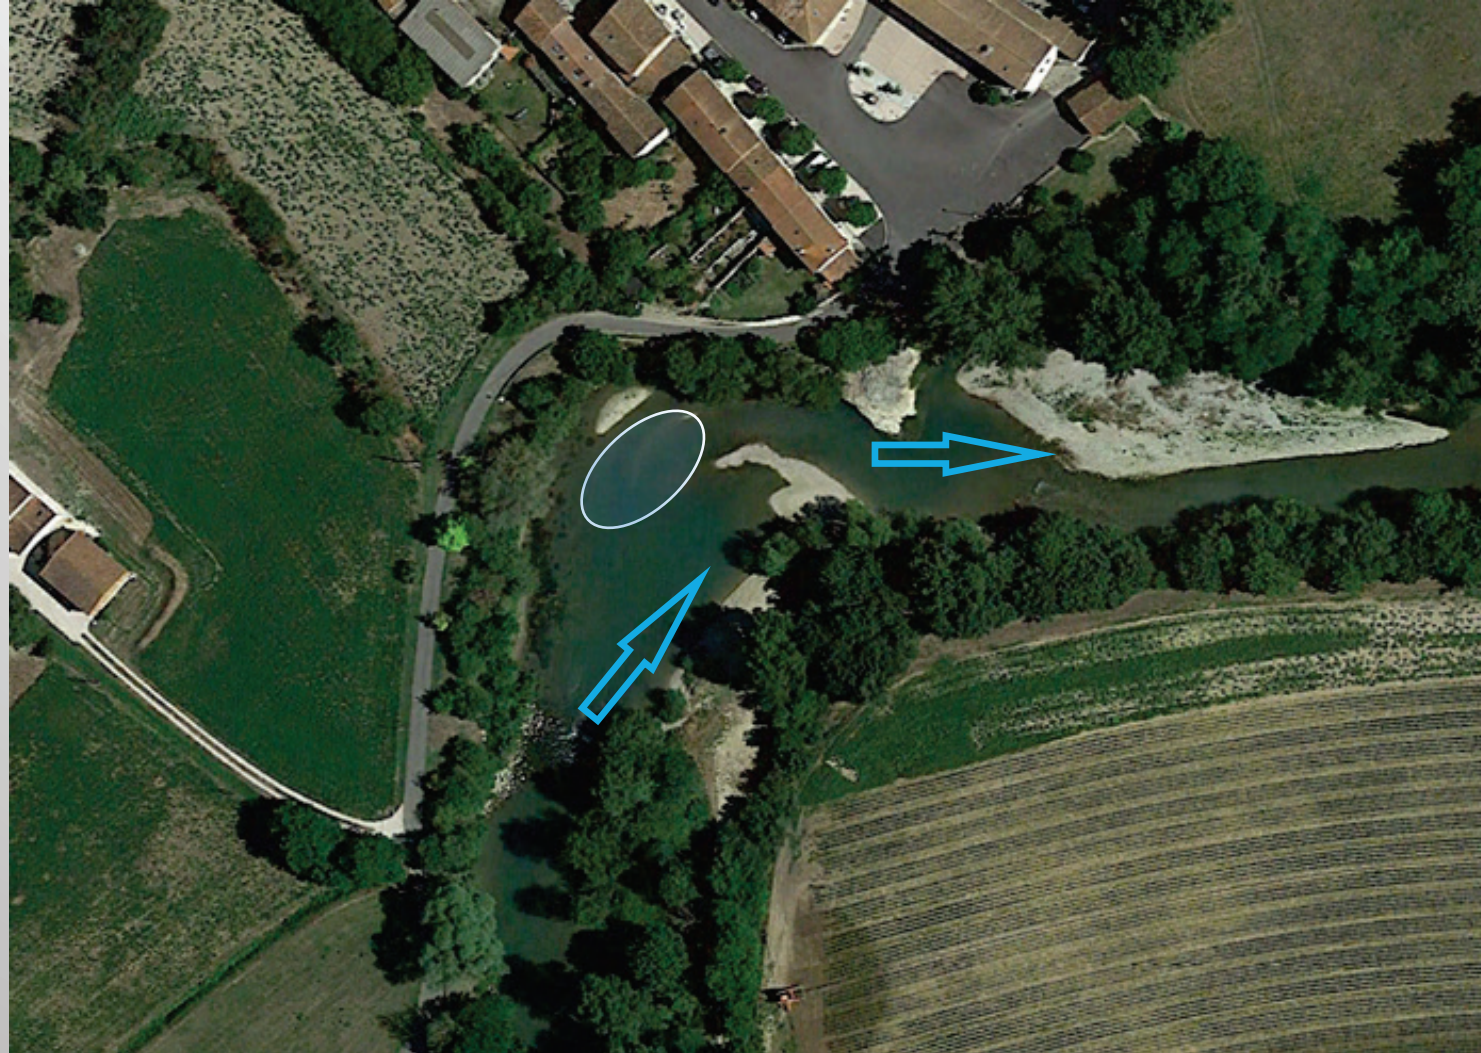
Satellite view indicates current state of construction: no more undermining as sedimentation now protects public road in the meander arch

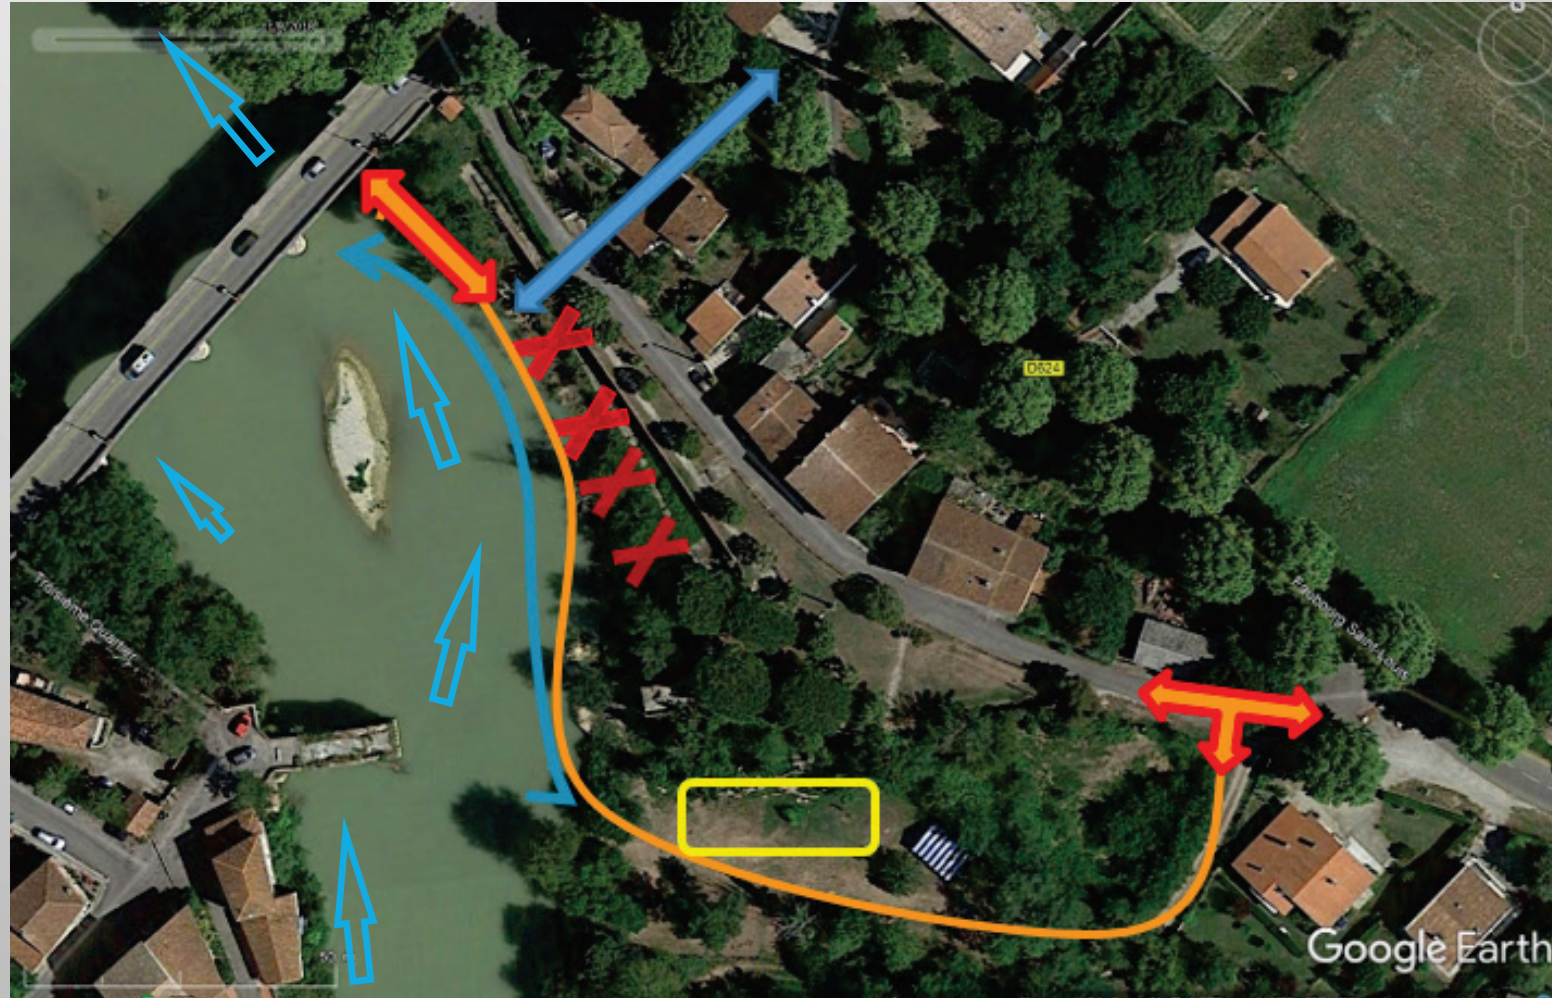
Both satellite view and X are indicating the most damaged right river bank in front of the residential area.

Yellow rectangle is the site equipment position.

Blue line is the position of longitudinal construction provided.

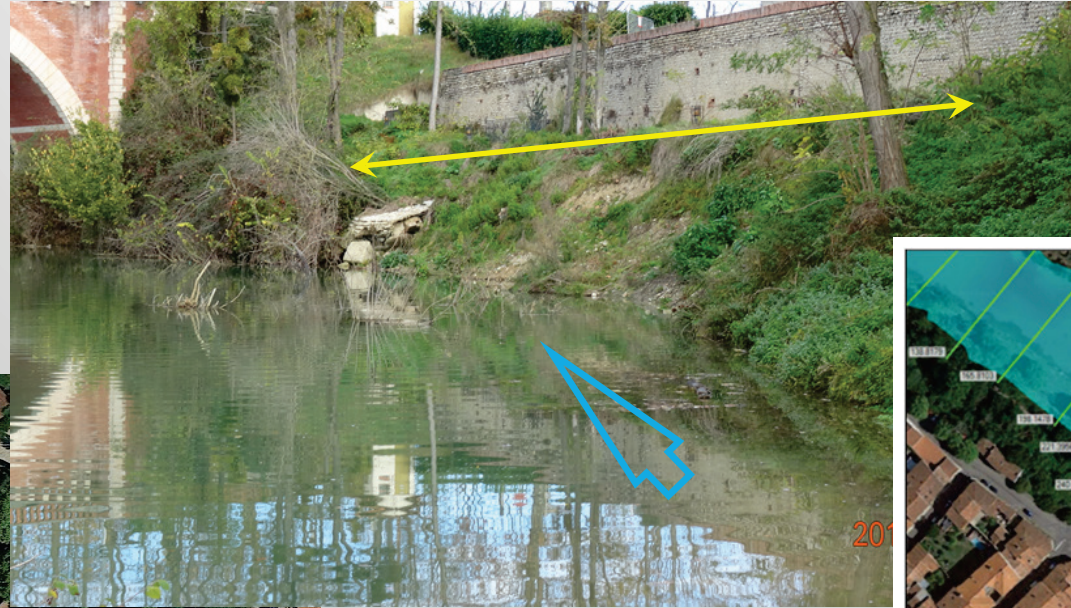
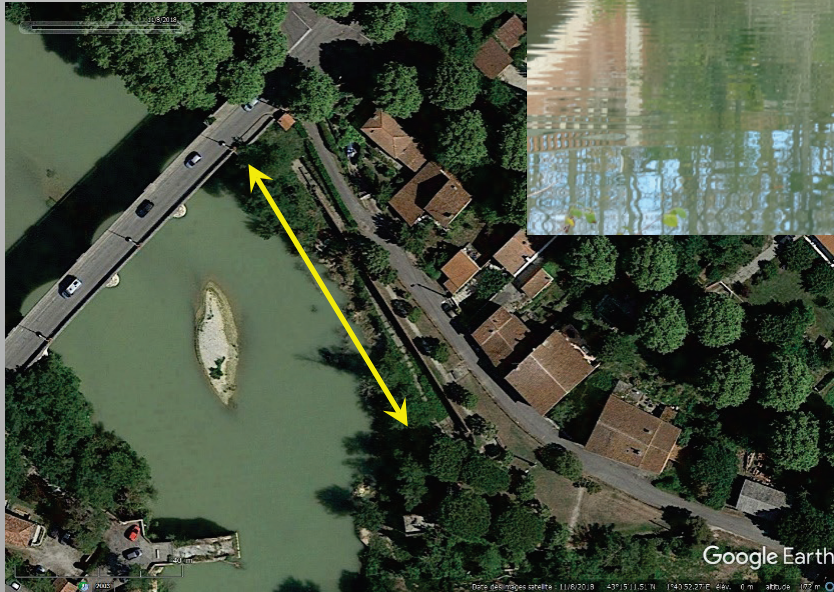
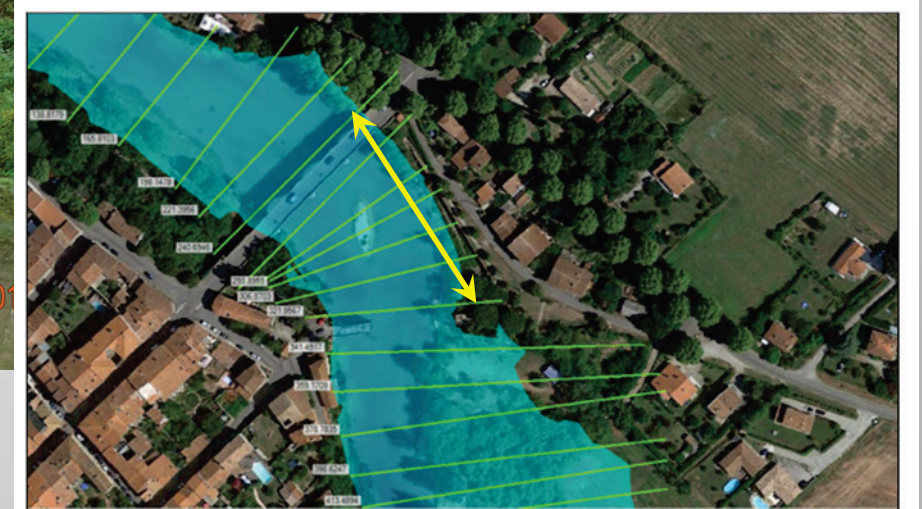
Figure 15 : Zone inondable pour T50ans

Preliminary stage: Onsite bathy, geotech and hydrodynamic investigations

Yellow arrow indicates the most damaged right river bank in front of the residential area. Blue arrow indicates the flood direction.

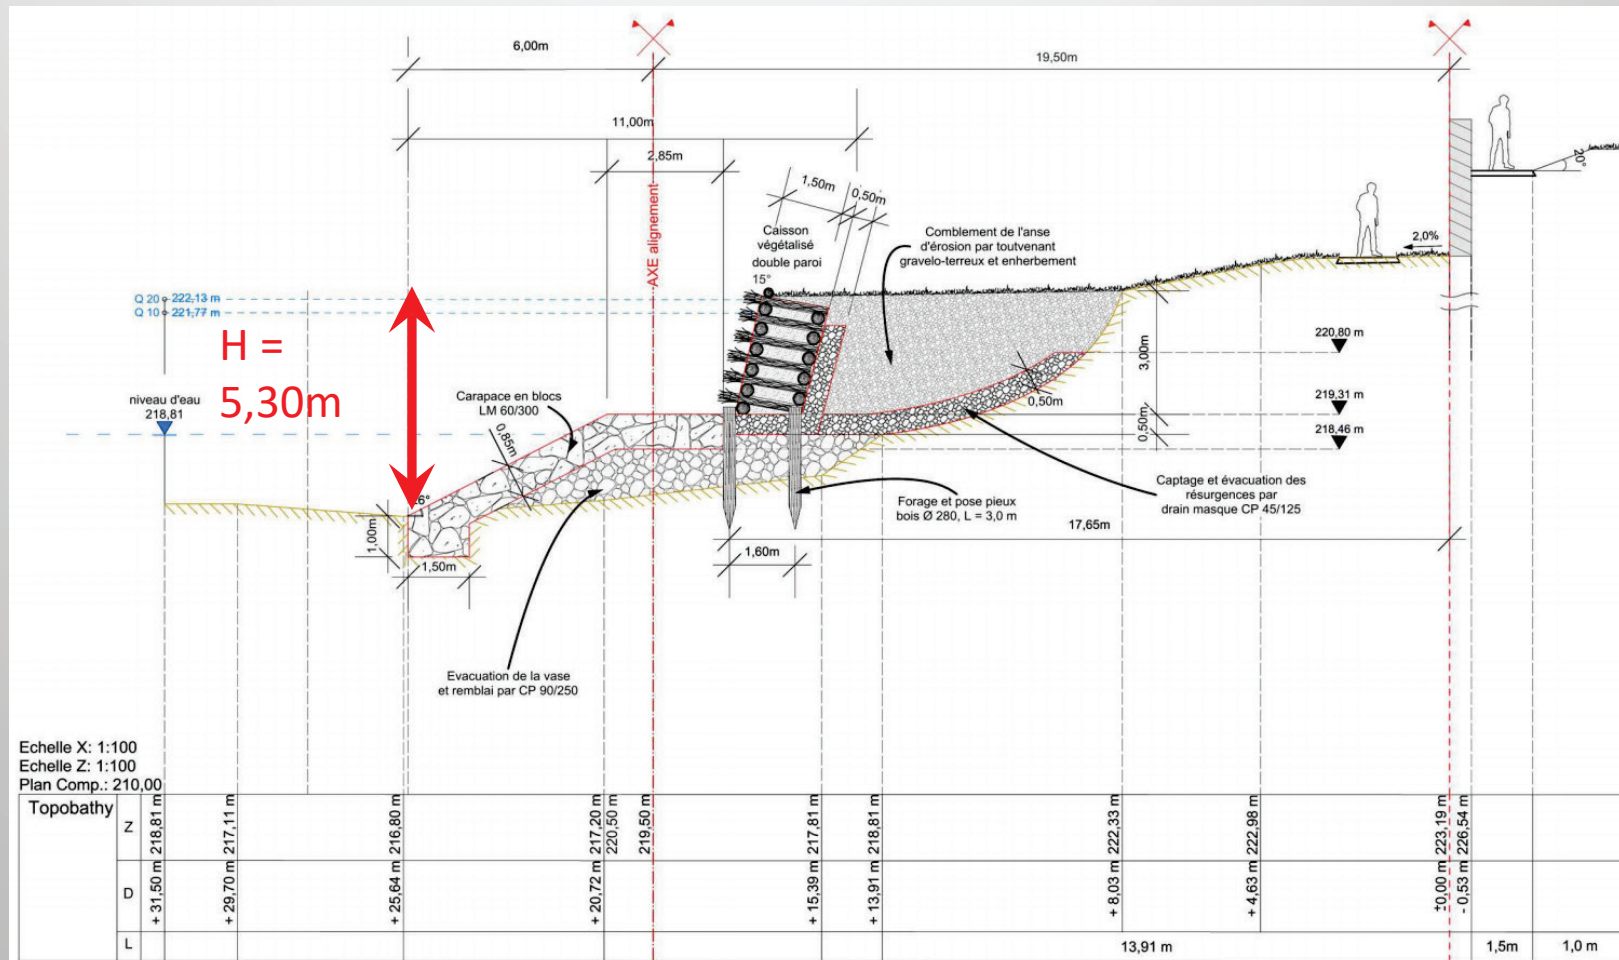
Final design stage: The final outflow section for public tender.

Right river bank reconstruction

Soil refilled between flood wall and crib wall to obtain open space

Greened log crib wall

Hydraulic filter between crib wall and public open space

EN 13383 bloc-stone carapace

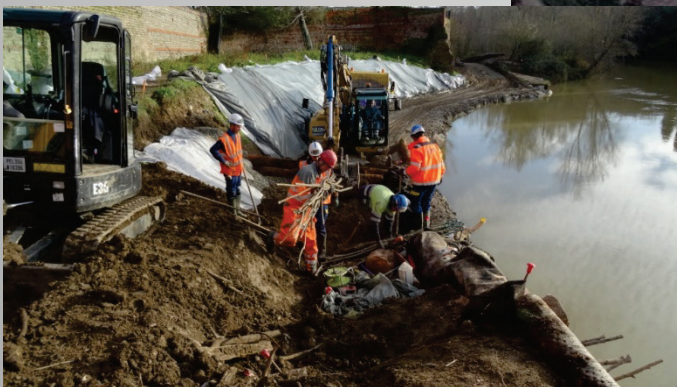
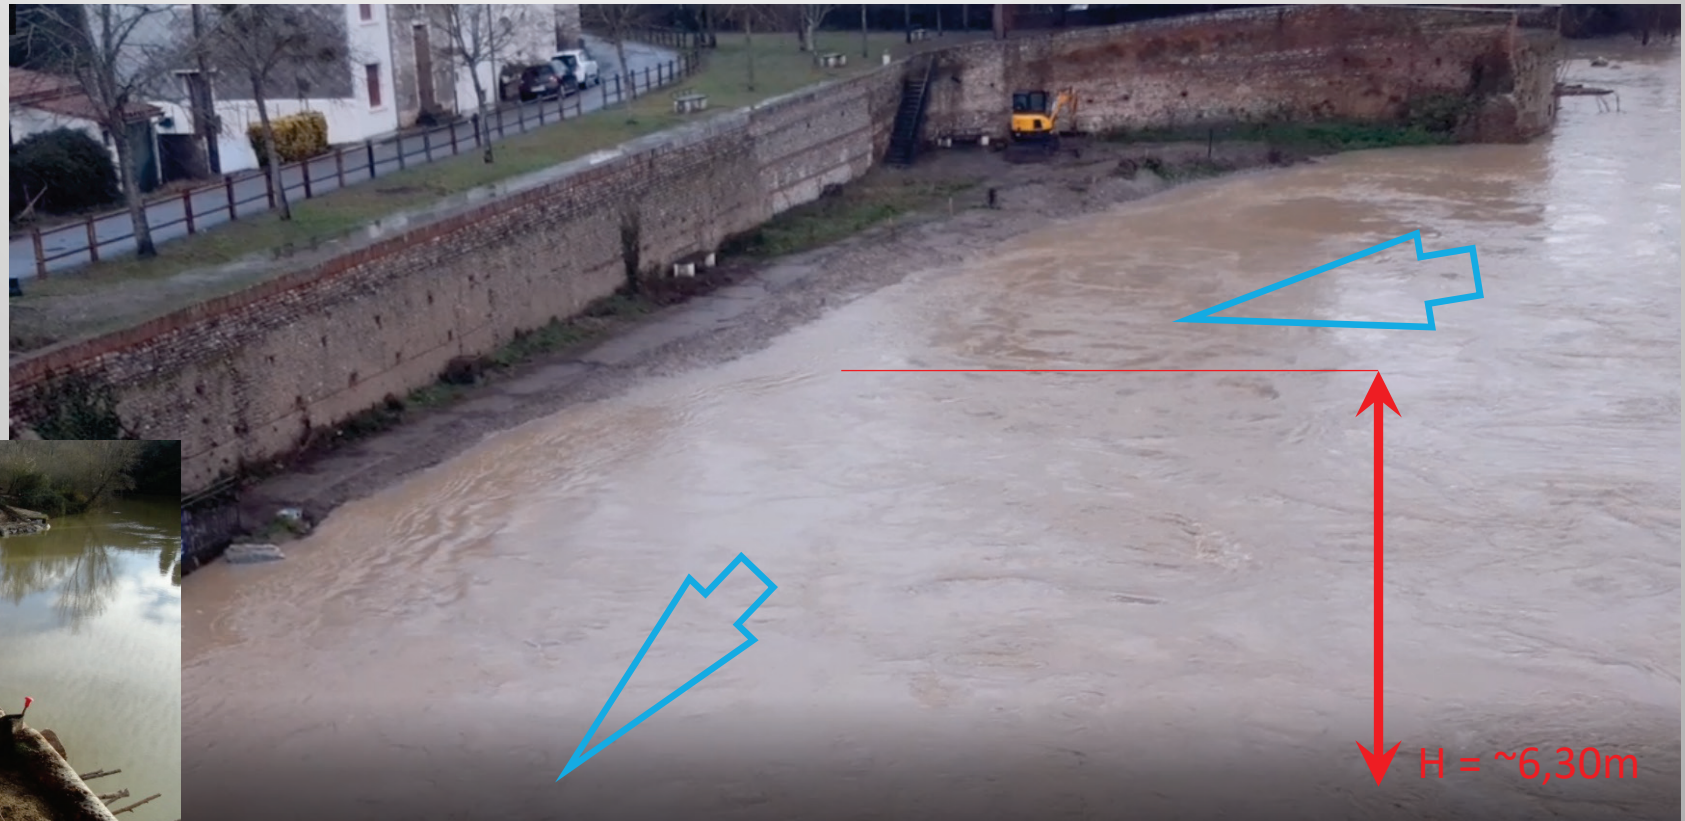
Construction stage April 2020: Construction progress stopped due to 50 year flood estimated about 650m³/s

Work in progress on 11/12/2019

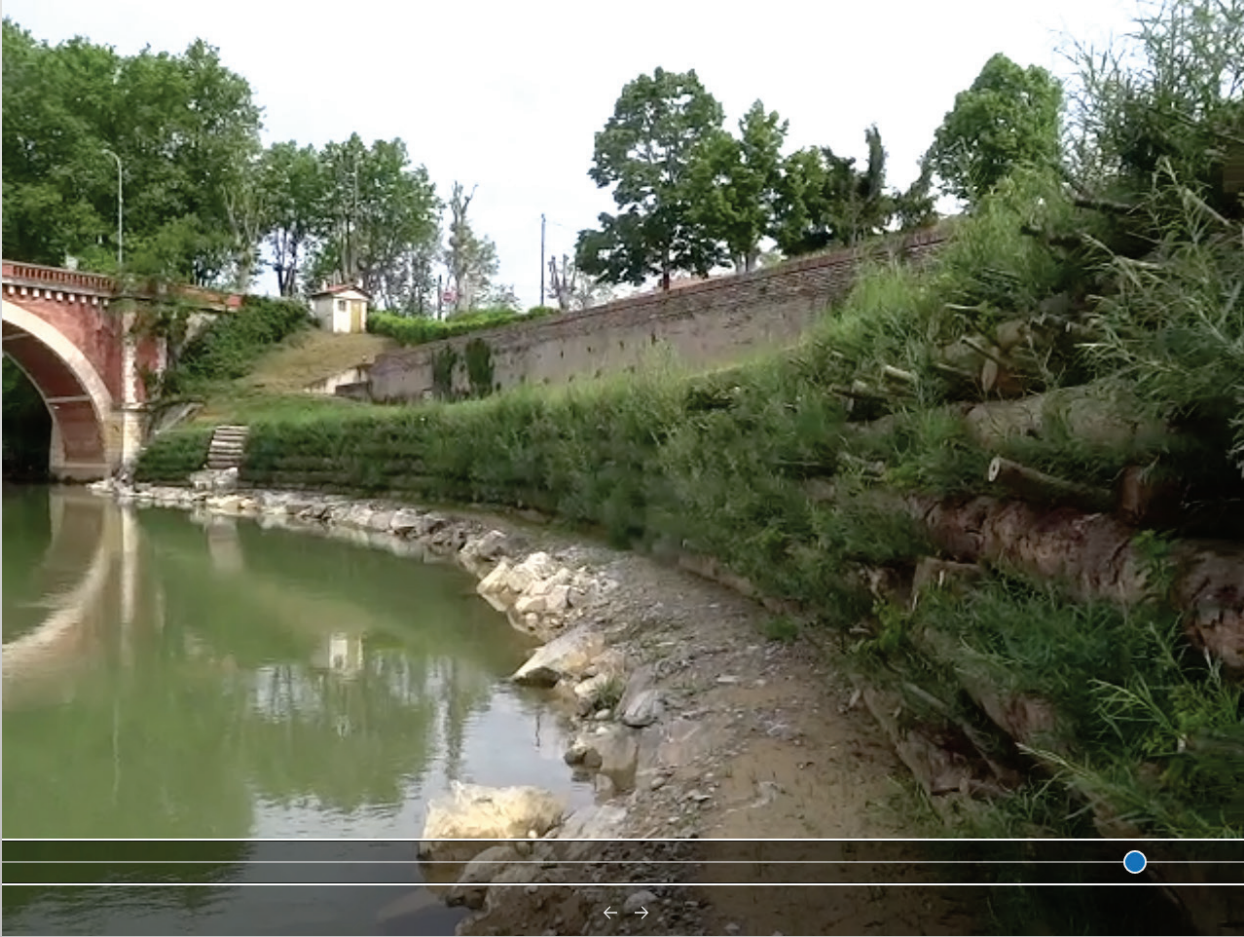
Picture taken in 14/05/2020

Beginning of lifetime cycle May 2020: Development of willow wood 4 months after the beginning of planting
