NH3.13

Nature-based and bio-based solutions for geohazard mitigation on slopes and streambanks ▶

“Nature based Solutions and combined techniques in the immediate vicinity of infrastructure and residential areas - 5 case studies of steep bank stabilization in the Garonne water catchment area in France realized between 1999 and 2022

Klaus Peklo Dipl.-Ing., graduate engineer

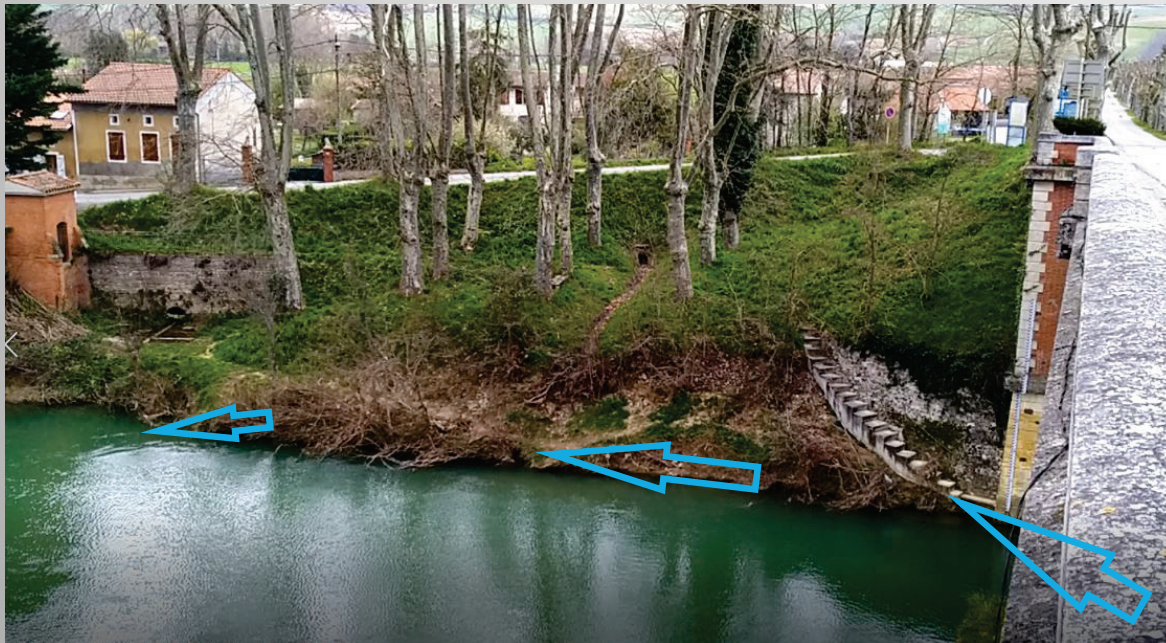
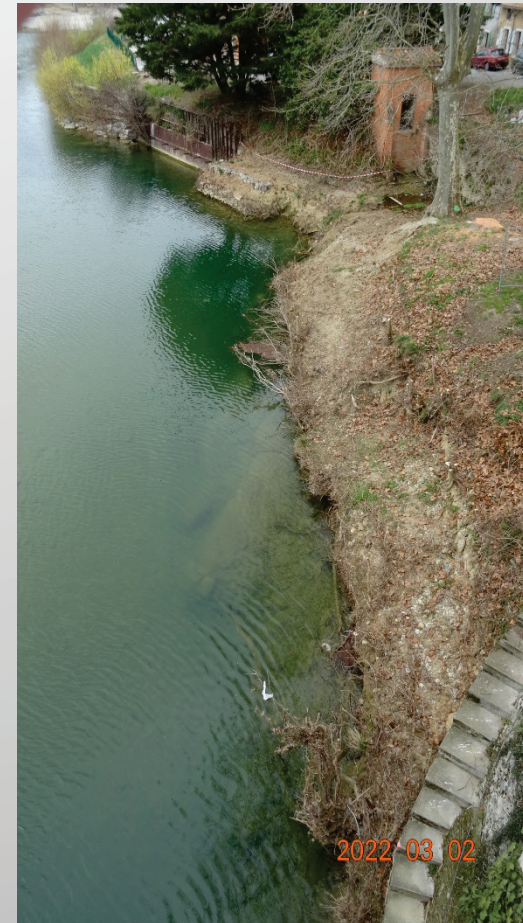
Current health state in march 2022: 50m erosion process is ongoing in direction both to public space and restaurant

Detailed view to downstream:
Regressive erosion progressing in close proximity to bridge pier

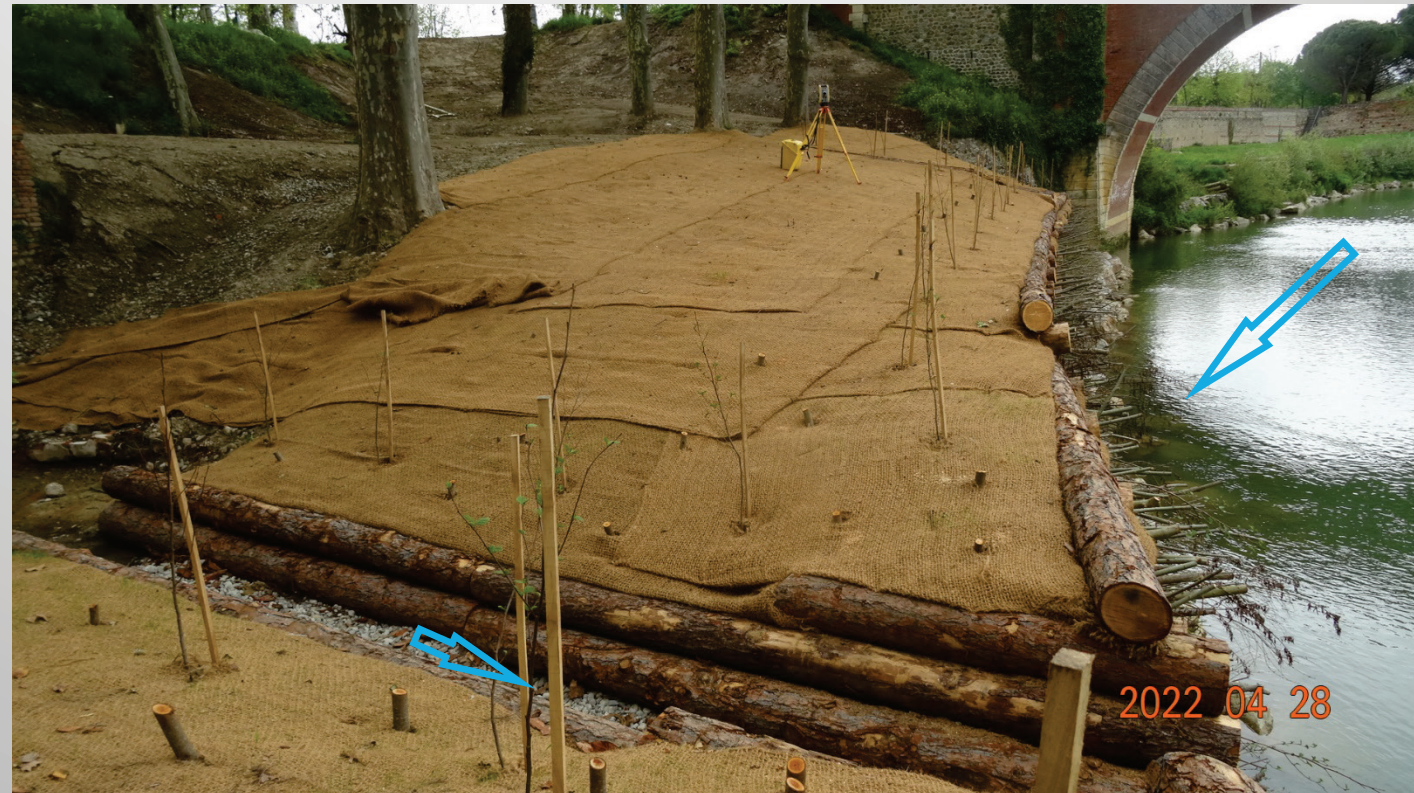
View to upstream:
50m erosion process
stopped by applying a
vegetated Log Cribwall

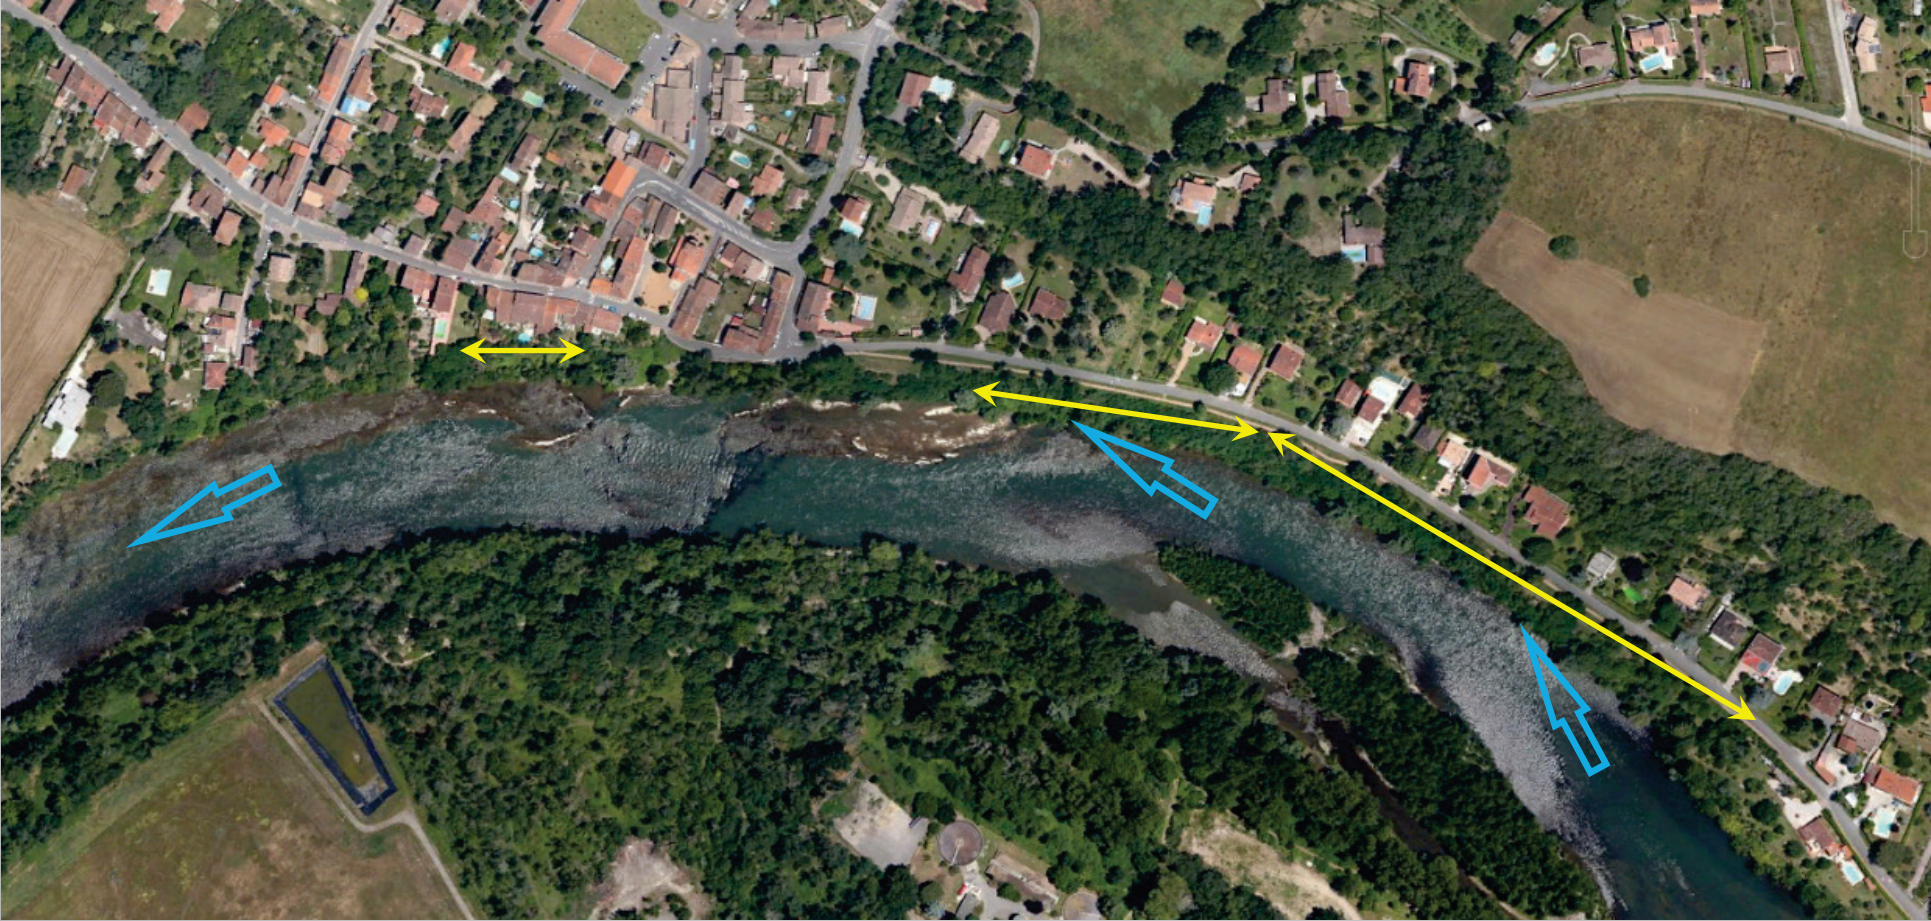
Preliminary stage: Diacronic analysis results in both bed shifting and bank erosion have progressed up to 6,5m over the last 50 years

GoogleEarthPro 2012: Yellow line indicates the most urgent job sections in NbS and combined techniques (total L ~ 500m)

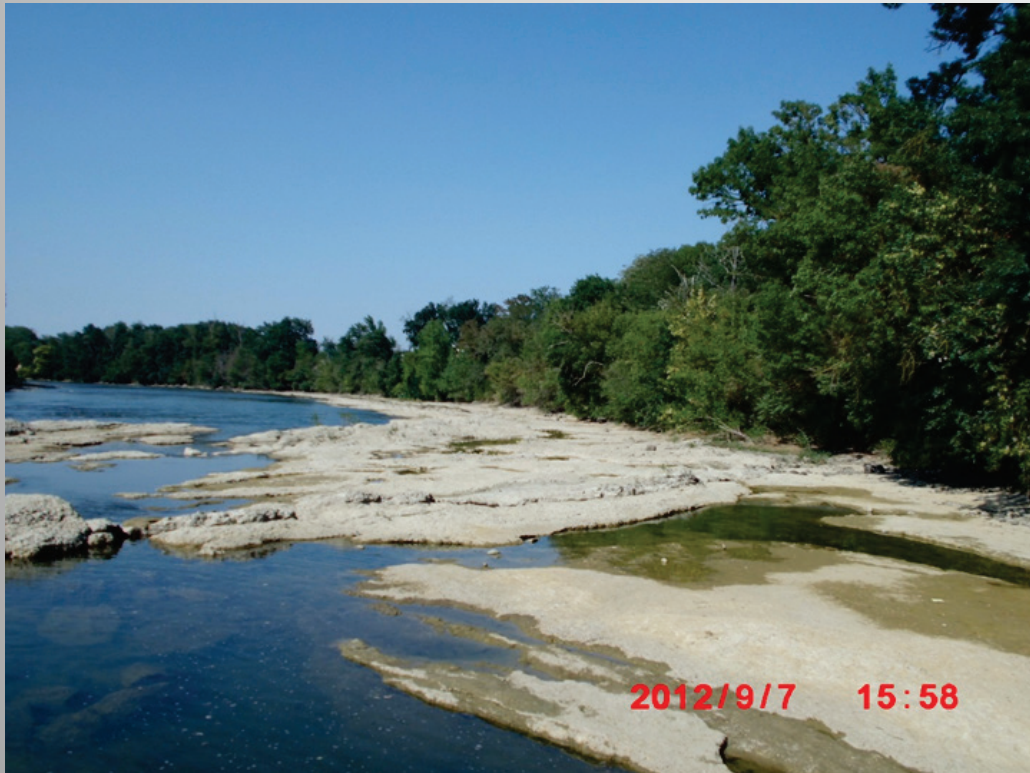
2012: Far advanced bed deepening due to lack of bedload caused substratum outcrop

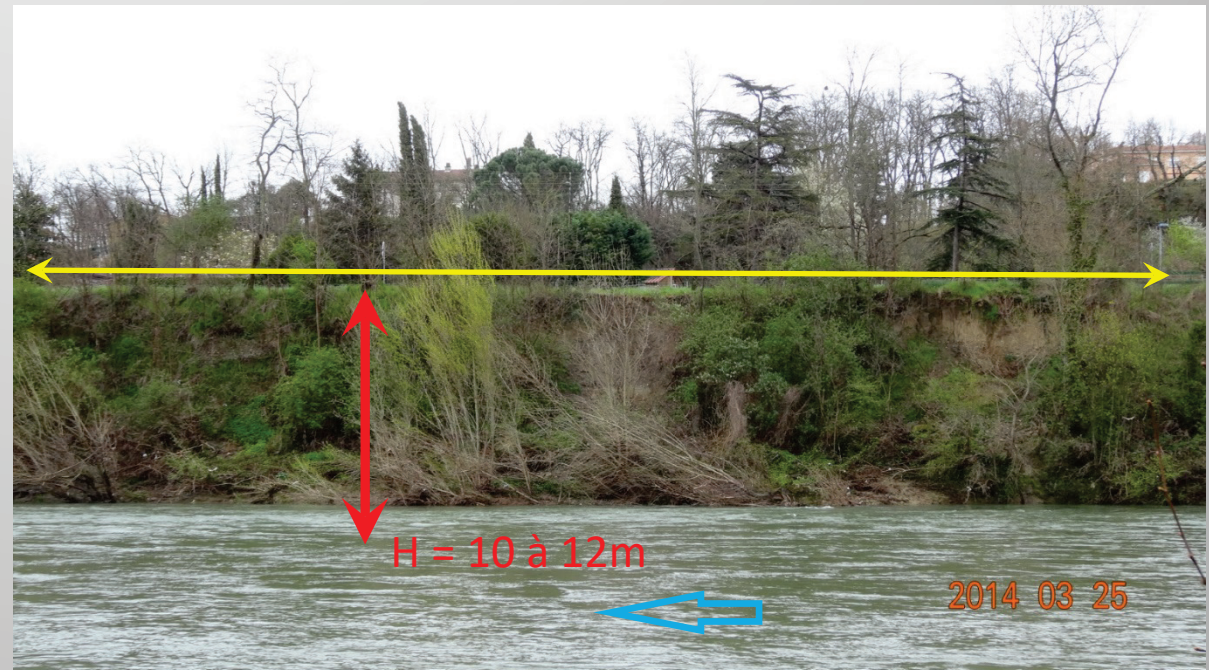
2014: Lateral movement continues and causes bank collapse close to the residential area access (position in yellow line)

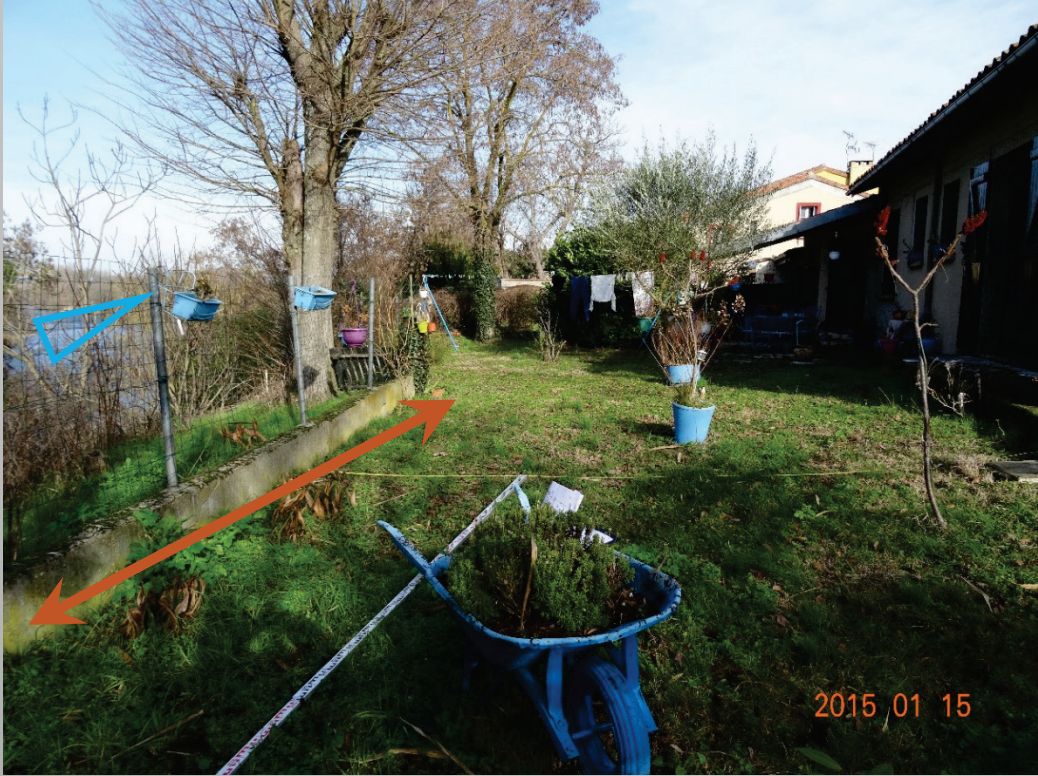
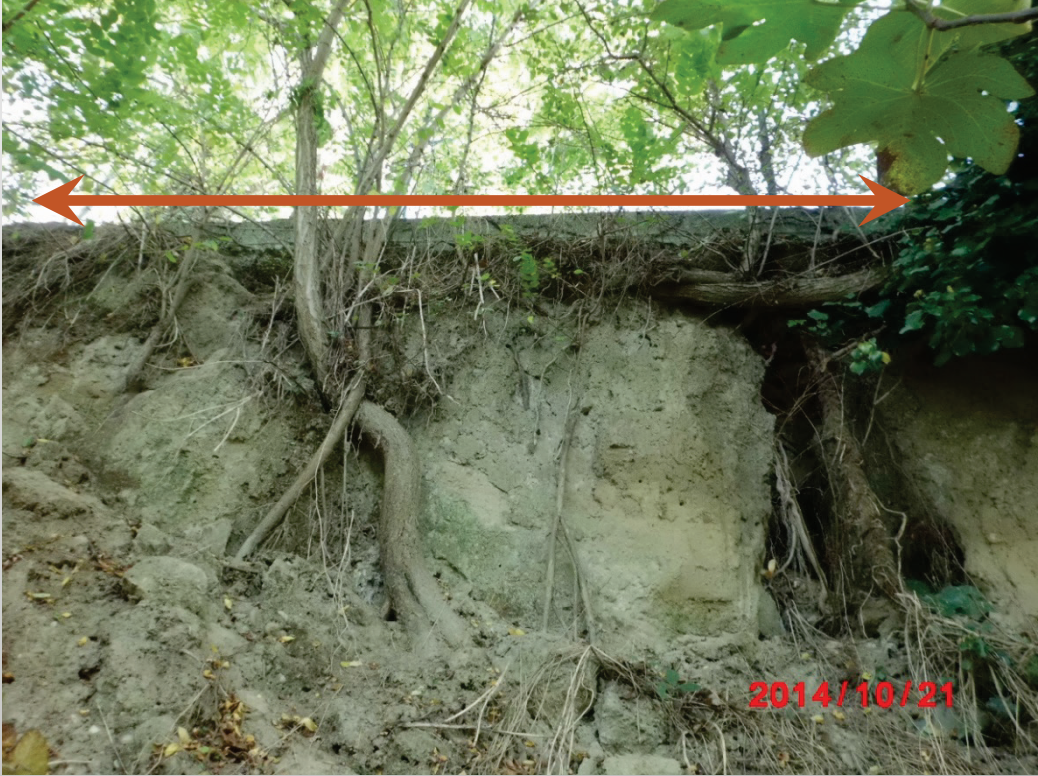
Preliminary stage: Important upper bank erosion in close proximity to residences

Same propertie, garden border shown by brown line

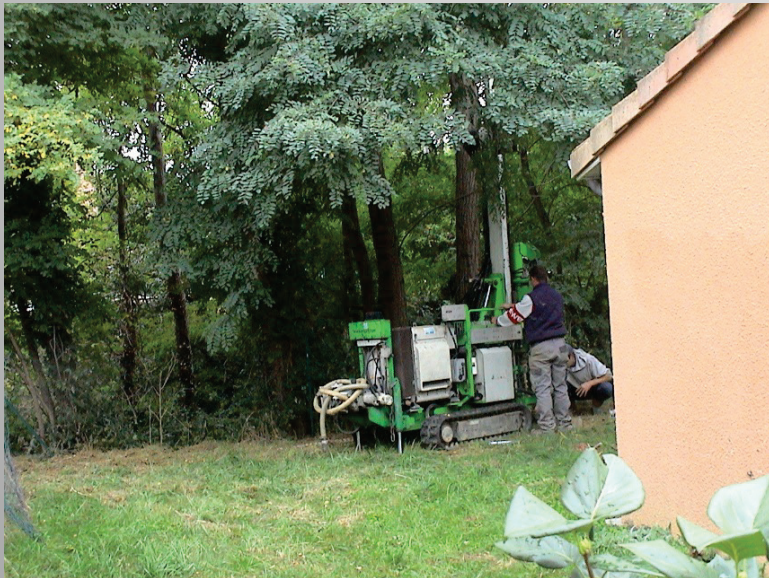
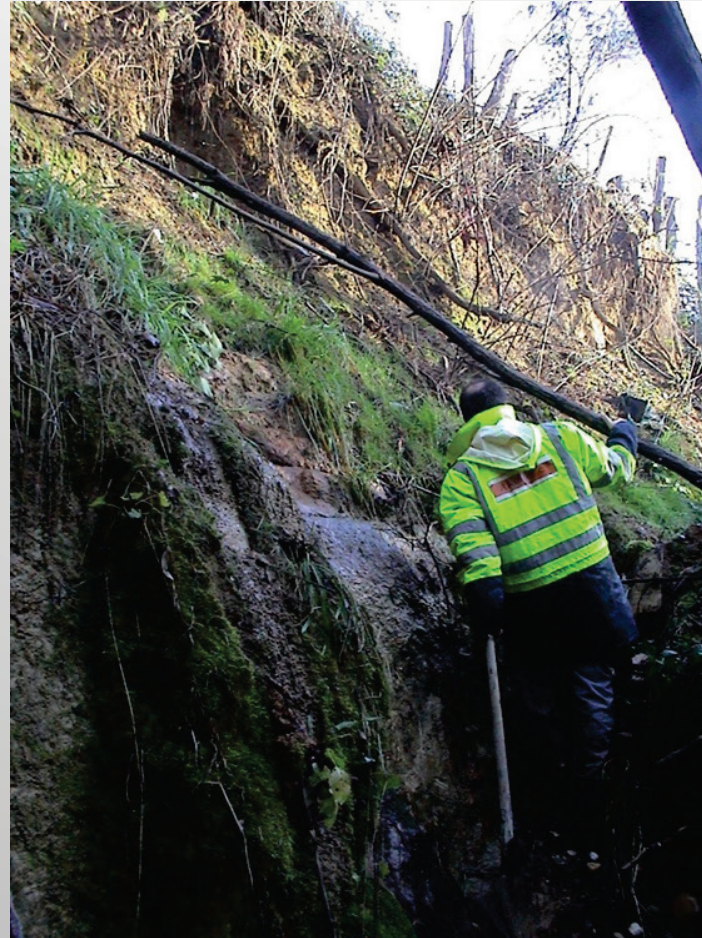
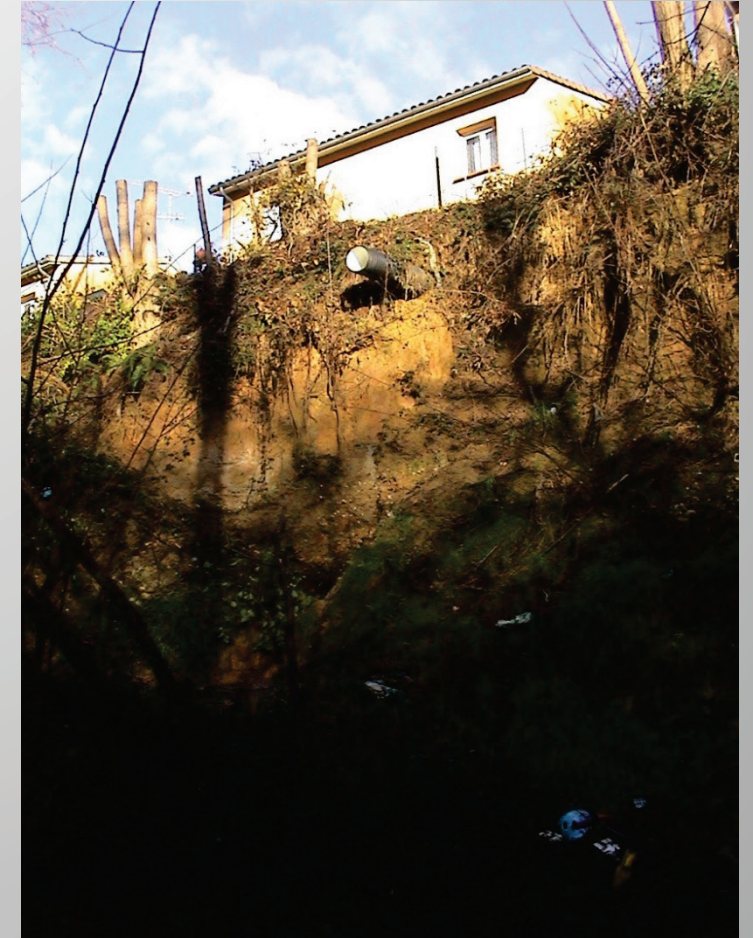
After clearing work we discovered broken sewers, huge building rubbish and a pretty nice groundwater horizon

As usual a subsoil geotechnical investigation ongoing to obtain soil properties in proximity of buildings

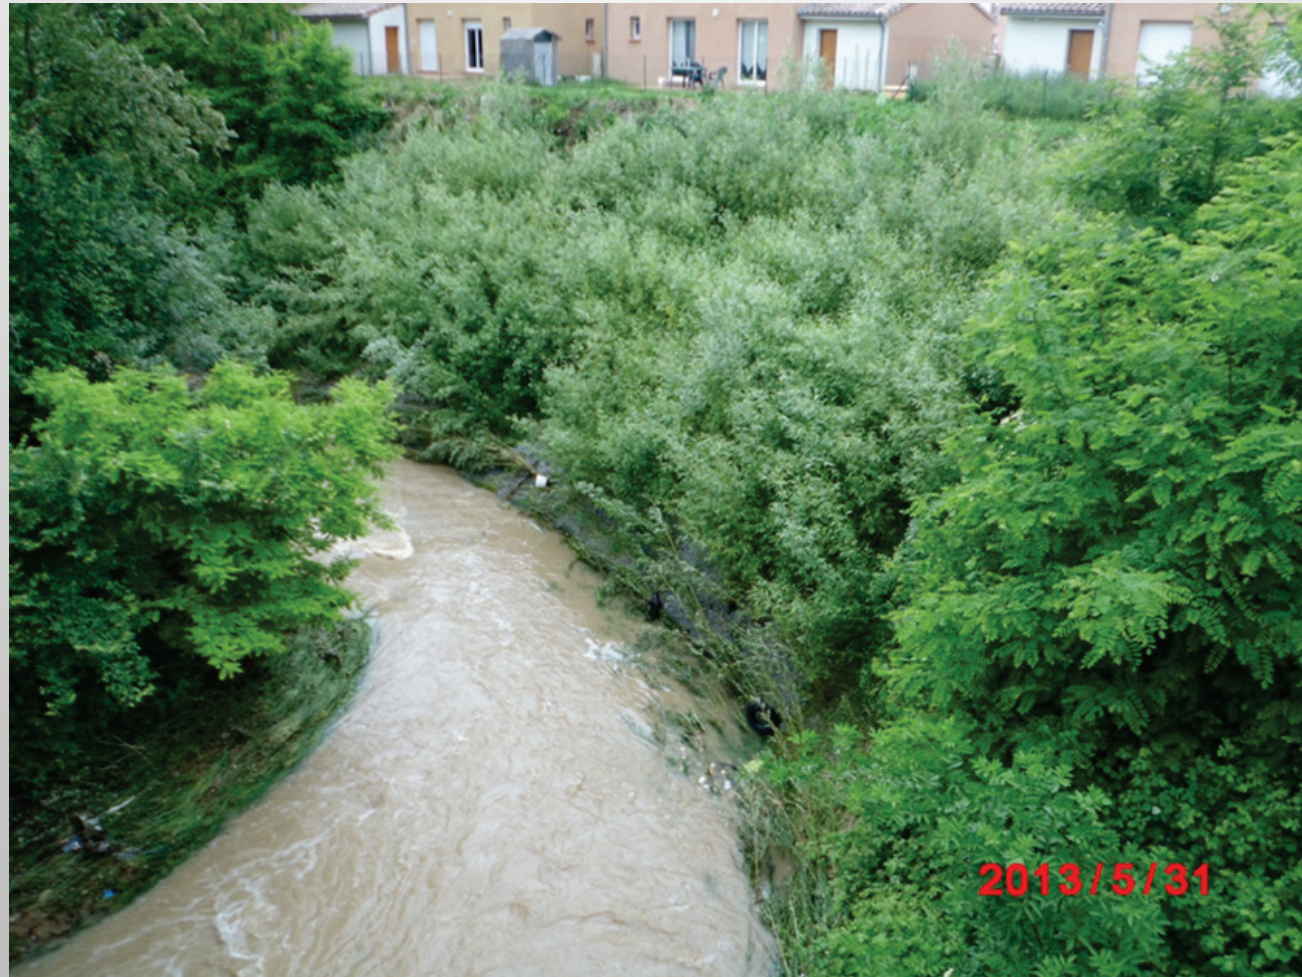
Lifetime monitoring stage: Shrub stratum condition during a small 1.50m high flood one year after completion date in 2013

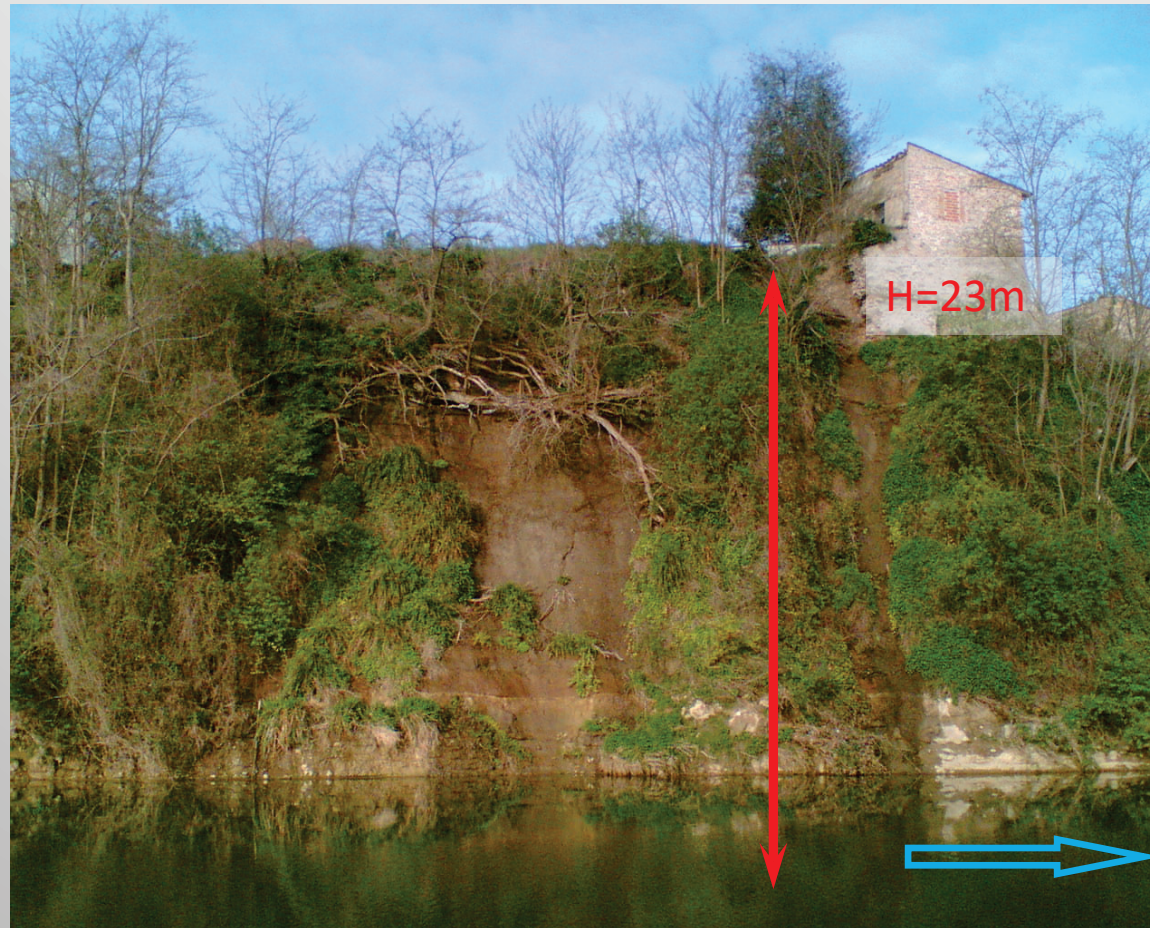
Preliminary studies: State of health of the steep limestone cliffs in 2006: several rockfalls areas are visible up to just before the public viewing platform

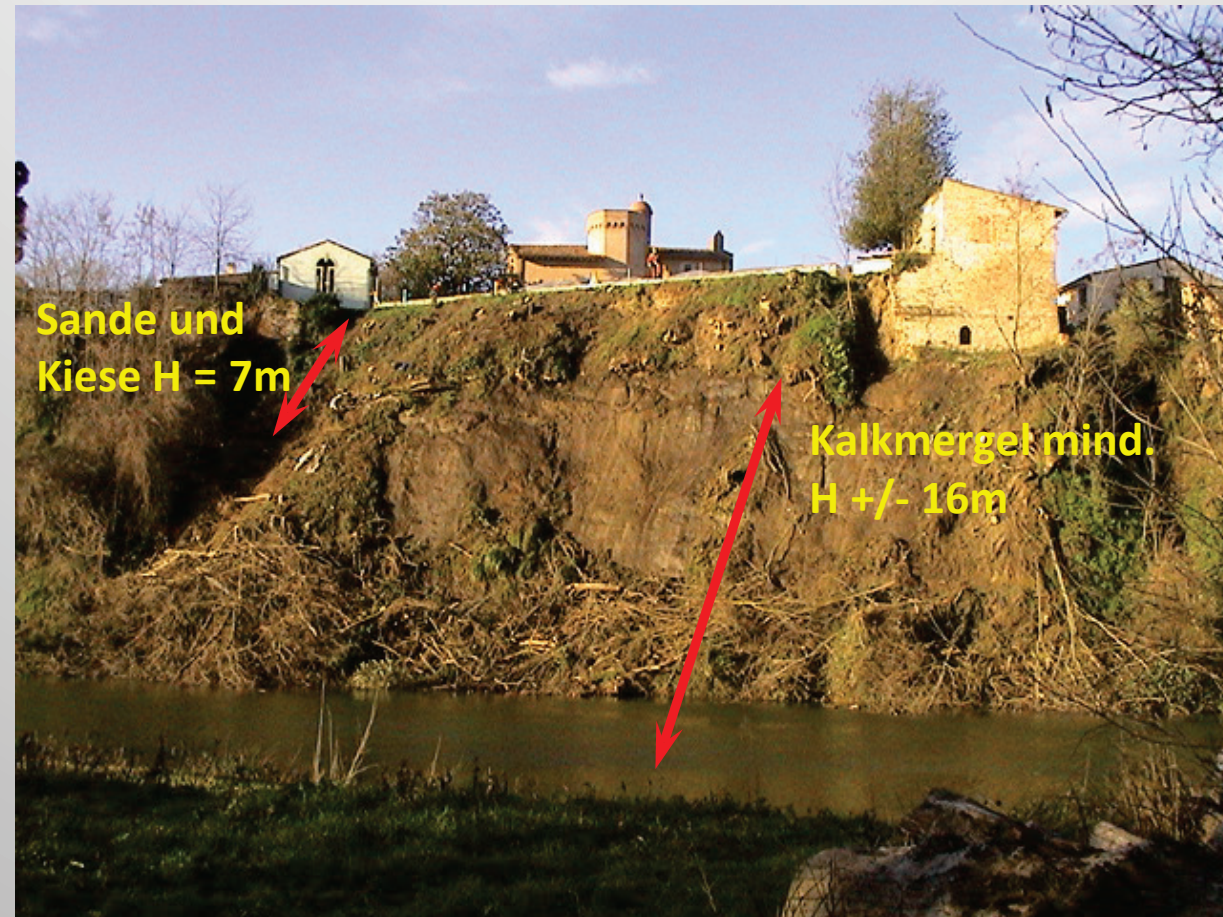
Pre-construction stage: Logging work in March/April 2007 to check the stability of the whole steep cliff

7m thick sand and gravel layer >>

<< At least 16m high limestone marl layer

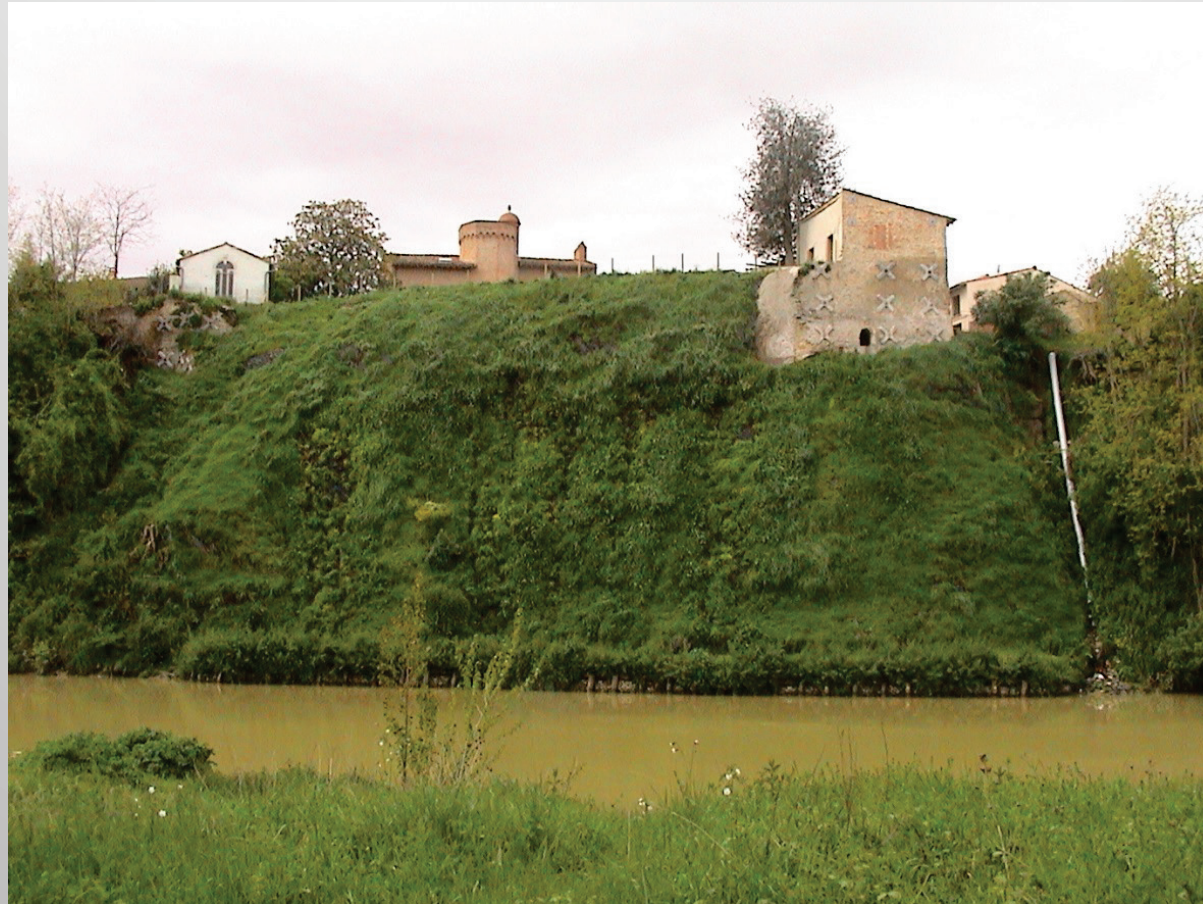
Lifetime monitoring stage: Cliff condition one year later after completion date
(picture taken in April 2008)

<<Growing vegetated log crib wall onto gabion wall

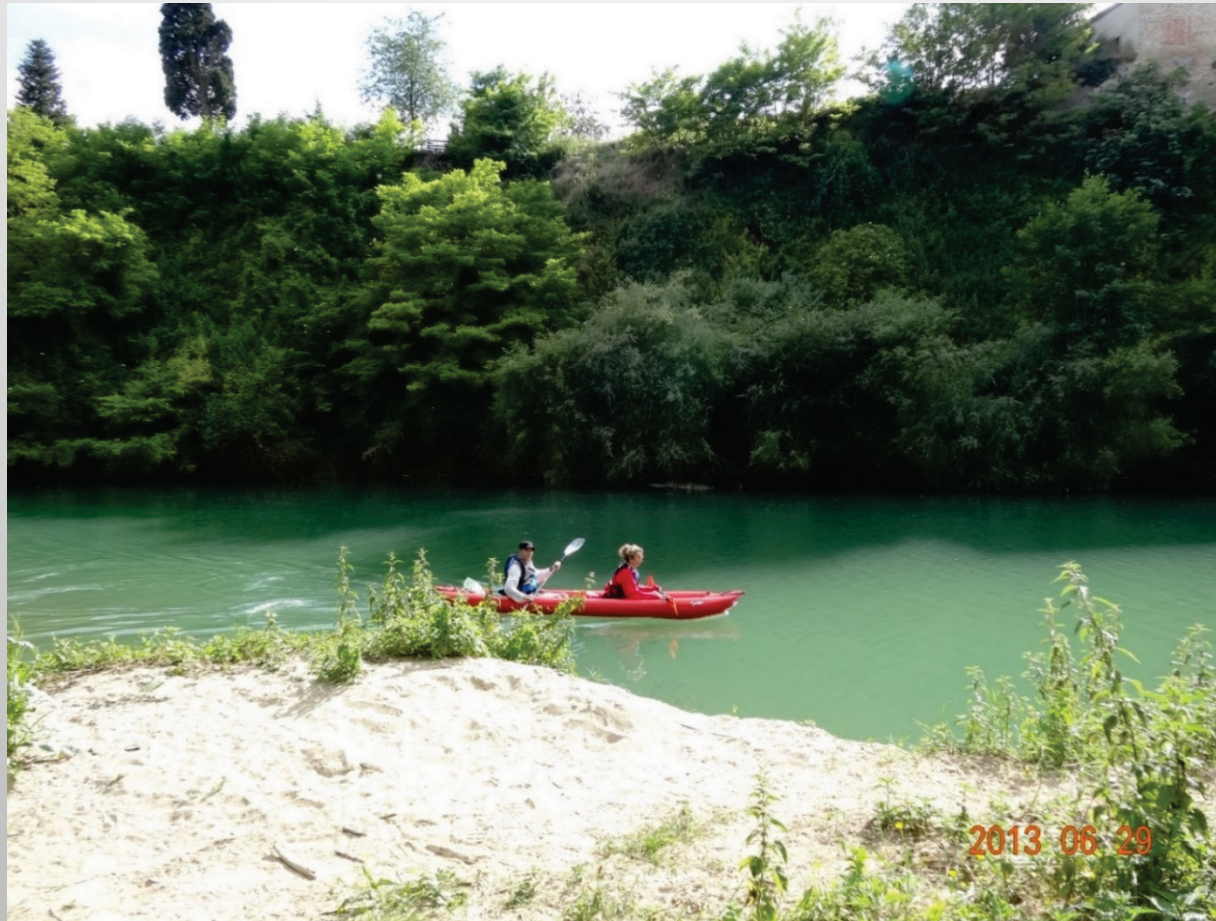
Lifetime monitoring stage: Cliff condition 5 years later after completion date
(picture taken in June 2013)
