IS THERE REALLY AN ACTIVE FAULT (CIBYRA FAULT?) CUTTING THE STADION OF THE ANCIENT CITY OF CIBYRA? (BURDUR-FETHIYE FAULT ZONE, TURKEY)

irem $ELITEZ^{1}$ and Cenk YALTIRAK^{1}

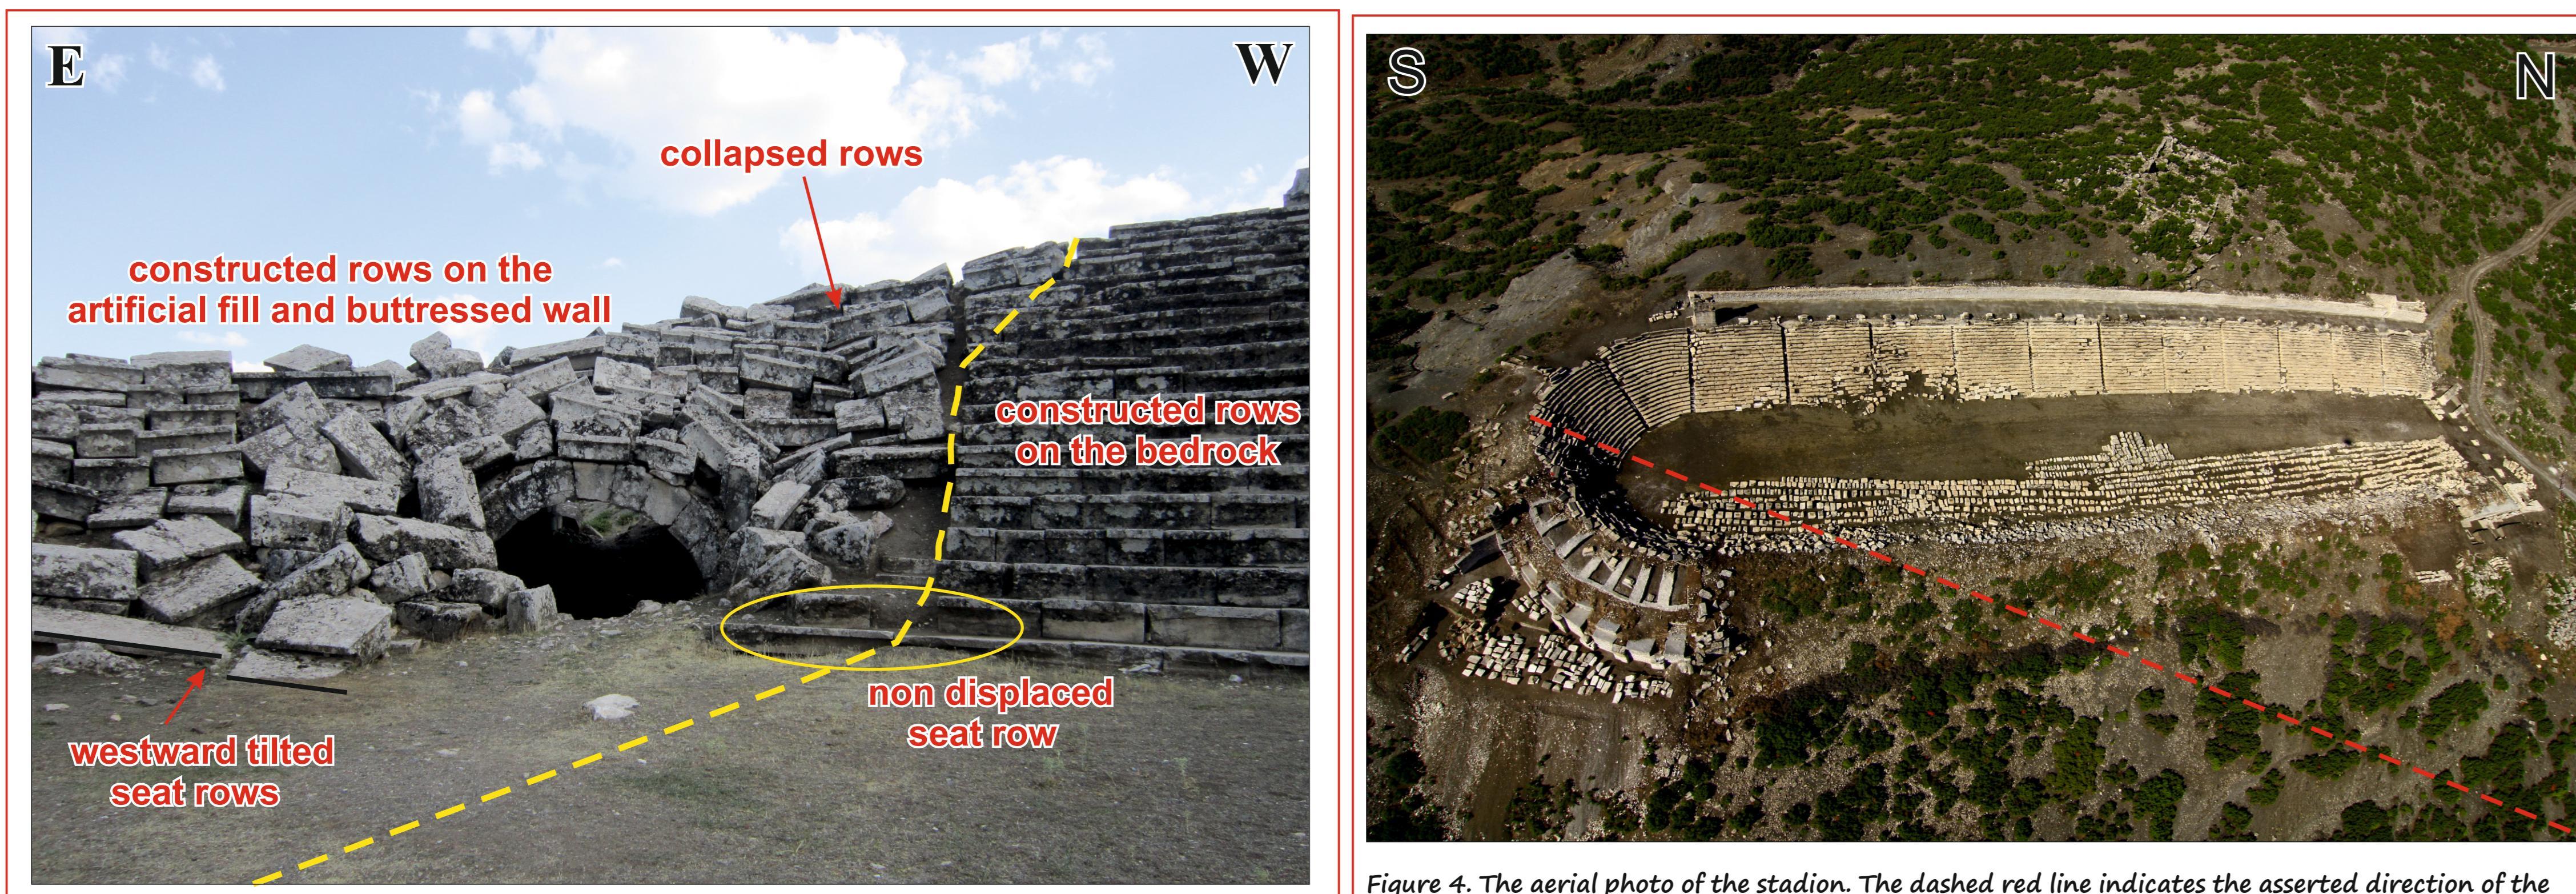
In the southern side of the stadion, there are 20 seat rows and the lowermost row is half-buried. It is an important contradiction that despite the marked fault direction on the southern seat rows, no offset is seen on that row (Figure 3). Also there are many collapsed rows tilted to different directions. This is because the ground of these seat rows has structurally heterogeneous properties. For instance, the seat rows on the entrance tunnel were tilted to the south and fell down inside. Briefly, a nonsystematic spread is clearly seen. When we look at the aerial photo (Figure 4), the photo taken from the northern hill (Figure 5) and the east wall of the stadion (Figure 6), there is no offset which can manifest the presence of a fault as stated by the researchers.

Figure 3. Earthquake damage on the southern side of the stadion: The yellow dashed line indicates the asserted direction of left lateral Cibyra fault (Akyuz and Altunel, 1997, 2001; Karabacak, 2011)
