Impact of SWC practices on sediment losses and discharge in the headwaters of the Lake Tana Basin in the Ethiopian highlands

10th Alexander von Humboldt International Conference Addis Ababa | Ethiopia | 18 – 20 November 2015 AvH10-42-1

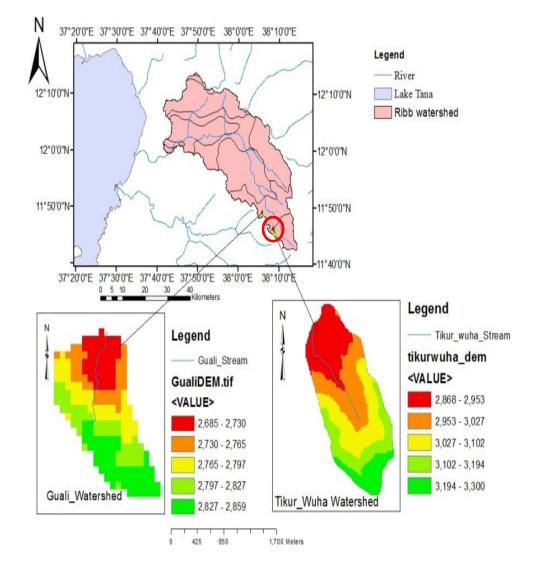
Tikur-Wuha community watershed

- Area = 500 ha
- Slope : 0.6% 84%,
- Altitude : 2868 -3300 m
- Land use
 - agriculture53%
 - forest, bushes and shrubs 25.3%,
 - bare land 13.2%,
 - grazing land 8.3%,
 - settlement 0.3%
- Soil type chromic Luvisols
- The depth of the soil
 - (95-55cm) at low and mid slopes
 - (25cm) on the top slope

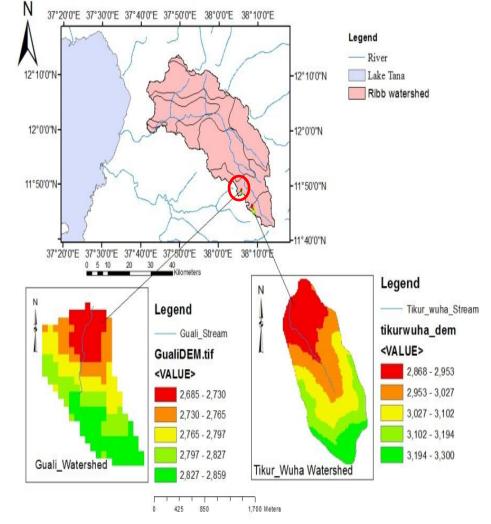
- Guali community watershed
 - Area : 190 ha
 - Slope : 0.8% 33%
 - Altitude : 2685 2859 m
 - land use
 - Agriculture : 60%
 - Forest lands, bush and shrubs = 20.9%,
 - Grazing land : 11.5%,
 - Bare land : 7.2%
 - Settlement : 0.4%
 - Soil type : chromic Luvisols
 - The depth of the soil
 - (70cm) at the bottom slope
 - (25-15cm) at the mid and top slope

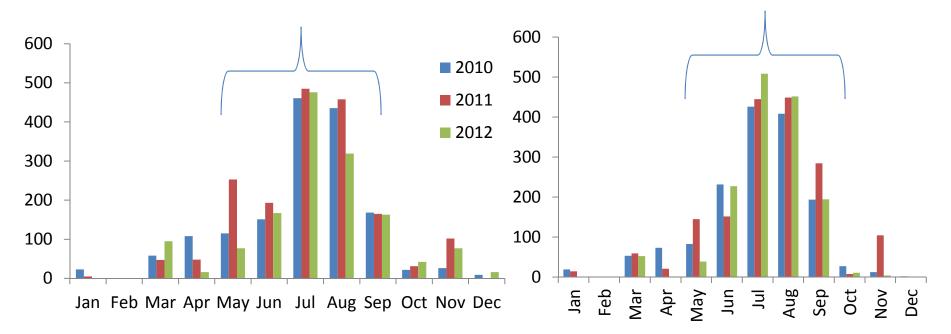
The rainfall pattern of both watersheds is unimodal and concentrated from May-September;

- 2011 the wet period and 2012 the dry period in both watershed
- The difference between the wet and dry period was **339**mm in Tikur-Wuha and **192mm** in Guali watershed.
- The average rainfall of Tikur-wuha (1604mm) greater than Guali watershed (1567mm) by 37mm

- During the wet period period (May-September) the average rainfall of
 - Guali 1412mm
 - Tikur-wuha 1362mm
 - Difference = 50mm
- At a 95% confidence level there is no a significant difference (p=0.6)

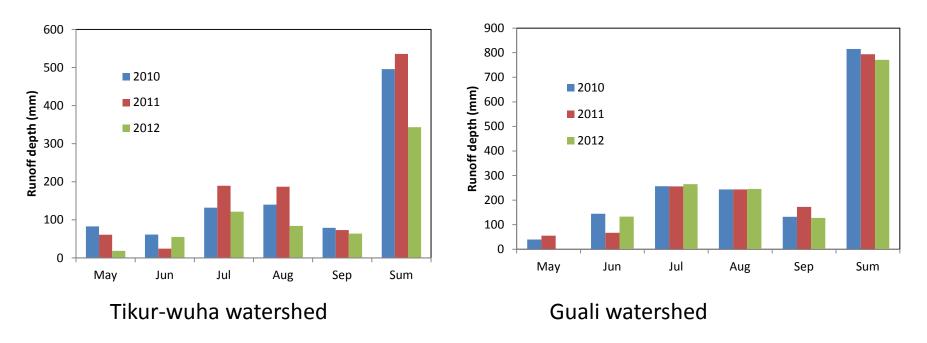
• Runoff Depth during Wet period (May – September)

- In Tikur-wuha watershed it increased by 8% in 2011 but decreased by 36% in 2012 due to increased rainfall by 17% in 2011.
- In Guali watershed it decreased by 3% in 2011 and 2012 due to small variation on rainfall amount between 2010-2012.

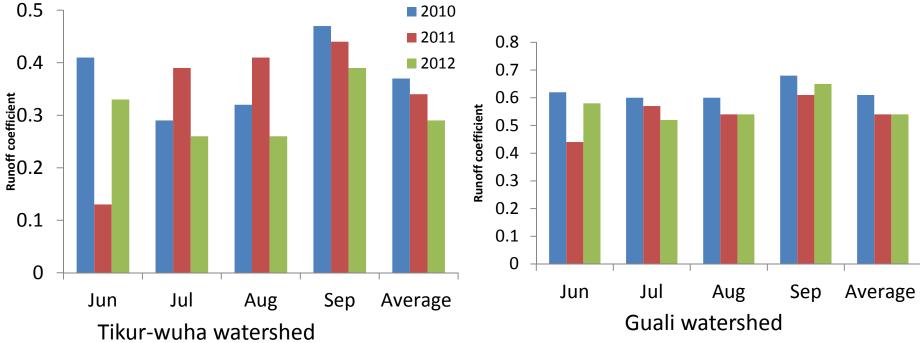
The runoff coefficient (wet period)

- It decrease by 8% in 2011 and 15% in 2012 in Tikur-wuha watershed.
- It decreased by 11% in 2011 but did not any change in 2012 in Guali watershed due to small change in rainfall amount (4%)
- Temporally Rc is increasing trend from June to September in both watershed

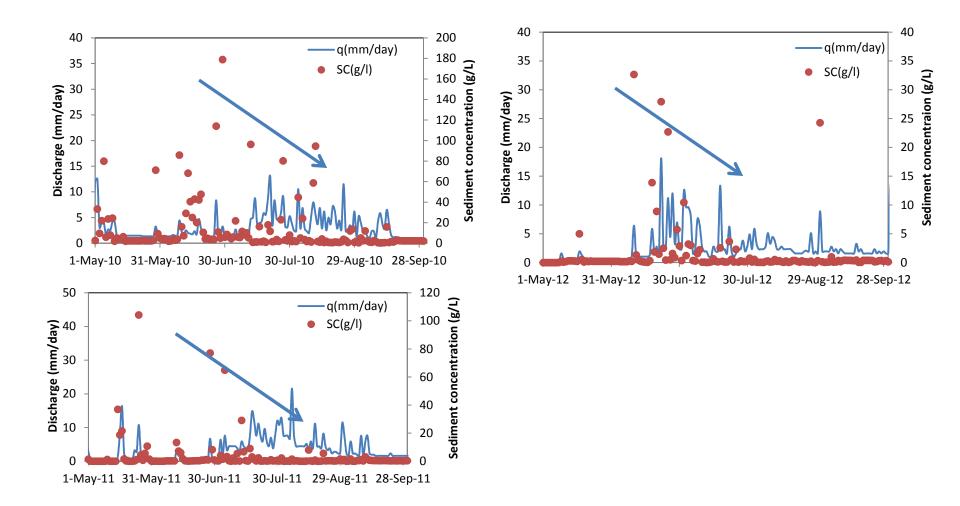
Temporal variation of sediment concentration of Tikur-wuha watershed

- The average sediment concentration of Tikur-wuha watershed decreased by 62% in 2011 and 55% in 2012
- Sediment concentration of Guali watershed did not change in 2011 but it decreased by 33% in 2012

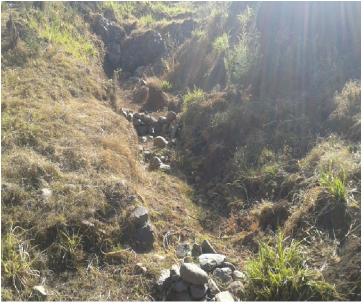
Treated gully in Tikur-wuha

- In Tikur-Wuha in 2010
- In Gulai in 2011;
- ii. Technology and area of extent difference
 - 29 Ha of Degraded land treatment in Tiku-wuha watershed
 - SWC works continued in Tikur-wuha while in Guali highly engaged in 2011 only
 - Limited works on gully treatment in Guali watershed (2200 m², 1100 m²)

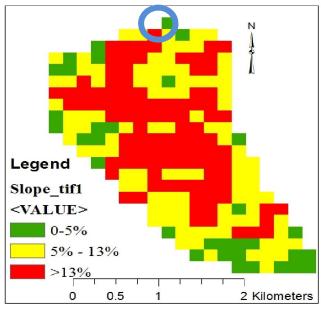
Stream profile of Tikur-wuha

- Guali watershed is flat at top and has a steep slope nearer to the outlet of the watershed,
- Tikur-Wuha watershed is a steep slope at the top and gentle slope towards the outlet of the

watershed.
