Hydrological monitoring of experimental karst catchment Sutina –Karakašica

The Sutina – Karakašica is an ungauged karst catchment in southern part of Croatia with relative small area but with existing records of several events of flash flood that compromised the structures as bridge and roads along the stream. This poster gives an overview of the creation of the experimental catchment and establishment of the hydrological monitoring system which has for a goal a better understanding of runoff processes within the experimental karst area as well as flash flood occurrence analysis.

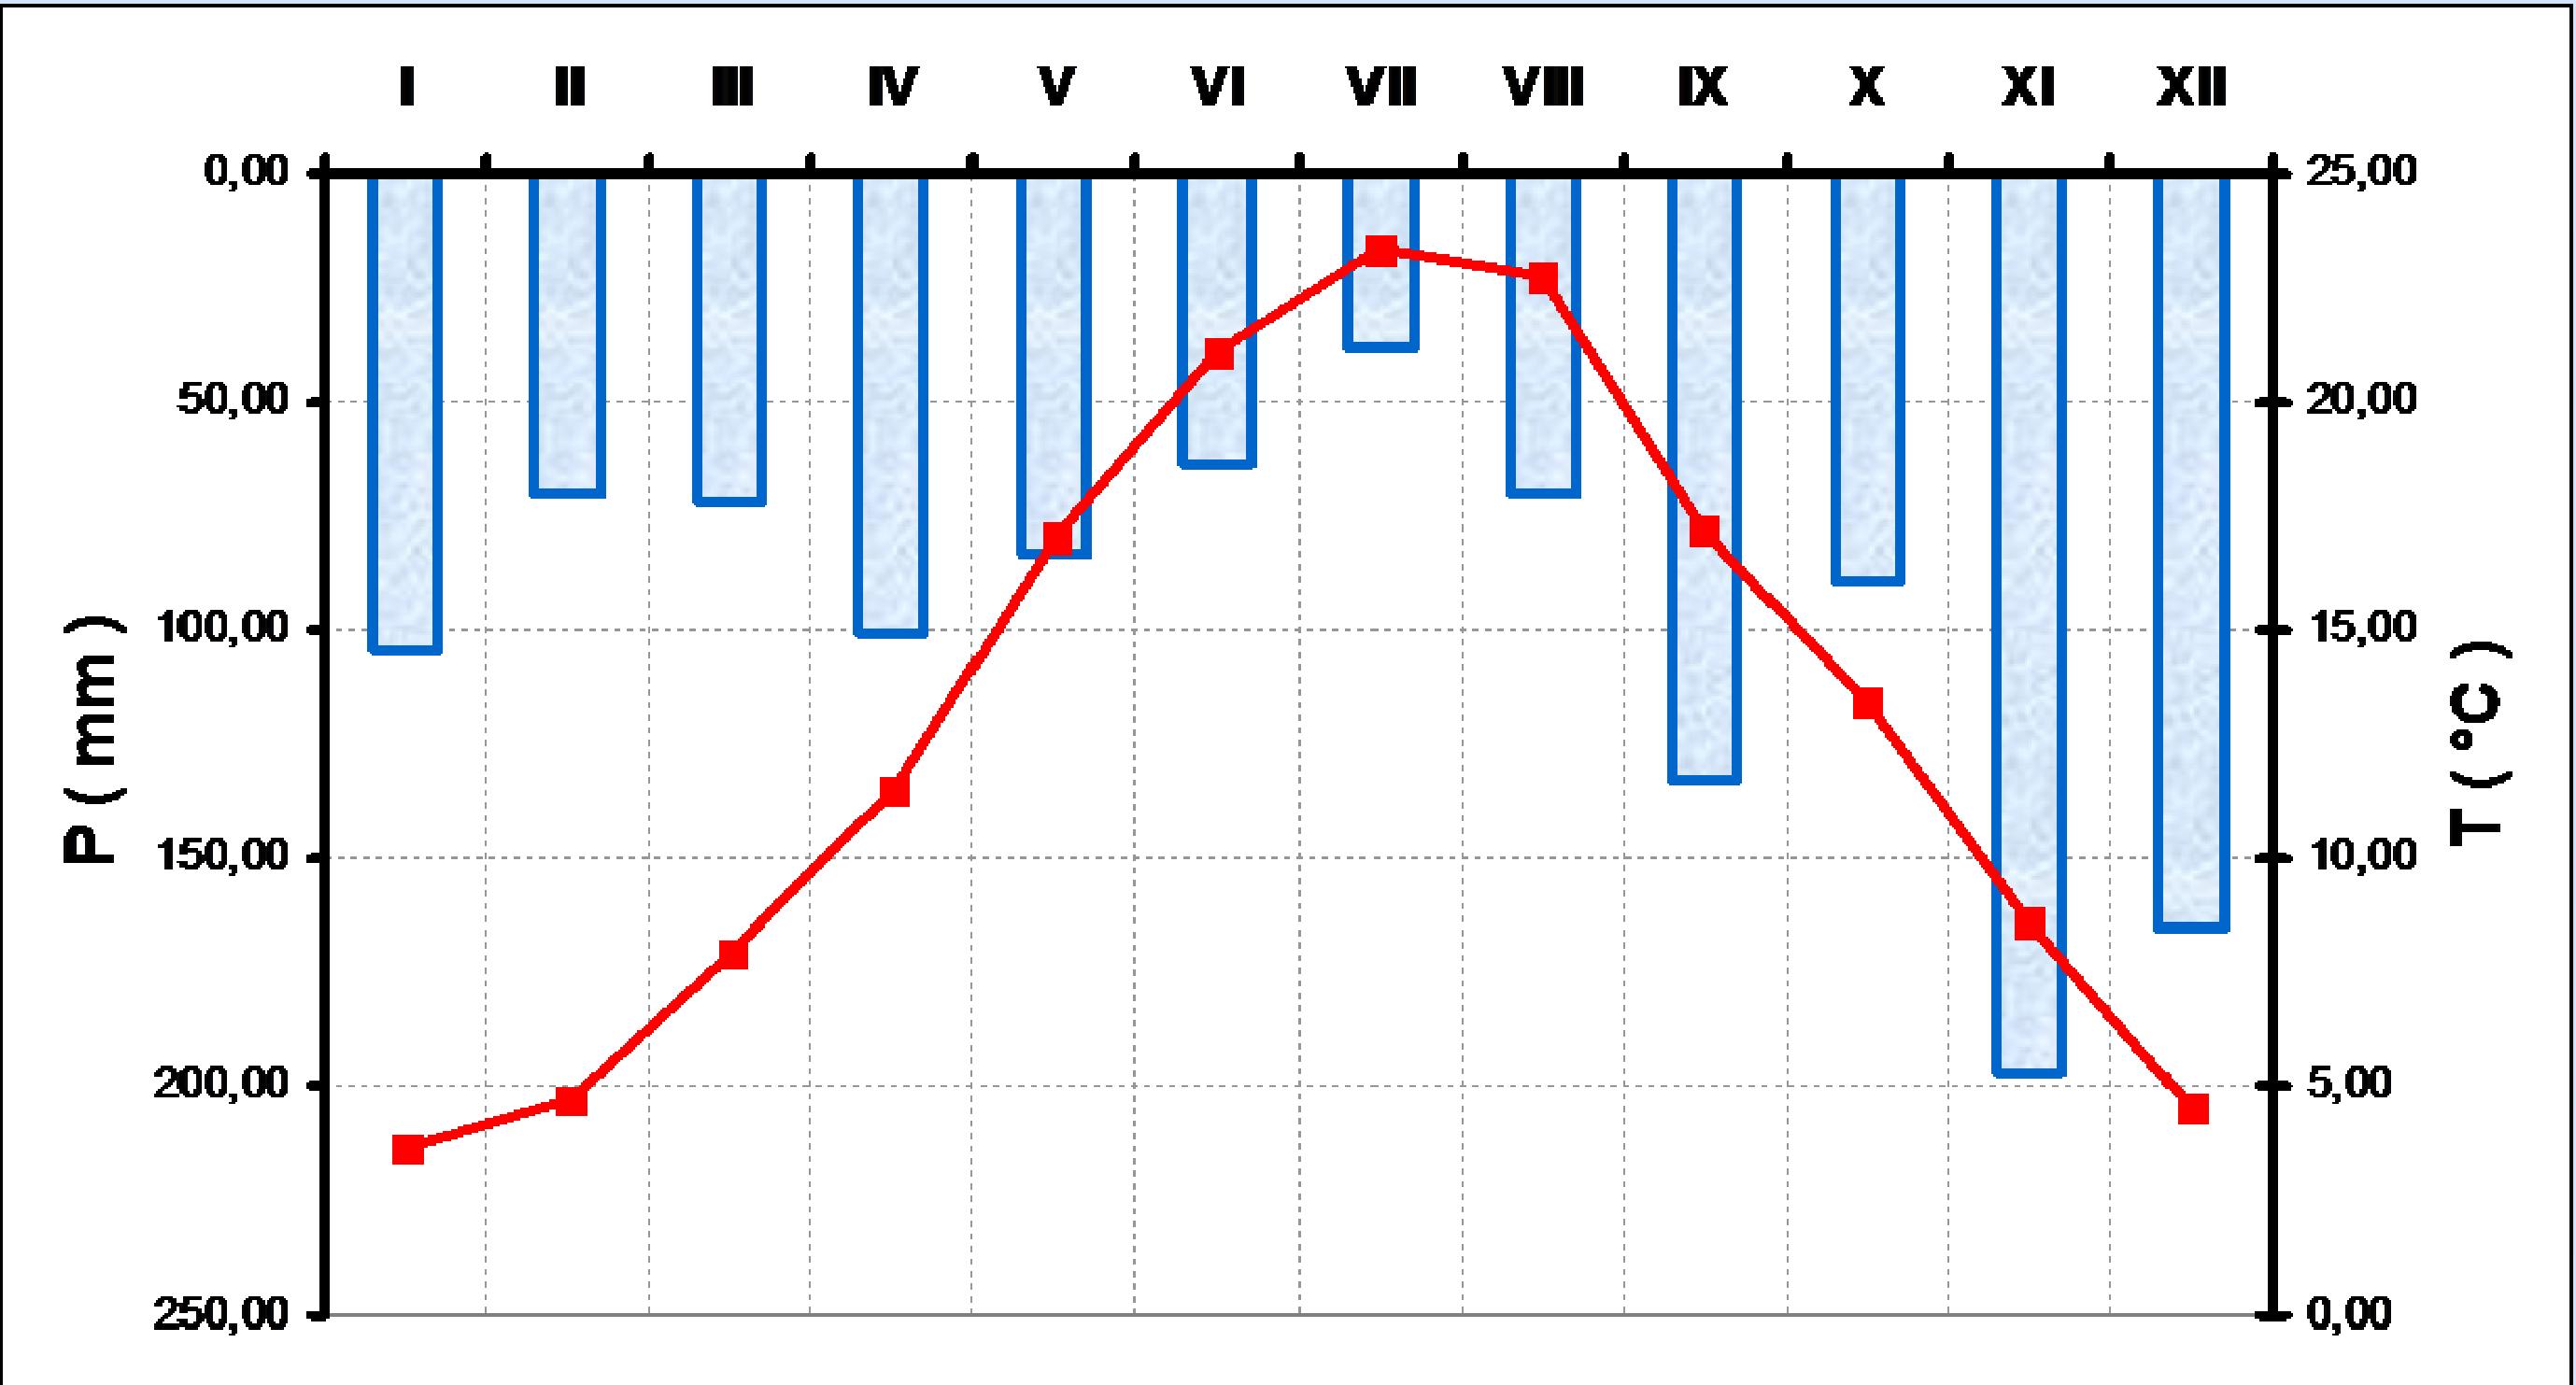
Annual time series of average monthly air temperatures and average monthly precipitation at the meteorological station Sinj during the period of 1995 – 2005.

The available daily data from 1995 to 2005 (precipitation, temperature and relative humidity) is provided by National Meteorological and Hydrological Service. The station is located 5 km from the study site at the altitude of 301 m a.s.l. It is running and operational.

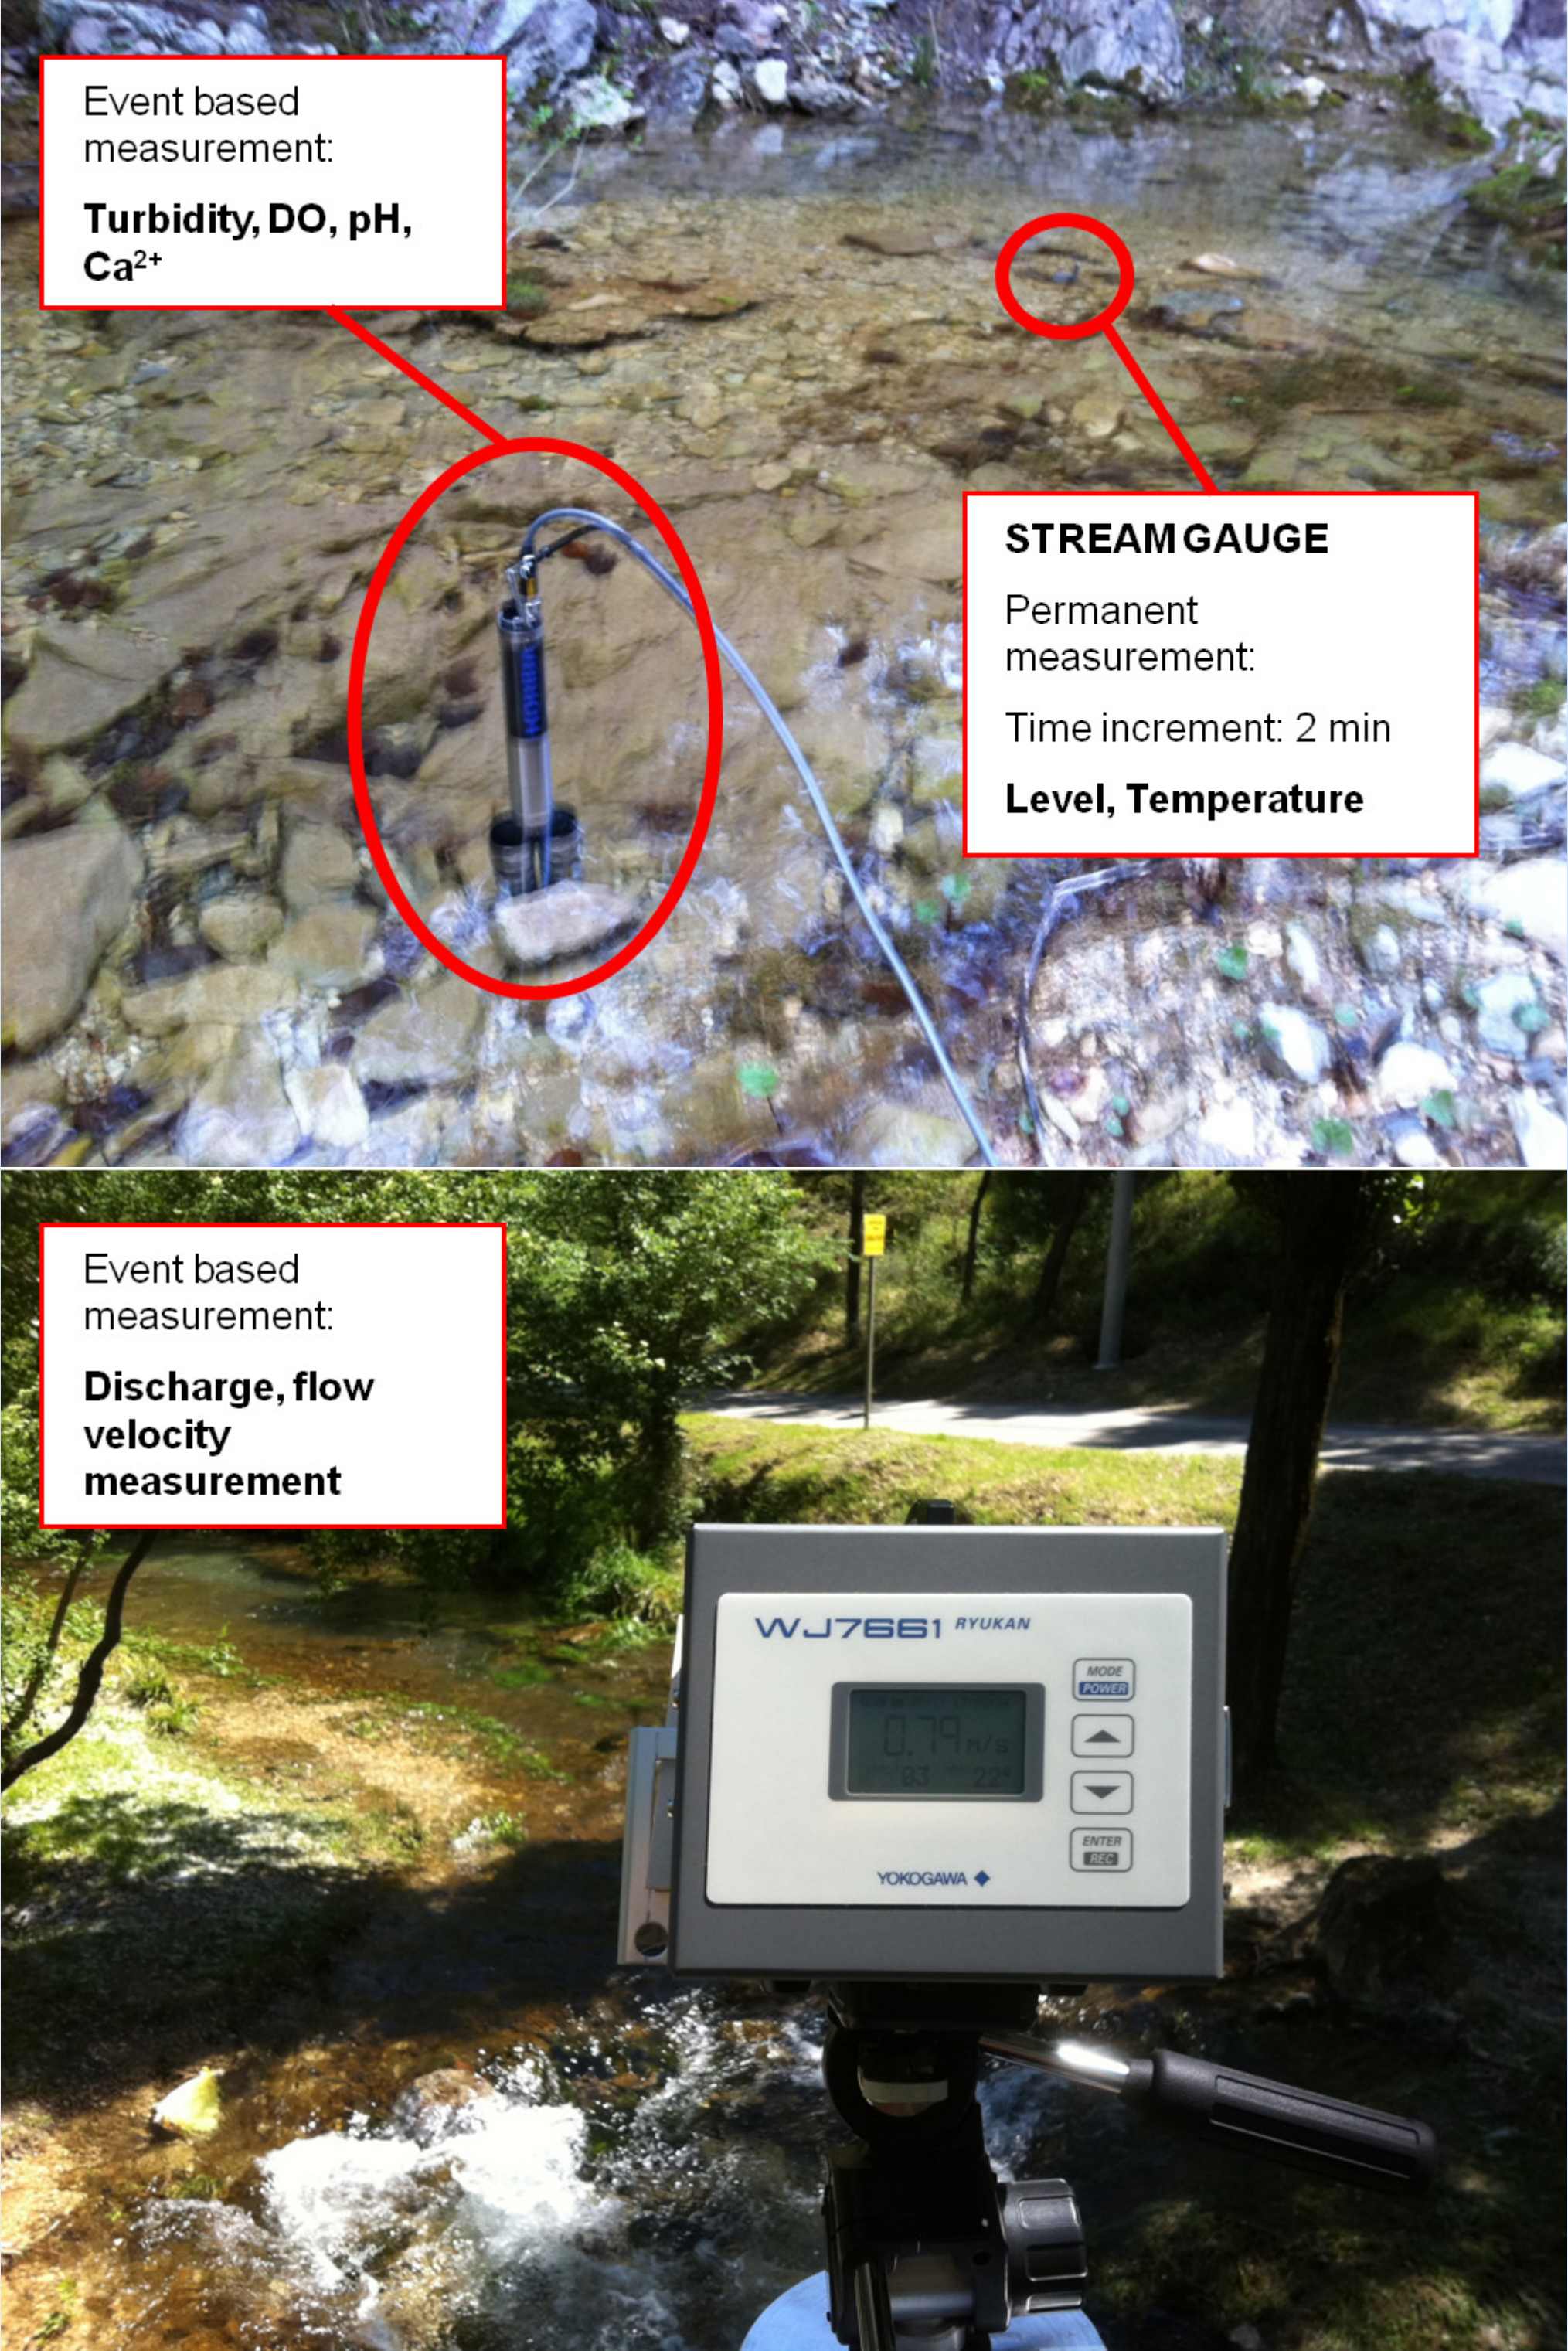
Event based measurements on the stream and permanent measurement of water level and water temperature on five locations.

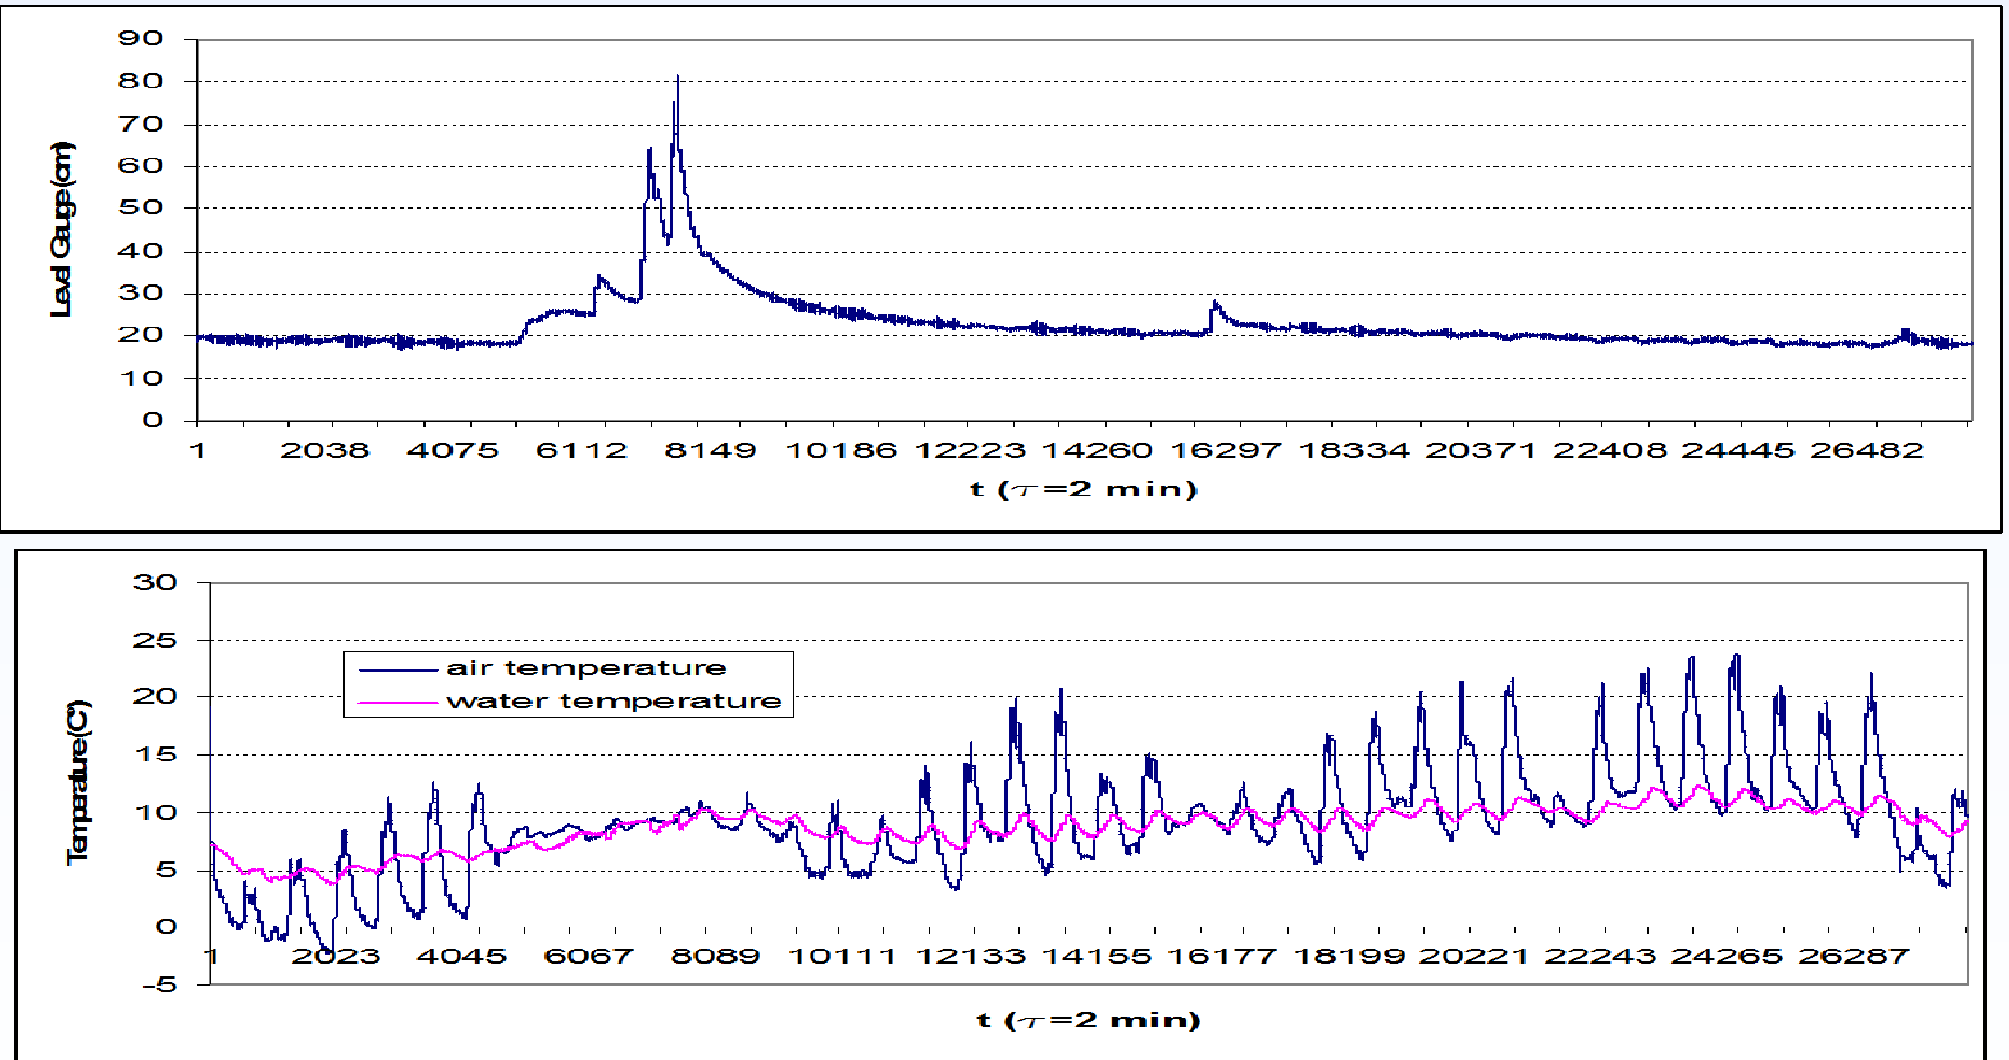
An example of recorded data during a storm event.

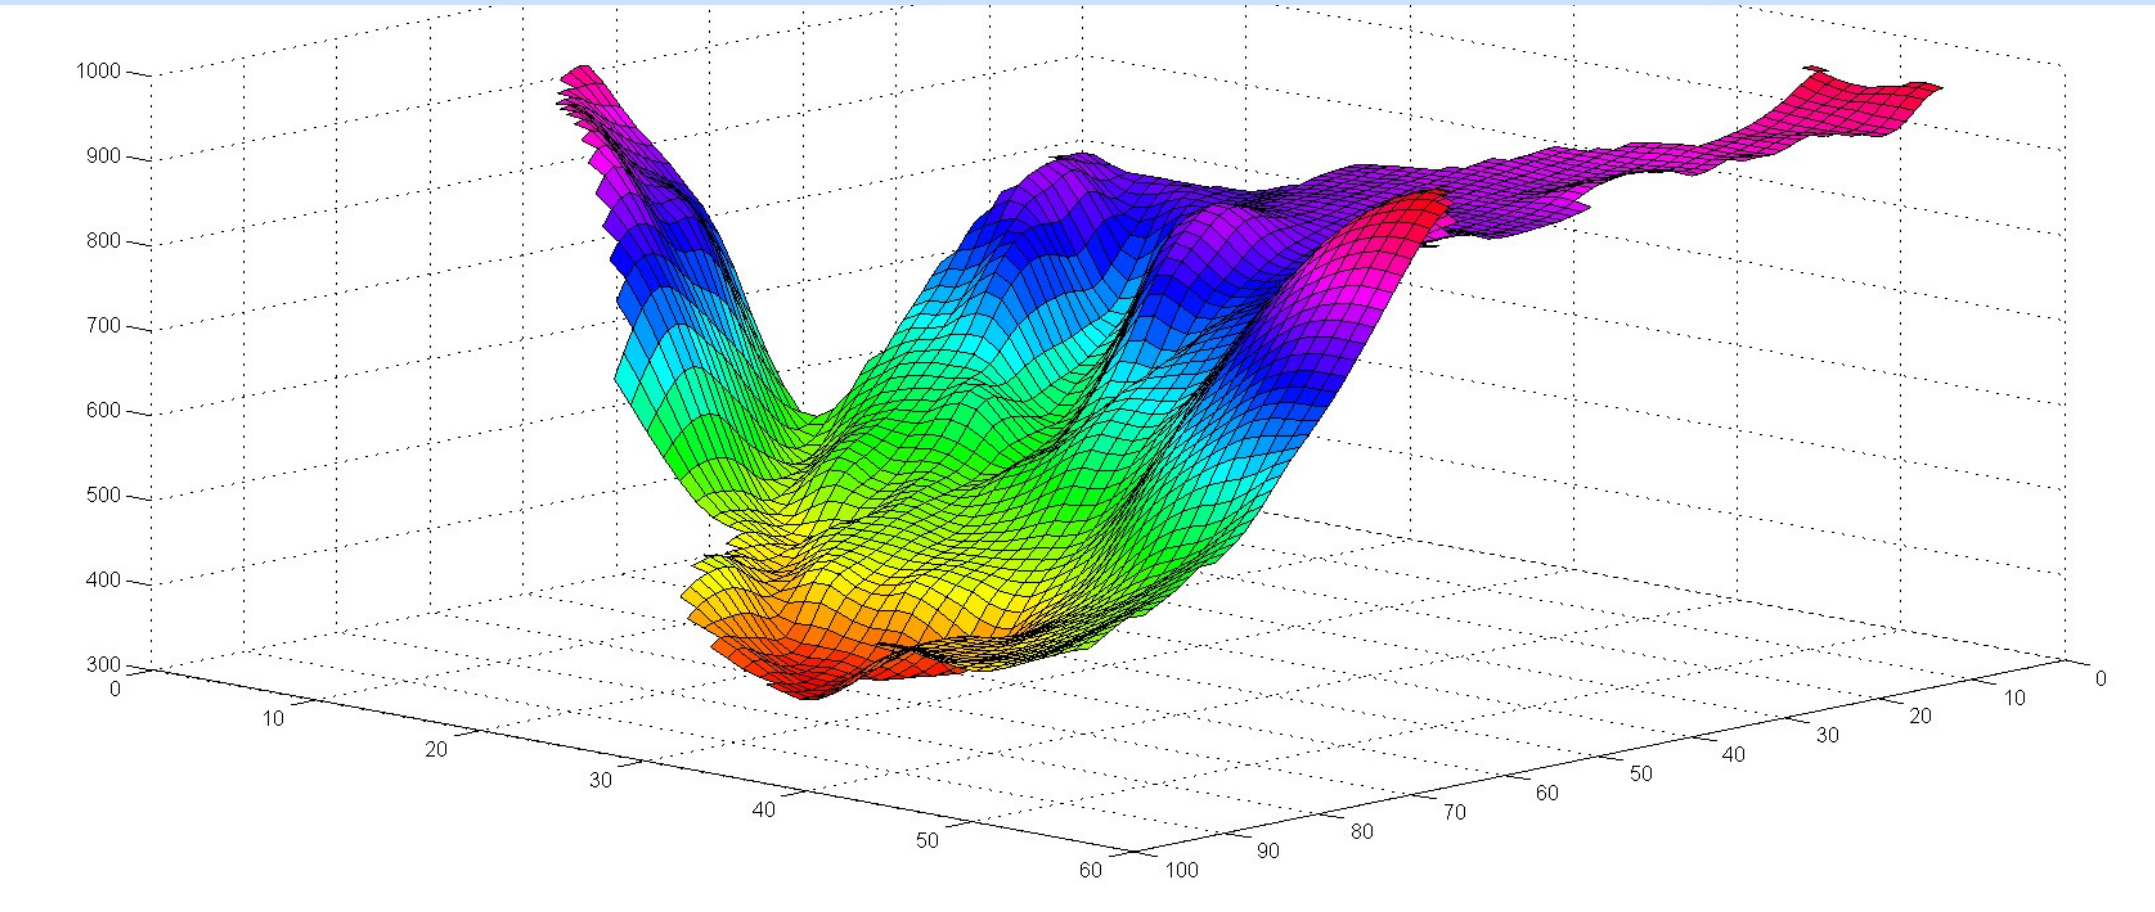
DEM of the study area that generates most of the surface flow.
