# Study and testing of the “Porta Férrea” stone materials

## University of Coimbra, Portugal

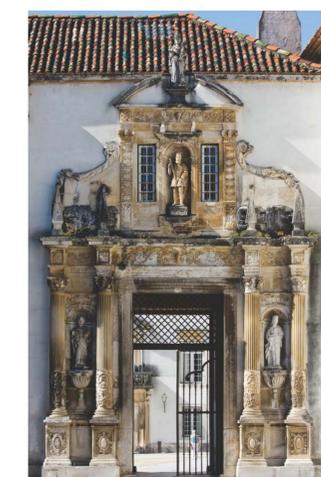
Figure 7 | Porta Férrea, East Portal, before intervention (Ribeiro, 2009)

The results allowed a more comprehensive and wised intervention in order to preserve a monument (figure 7, 8) that is part of the UNESCO Word Heritage.

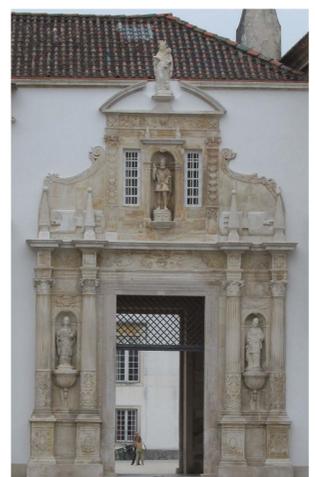
Figure 8 | Porta Férrea, East Portal, after intervention.
