# Towards biological restoration of Tehran megalopolis river-valleys

## case study: Farahzad river

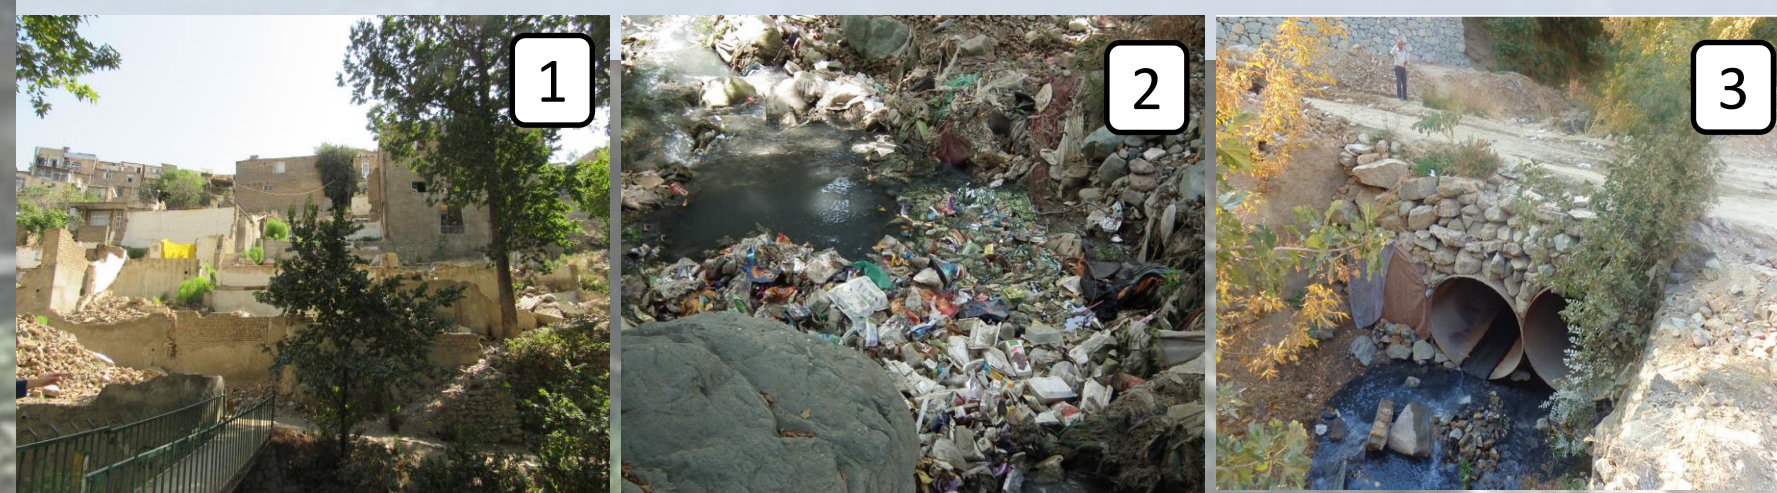
Fig. 1. Challenges in the pilot of project: 1. Illegal building construction, 2. Garbage, 3. Waste water release.

□ **Challenges:** Restoration face with different challenges in urban river valley like Farahzad River. Some of these challenges illustrated in fig.1.

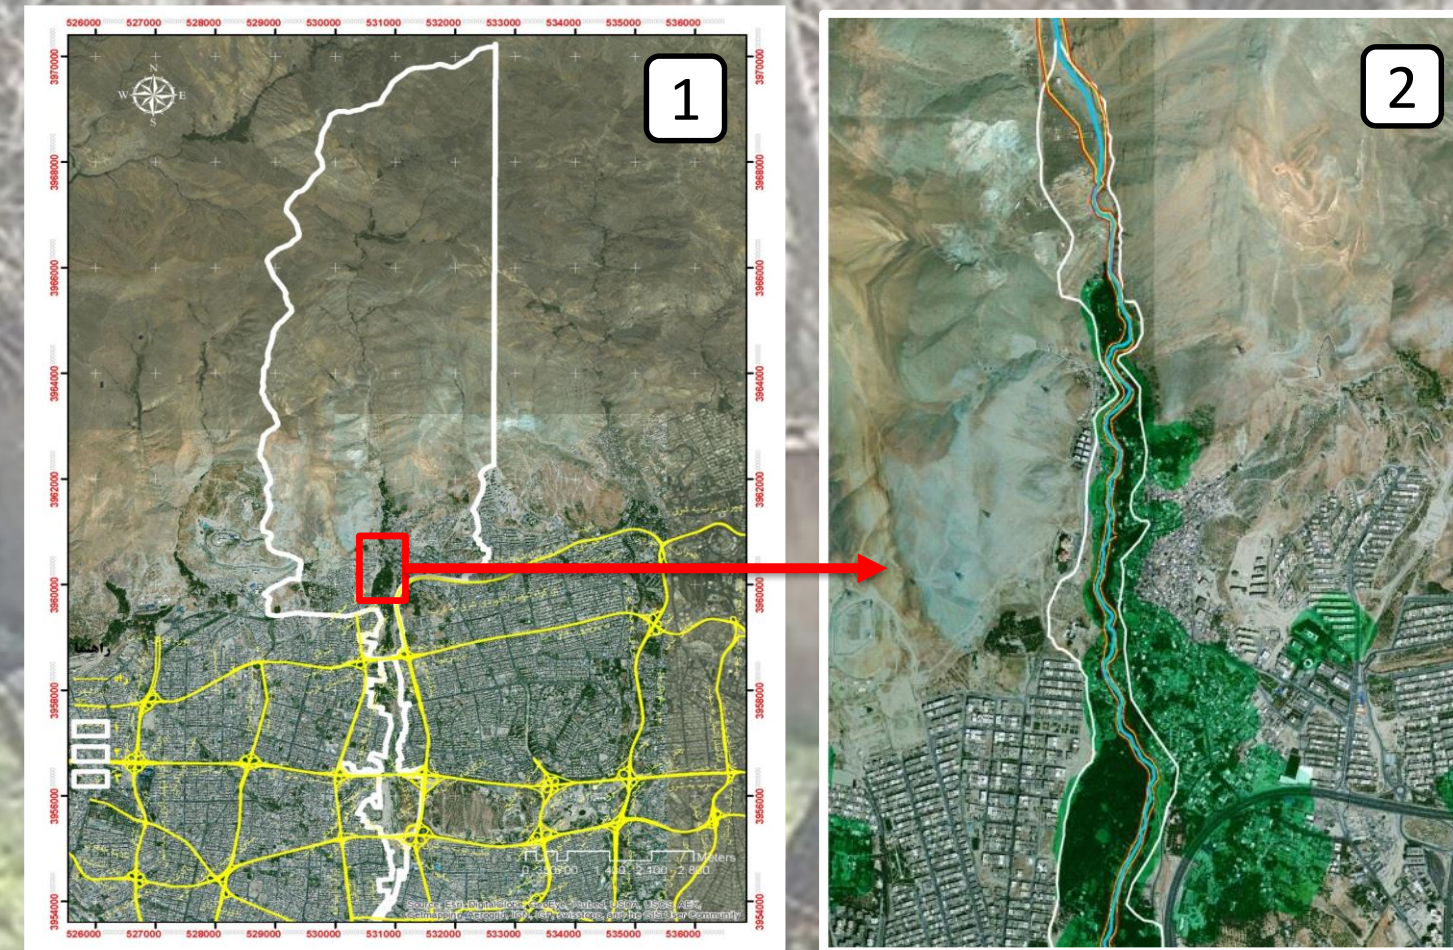
Fig.2: 1.Study area boundary, 2. Pilot area: White line: boundary of valley sides, green layer: vegetation zone in 1956 compared with today land use.

**Study area:** The pilot restoration project aims to restore 3.2 km of 12.3 km of the river valley where the river is still running in its original/semi-natural place (fig.2). Aerial photos from 1956 and vegetation data collected during 2002 in Pardisan park (3 km southern parts of the valley) by H. Akhani and V. Zarrinpour are used as reference (1).

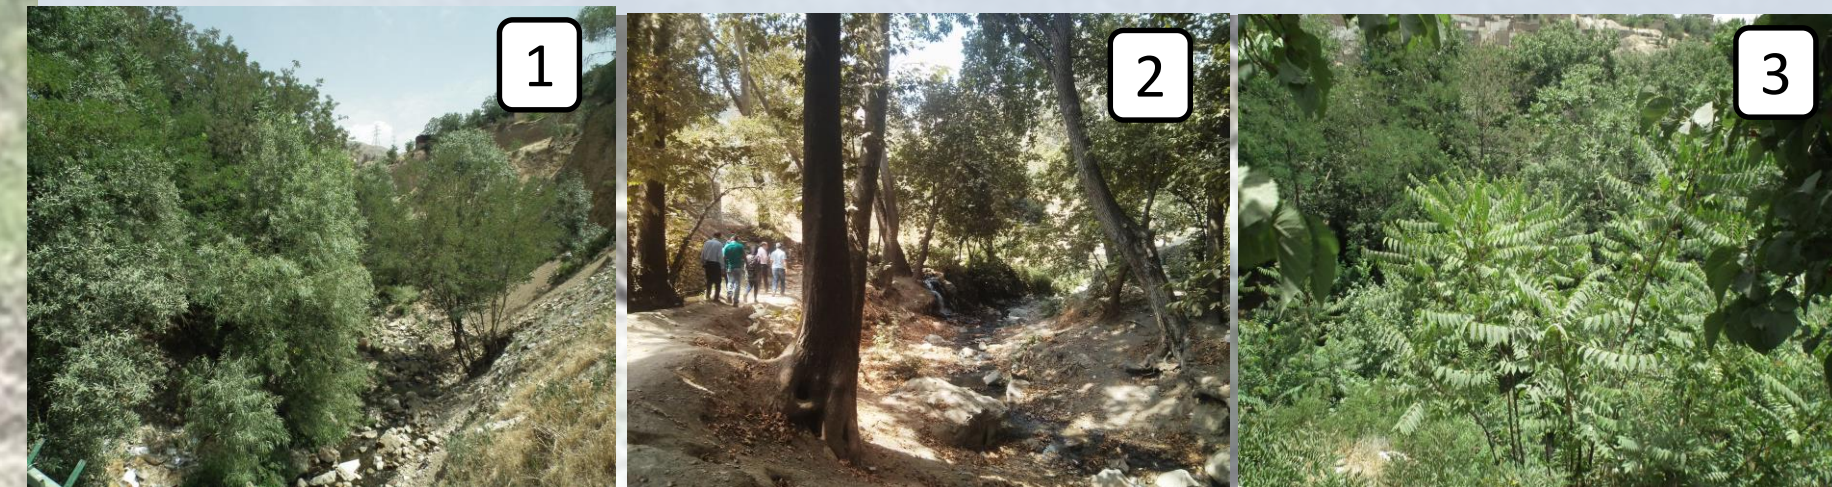
Fig.3. Existing vegetation: 4. *Salix acmophylla* community, 5. planted *Platanus orientalis*, 6. Domination of *Ailanthus altissima* as an invasive species.

**Present Vegetation of degraded area:** The degraded area are very heterogenous. The semi-natural parts along the river still support growing of hygrophytic species or shrubs of the steep slopes such as *Tamarix ramosissima*, *Salix acmophylla*, *Fraxinus excelsior*, *Celtis caucasica* or cultivated species such as *Morus alba*, *Juglans regia*, *Platanus orientalis*, *Acer negundo* and *Robinia pseudoacacia* in severely degraded area or areas which buildings are removing, ruderal species and pioneer plants such as *Bassia scoparia*, *Heliotropium europaeum*, *Amaranthus blitoides*, *A. retroflexus*, *Persicaria lapathifolia*, *Echinochloa crus-galli*, *Chenopodium spp.*, *Sorghum halepense* etc. are frequent. These are mostly nitrophilous plants which are very effective in denitrification of wastewater runoff flowing from the surrounding residential buildings.
