Using structures of the August 24, 2016 Amatrice earthquake affected area as seismoscopes for assessing ground motion characteristics and parameters of the main shock and its largest aftershocks

Panayotis Carydis ⁽¹⁾, Efthymios Lekkas ⁽²⁾, Spyridon Mavroulis ⁽²⁾

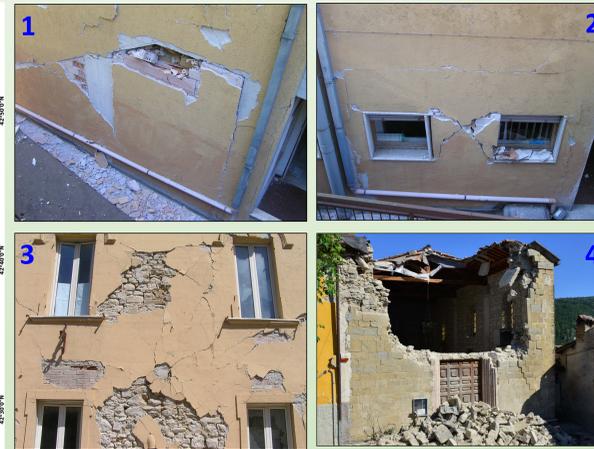
(1, 2) Non-structural damage observed in reinforced-concrete (RC) buildings in Amatrice town. (3, 4) Non-structural and structural damage to unreinforced masonry (URM) buildings in Amatrice (3) and Accumoli (4) towns. Both towns are located close to the causative fault of Mt. Vettore.

Non-structural damage Horizontal cracking of infill and internal partition walls, detachment of infill walls from the surrounding RC frame and of large pieces of plaster from walls.

Structural and non-structural damage Damage varies from cracks and detachment of large pieces of plaster from walls to mainly and mostly destruction of the building. Moreover, damage to masonry walls, piers, floors and roofs was also observed.

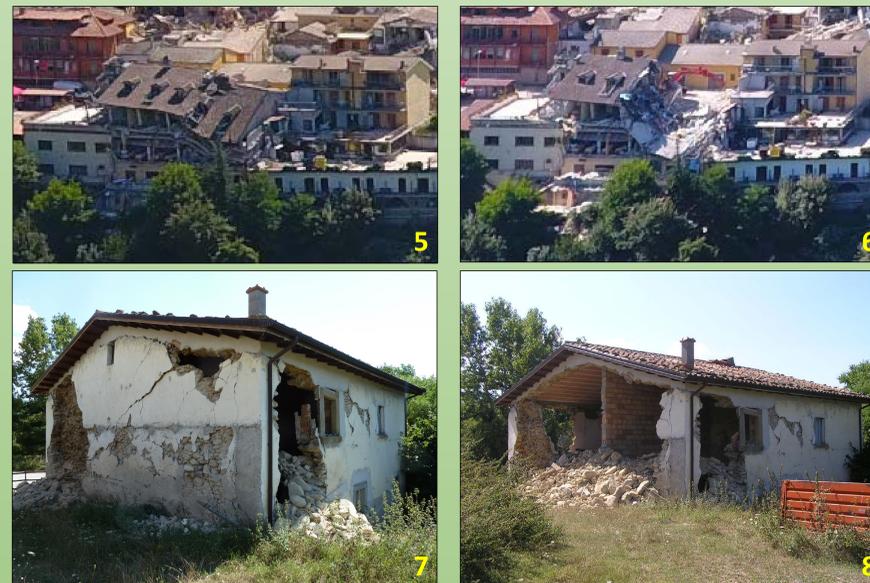
The main shock and its largest aftershocks caused damage including spatial homothetic motions of RC buildings (5, 6) and URM buildings (7, 8). Photos on the left (5, 7) were taken on 2016.08.25 after the main shock and an Mw 4.3 aftershock and photos on the right (6, 8) on 2016.08.26 after a shallow near-field Mw 4.8 aftershock with focal mechanism indicating normal faulting.

During on-site inspection in the affected area immediately after the earthquake, the authors had the opportunity to observe the damage induced not only by the main shock but also by its largest aftershocks generated during the first three days of the aftershock sequence. Bearing in mind that:

- the soil conditions in foundations of the affected villages were neither changed nor altered,
- the conventional dynamic parameters of buildings did not play a significant role in their seismic response against the vertical component of the earthquake ground motion, due to its impact type of loading,
- the structures and materials have carried memories from the previous large shocks of this sequence and
- the main shock and its largest aftershocks caused damage on buildings including spatial homothetic motions,

- the main shock and its largest aftershocks had similar focal mechanism parameters (normal faulting),
- the main shock and its largest aftershocks were shallow near-field seismic events with short duration but high amplitude,
- the observed damage is typical of such earthquakes and
- the vertical component of the earthquakes' ground motion has prevailed.

These homothetic motions were not an isolated case, but they reached statistically significant levels. Therefore, the characteristics of the largest aftershocks derived from portable instruments installed after the main shock can be used for extracting relevant conclusions for the main shock and effectively addressing the lack of seismographs in the near field during its occurrence time.

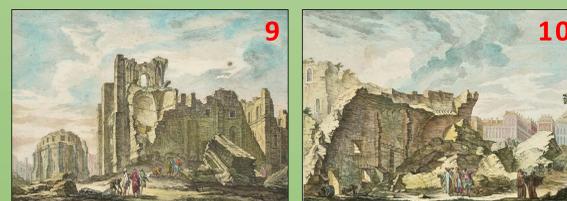
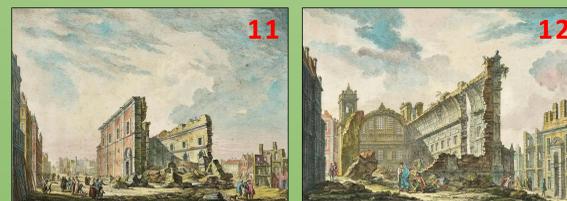
Engravings made by Jacques Philippe Le Bas on 1757 illustrating damage caused by the 1755 Great Lisbon earthquake showing the Lisbon Cathedral (9), the St. Roch Tower (10), St. Paul's Church (11) and the St. Nicholas Church (12). The roofs of the studied buildings partially collapsed along the vertical direction and within their own footprint indicating the prevalence of the vertical component.

Following the aforementioned approach based solely on macroseismic field observations, very important conclusions related to famous historical earthquakes may be drawn. We applied this approach to the case of the 1755 Great Lisbon earthquake in order to determine its characteristics. Macroseismic observations derived from: (a) on-site inspection of damaged historical buildings in Lisbon city and (b) artworks illustrating famous buildings that suffered damage from this sequence. In brief, the studied building collapsed along the vertical direction, within their own footprint and within the very first moments of the ground shaking. Thus, inhabitants had no time to react by escaping or protecting themselves and therefore the lethality rate was really high.

It is concluded that this damage are attributed to an earthquake with (a) a strong vertical component, (b) its epicenter located very close to Lisbon, (c) a small focal depth and (d) perhaps of not so great magnitude. Probably, due to the other evidences, the Great Lisbon earthquake, that generated the devastating tsunami, had its epicenter located in the ocean (to the W of Lisbon) and immediately followed the previous earthquake of the prevailing vertical component.
