# Modelling maximum rain intensity and discharge of the Santa Tecla flash flood (1874) in Conesa (Catalonia, NE Iberian Peninsula)

Josep Carles Balasch (1), Jordi Tuset (2), Kevin Jurado (3), Glòria Furdada (3), Josep Lluís Ruiz-Bellet (1)  
 Corresponding author: cbalasch@macs.udl.cat

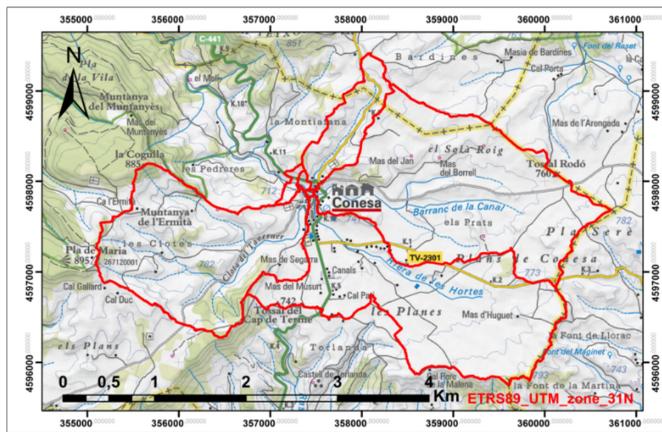
Figure 2. The seven subcatchments that meet at Conesa (Map by www.icgc.cat)

Santa Tecla flood (22-23 September 1874) is one of the most devastating flash floods events in Catalonia. We are thoroughly studying it since 2010 (Ruiz-Bellet et al., 2015). In this study, we provide new results in the small town of Conesa, in the headwaters of the Corb River basin (Figures 1 and 2).

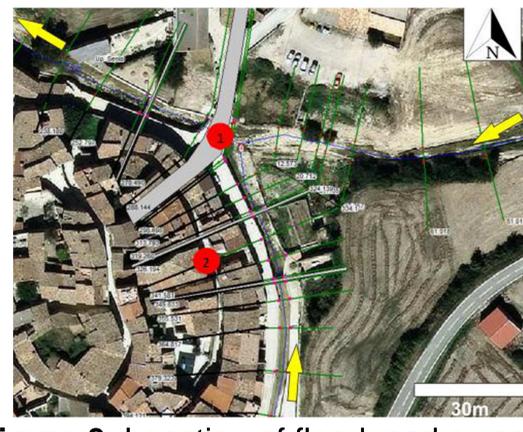
Figure 3. Location of flood marks used (1: 2-3/Nov/2015 (see Figure 5) and 2: 23/Sep/1874) and cross sections of the hydraulic model (Photo by www.icgc.cat)

We calculated 1874 flood's peak flow and the rainstorm's hyetograph using flood marks and hydraulic and hydrological models HEC-RAS v.5 and HEC-HMS v.4.2 (Figures 3 and 4). The hydrological model was calibrated with the 2-3 November 2015 flood event (Figure 5).

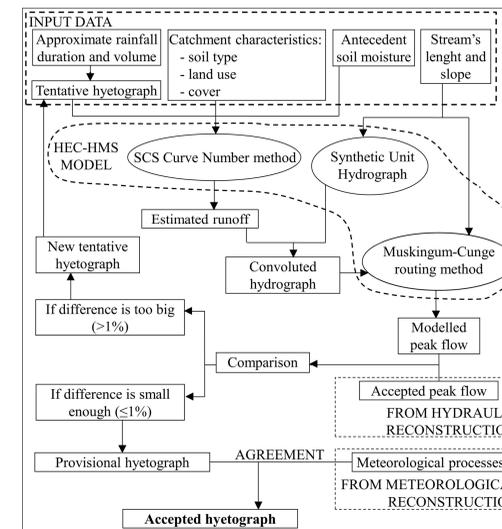
Figure 4. Hyetograph estimation with a hydrological model

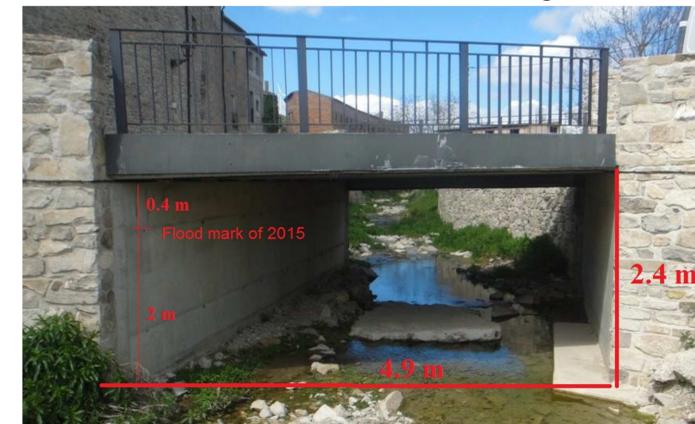
Figure 5. Mark of 2015 flood at Riera de les Hortes and Riera de la Canal junction (see Figure 3)

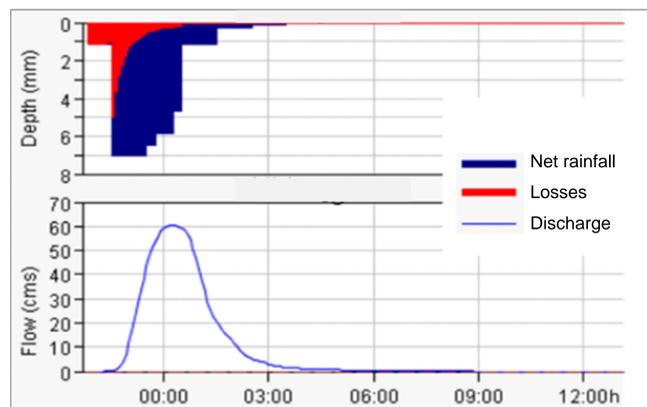
Figure 6. Modelled rainfall and discharge for 1874 flood in Riera de les Hortes subcatchment (Jurado, 2016)

Santa Tecla flood in Conesa was caused by a rain of 188 mm in six hours, with a maximum intensity of 84 mm·h<sup>-1</sup> (Figure 6; Jurado, 2016). The peak flow was 60 m<sup>3</sup>·s<sup>-1</sup> that is, a specific peak flow of 18.8 m<sup>3</sup>·s<sup>-1</sup>·km<sup>-2</sup> for a 3.2 km<sup>2</sup> basin. These high values confirm the exceptional nature of the event, and place it among the most extreme known events in the Mediterranean region (Figure 7). It has an approximate return period of 500 years. A sensitivity analysis on the hydrologic modelling estimated a minimum error of 10-15%, which is acceptable in this kind of study. Rainfall and maximum intensity evolution along the Corb River (Figure 8) confirm our hypothesis that the core of 1874 storm was located over the catchment's headwaters ridges.

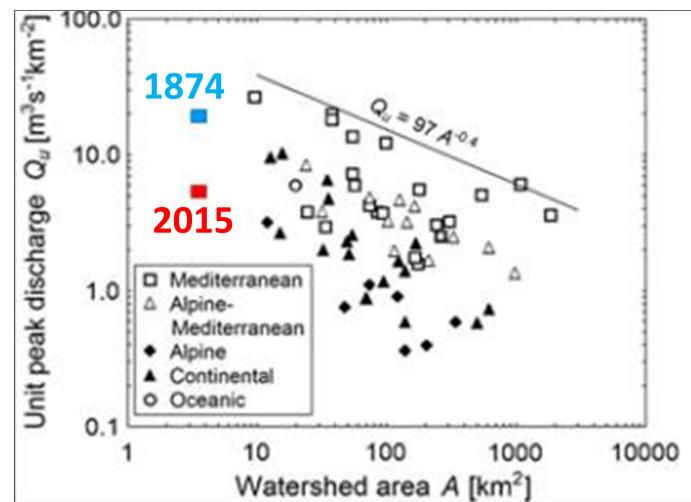
Figure 7. Specific peak flows of 1874 and 2015 floods in Conesa, compared to the highest values ever modelled in the Mediterranean basin. (Adapted from Marchi et al., 2010)

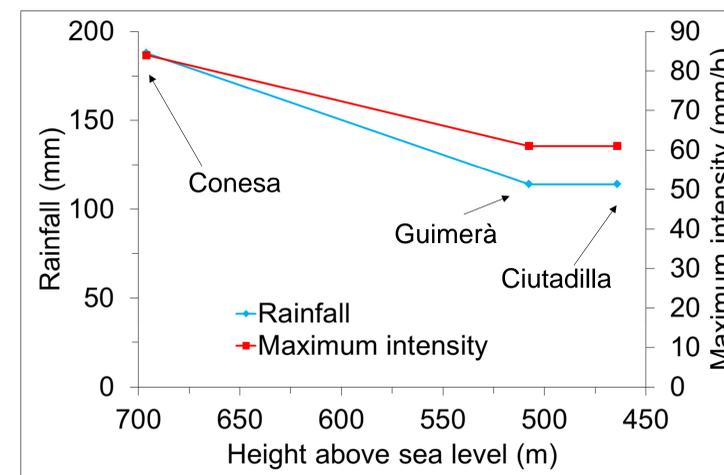
Figure 8. Evolution of modelled rainfall and maximum intensity at the towns of Conesa, Guimerà and Ciutadilla along the Corb River (Data from Jurado, 2016 and Ruiz-Bellet et al., 2015)
