# Identifying factors leading to hurricane induced landslide dam flood risk in Dominica

*D2107 EGU2020-11281*

- Research is part of “Reducing flood debris and flow risk for infrastructure resilience” in Dominica (World Bank)
- We undertook 9 river reaches studies with 19 bridges included in the assessment
- Reaches prioritised by Government (MoPW)
- Engineering level assessment of key bridges (Hydraulic capacity, forces and scour)
- Included a study of bridge resilience using post event forensics
- Used drones to fill data gaps.
- Driving questions – “What makes a bridge resilient to multiple hazards and which risk is more important and where”

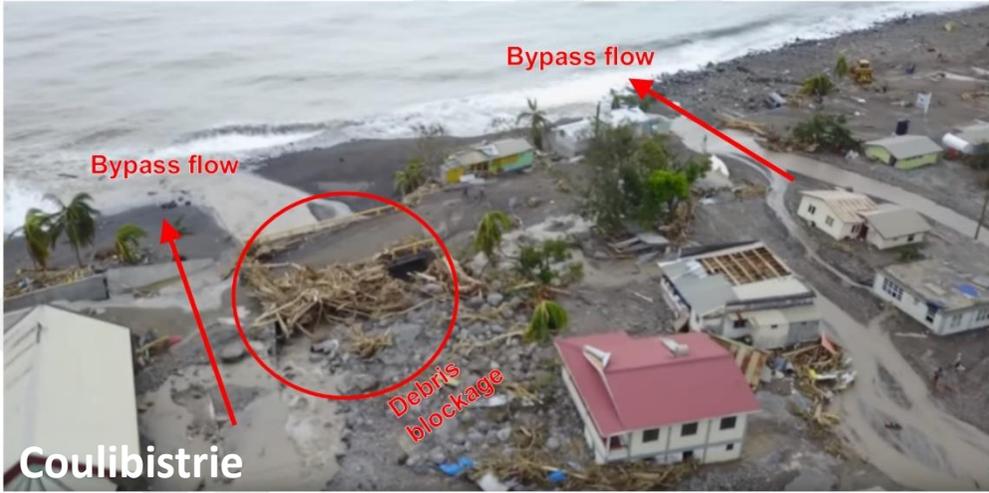
# Examples of bridges - post Maria

River flows are very high and not monitored routinely. Rivers are steep and have a lot of energy, and also bringing sediment and debris as additional risks to infrastructure on the island.

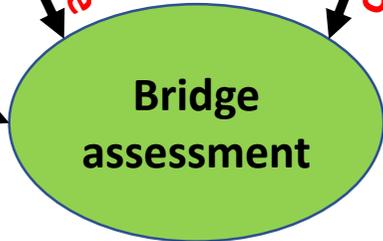
UoM Drone Surveys

Upstream landslide

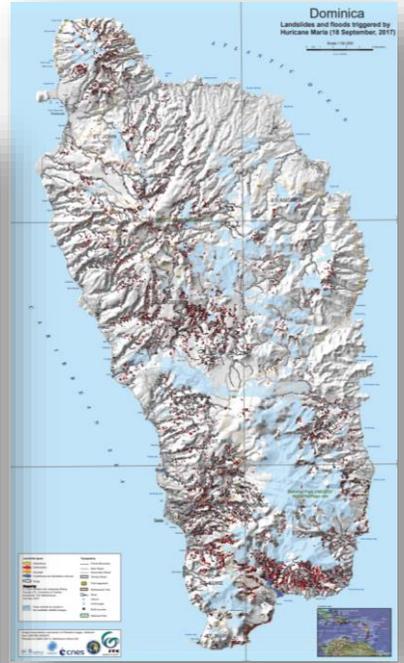
# Thousands of landslides and floods triggered by Hurricane Maria (18 Sept 2017), Dominica

**Landslide types**

- Debrisflow
- Debrislide
- Rockfall
- Flashflood and debrisflow channel
- Scarp

Mapped by  
C.J van Westen and Jianqiang Zhang  
Faculty ITC, University of Twente  
Enschede, The Netherlands  
Oct-Dec 2017

Image interpretation was based on Pleiades images, obtained from UNITAR-UNOSAT  
Pleiades © CNES (2017), Distribution Airbus DS

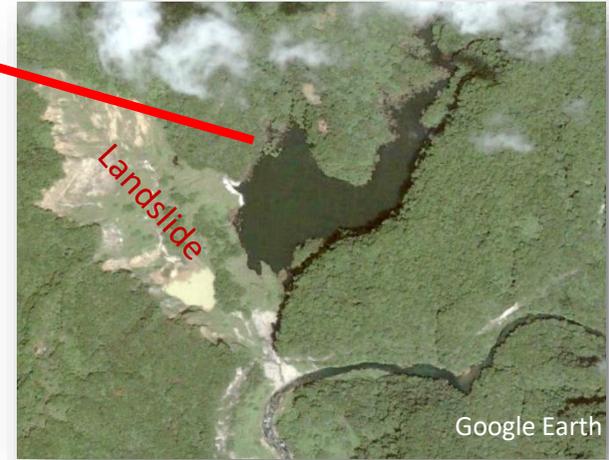
# Hydraulic modelling of historic landslide dam events

Using HecRas 2D modelling of historic landslide dam events to understand downstream implications for structures

James, and De Graff, 2012. The draining of Matthieu landslide-dam lake, Dominica, West Indies. *Landslides*
