Study area

North Slope of Alaska, focussing on Point Lay

Drained drinking water lake in Point Lay

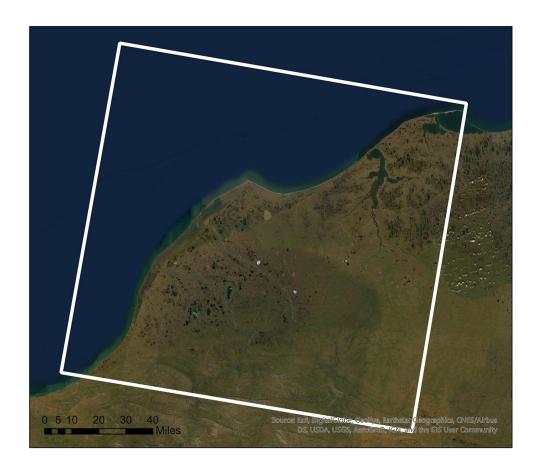
- August of 2016: drinking water source for Point Lay drained during a period of intense rainfall
- village is seeking alternative sources for a freshwater supply

Landsat 8 mosaic (2019 July-August acquisitions)
