# Quantifying the effects of the M7.8 November 14, 2016 earthquake on rainfall-induced landslide triggering and reactivation, Kaikoura, New Zealand

**Authors:** Brenda Rosser, Katie Jones, Chris Massey, Georgia Strawbridge, Samuel Morris (GNS Science, New Zealand)

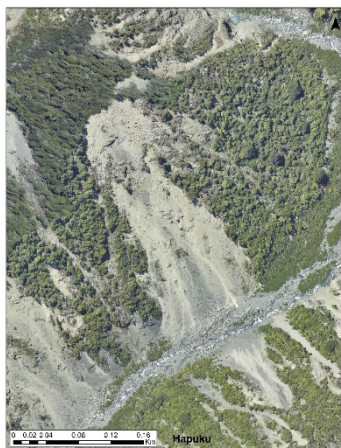
Post-earthquake ortho image (E1 Dec 2016).

Example is a reach in the Hapuku River catchment

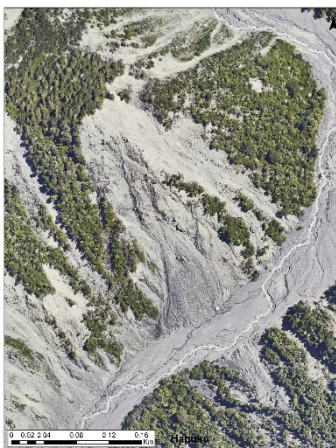
Ortho image Epoch 2 (E2 Dec 2017)

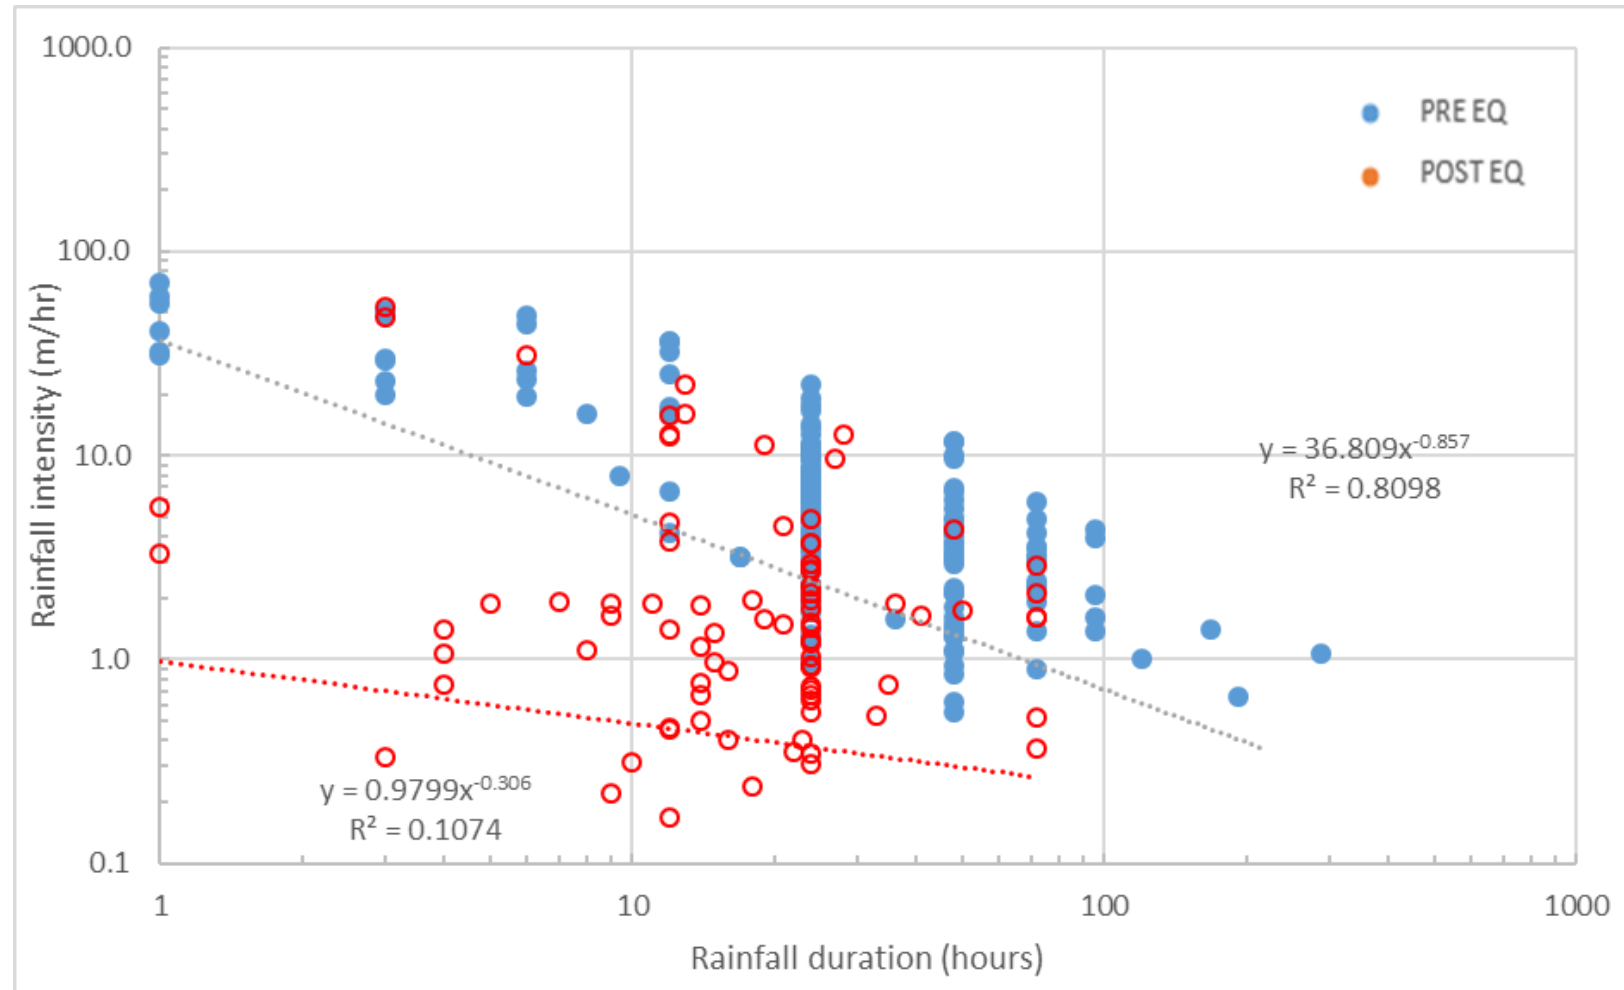
- The pre-earthquake threshold was about 60 mm/24 hrs and reduced to 9 mm/24 hrs after the earthquake
- A reduction in the rainfall threshold for triggering landslides means that landslides are triggered at much lower rainfalls than previously, and more landslides are triggered for a given rainfall amount
- We will continue to monitor this relationship to see how it changes through time.

174 pre-EQ events  
88 post-EQ events

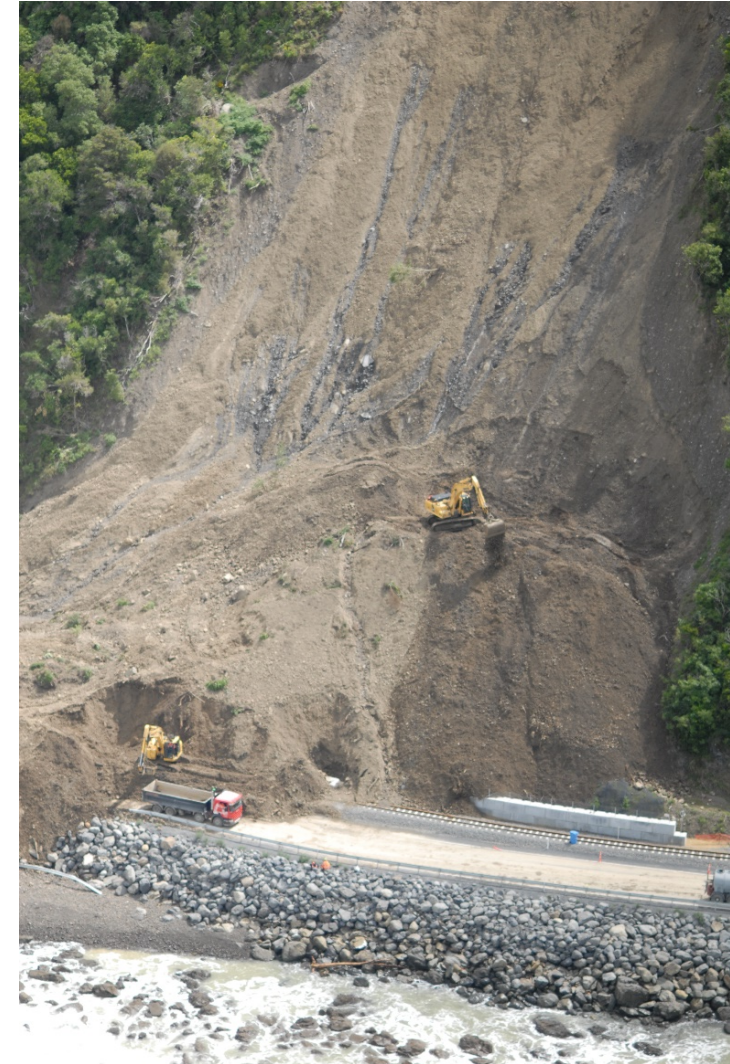
Debris flow deposit from reactivation of co-seismic landslide, SH1, Cyclone Gita, Feb 2018
