LONG-TERM MONITORING OF THE RECRUITMENT AND DYNAMICS OF LARGE WOOD IN KAMIENICA STREAM, POLISH CARPATHIANS

Paweł MIKUŚ¹, Bartłomiej WYŻGA¹

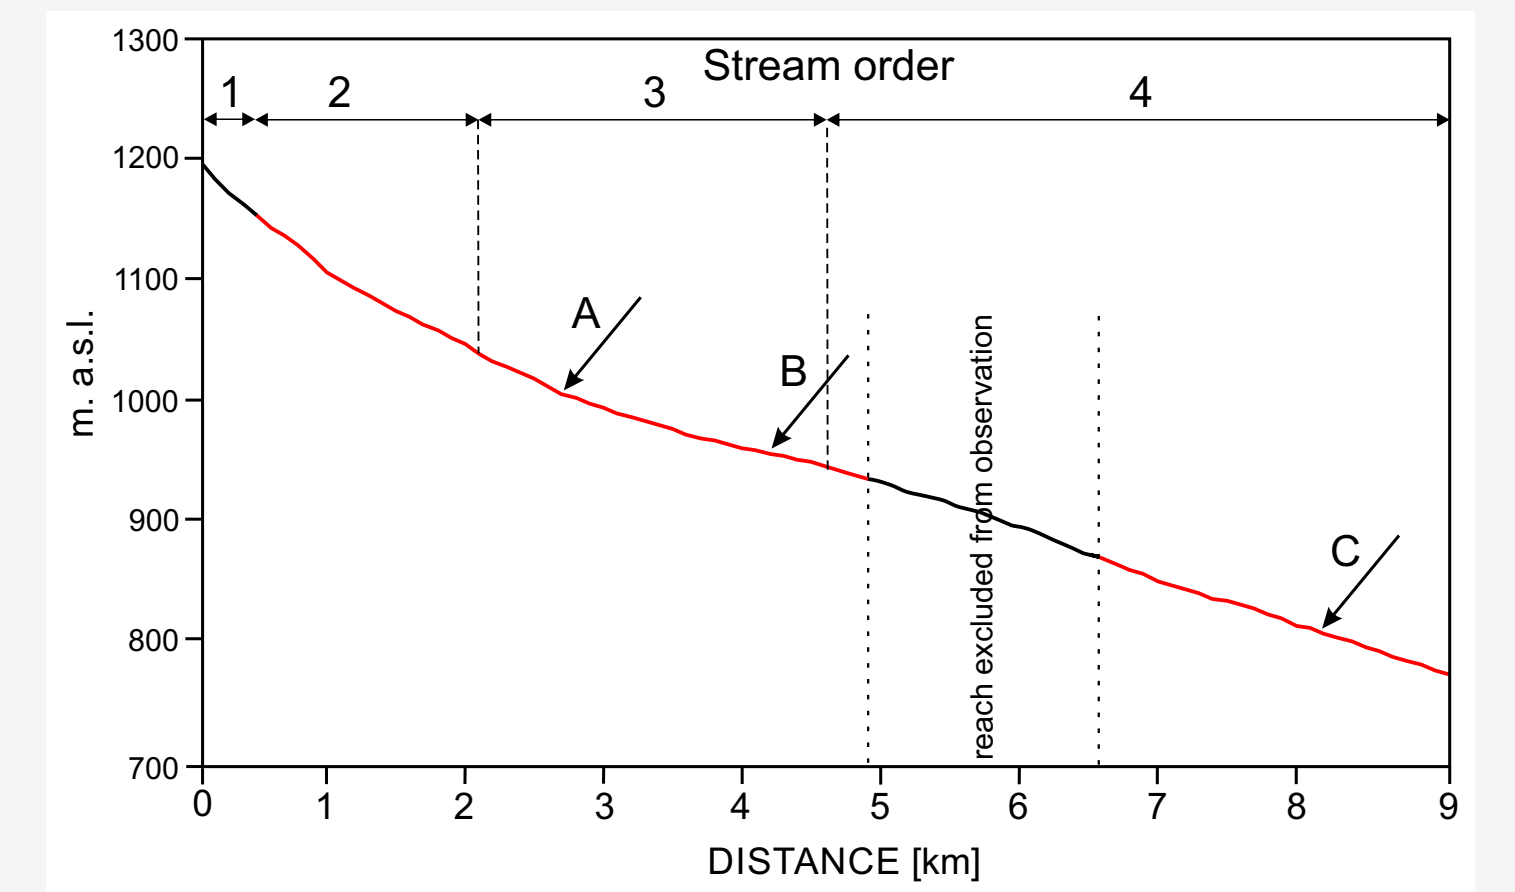
2 Locations of the studied reach showed on longitudinal profile of Kamienica Stream. A,B,C - reaches with tagged trees. Reaches covered by wood inventory were marked with red line.

In 2009, 429 living trees growing along three reaches of its upper course (2) were tagged with numbered metal plates. The timing and mechanisms of tree recruitment to the stream (4) have been monitored for 9 years. Wood inventory performed in 2012 documented amounts (5), orientation (6), location (7) and the degree of preservation (8) of large wood after a prolonged period with low to moderate floods; the data were next compared with the results of similar inventory performed after a large flood of 1997.

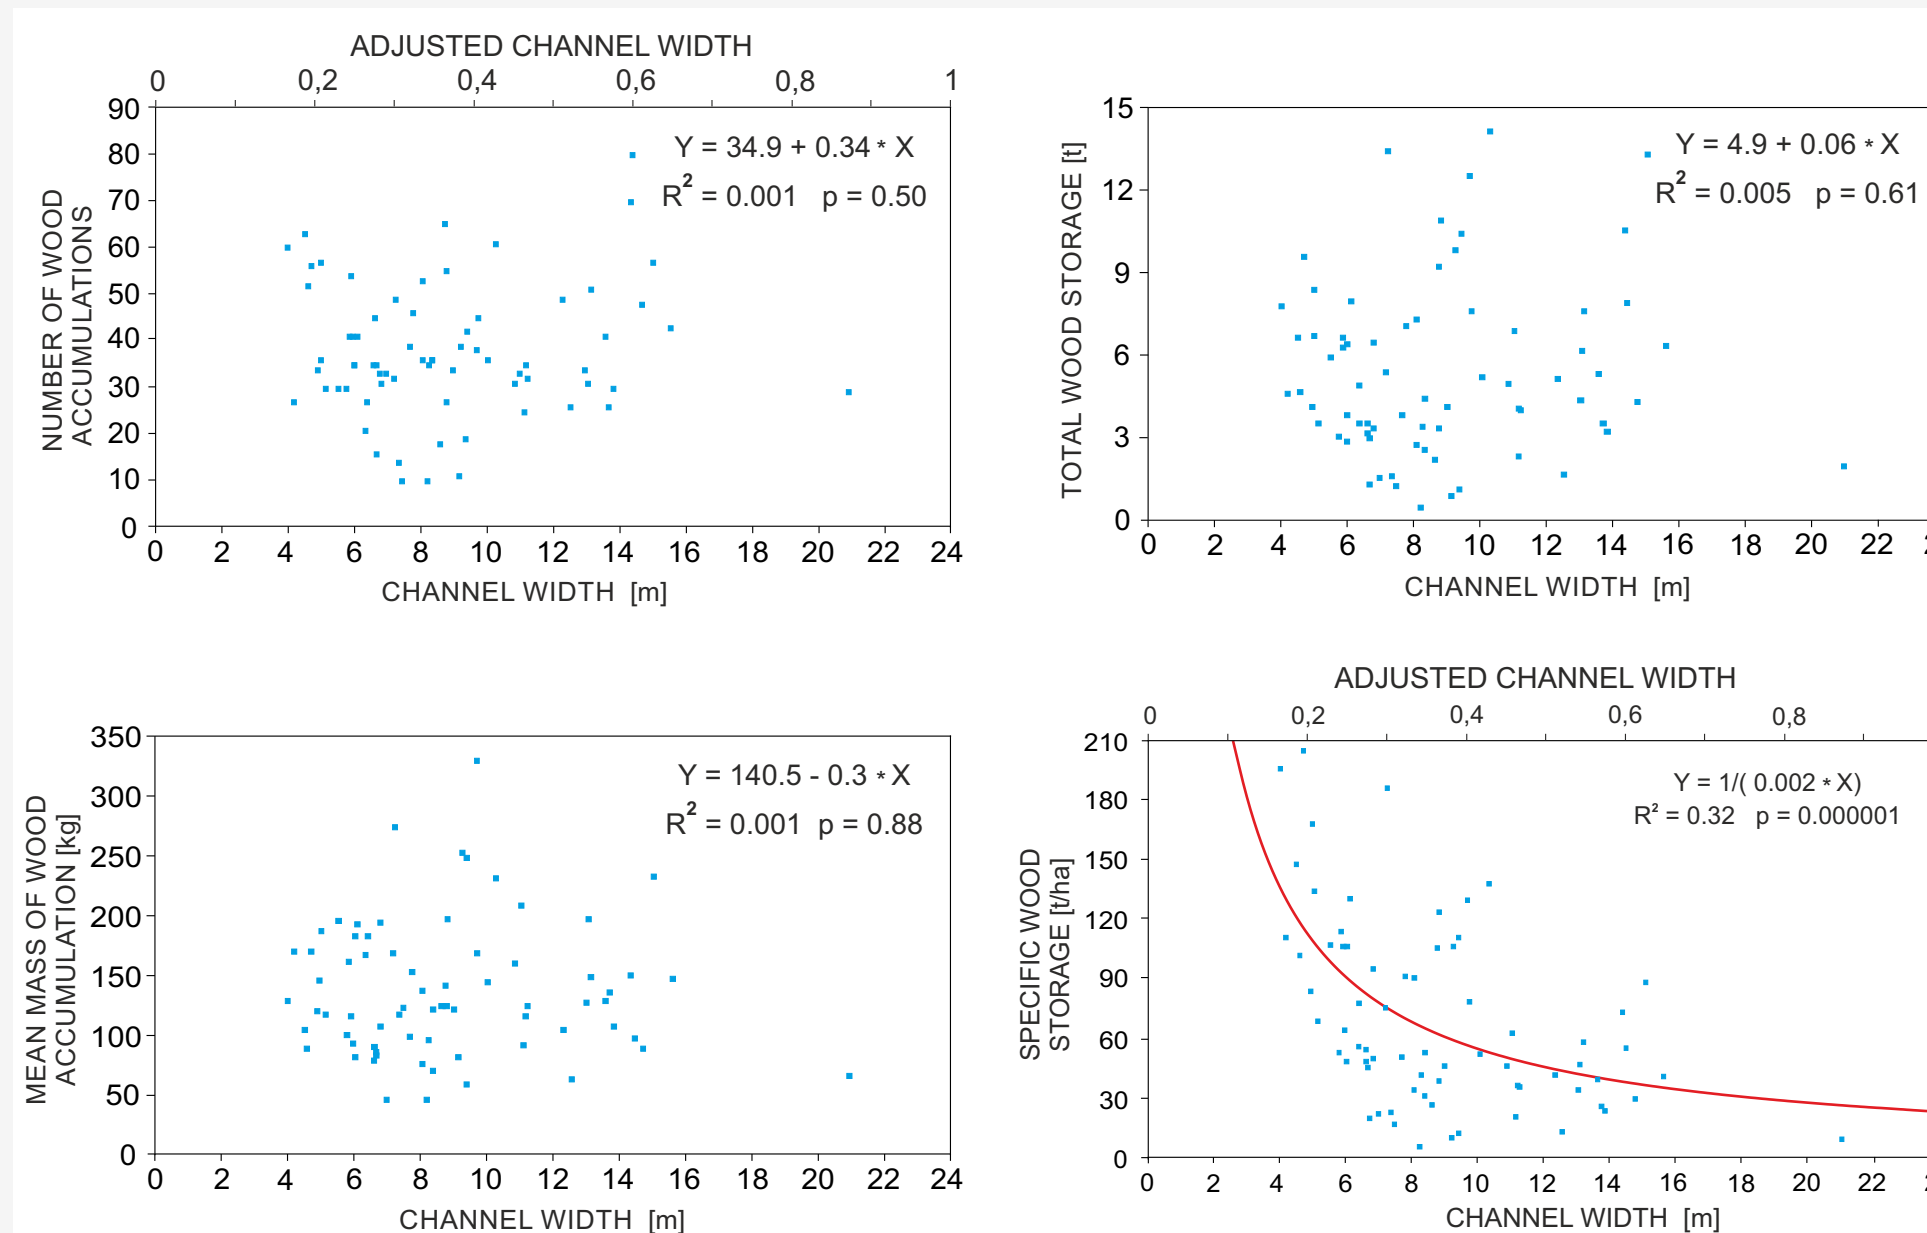
5 Scatter plots and estimated regression relationships between number of wood accumulations, mean mass of wood accumulations, total or specific wood storage and river width during wood inventory performed in Kamienica Stream in 2012. No regression lines are indicated for the relationships which are not significant.

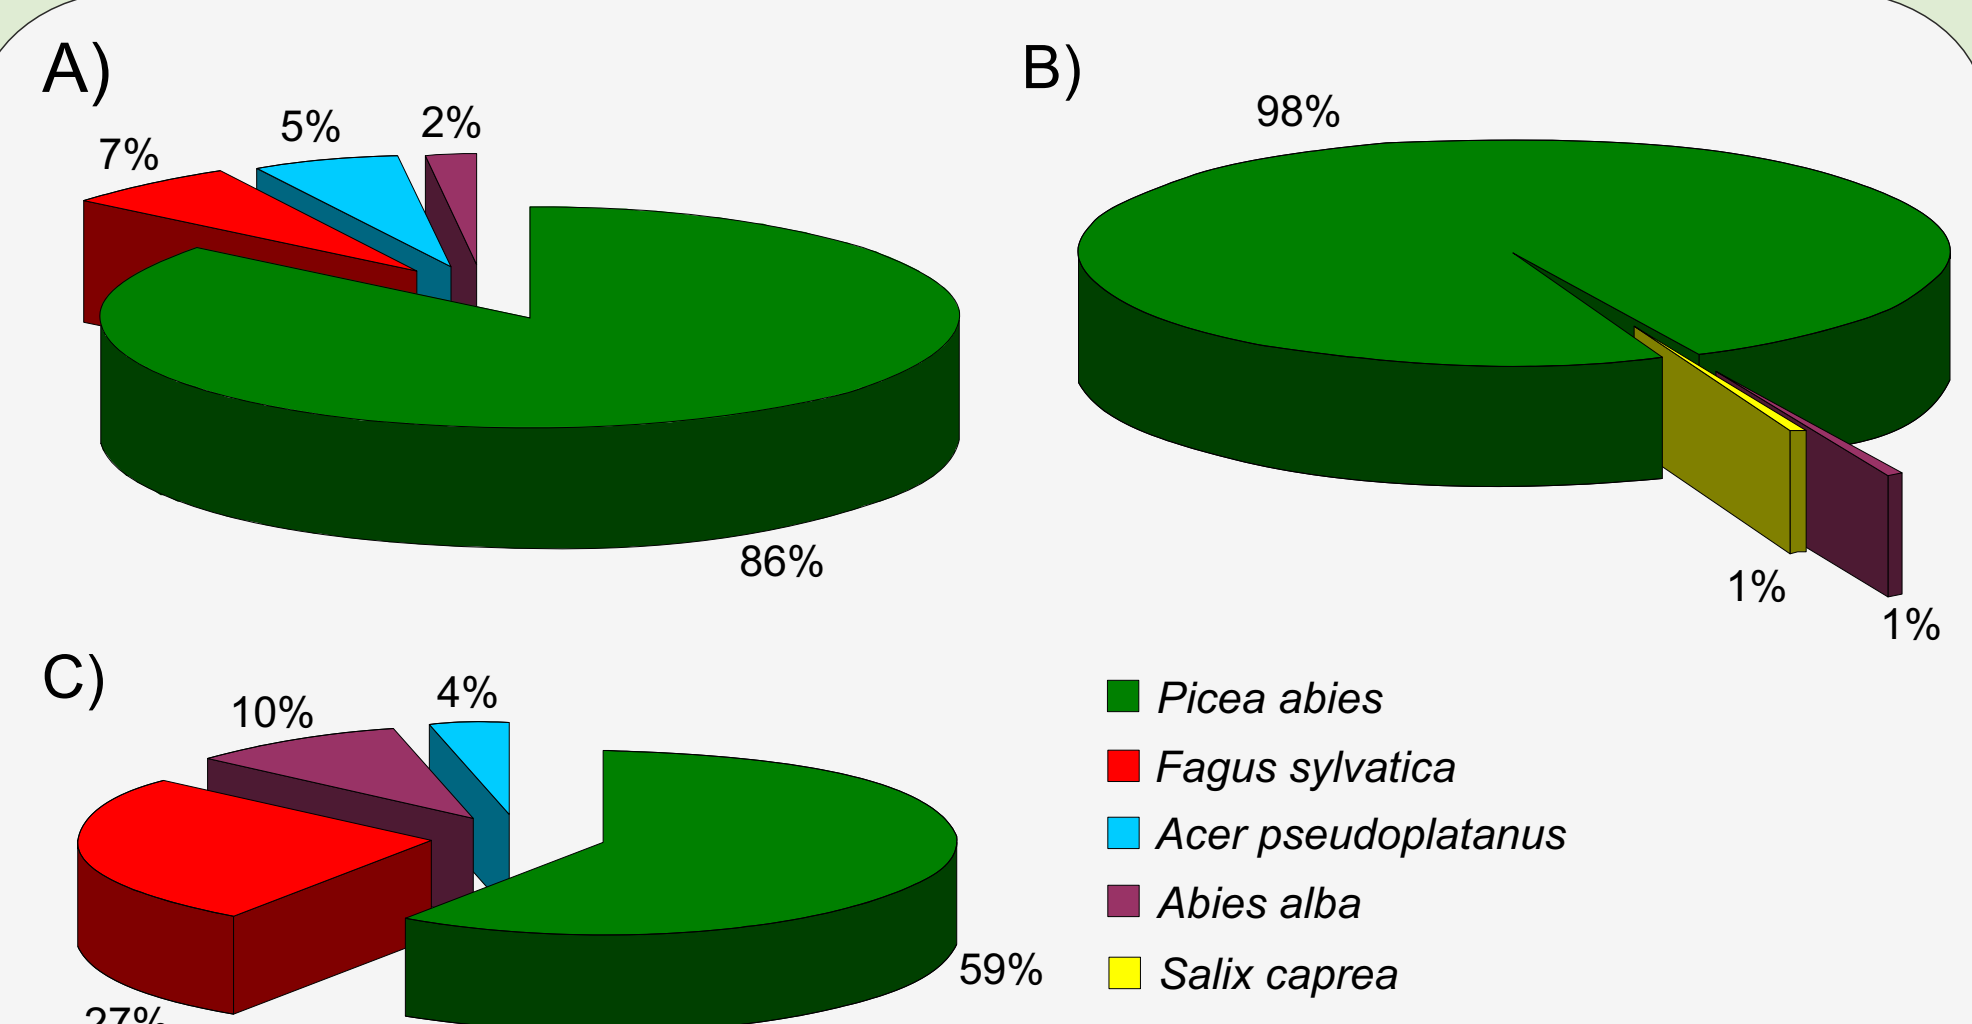
3 Species composition in the uppermost (A), middle (B) and lowest (C) studied reach of Kamienica Stream.

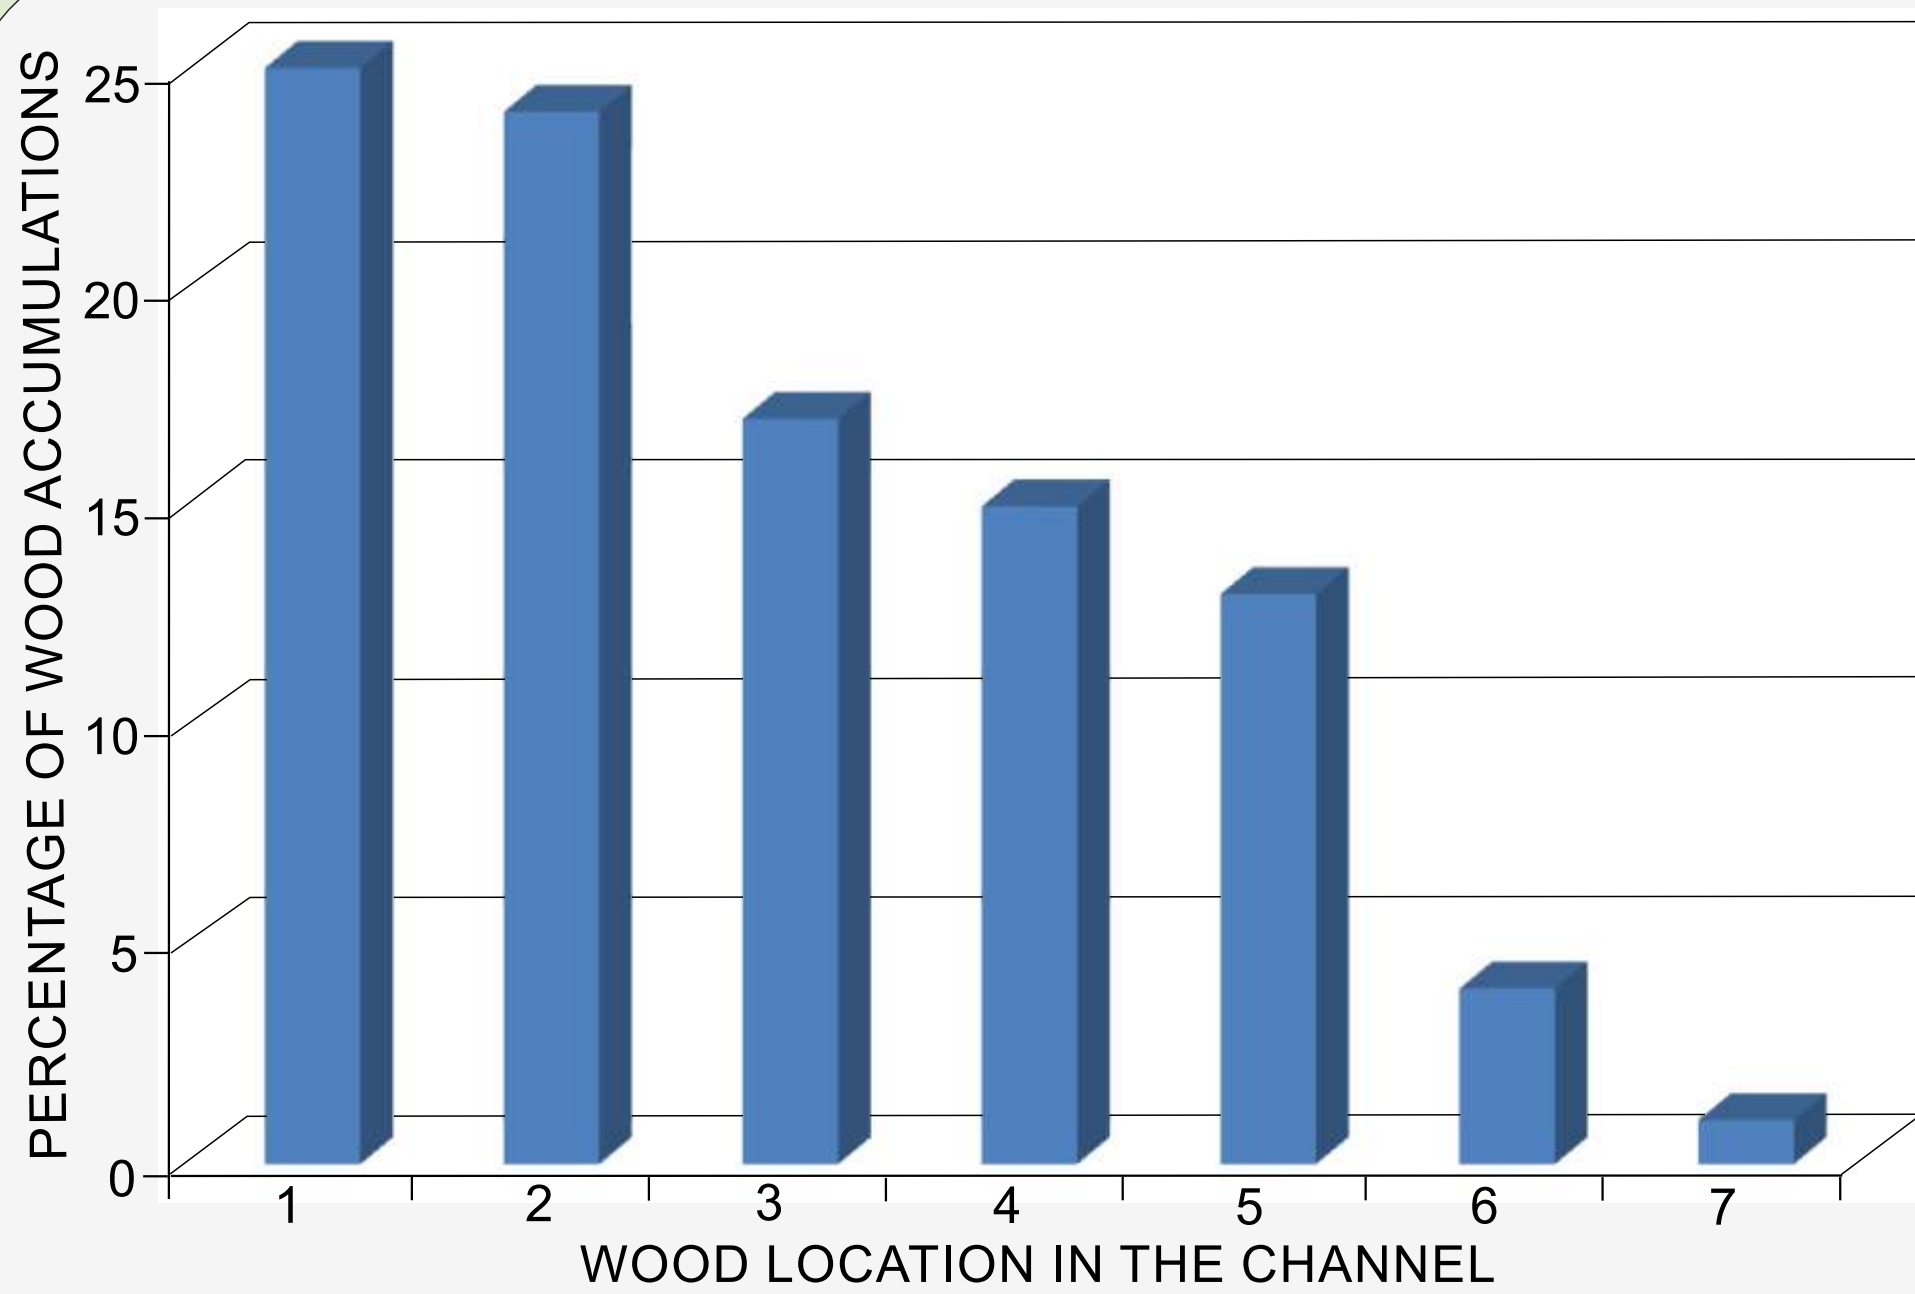
7 Predominant types of large woody debris location within studied sections. 1 - top of the log in the channel; 2 - the whole log in the channel; 3 - the whole log on the left channel; 4 - in channel dam; 5 - the whole log on the right channel bar; 6 - the whole log on the channel bank; 7 - spanning over the channel.

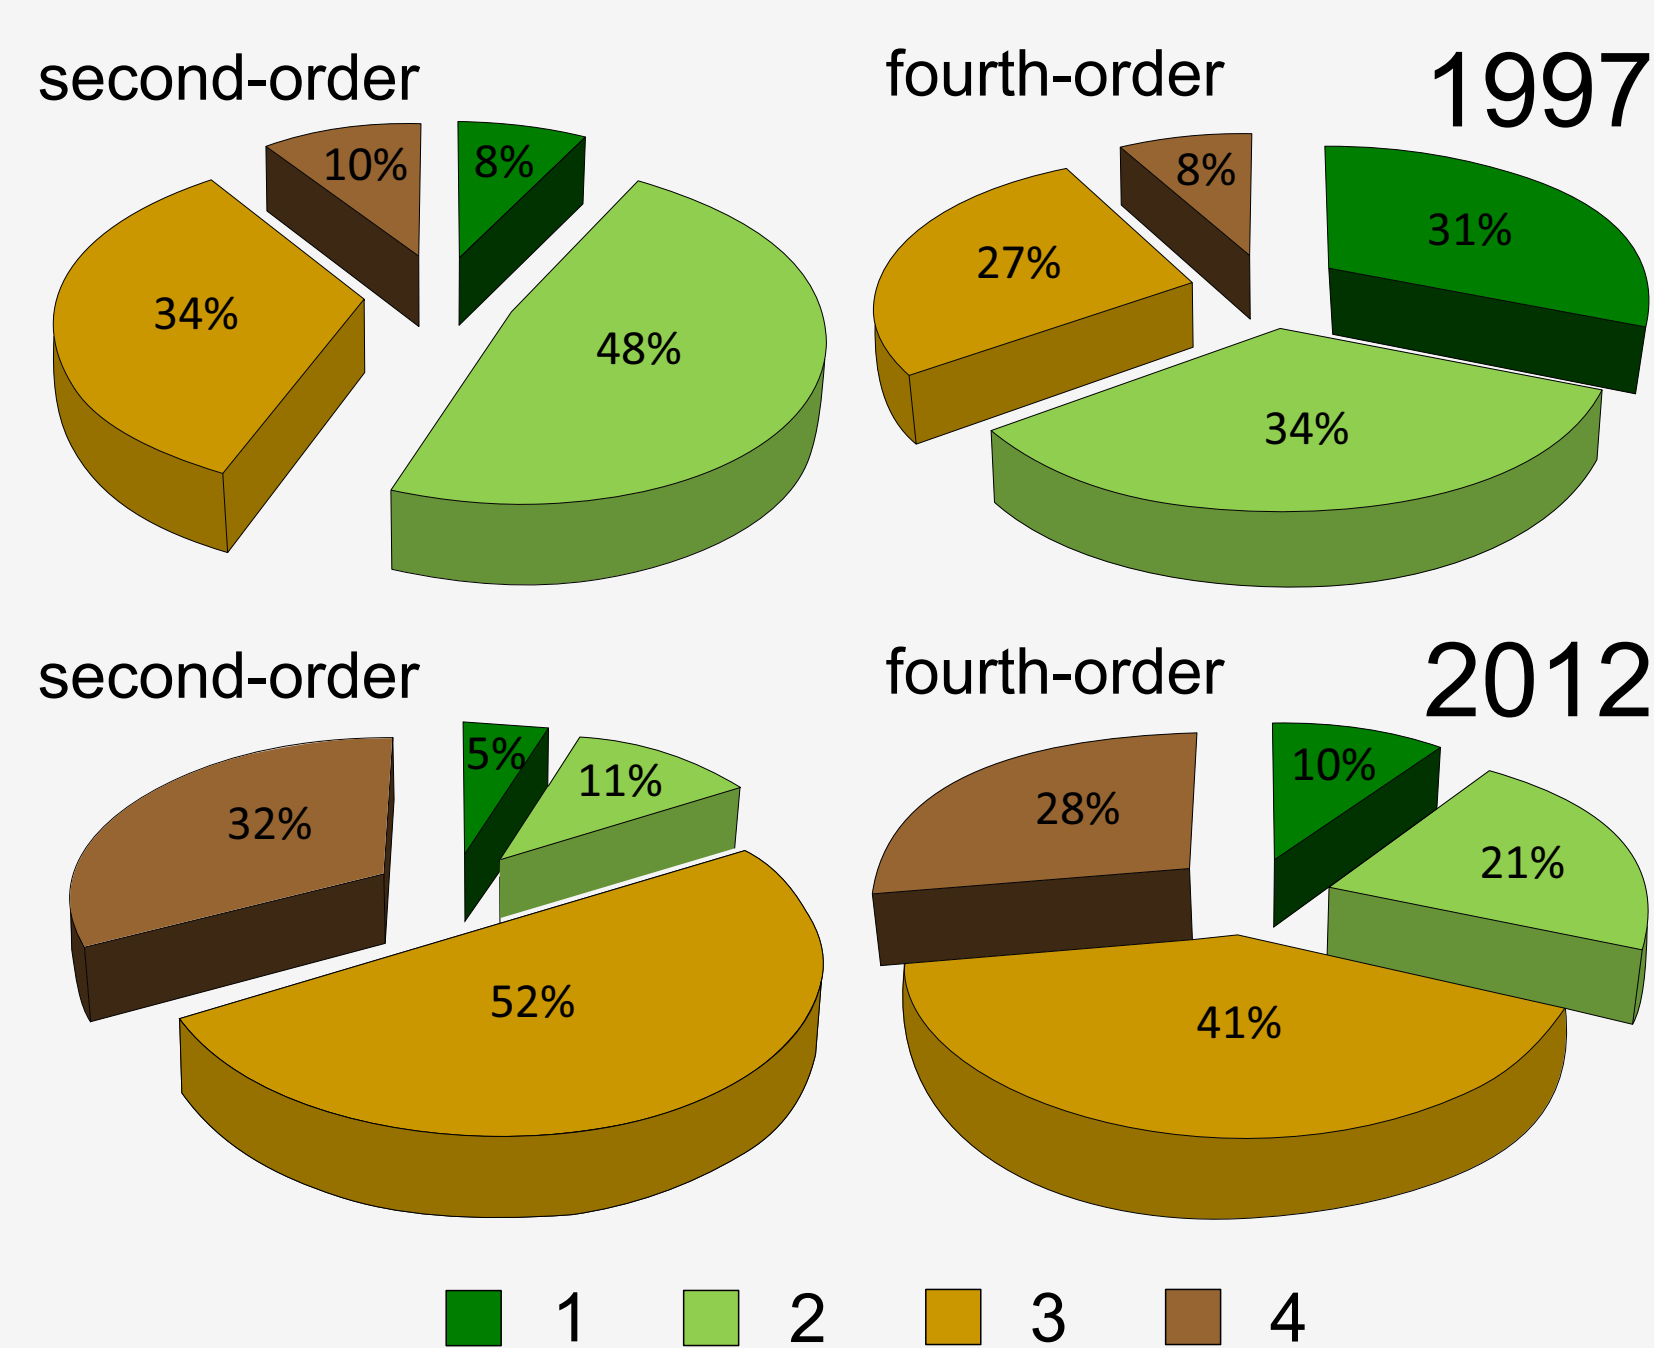
8 Classes of large wood decay recorded in second- and fourth-order reaches of Kamienica Stream in 1997 and 2012. 1 - fresh, bark adheres tightly, 2 - loose bark, 3 - no bark, wood hard, 4 - no bark, wood soft.

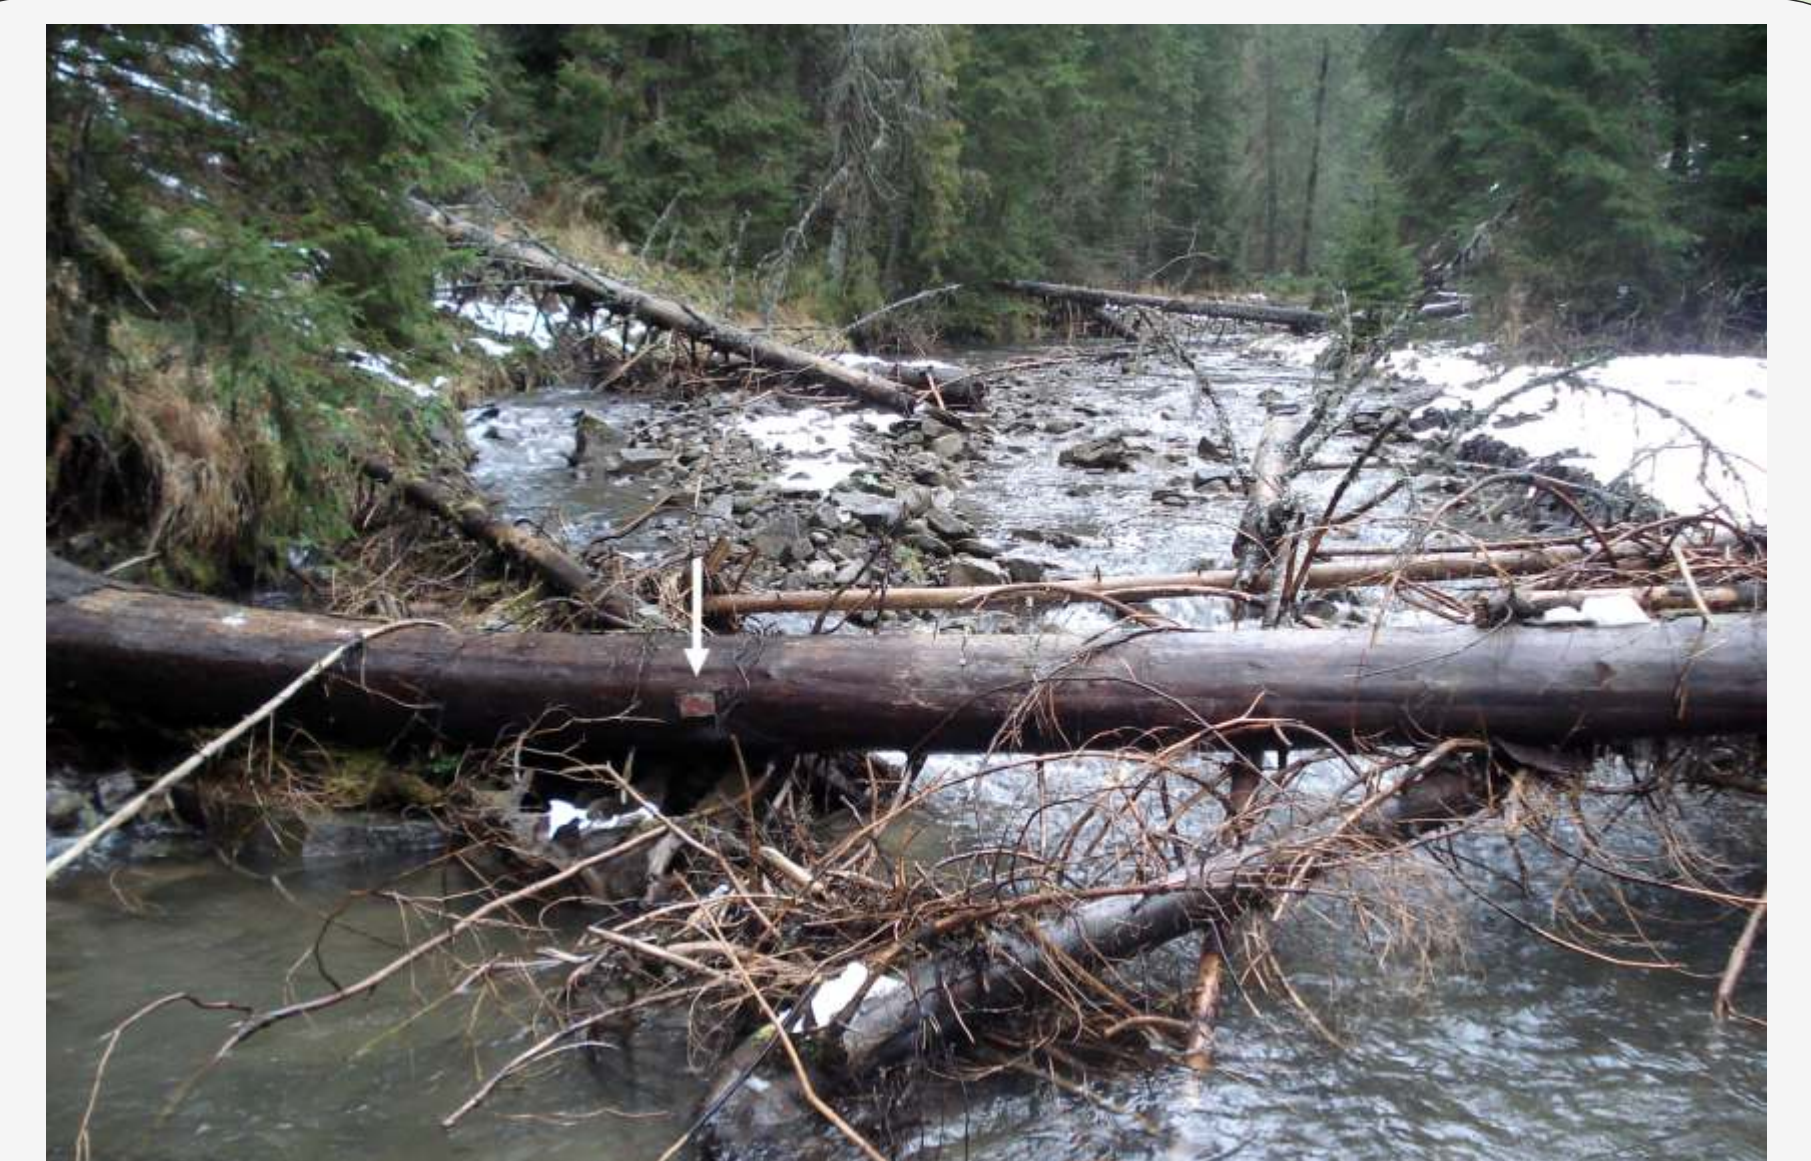
9 Spruce tree fallen to the channel of Kamienica Stream in a monitored reach. The tree was tagged with a numbered aluminium plate (shown by a white arrow) when growing close to the channel bank to allow its identification after displacement in the stream. The fallen tree forms a complete dam.

Bark beetle infestation that resulted in the widespread dieback of spruce forest in the Kamienica valley significantly increased the rate of spruce tree delivery to the stream. Many of these trees are longer than the channel width and often form complete and active dams (9).

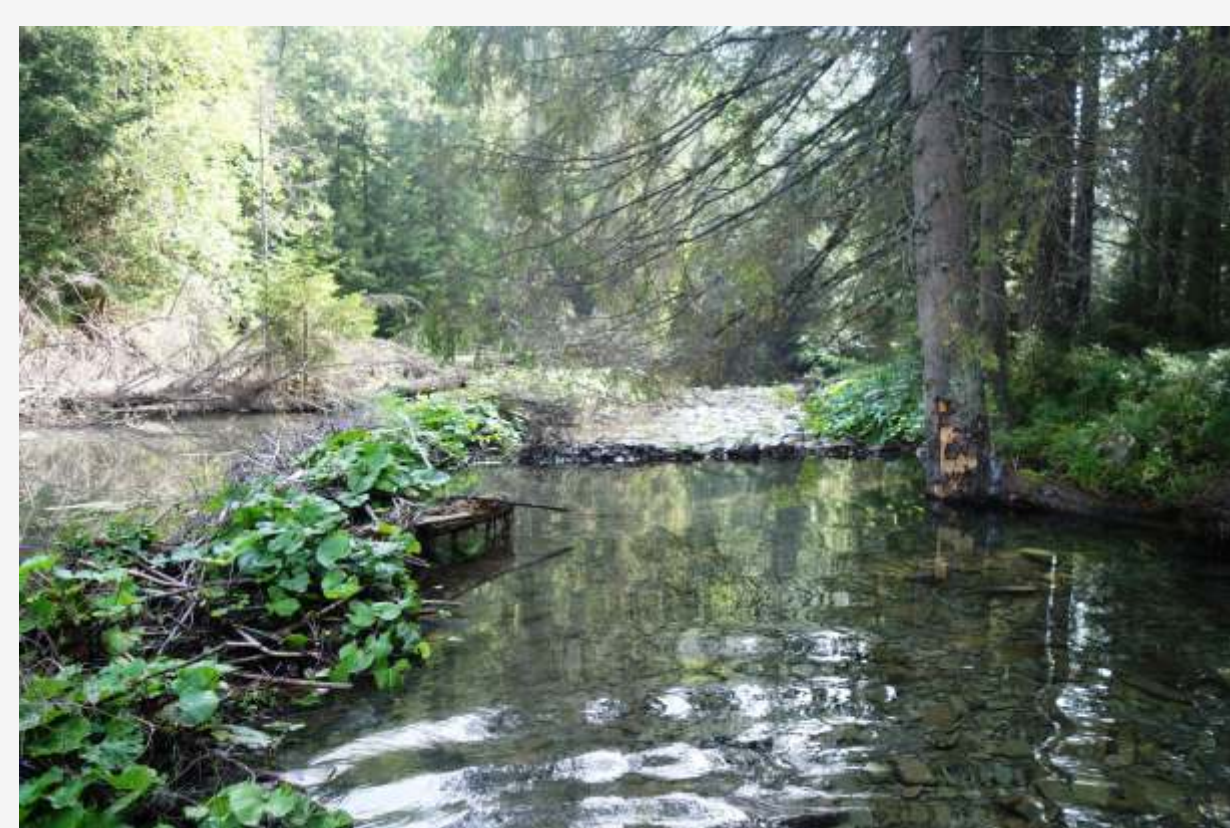
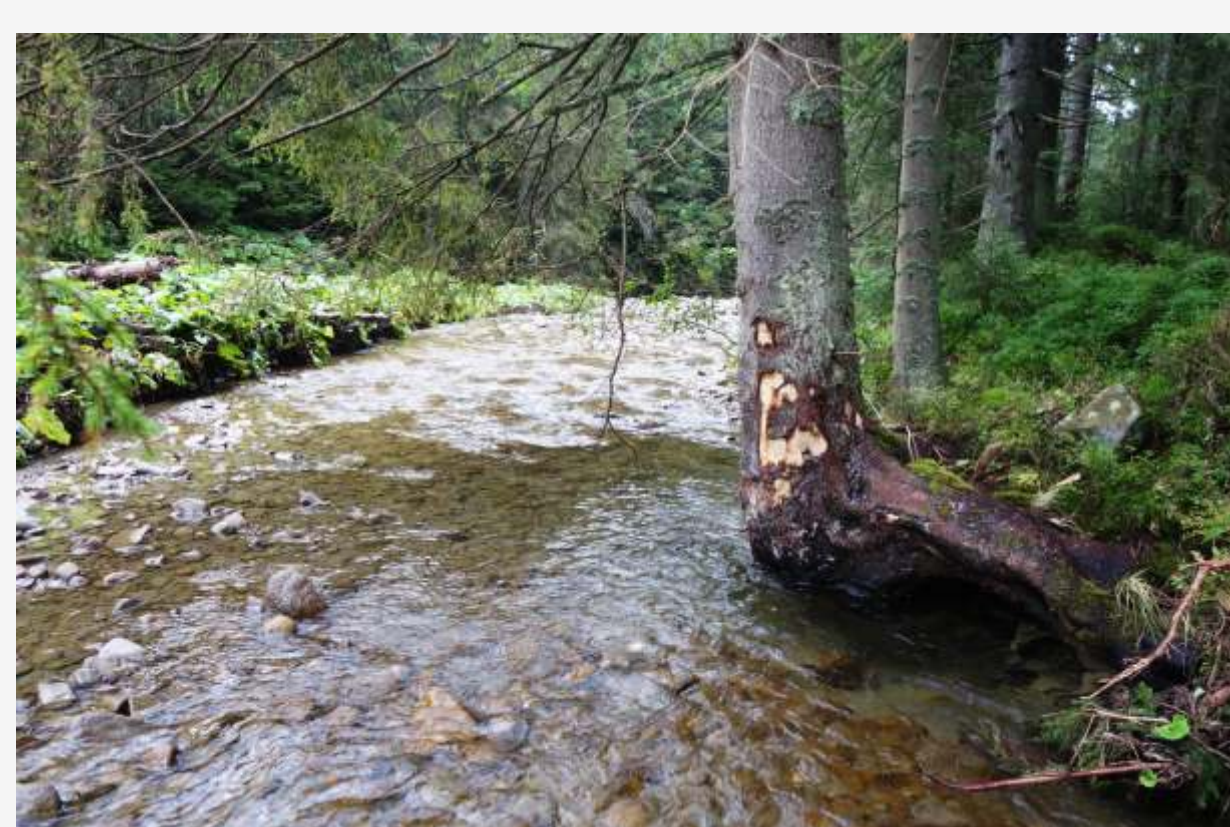
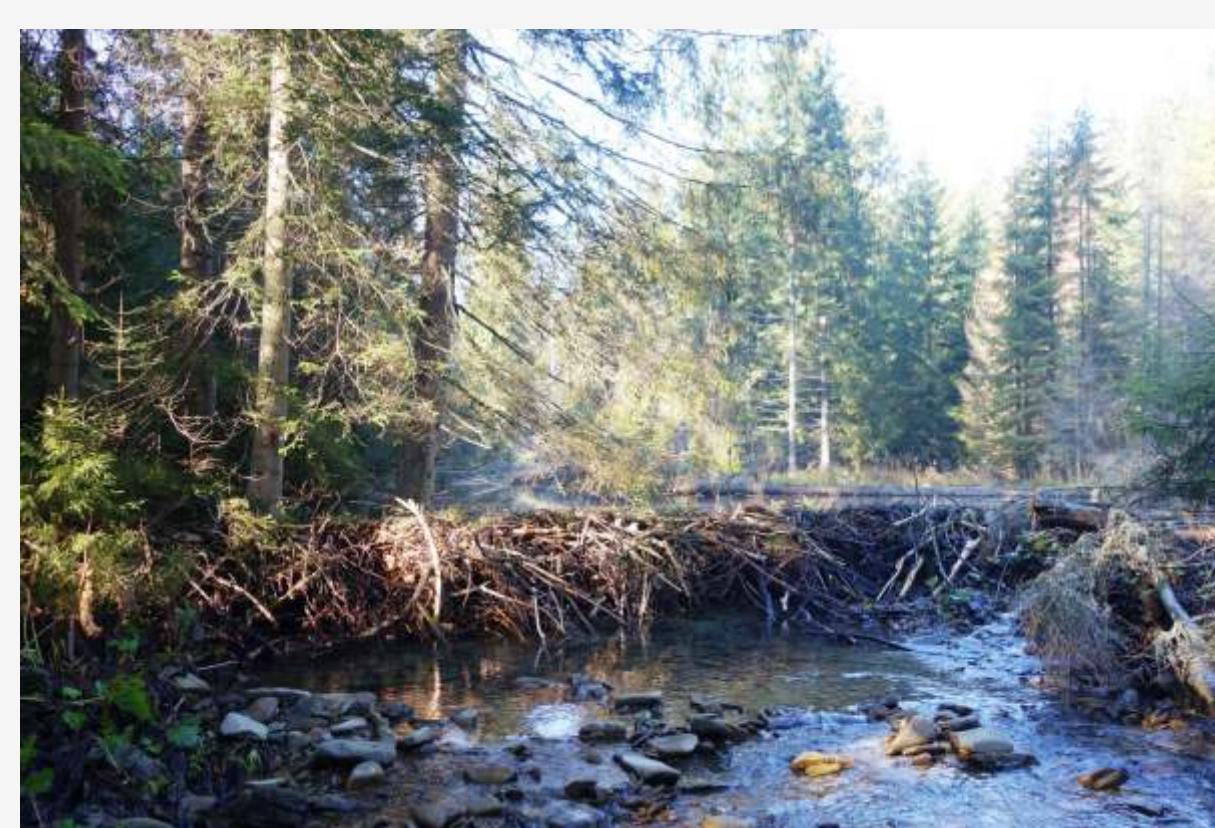
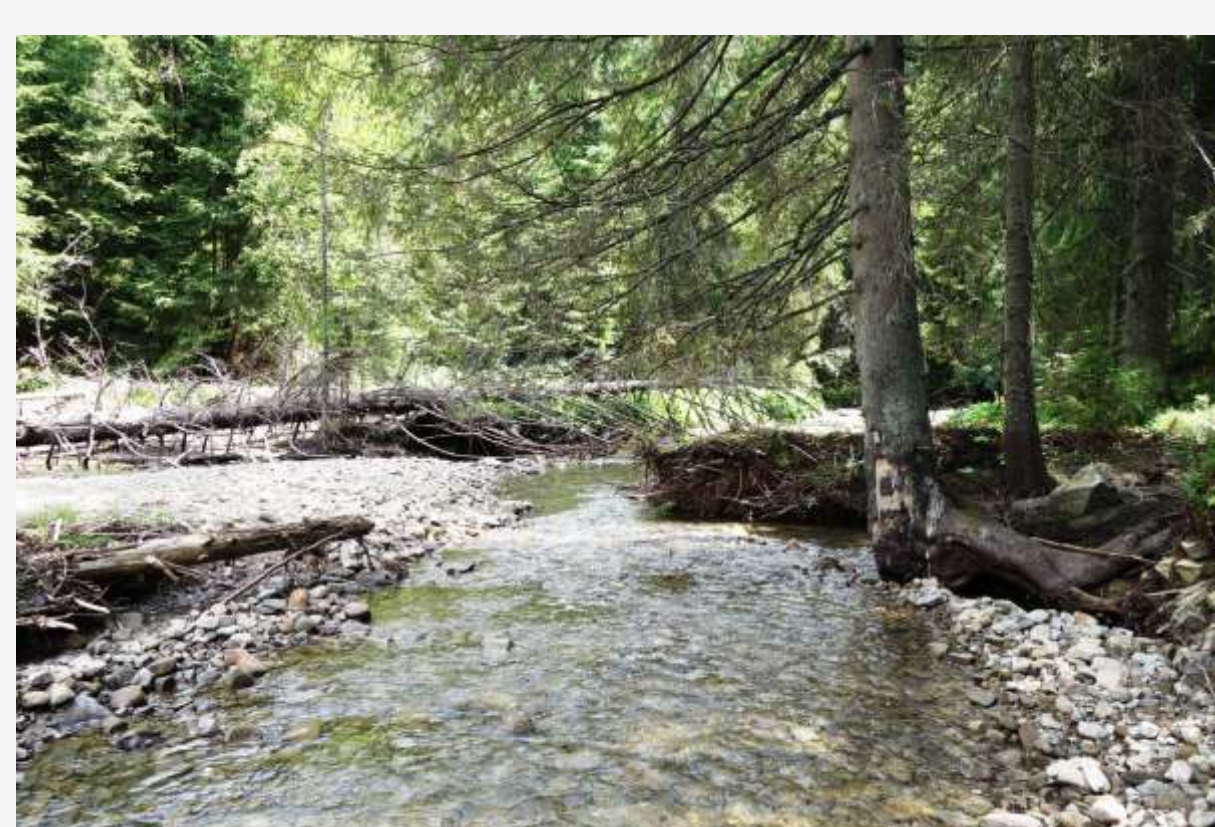
10 The unstable nature of beaver dams

spring 2016

summer 2016

spring 2017

summer 2017

Since 2010, studied sections are colonized by beavers, building dams and ponds. However, the dynamic of mountain streams makes that these structures used to be cyclically destroyed and rebuilt (10).
