Constructional GeoMaterials: Resources,
Properties, Uses, and Environmental Interactions

CHARACTERIZATION OF HISTORICAL INORGANIC BINDERS AND DESIGN OF RESTORATIVE MATERIALS - CASE STUDY OF THE LATE ROMAN MOSAIC

INORGANIC BINDERS AND DESIGN OF RESTORATIVE MATERIALS - CASE STUDY OF THE LATE ROMAN MOSAIC

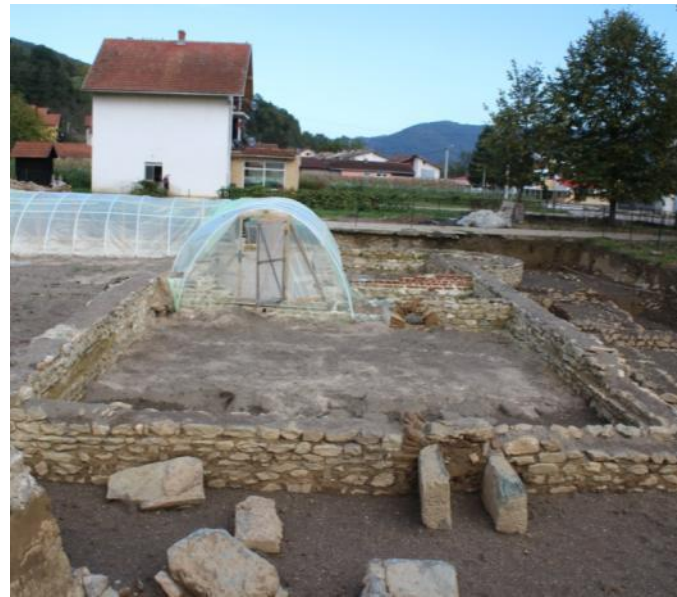
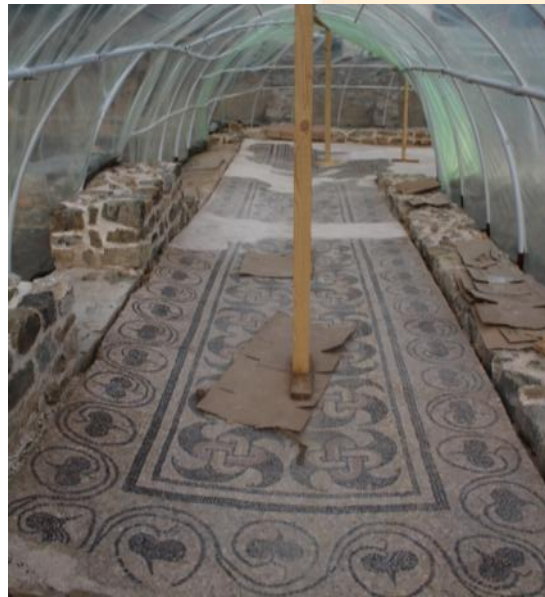
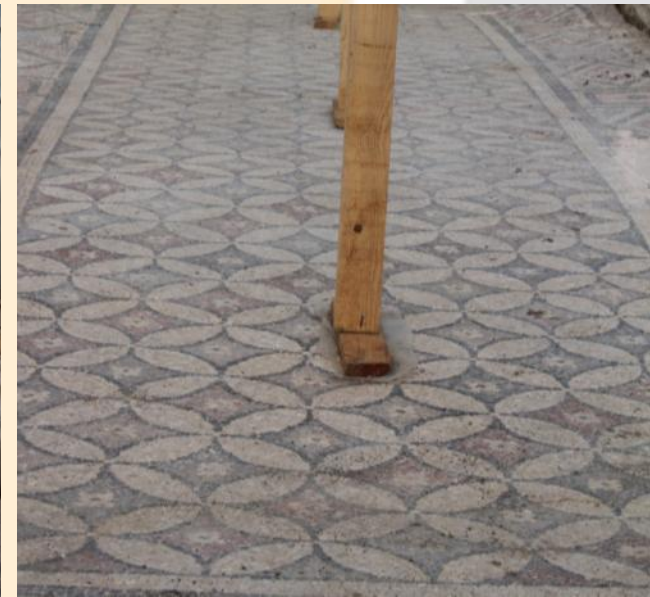
- Archaeological site “Zadružni dom” is located in village Skelani on the left bank of Drina river – on the border between Serbia and Republic of Srpska (BH).
- It was centre of municipium Malvesiatium - important administrative center of the Roman Empire II-IV c. AD.
- It was first discovered 120 years ago by Carl Patsch, Austro-Hungarian historian.
- First systematic archaeological excavation started in 2008 with extraordinary findings, including the late Roman building with *hypocaust* heating system and mosaic floors.

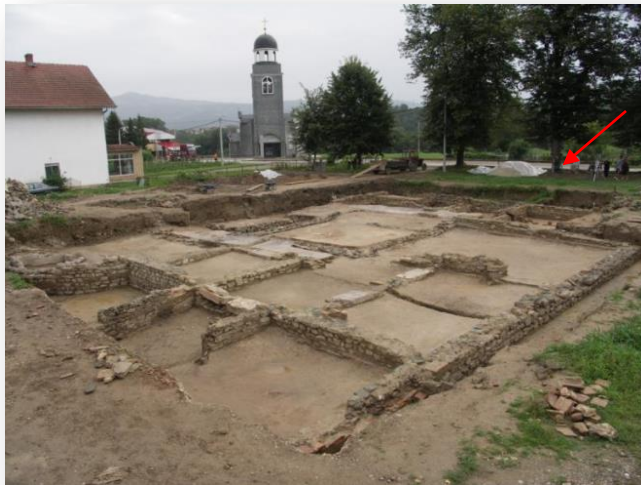
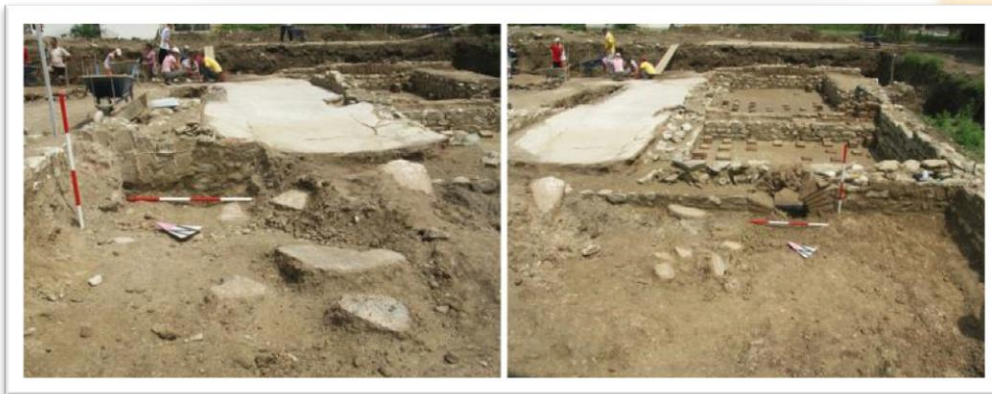
ARCHAEOLOGICAL EXCAVATIONS IN 2014 room K. sq.E

- In one of the rooms of a late antic building, a fragmented mosaic was discovered in 2014
- It was built over the *hypocaust*
- Central mosaic representation was the head of *Medusa*

Causes of
mosaic deterioration:

- **building technique**
(mosaic was built over
brick pillars of the
hypocaust system)
- **destruction of the
building**
- **burial conditions**
(flooding and soil
movement due to
proximity of the river)

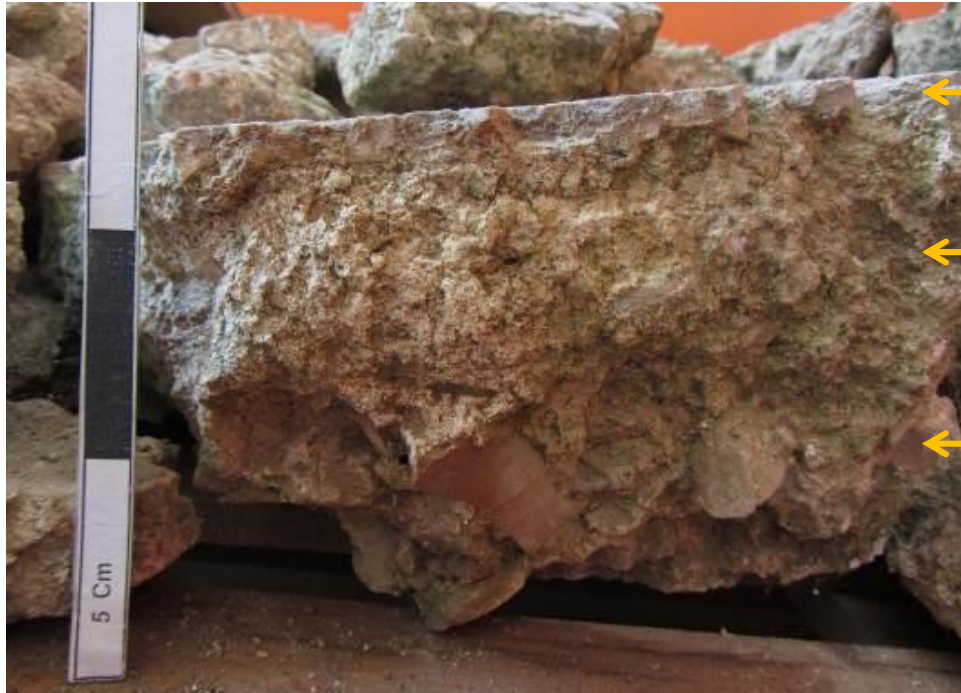
STRATIGRAPHY OF MOSAIC ORIGINAL PREPARATION LAYERS

tessellatum – mosaic tesserae placed in the fresh lime mortar

nucleus – lime mortar with *cocciopesto* (crushed brick)

rudus – coarser mortar with gravel and brick fragments

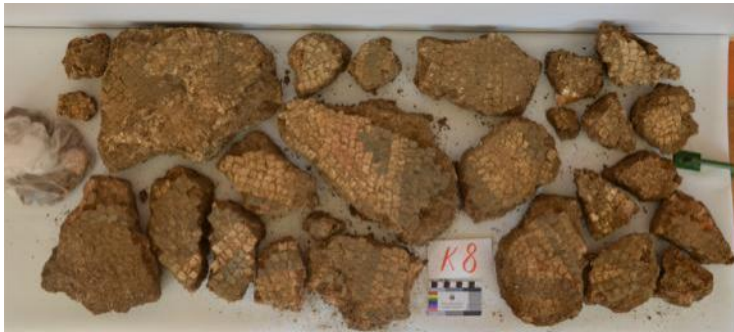
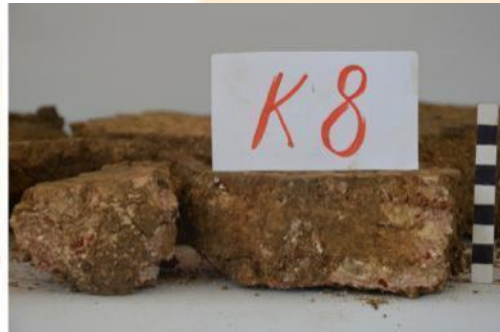
MOSAIC CONSERVATION

In the first phase mosaic conservation comprised of:

- Cleaning mosaic fragments
- Triage and reconstruction of mosaic decorative scheme
- Connecting fragments and positioning them in the sand basin

Final goal was to restore mosaic with the **compatible restoration mortar** and to **expose it on the site** under the shelter

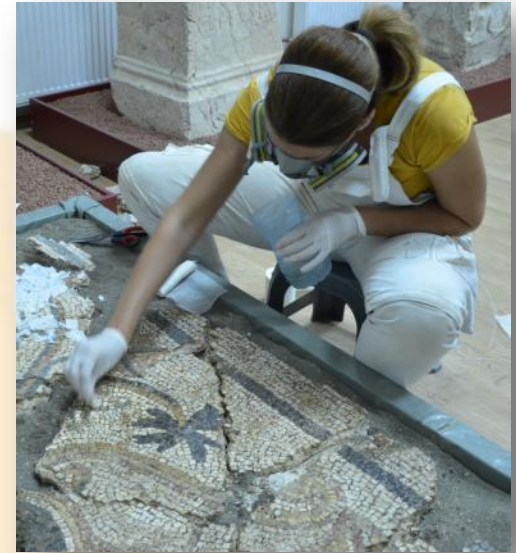
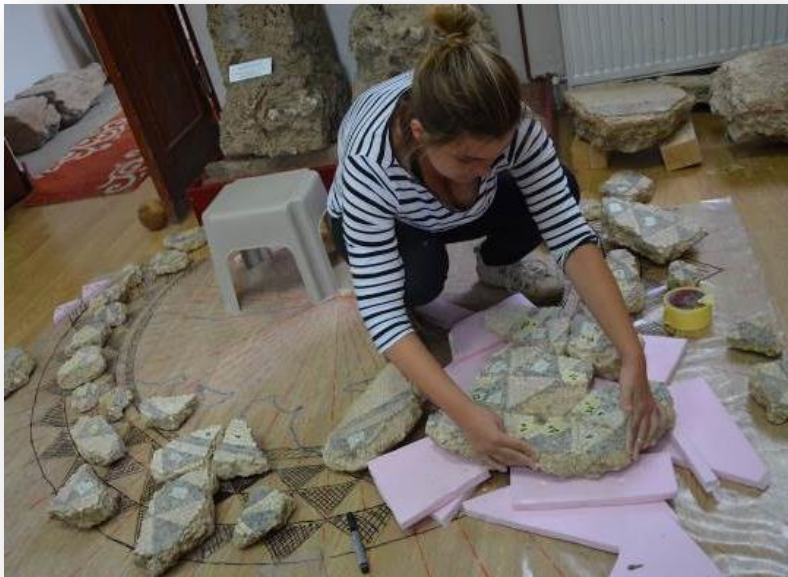
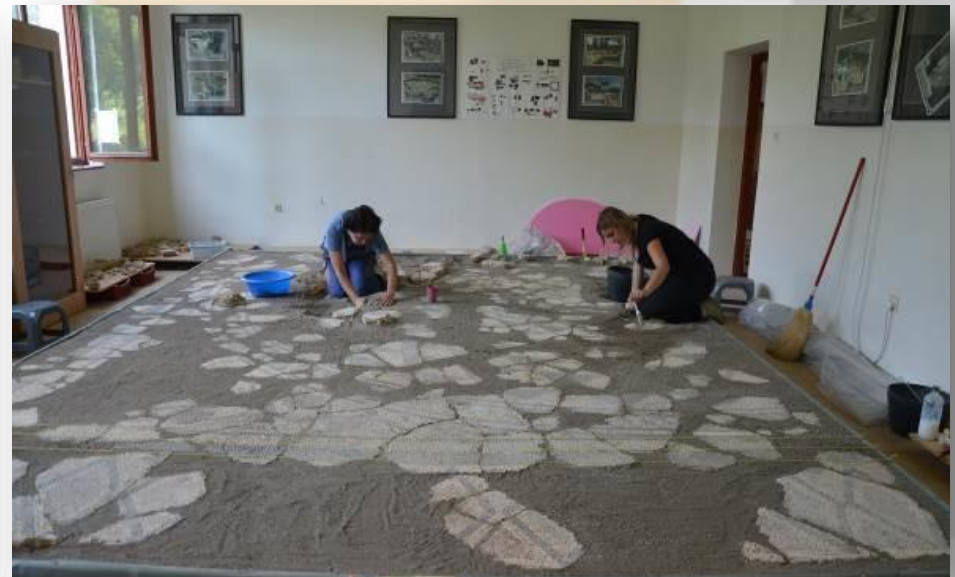
RECONSTRUCTION OF MOSAIC DECORATION

Central mosaic carpet

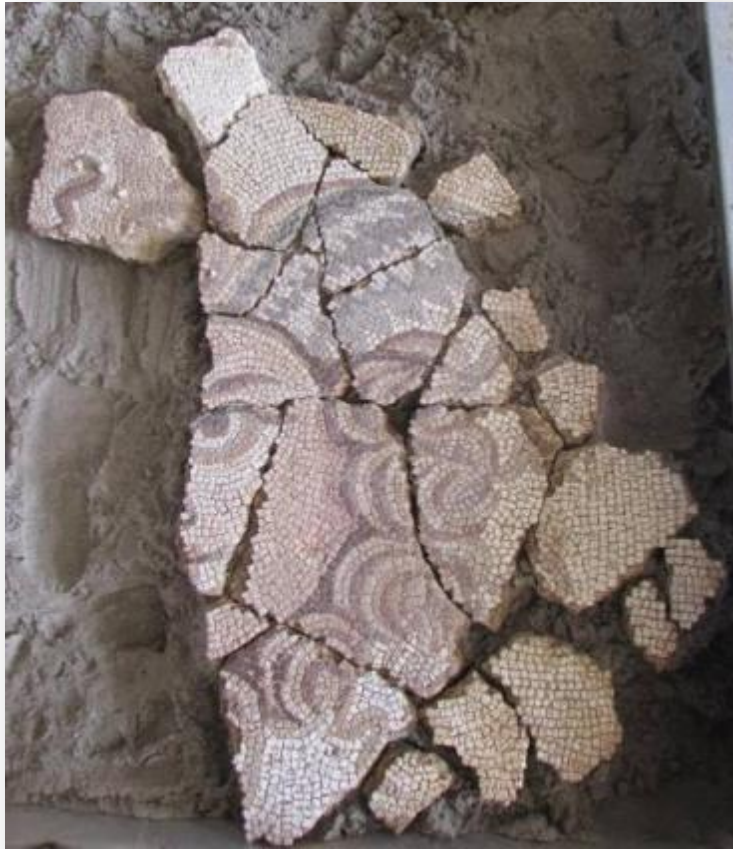
RECONSTRUCTION OF MOSAIC DECORATION

Borders

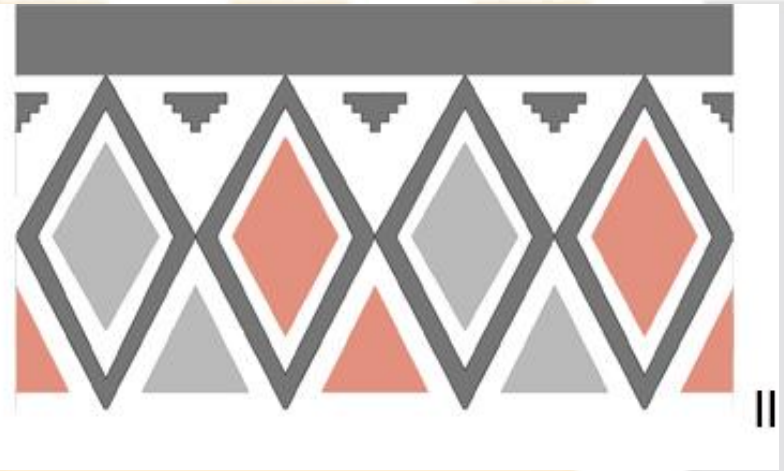
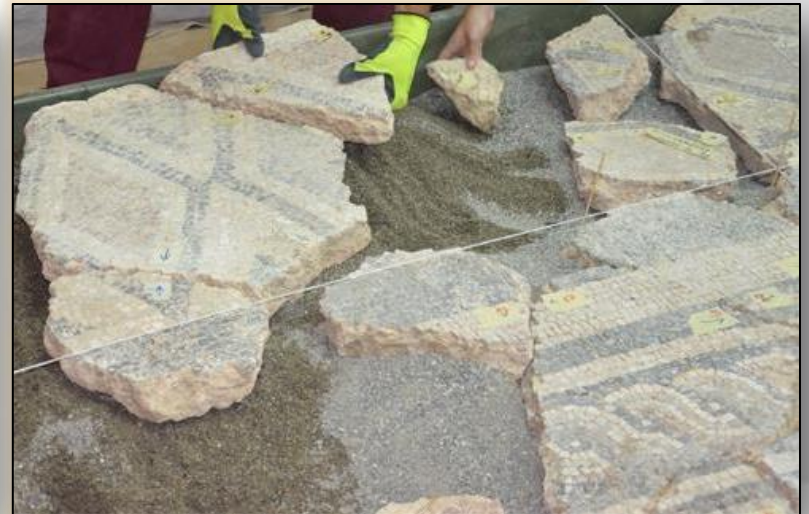
REQUESTS FOR THE RESTORATION MORTAR

- Keeping original nucleus on mosaic fragments
- Compatible with original *nucleus*
- Eco and health friendly
- Low cost
- To allow on site presentation of the mosaic (under the shelter)

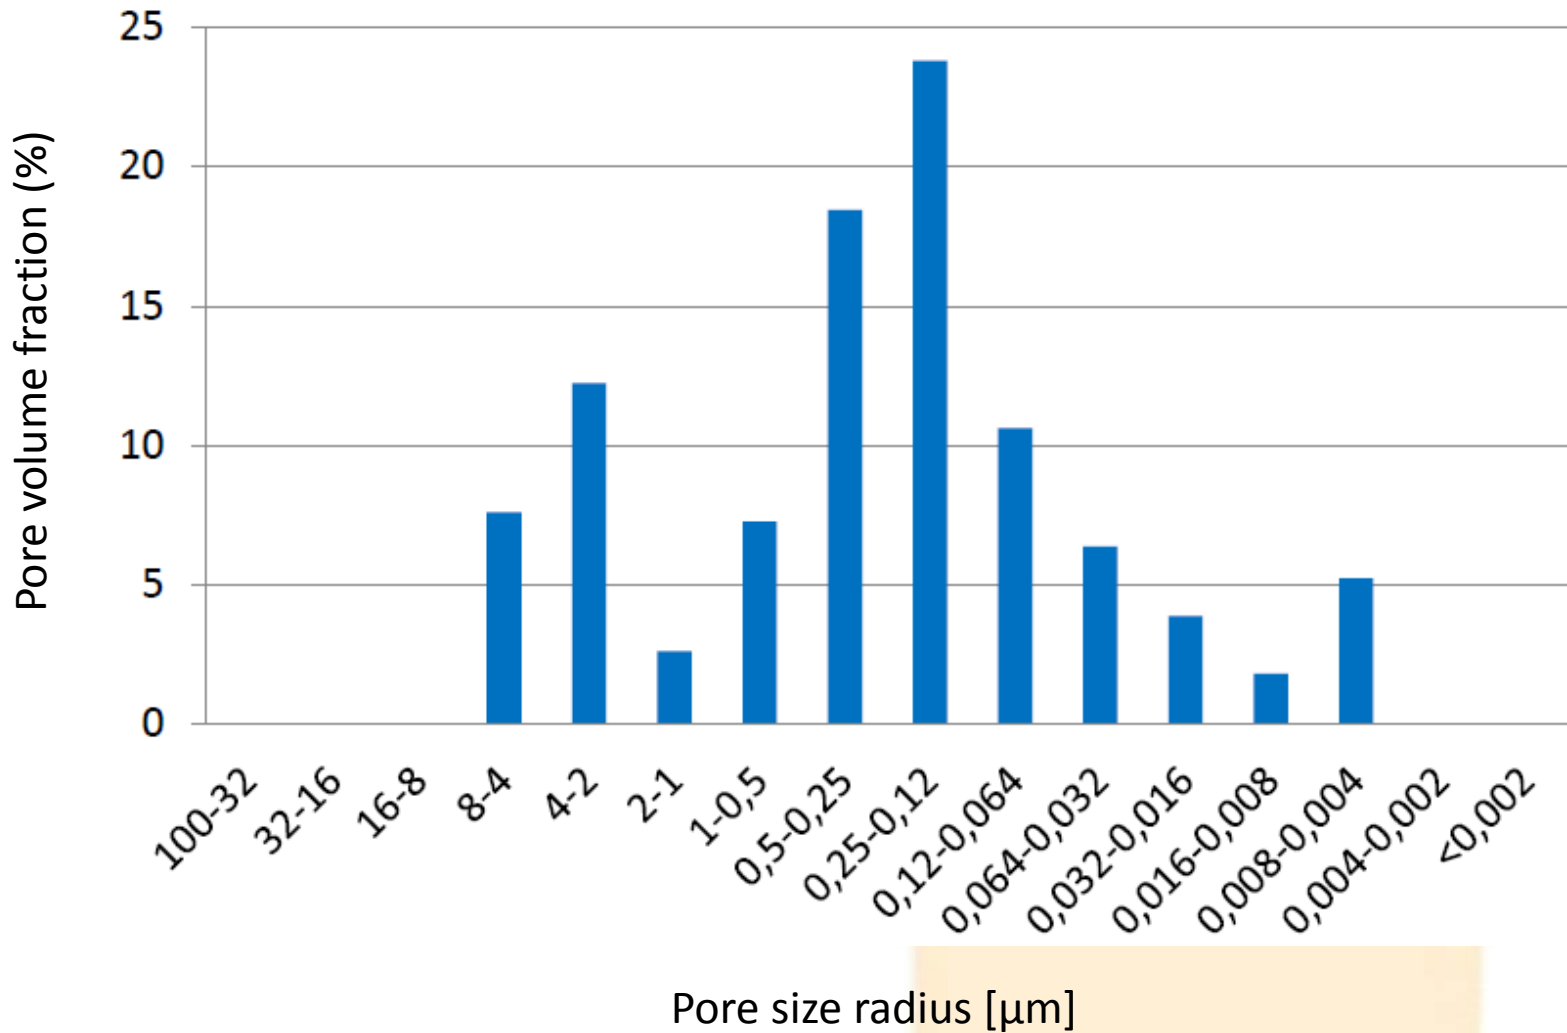
TEXTURAL PROPERTIES – Hg porosimetry

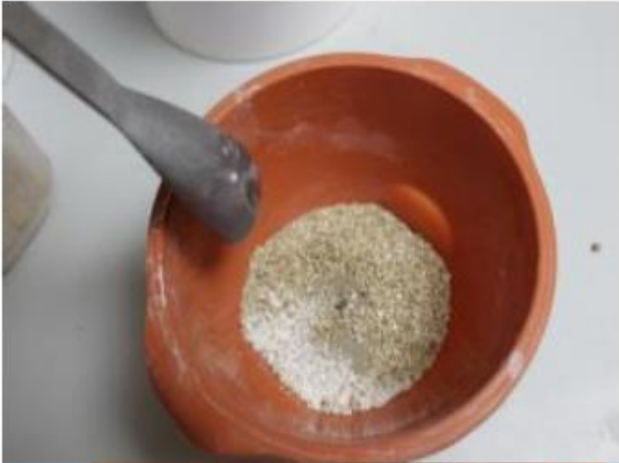
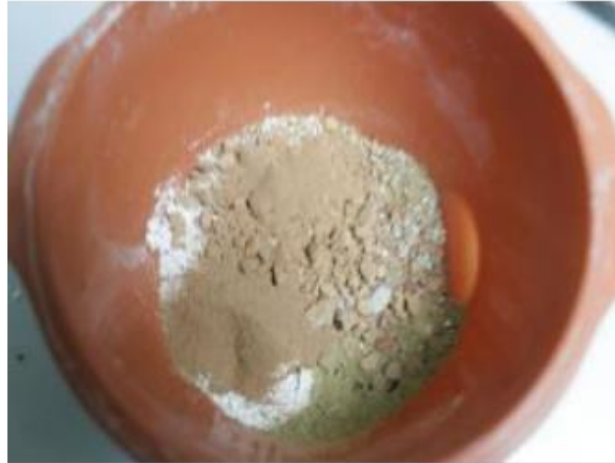
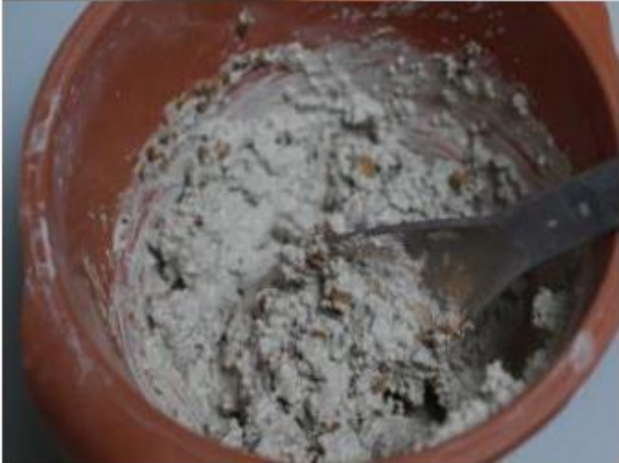
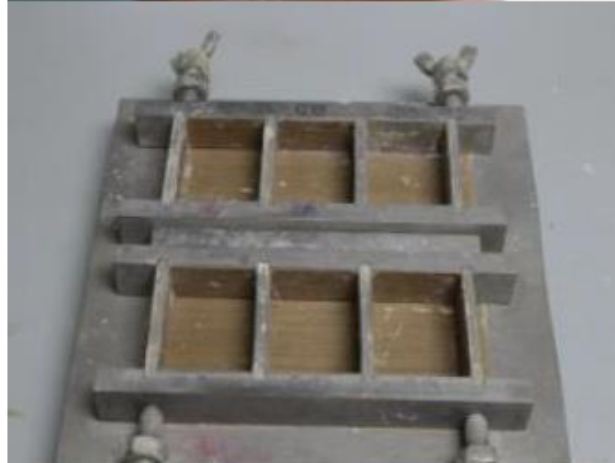
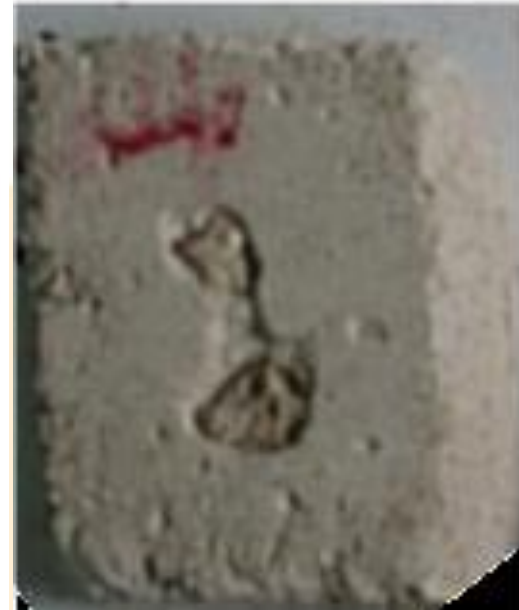
Model mortars laboratory preparation

**New mortar
with a small pieces
of ancient mortar
imbedded**

LABORATORY MODELS WITH ANCIENT MORTAR SAMPLE

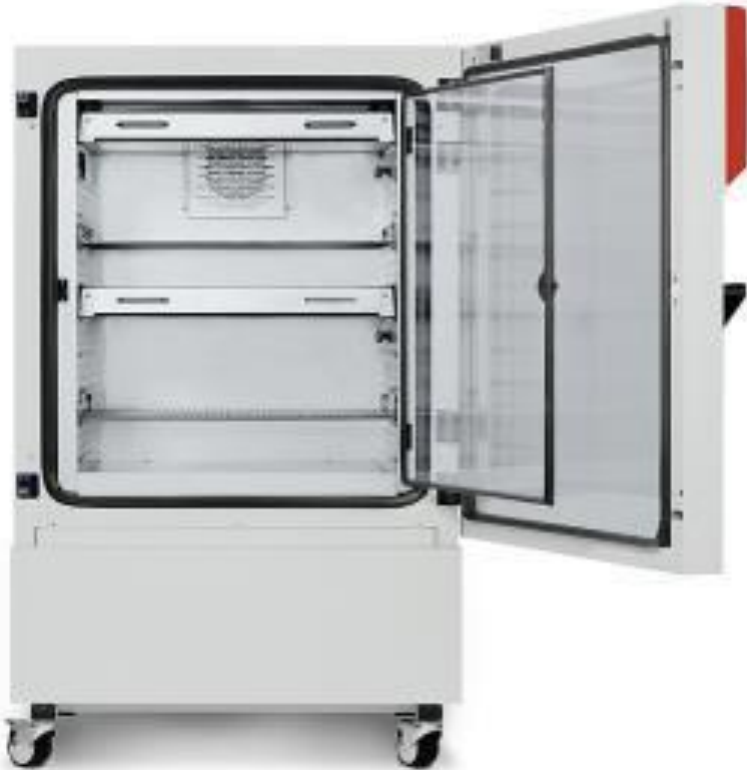
Laboratory aging chamber
Binder Climate chamber KBWF 240

Aging conditions

- Room conditions
($T = 20^{\circ}\text{C}$ i $\text{RH} = 60\%$); 7 days
- Extreme conditions:
 - ($T = 10^{\circ}\text{C}$ i $\text{RH} = 80\%$); 3 h
 - ($T = 35^{\circ}\text{C}$ i $\text{RH} = 35\%$); 3 h
 - ($T = 45^{\circ}\text{C}$ i $\text{RH} = 35\%$); 2 h
 - 5 cycles repeated

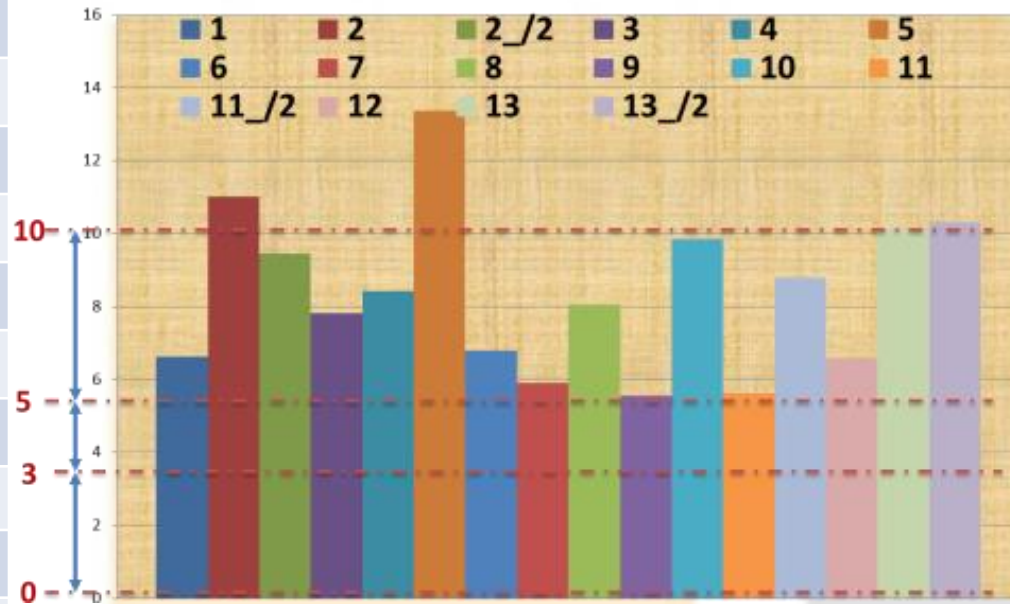
TOTAL COLOUR CHANGE

Sample	(ΔE)			
	In point			Average
1	6,1	6,97	6,86	6,64
2	11,86	9,76	11,43	11,02
2/2	8,95	9,53	9,88	9,45
3	8,99	6,44	8,01	7,81
4	8,34	9,16	7,79	8,43
5	13,4	13,33	13,35	13,36
6	9,24	5,49	5,63	6,79
7	4,85	7,77	5,08	5,90
8	8,11	7,62	8,4	8,04
9	4,95	5,79	5,92	5,55
10	10,61	10,2	8,73	9,85
11	6,11	5,79	5,01	5,63
11/2	9,58	9,36	7,44	8,79
12	6,19	7,4	6,15	6,58
13	9,57	10,87	10,05	10,16
13/2	11,31	11,06	8,55	10,31
