The Sentinel-1 CNR-IREA SBAS service of the European Space Agency's Geohazard Exploitation Platform (GEP) as a powerful tool for landslide activity detection and monitoring

Cristina Reyes-Carmona, Jorge Pedro Galve, Anna Barra, Oriol Monserrat, Rosa María Mateos, José Miguel Azañón, José Vicente Pérez-Peña and Patricia Ruano

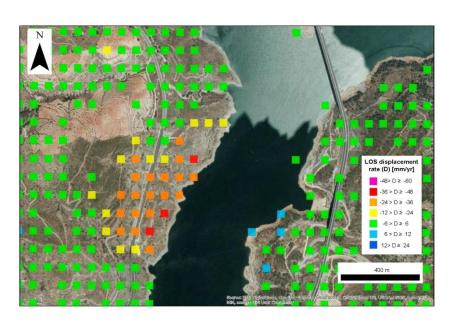
Satellite: Sentinel-1B
Orbit: Ascending
Track: 1

Number of images: 101

Temporal span: September 2016- March 2020

Standard Deviation: 3 **Stability range:** -6 to 6 (mm/yr)

The El Arrecife Landslide activity was detected by both ascending and descending GEP processings while the Rules Viaduct Lansdlide activity was detected just by the descending processing.

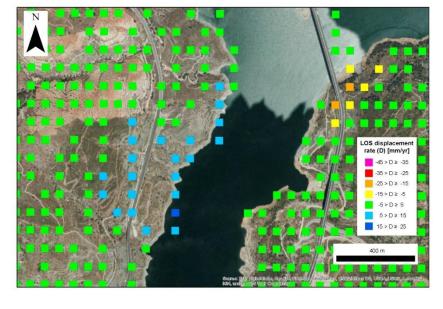
Satellite: Sentinel-1 A and B
Orbit: Descending

Track: 81

Number of images: 241

Temporal span: December 2014-March 2020

Standard Deviation: 2.5

Stability range: -5 to 5 (mm/yr)

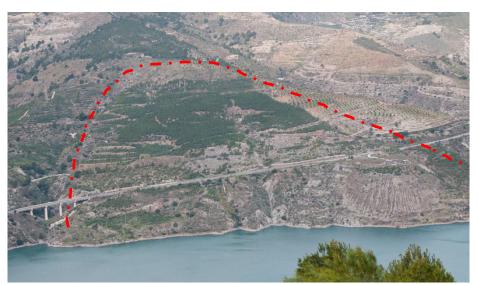
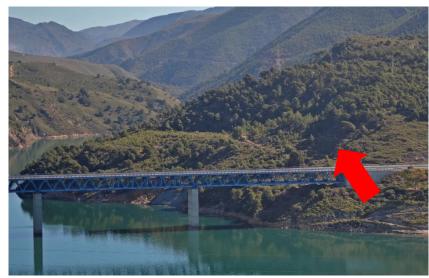
El Arrecife Landslide

Rules Viaduct Landslide
