Seasonal active landsliding and hillslope activity in the southern Central Andes of NW Argentina

Mohammad M.Aref ^{1,2} Bodo Bookhagen ² Taylor T. Smith ² and Manfred R. Strecker ²

8 May 2020

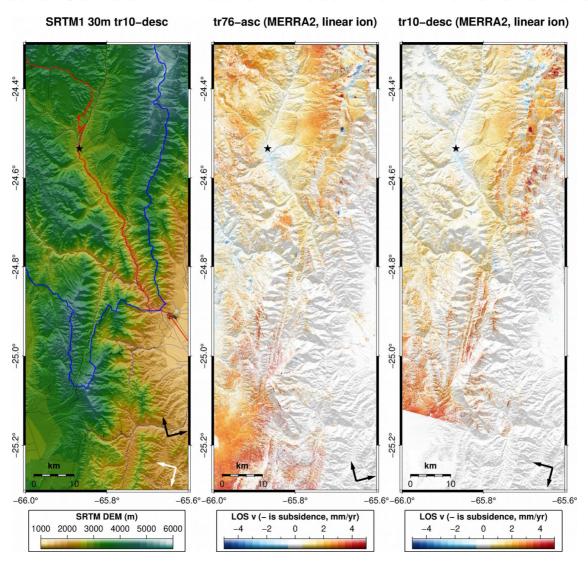
Sentinel-1 3D deformation field from Persistent Scatterer
