The use of UAV data for environmental monitoring of the coastal area of Lake Sevan, Armenia under the increase in water level

Andrey Medvedev¹, Natalia Telnova¹, Natalia Alekseenko^{1,2}, Alexander Koshkarev¹

1 - Institute of Geography, Russian Academy of Sciences, Moscow, Russia medvedev@igras.ru;

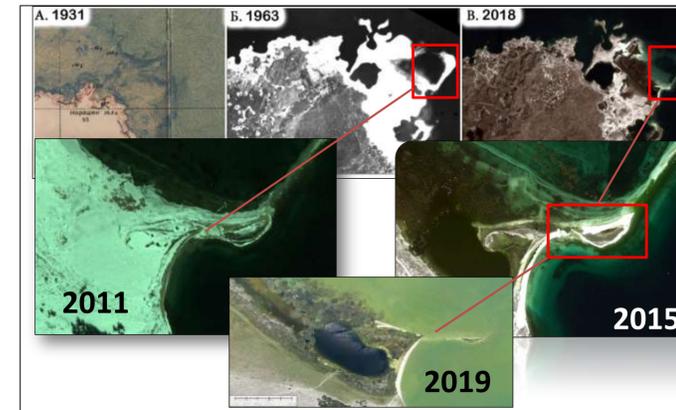
Complex of beach ridges, coastal lagoon and adjacent wetlands complex in Norashen, west shore of Sevan : history of creation and current degradation

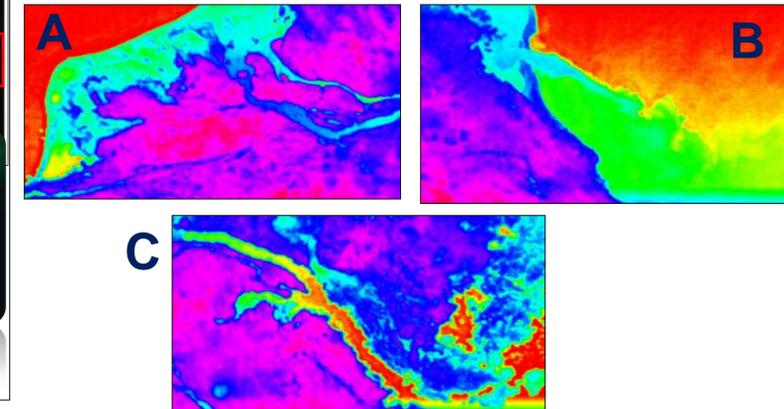
Thermal UAV images, illustrated the submerge of wetlands in river delta (A); discharge of river debris (B); development of macrophytes in offshore zone . Masrik site

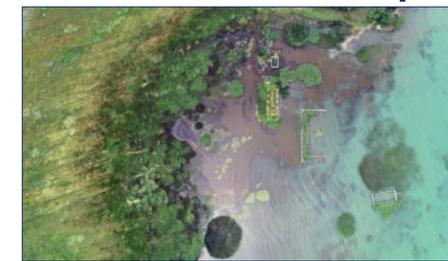
Submerged recreational facilities, 2018

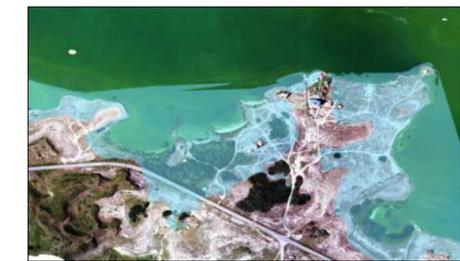
Areas of potential inundation after planned rise in water level of Lake Sevan modeled from UAV-derived highly-detailed DSM

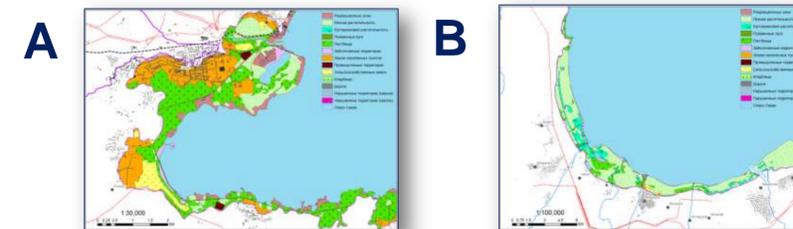
A Razdan area, west Sevan : predominance of built-up areas and recreational facilities;

B – Martuni and Tsovinar, south shores of Sevan: small-sized croplands, pastures and degraded forests planted in 1960s

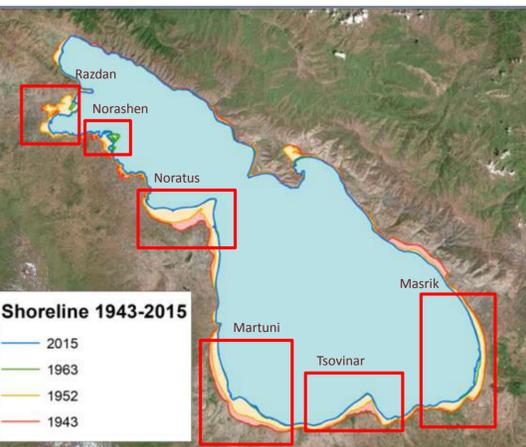
Dynamics of Sevan's shoreline and key areas for UAV surveys

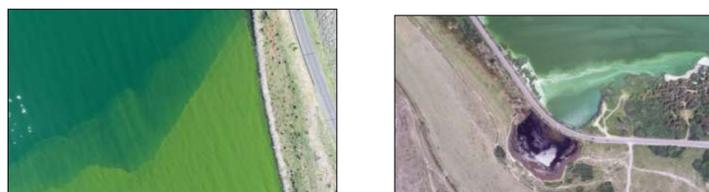
Algae blooms in Lake Sevan have been periodically fixed since 1964 but with the current increase in lake level such mass blooms, as UAV fixed in July 2019 become the heaviest environmental issue for the whole lake areas bloom now

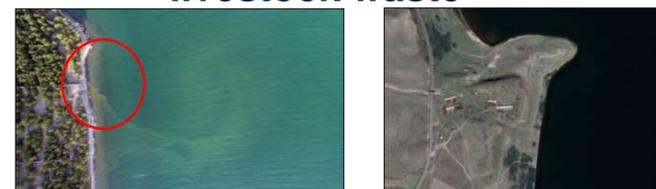
Uncontrolled release of sewage water from a recreational facility (red circle). Masrik

Small livestock farm in the coastal zone. Noratuz
