Spatial distribution of geomorphic changes after an extreme flash-flood compared with hydrological and sediment connectivity

9th October 2018 rainfall event main characteristics (Estrany et al., 2020)

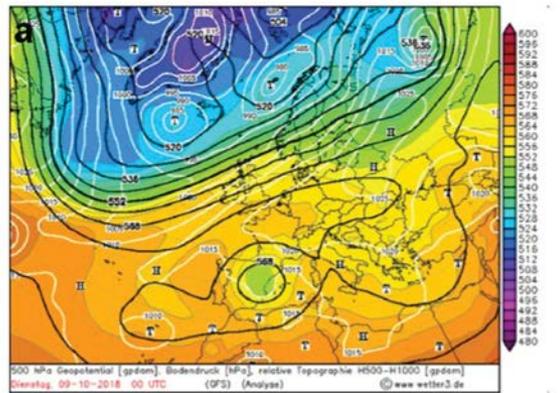
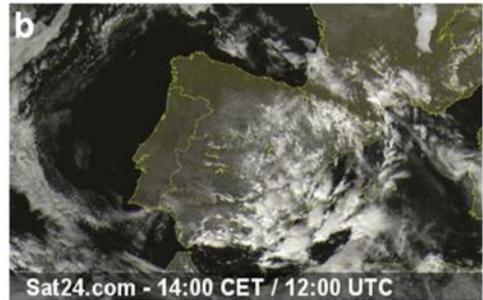
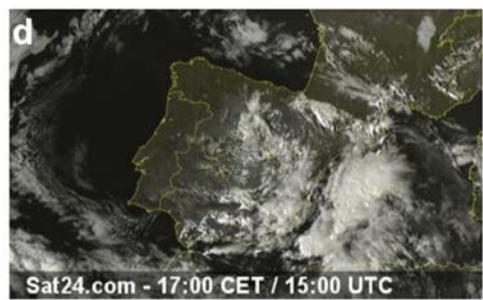
Surface pressure and 500-hPa height analyses at 1200 UTC (<http://wetter3.de>); i.e., at the beginning of the event (a). Satellite image at (b) 12.00UTC and (d) 15.00UTC (<http://www.sat24.com>). EUMETSAT and radar images at the same hours (c and e) (<http://www.aemet.es>)

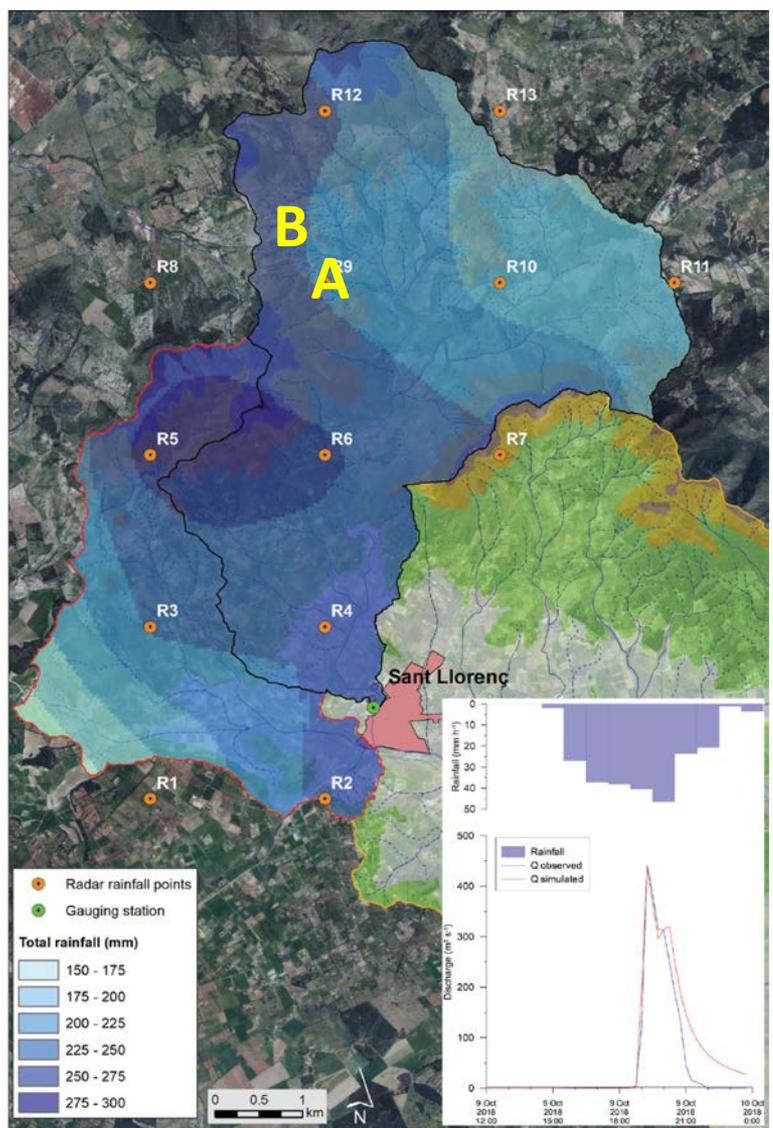
Map of isohyets of the rain storm (10-minute radar images obtained from the web <https://opendata.aemet.es/>) A-B, Studied catchments.

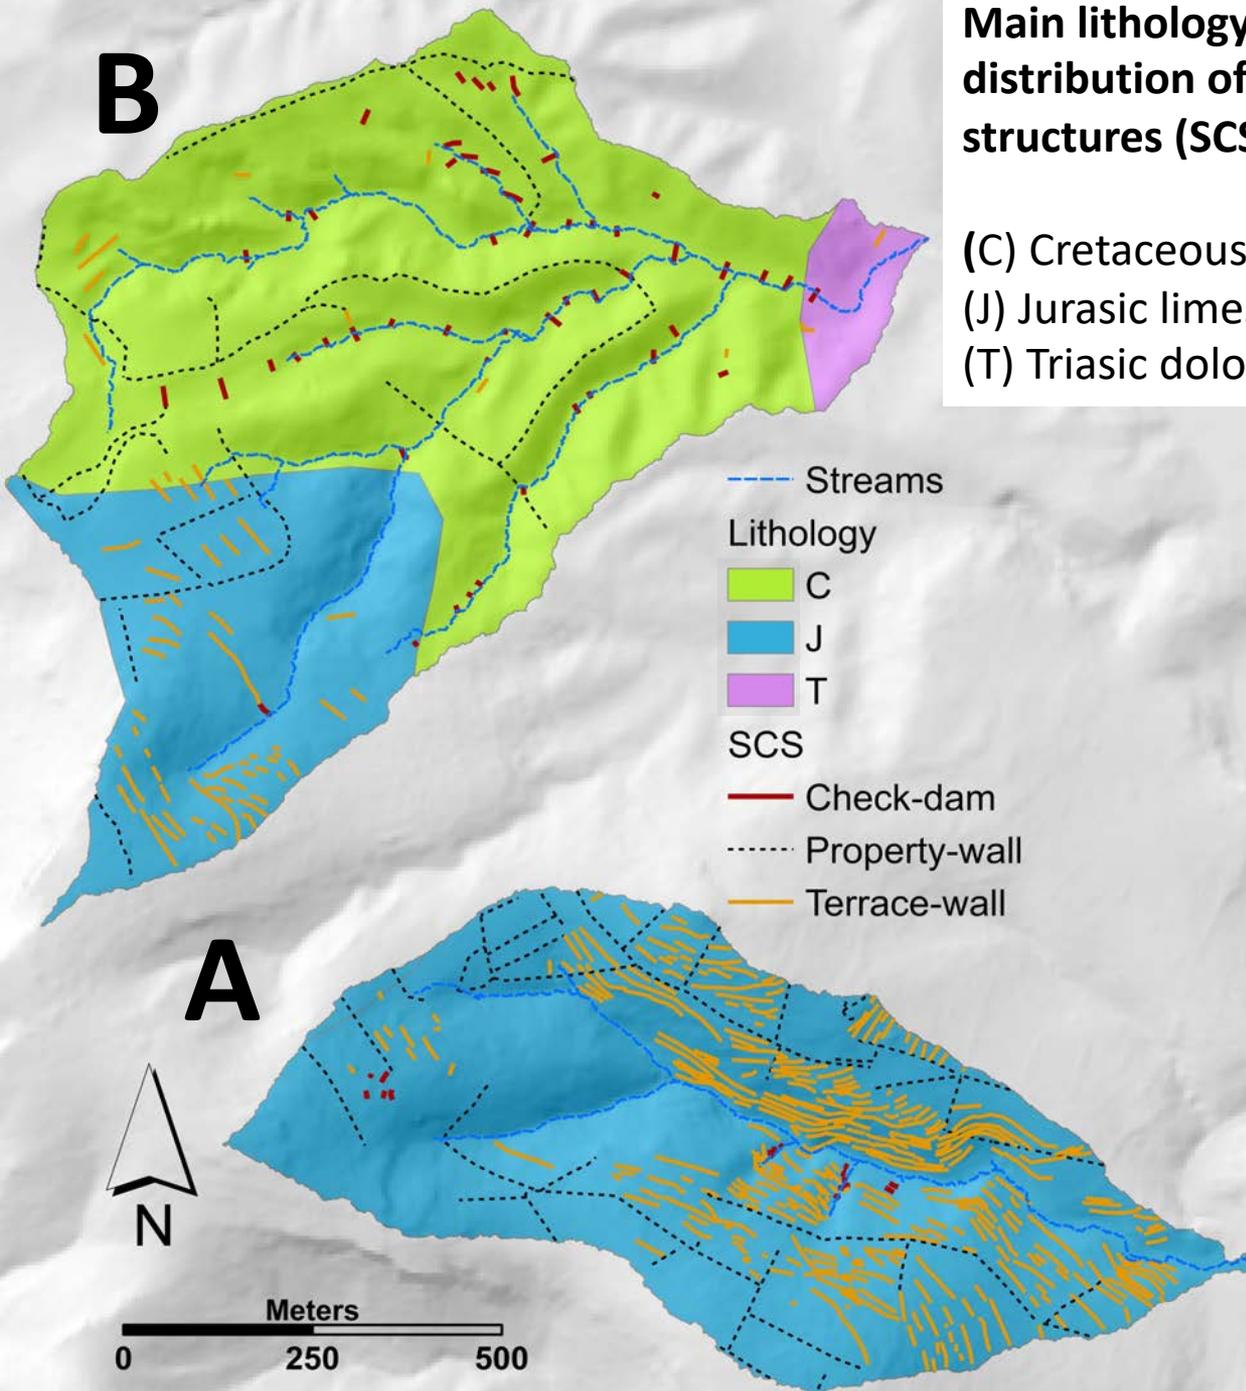
Main lithology of the studied catchments and distribution of the main made soil conservation structures (SCS).

(C) Cretaceous limestones, clays and marls.
(J) Jurassic limestones and dolomites.
(T) Triassic dolomites

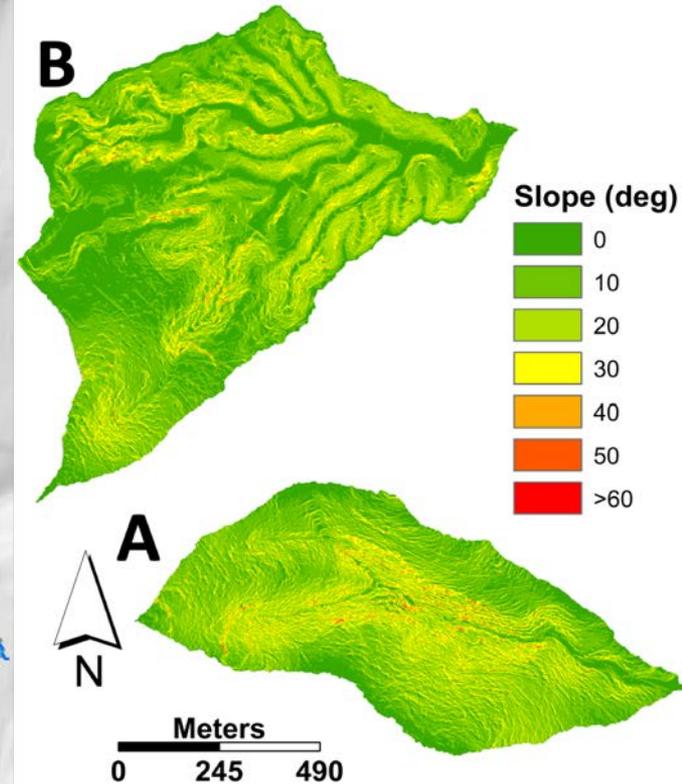
Slope intervals from 1 m LiDAR 2014 DTM.

Average

A = 15.8° B = 19.0°

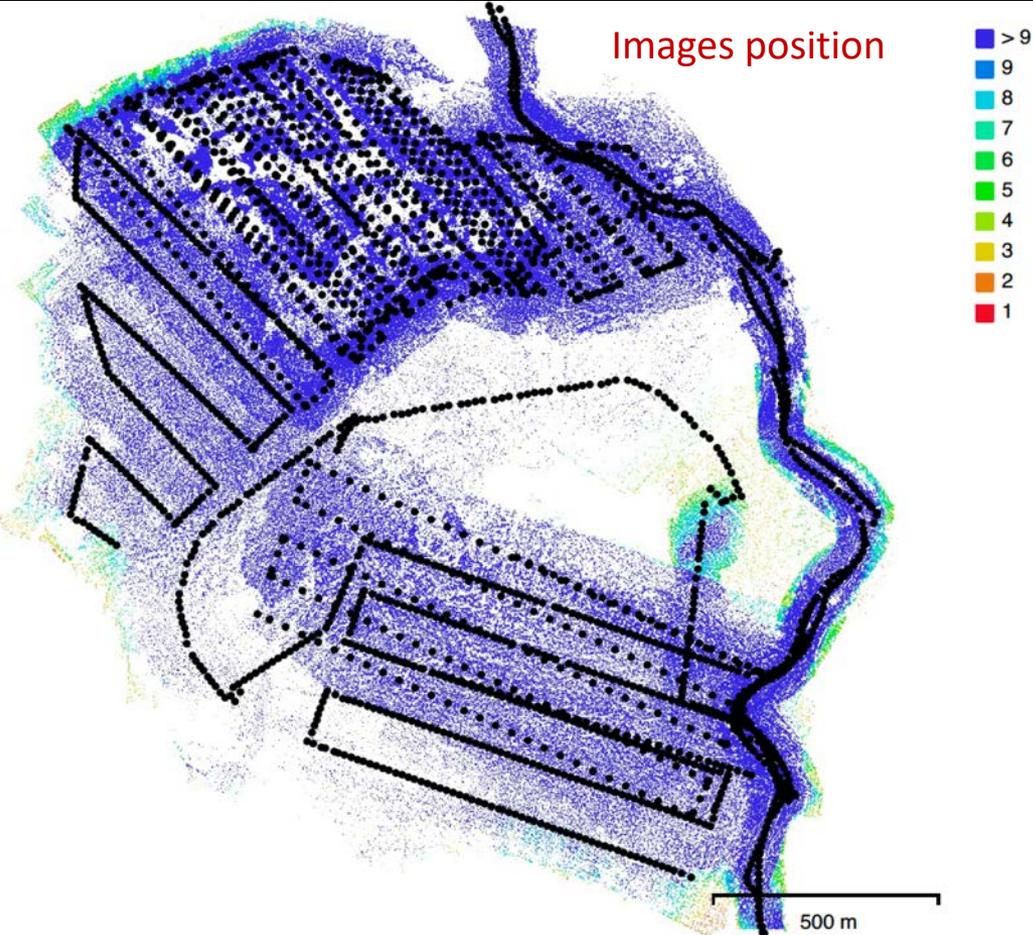
UAVs flight characteristics and processing

Two weeks after the 9th October 2018 event, two UAVs were used to record aerial photographs and build high-resolution digital elevation models. UVA flight characteristics are summarized on the tables and map.

Camera Model	Resolution	Focal Length	Pixel Size
FC6310 (8.8mm)	5472 x 3648	8.8 mm	2.41 x 2.41 μ m
ILCE-5000 (16mm)	5456 x 3632	16 mm	4.4 x 4.4 μ m

Number of images:	2,515	Camera stations:	2,423
Flying altitude:	143 m	Tie points:	1,977,432
Ground resolution:	3.88 cm/pix	Projections:	7,495,427
Coverage area:	1.22 km ²	Reprojection error:	0.797 pix

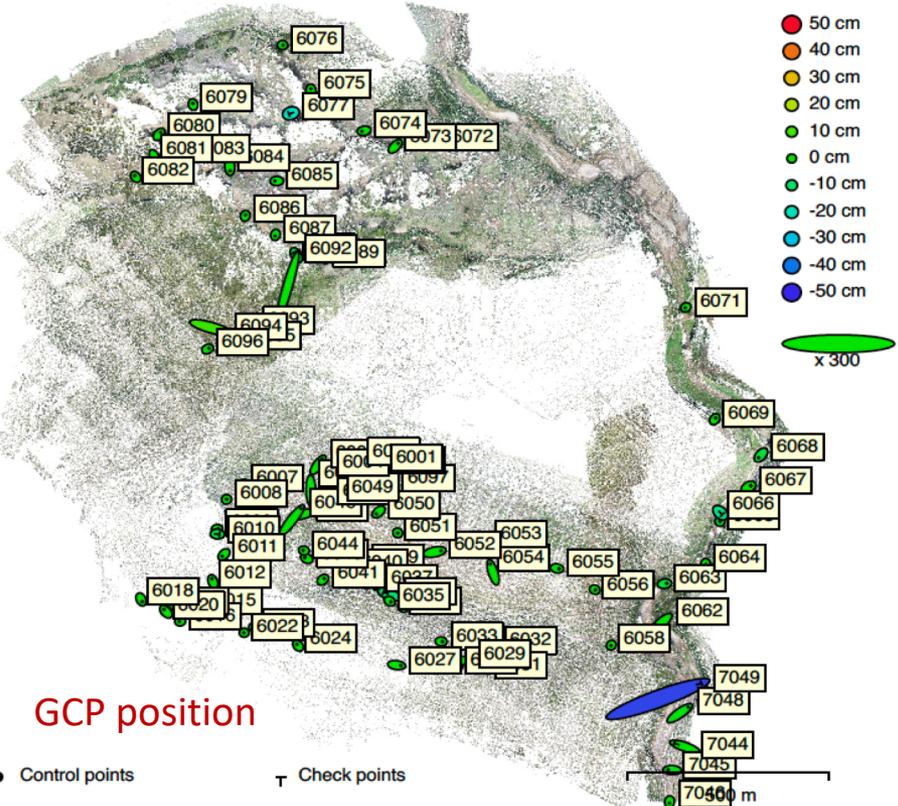
UAV flight characteristics and processing

Distributed within the two catchments, 83 GCP were marked in the field and coordinates taken with a Leica 1200 differential GPS with the spatial distribution allowed by available tracks.

The GCP with a initial larger RMSE (10 points) were deactivated and considered check points, following the referencing procedure with the remaining 73 points. Resulting provisional DEM and orthoimages have 10 and 5 cm in resolution respectively. Both the orthoimage and the DEM has been proved very useful for identification, mapping and measurement of the erosional forms (see below).

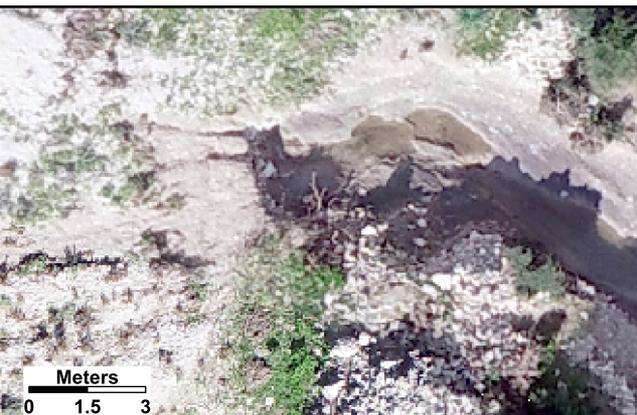
BUAV 5 cm orthoimages
and details

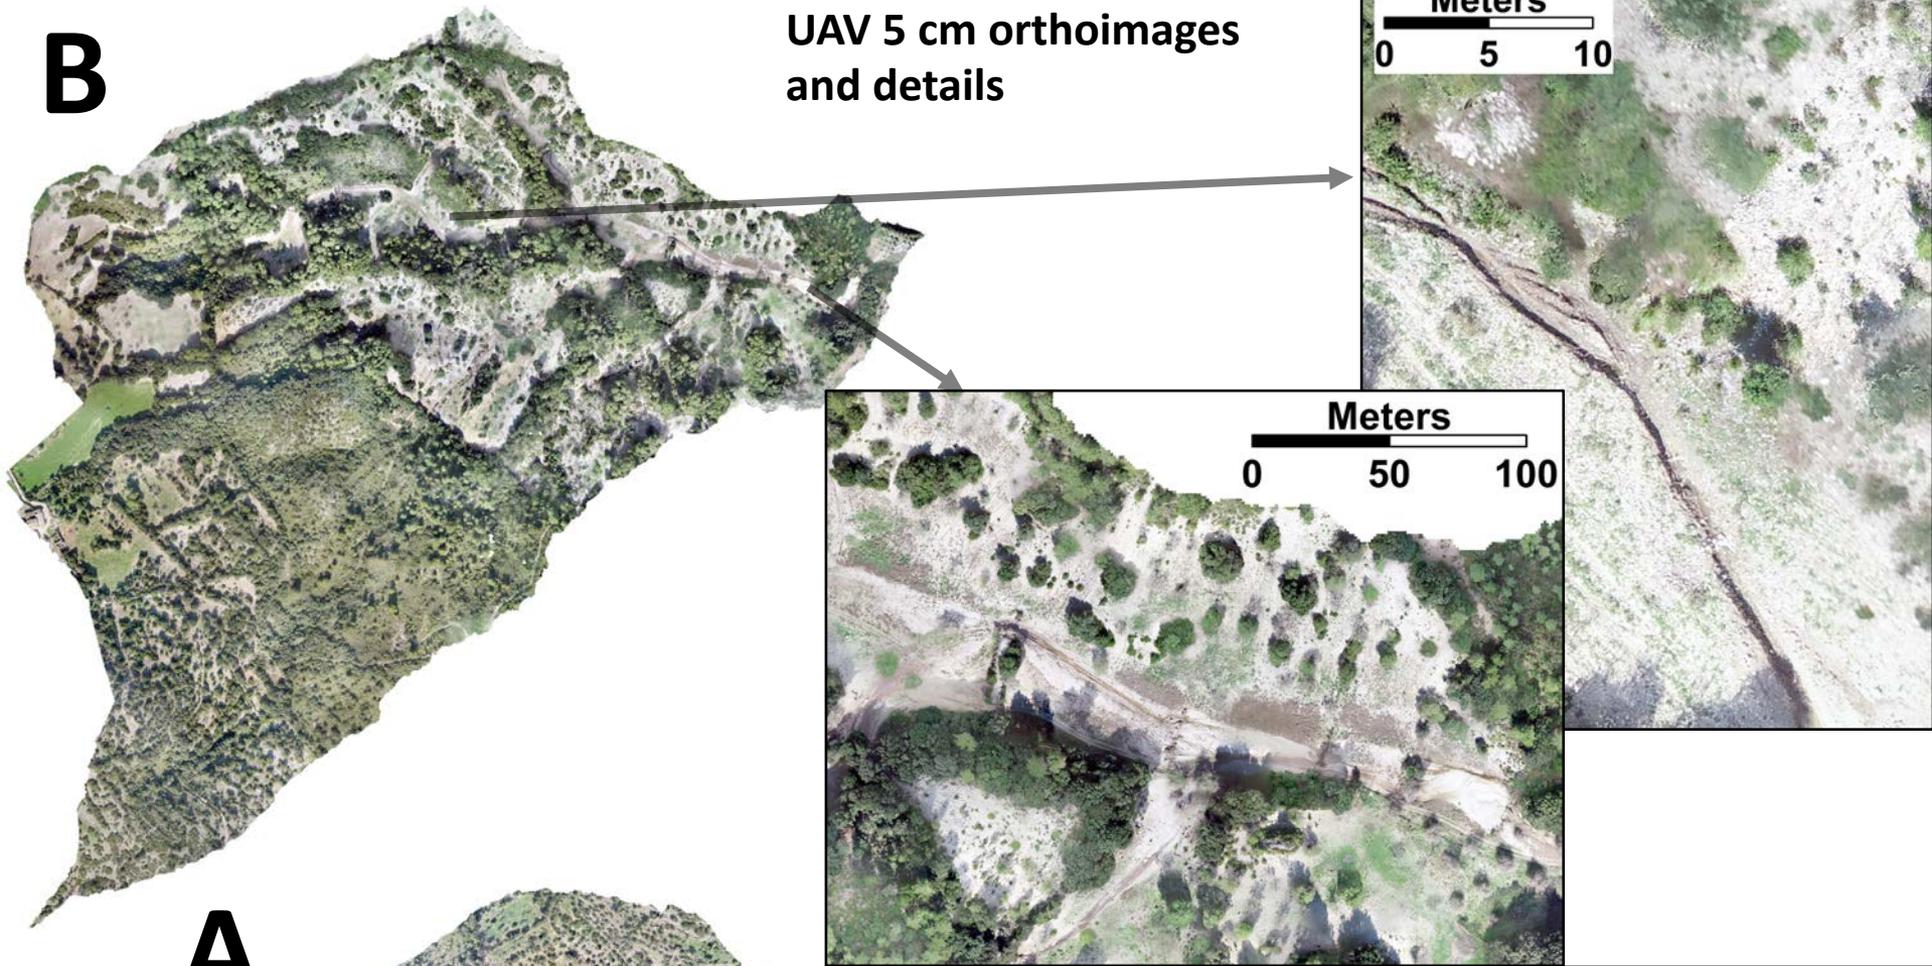
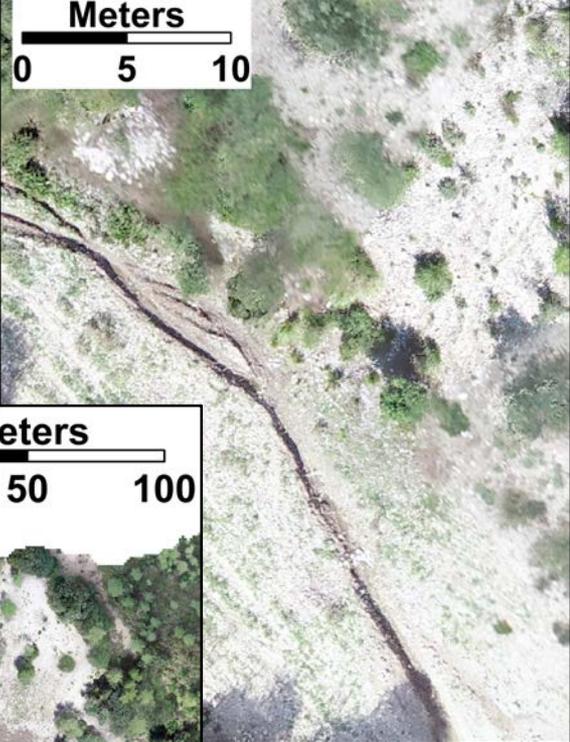
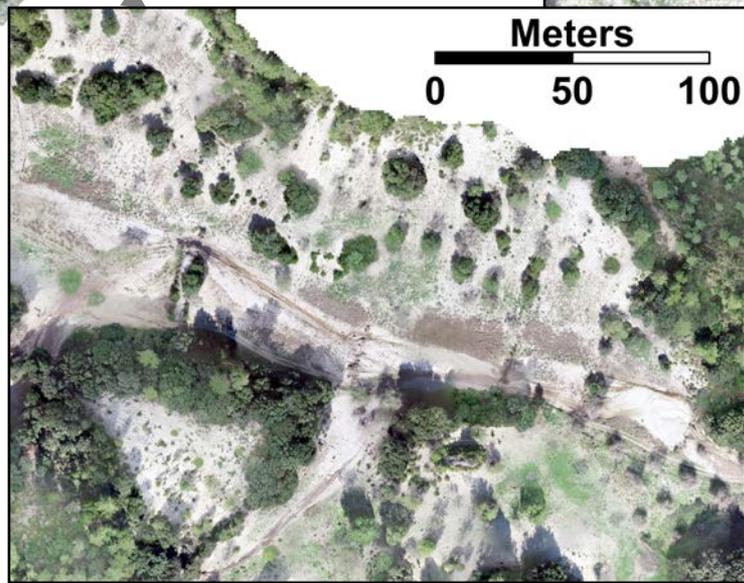
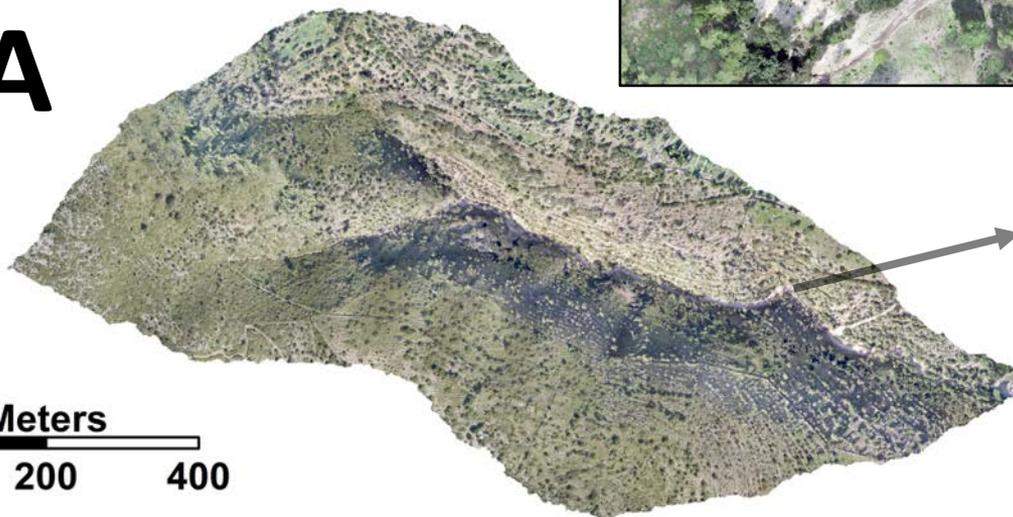
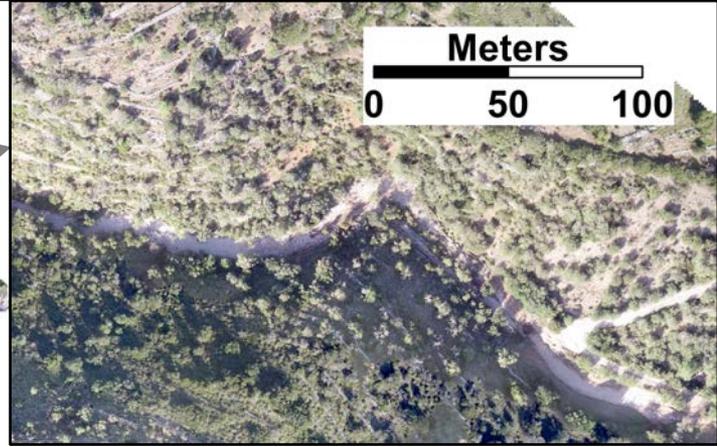
Spatial distribution of the observed response to the rainfall event on the UAV 5 cm resolution orthoimages.

(CWSF) water surface flow evidences.
 (Erosion) rill and gully developed during the event.
 (Deposition) gravel and fine sedimentation.

The evidences of runoff and, especially dissection forms are exclusively affecting to the parts of catchment B over soft and more erosive material.

Here the response to the event generated mid hillslope rills in bare parts of the south-facing slopes and activated most of the channels network, producing a considerable amount of sediment movement, with a high proportion of gully development. At catchment B, 24 % of the 7.3 Km of lines with runoff evidences are rills or gullies.

In contrast, at the upper part of the B catchment (limestones) the images do not show any evidence of runoff, or erosion.

At catchment A, also on limestones, only the main channel have evidences for runoff and sediment movement.

The limestone areas, have a notable improvement of the matorral cover, in combination with the remains of old agricultural terraces, showing very relevant stability.

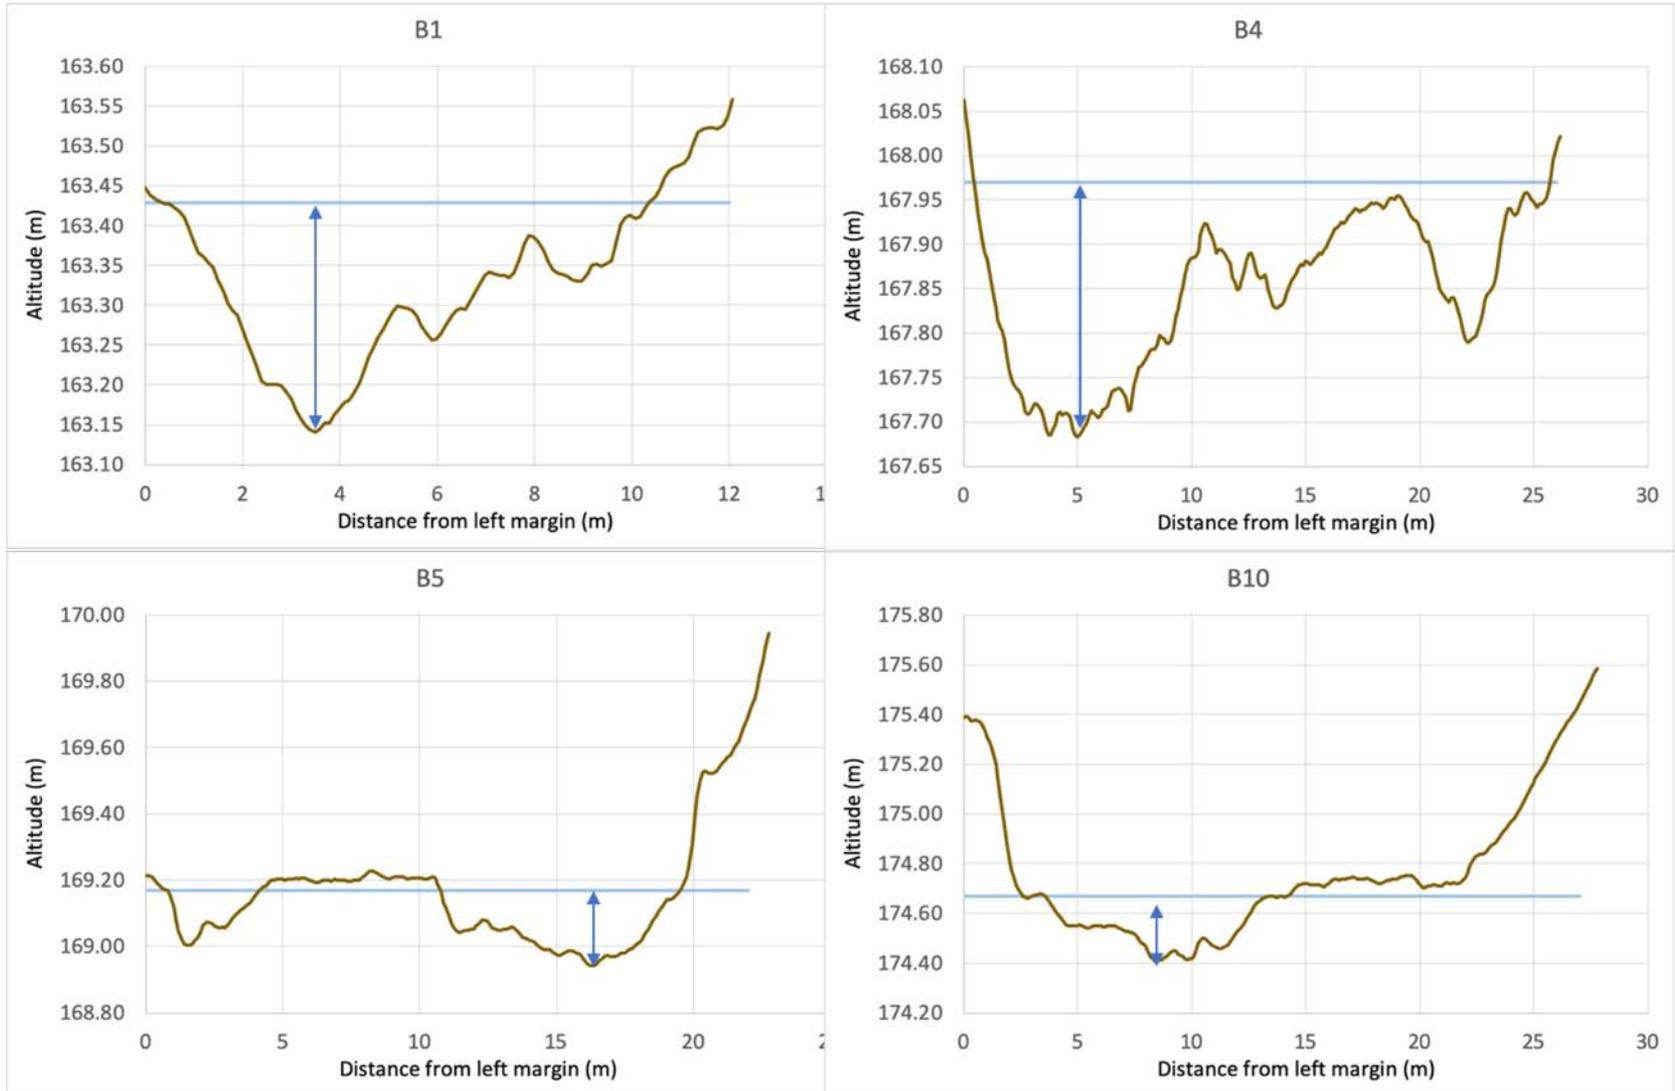
Some of the cross section extracted from the 10 cm DEM obtained from the UAV images of catchment B. Indications of the assumed original surface and the maximum incision.

As the DoD results were not satisfactory, the eroded parts of catchment B were sampled with 58 cross sections and profile reconstruction was made with the 10 cm DEM. Looking on the orthoimages for the erosion limits the maximum incision was measured in each section.

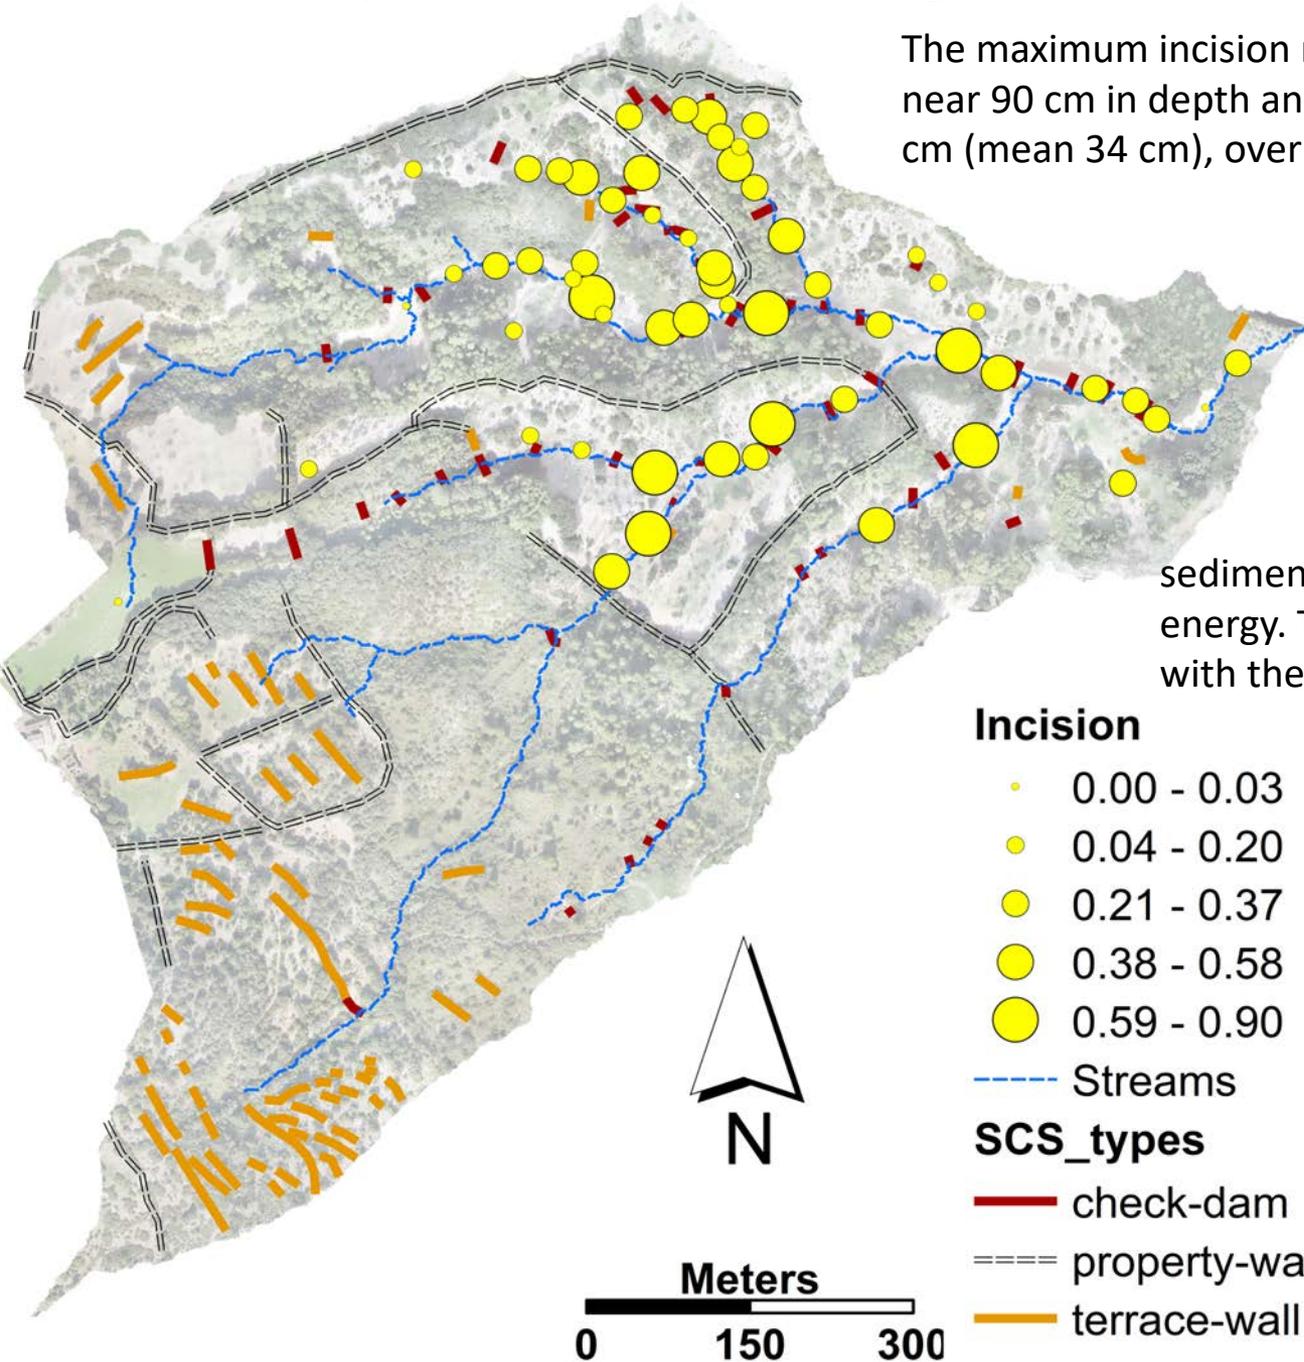
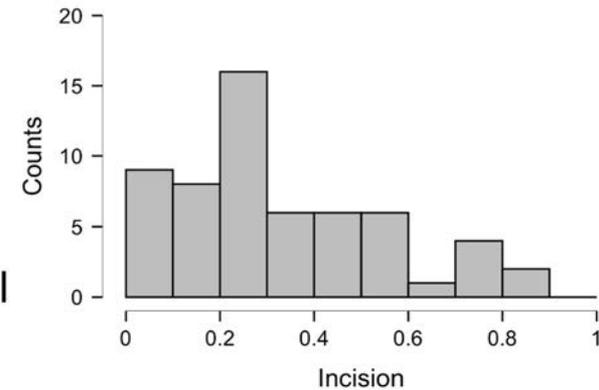
Spatial distribution of the magnitudes of incision and the position of the SCS

The maximum incision measured at each section, reach near 90 cm in depth and half of the sections are over 30 cm (mean 34 cm), over previous surface.

The irregular spatial distribution, show the interferences of the man-made SCS, specially the check-dam style agricultural terraces, that combine the steps and sediment availability along the talwegs, making variable the sediment concentrations and channel energy. This affects to the certain disparity with the IC values (next slide), showing a

poor interdependence, although subgroups are identifiable.

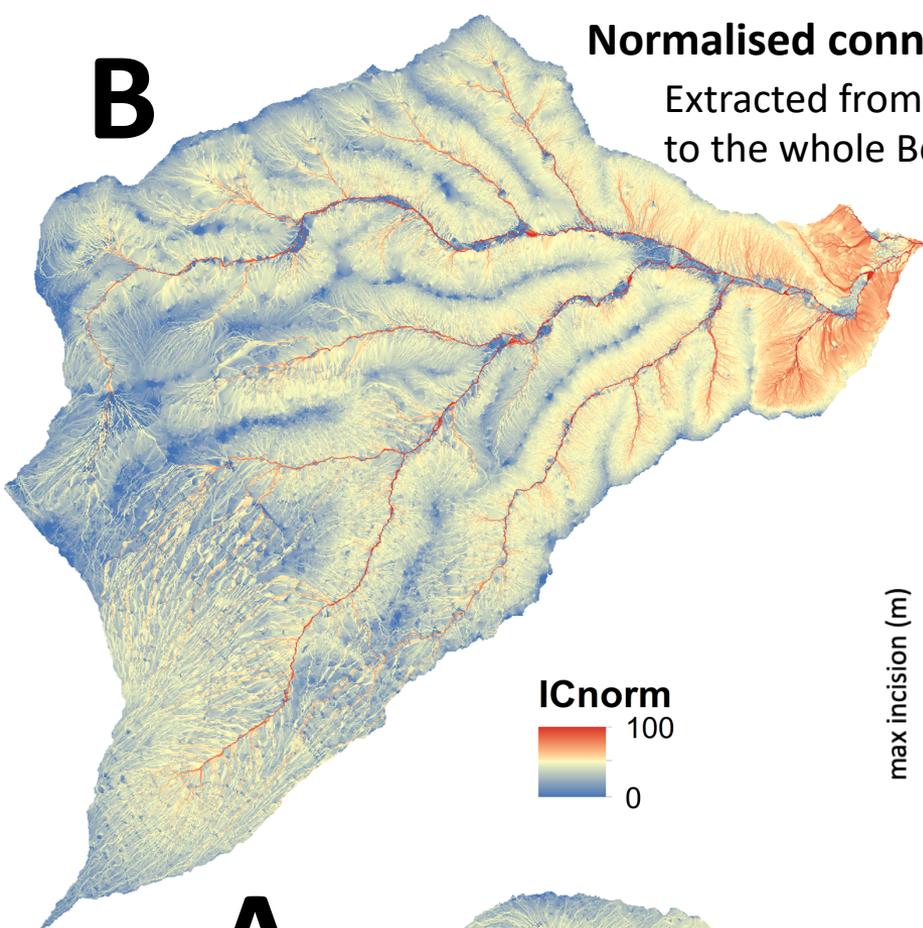
Normalised connectivity index (IC) values for the two catchments.

Extracted from a subset of the Cavalli et al. (2013) IC procedure applied to the whole Begura de Saumà basin to the 1 m LiDAR 2014 DTM.

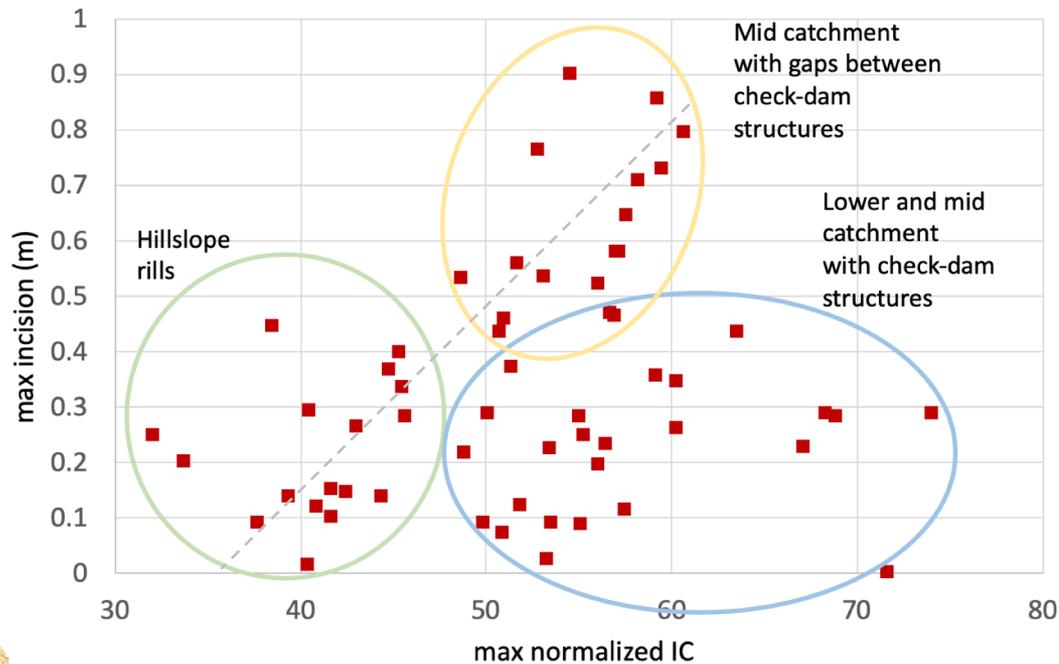
The maximum IC values for for each measured cross section, in catchment B, plotted versus the maximum incision reached, allow to establish the three main

groups visible in the figure, that illustrate how the check-dam terraces can distortion the potential positive trend that draw the set of measurement not directly affected by the artificial structures.
