Landslide mapping, monitoring and early warning based on multi-source data

Case study of the Qingpo landslide (Wenchuan, China)

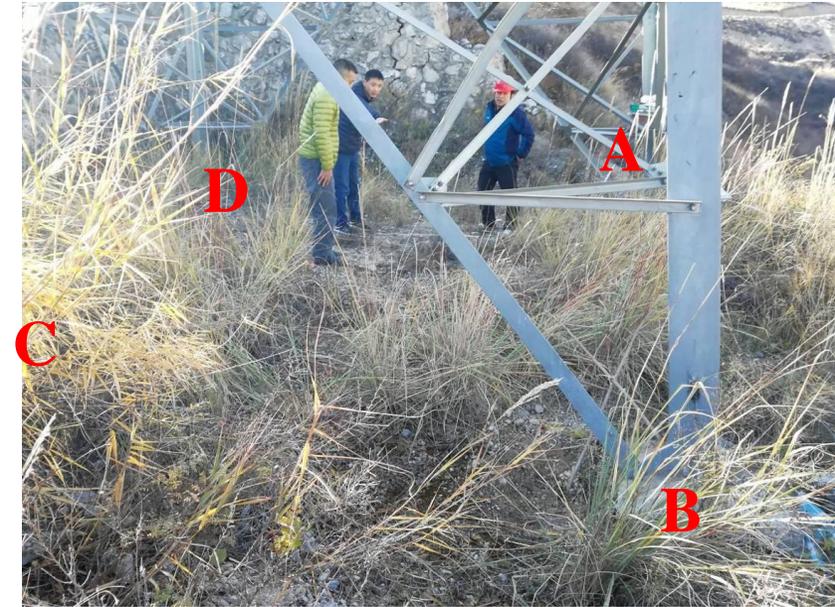
- ◆ On November 28 and December 4, 2018, deformation and tension cracks were discovered in the ground. The settlement of two pylon legs (A and B) was obvious, while the other two appeared stationary.

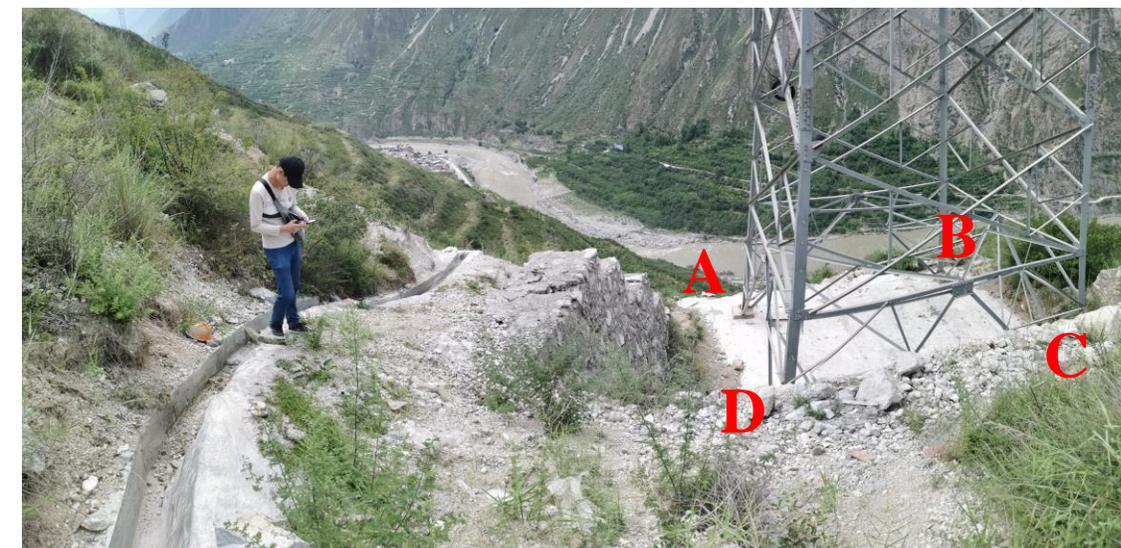
- ◆ Then the company reinforced the surface with concrete.
- ◆ After the treatment, the deformation did not stop completely, and the deformation was still developing until July 2019. Concrete and retaining walls also cracked with large cracks.

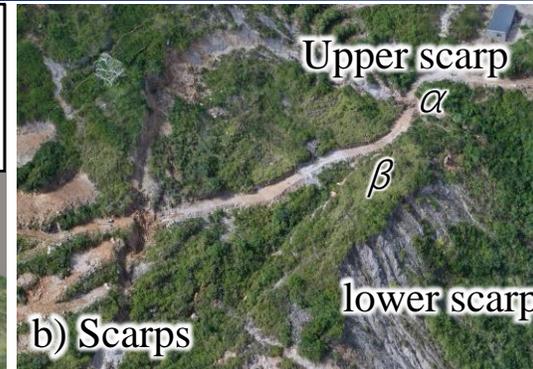
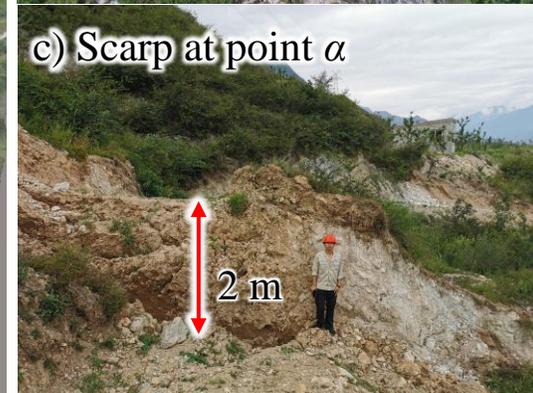
A panoramic view of the landslide taken by UAV on July 20, 2019.

The main scarp and the left flank (facing the sliding direction) cracks have formed.

- a) Cracks in the main scarp and left flank have formed but are not fully formed at the right flank boundary.
- b) The landslide is characterized by two scarps, the upper scarp and the lower scarp.
- c) The main scarp is approximately 2 m high at the small road (point α).
- d) Tensile cracks at point β . I-I' is the location of profile.

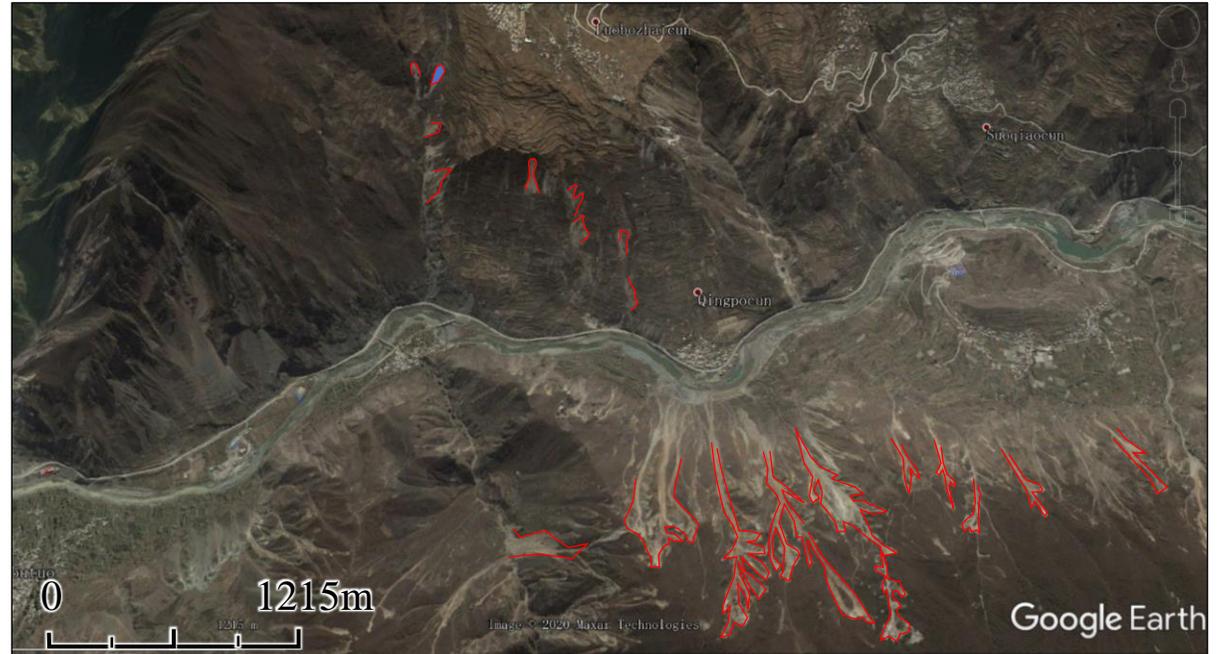
The remote sensing image of the study area on April 4, 2010 (two years after the Wenchuan earthquake, , no clear remote sensing image was found in 2008-2009)

- ◆ A large number of small-scale collapses occurred in the vicinity of the study area, and only small collapses occurred in the landslide area studied, but **the study slope still did not deform as a whole.**
