# Mapping and monitoring of landslide-dammed lakes using Sentinel-2 time series

A case study after the 2016 Kaikōura  
Earthquake in New Zealand

Session NH6.1 – Live chat: Thu, 07 May, 14:00–15:45

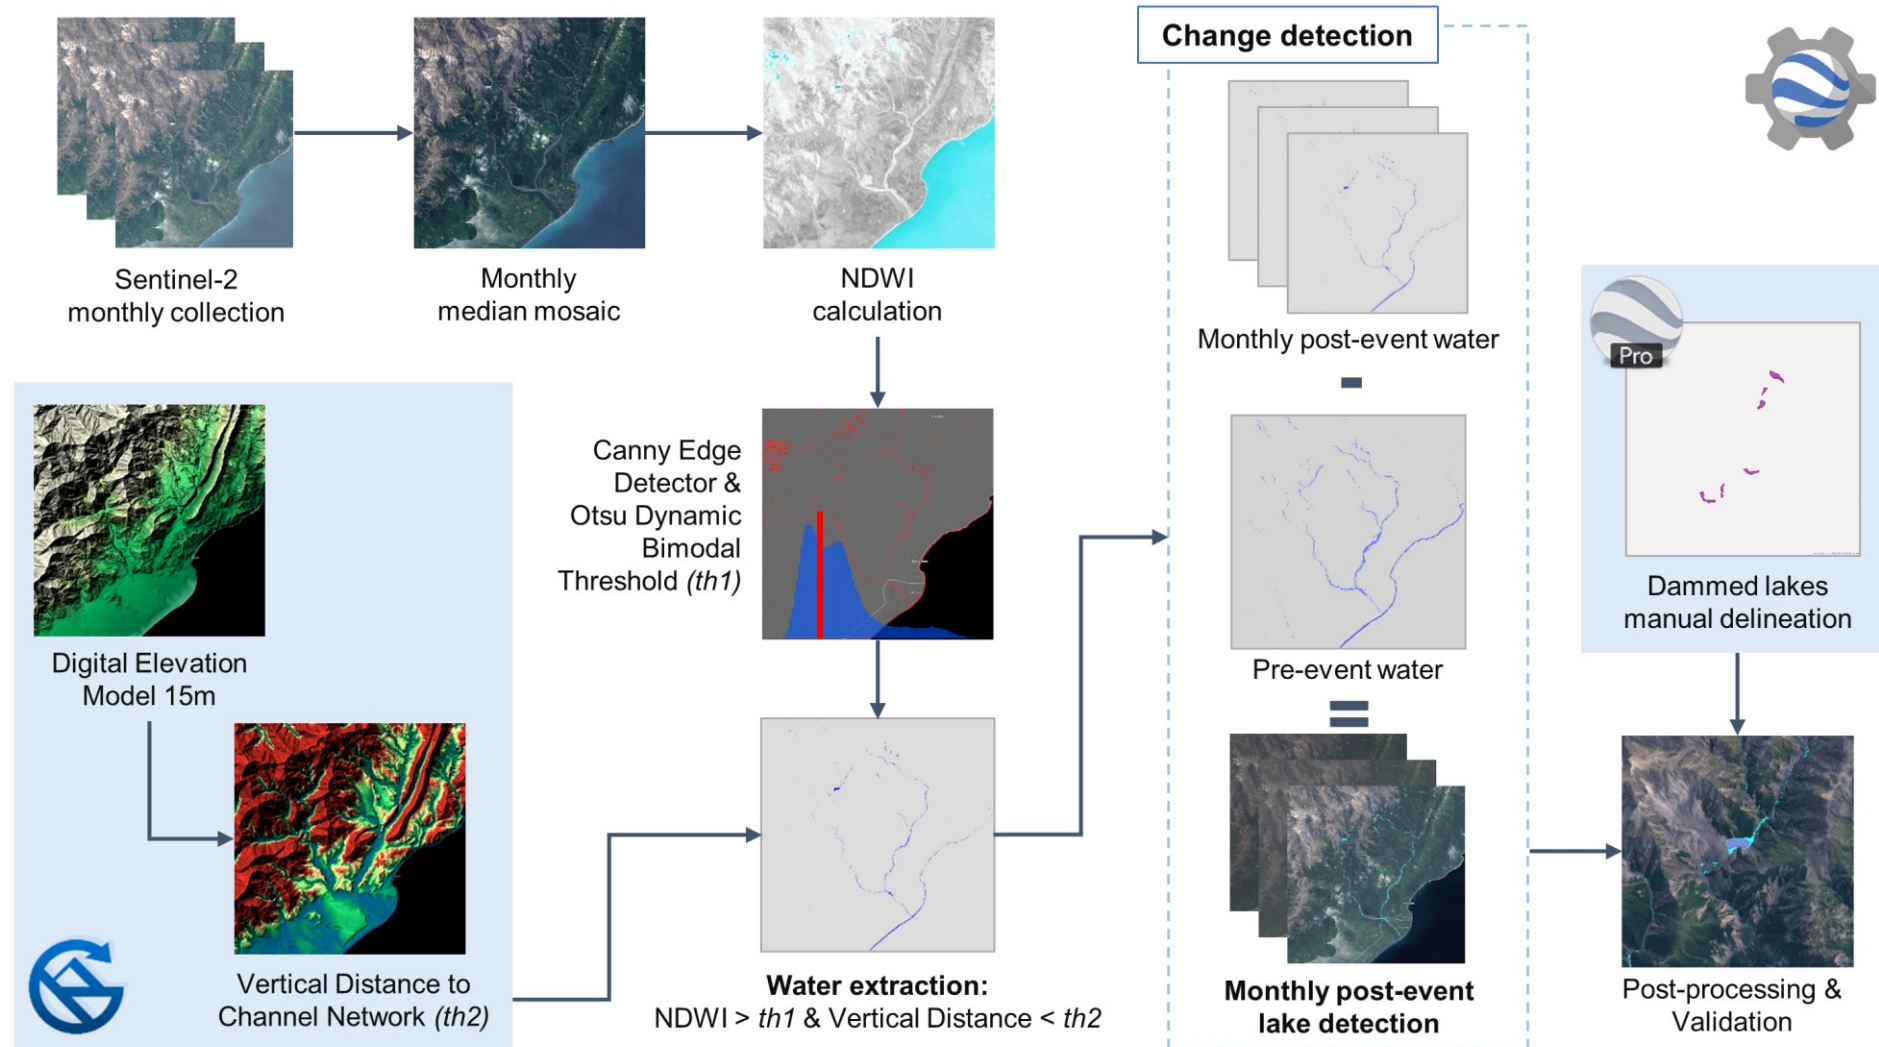
The lake detection method applied on GEE can be summarized in 4 basic steps:

1. Monthly mosaic and NDWI calculation from Sentinel-2 imagery.
2. Monthly water extraction <sup>[1]</sup> based on vertical distance to the channel network and NDWI thresholding.
3. Differencing change detection of water layers using pre- and post-event mosaics.
4. Post-processing and validation of detected dammed-lakes.

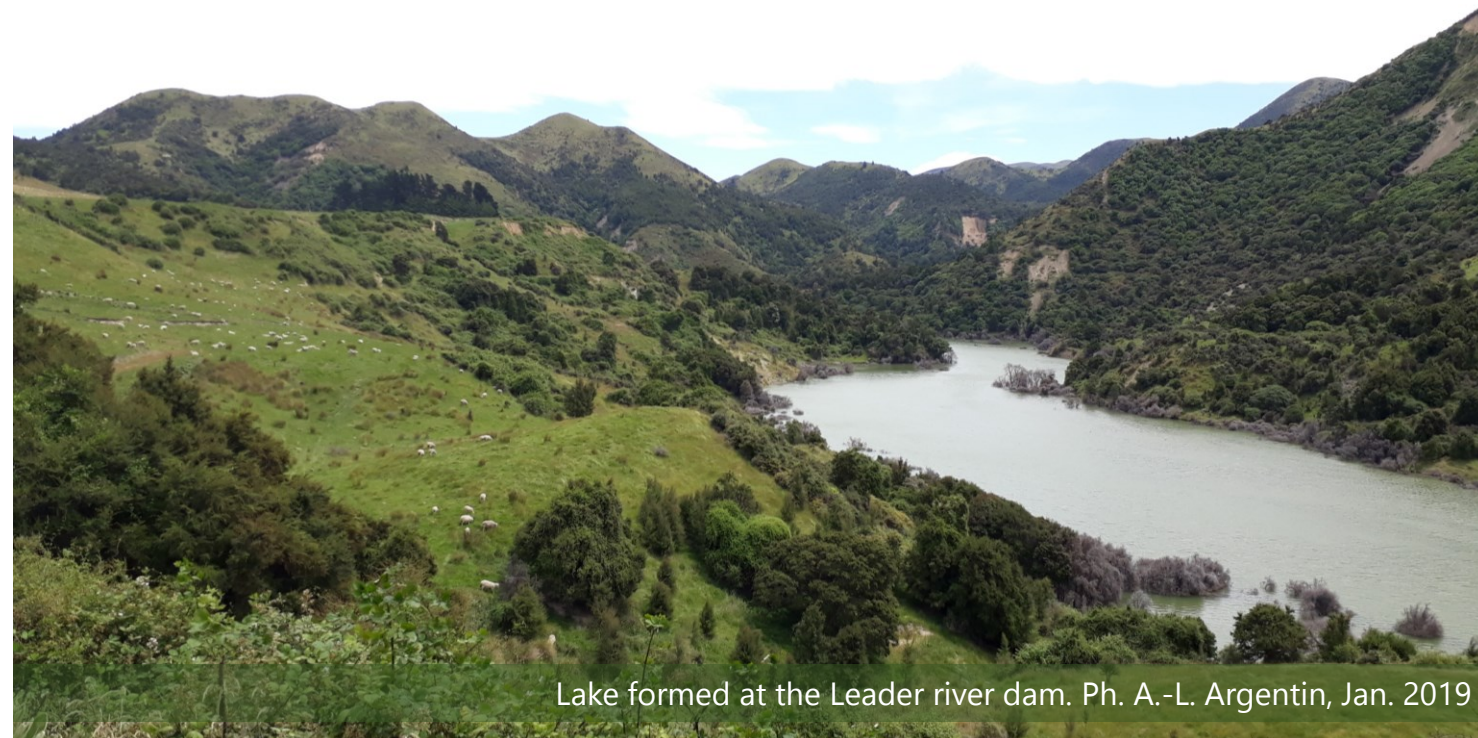
Lake formed at the Leader river dam. Ph. A.-L. Argentin, Jan. 2019

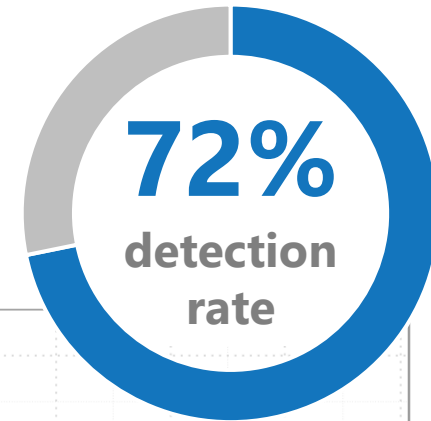
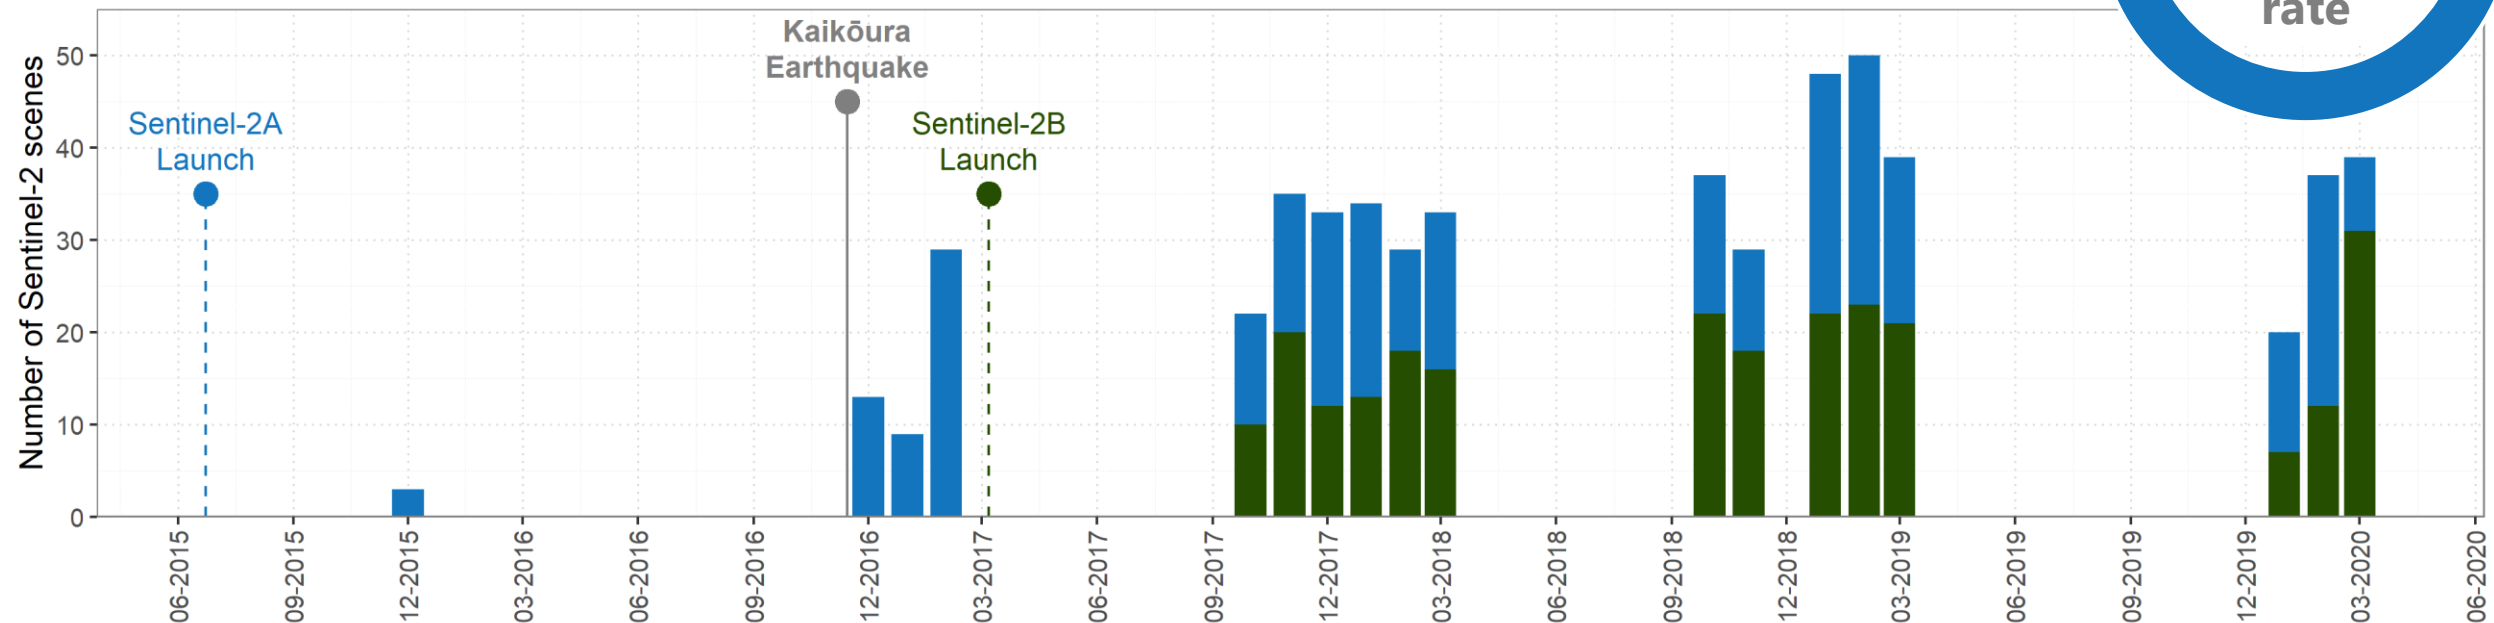
**One** pre-event and **17** post-event monthly mosaics were composed on GEE, selecting scenes with cloud coverage below 30%. The analysis considered imagery from October to March. A mosaic was used for analysis when the study area was completely covered. The launch of Sentinel-2B increased the number of available scenes significantly.

For validation, the detected lakes for December 2016 were overlapped with lakes delineated manually on Google Earth Pro for the imagery available immediately after the earthquake. **28** out of **39** lakes were successfully detected with the automated method. Undetected lakes are due to topographic shadows on highly mountainous terrain.
