## The August 2020 *jökulhlaup* from a marginal lake at Langjökull, W-Iceland: Course of events - discharge and volume estimates - future monitoring

Thorsteinn Thorsteinsson<sup>1</sup>, Kristjana G. Eypórsdóttir<sup>1</sup>, Esther H. Jensen<sup>1</sup>, Ingibjörg Jónsdóttir<sup>2</sup>, Finnur Pálsson<sup>2</sup>, Andri Gunnarsson<sup>3</sup>, Hlynur Sk. Pálsson<sup>4</sup>, Oddur Sigurðsson<sup>1</sup>, Guðbjörg H. Karlsdóttir<sup>2</sup>, Ragnar H. Þrastarson<sup>1</sup>, Gunnar Sigurðsson<sup>1</sup>, Tómas Jóhannesson<sup>1</sup> & Matthew Roberts<sup>1</sup>

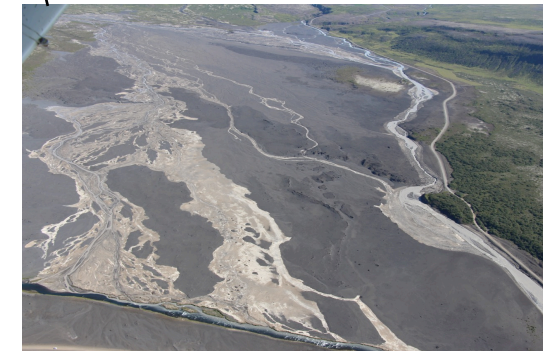
# Timeline of events:

**1** – August 17, early morning: Water level in the lake reaches a critical point, floats ice and water flows into subglacial tunnel.

**2** – Jökulhlaup escapes ~2 h later from beneath the ice margin, 2 km downstream, entering the Svartá river.

**3** – Noon: Water level starts rising beneath bridge at Húsafell. Has risen >2 m at peak flow (~21:00).

**4** – 16:00. Flood has reached Kljáfoss hydrometric station on Hvítá river. Peak flow there on August 18, at 01:45.

**5** – ~19:00. Flood reaches ocean in the bottom of the fjord Borgarfjörður.

Sandur area flooded during the jökulhlaup. Sediment deposition.

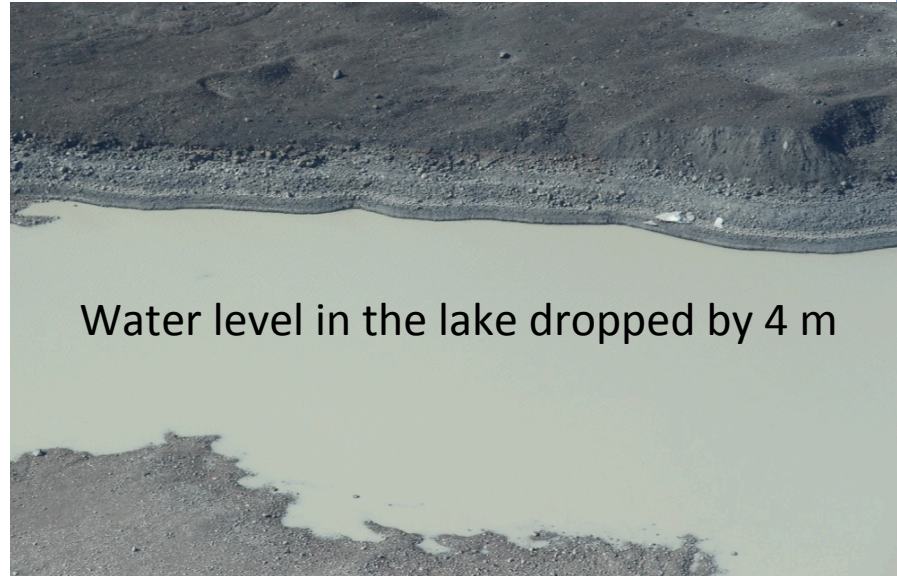
Area before and after 2020 event:

Before: 1.4 km<sup>2</sup>

After: 0.4 km<sup>2</sup>

Estimate of volume of water emptied out :

$V = 3.5 \cdot 10^6 \text{ m}^3$

Compares well with data from hydrometric station downstream.
