## MULTITEMPORAL GEOMORPHOLOGICAL ANALYSIS TO PREDICT FLASH FLOOD IMPACTS: ITS CONTRIBUTION TO INFORM FLOOD RISK MANAGEMENT

This work contributes to determine the flash flood effects and, therefore, to define the ZPF, through multitemporal geomorphological analysis applied to a case study of the upper basin of the Francolí river in Catalonia, Spain.

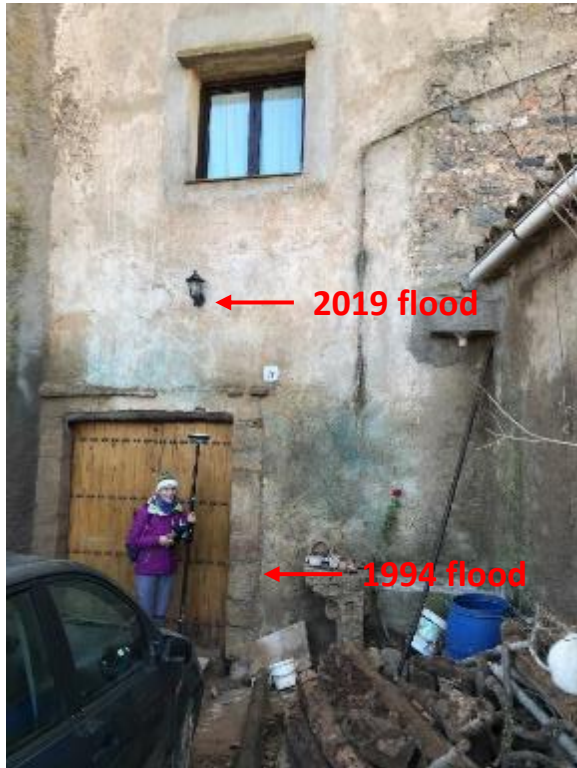
P1. Molí de Guasch

Water levels at different sites corresponding to the 2019 and 1994 floods (see previous page)

P1 Photo showing the water levels for the 2019 and 1994 floods (see next page)

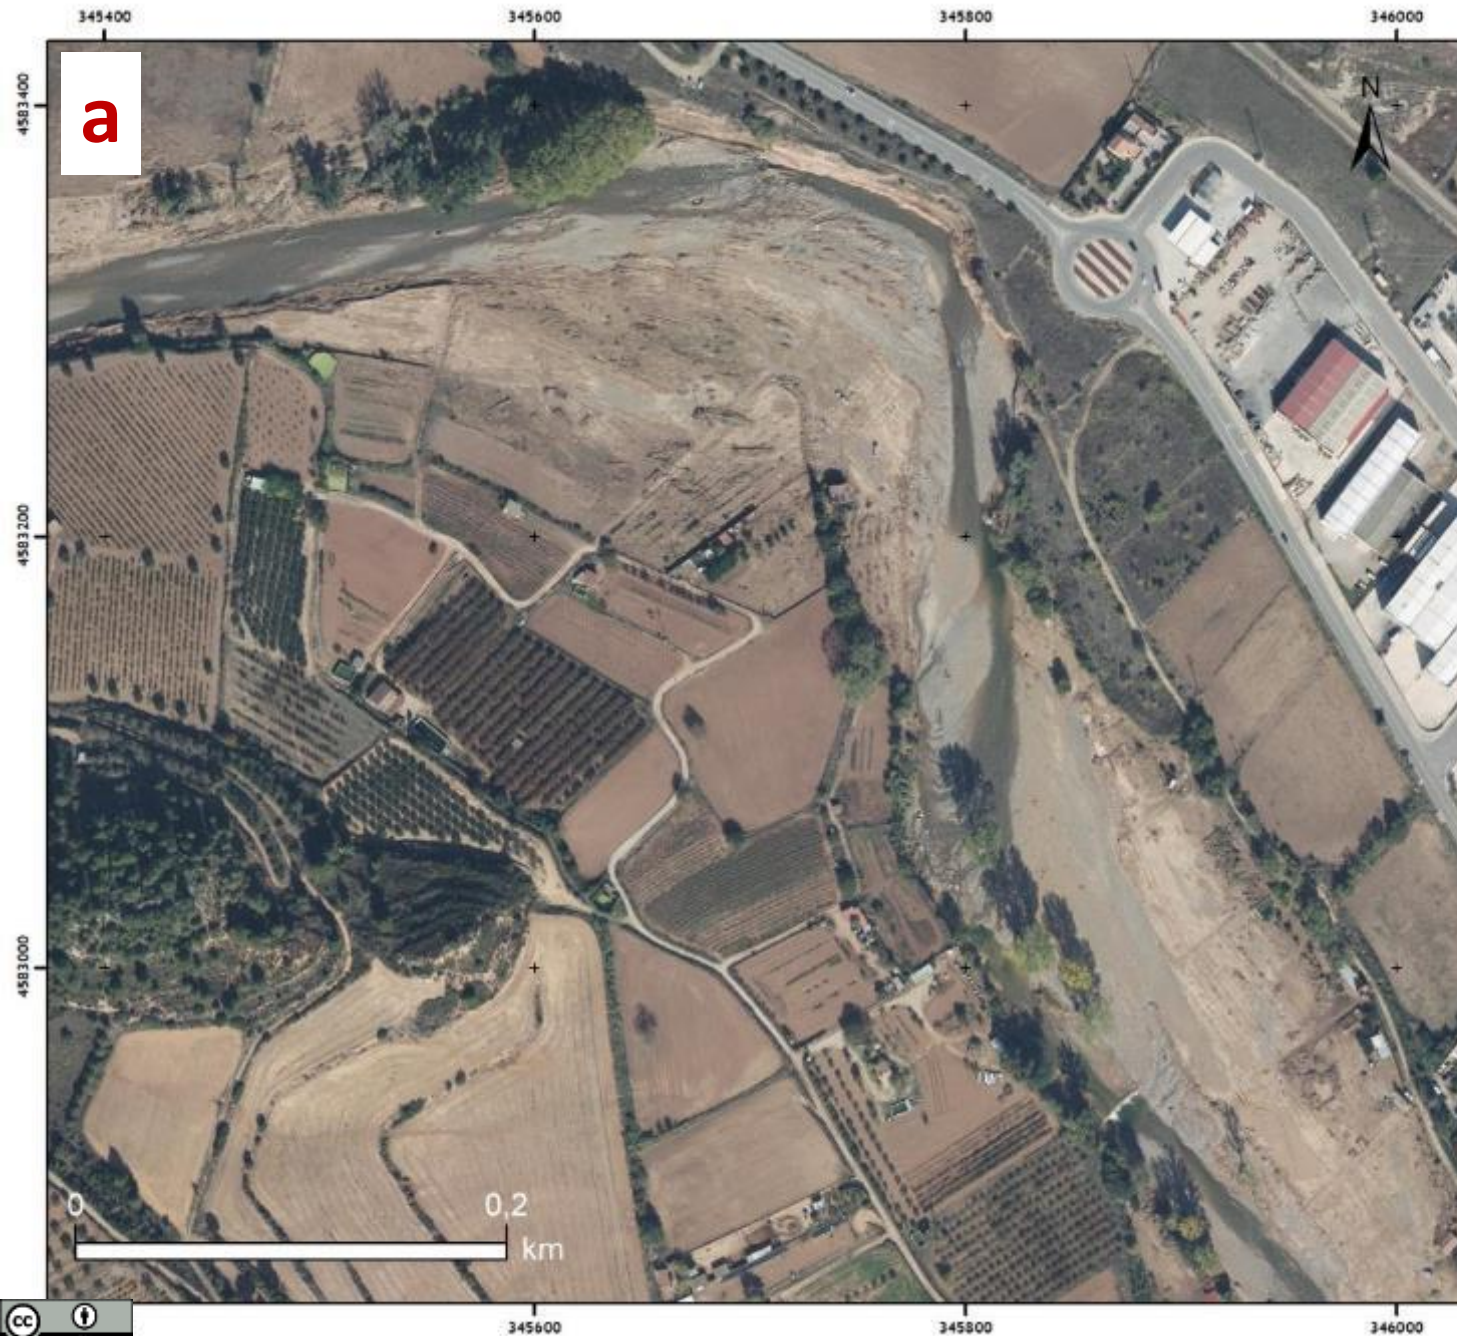
**2019**

ORTHOPHOTO  
POST FLOOD

## ANALYSIS CRITERIA

Bank erosion

Large wood acumulation

Gravel bars

Water marks

Channel widening

Affected crops

Vegetal drifted  
ephemeral evidence

Affected riparian trees
