Response of a small mountain river to a sediment pulse tracked using sub-canopy UAV surveys

EGU22 - 10675

East Creek, British Columbia

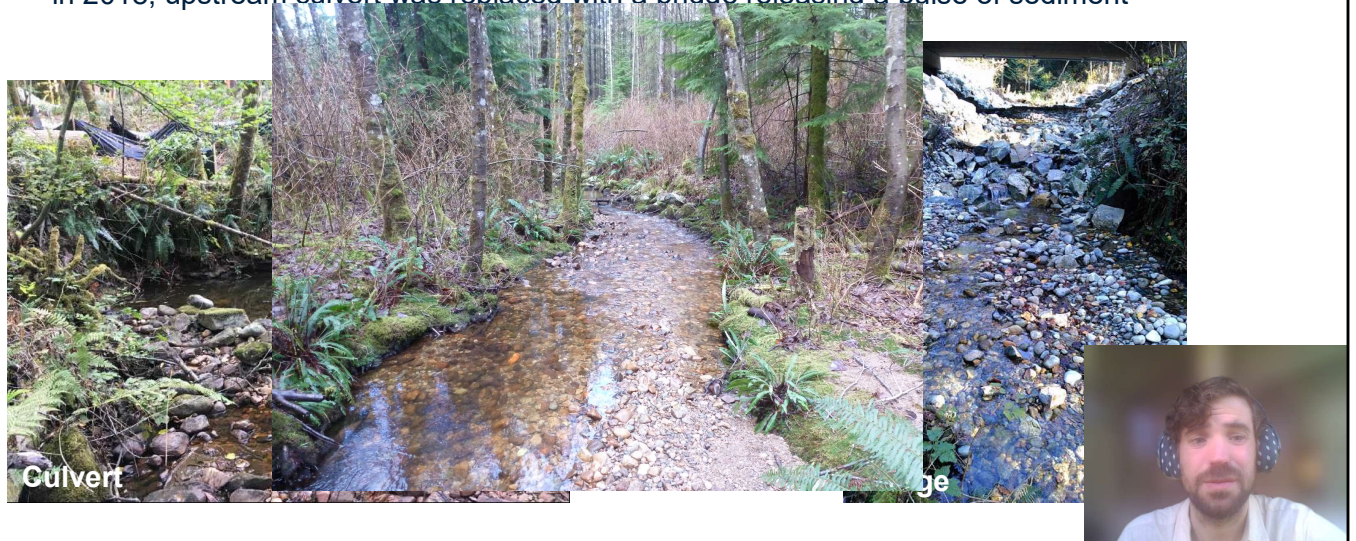
On the left, here, you can see a picture of the upstream culvert, this is taken looking upstream. On the right, you can see the bridge that replaced it, taken from about the same spot. Notice the built-up slope and rip-rap. That wedge of sediment trapped behind it was made available to the downstream reach.

In 2018, those morphodynamics changed, as a culvert immediately upstream was replaced with a bridge, releasing a pulse of sediment.

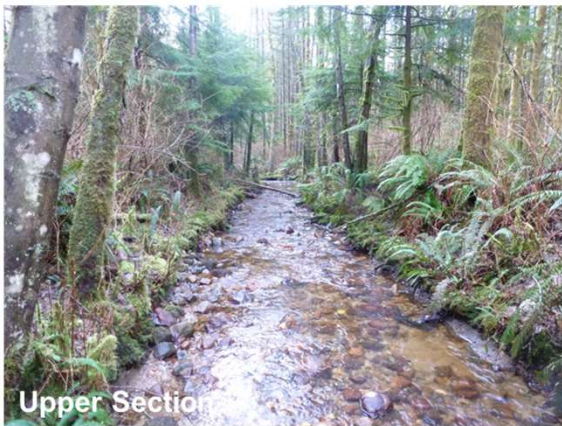
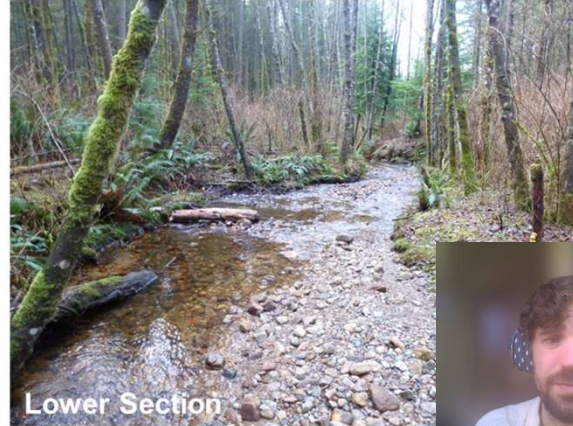
Upper reach is a narrow rapid section, downstream reach is a wider pool-riffle section

I'm going to oversimplify the channel here, but broadly you can split the study reach in two. Upstream, as you can see in the photo on the left, there is a narrow, about 50m long, channel segment with a relatively featureless bed. Further downstream, as you see on the right, the channel gets a bit wider, and has notable, if suppressed, topographic features that can store sediment.

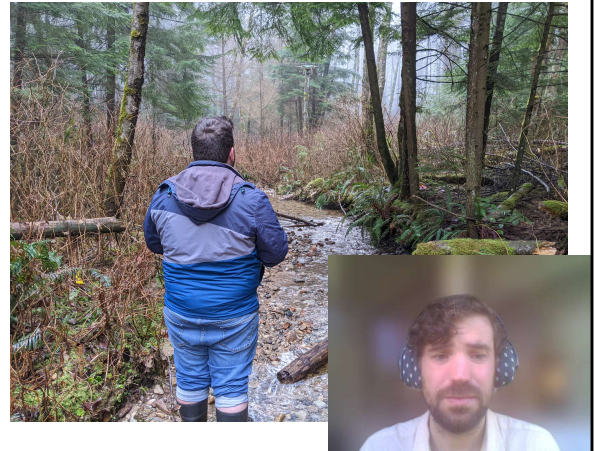
1. Conducted 12 UAV surveys between summer 2018 – summer 2021
2. Surveys were flown beneath the canopy at 2-4 m altitude.
3. Built DEMs using Metashape and CloudCompare
4. Georeferenced DEMs using 78 XS pins and 50-150 surveyed control points

Because the stream was forested, these surveys were flown at 2-4 m altitude, as you can see on the photo on the right (the drone is in the middle of the channel here)

We then build DEMs from drone imagery using metashape and cloudcompare and georeferenced those DEMs using 78 cross-section pins and 50-150 control points (depending on the survey).

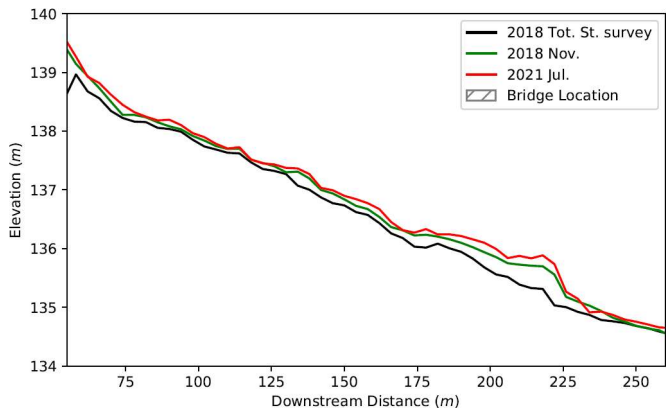
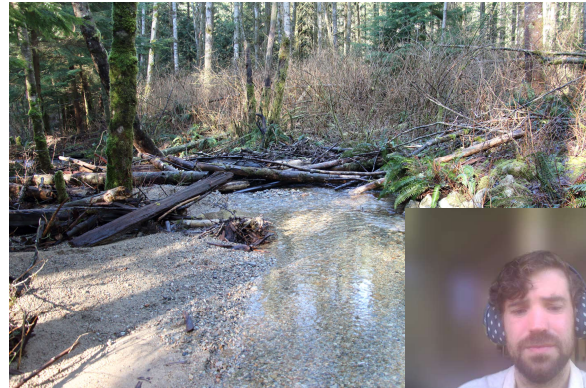
1. Approx. 140 m³ of sediment was added to storage in the reach after bridge installation
 - 80 m³ was stored during the first event – 110 m³ during the first year
 - 100 m³ was stored in the downstream riffle-pool section, only 40 m³ was stored upstream
2. A channel-spanning logjam formed during the first event and remained throughout

As you can see in the longitudinal profile here, Most of the sediment storage occurred downstream in the wider section with features that can store sediment. Some of the furthest upstream changes were constructed during bridge installation, but the narrow featureless section only experienced minimal change.

You might notice the large hump about 225 m downstream, that was caused by a channel-spanning logjam that formed during the first event and is still there today. There is almost no sign of downstream transport past the logjam, so the large sediment wedge that formed trapped most of the sediment.

We observed that approximately 140m³ of sediment was added to storage in the reach after bridge installation. For context, prior to the bridge, we regularly observed 1m³ of upstream supply, so this event was about 100x bigger than normal.

Most of the storage and transport happened immediately after the bridge was installed. Over half of sediment was stored during the first event and 80% of it during the first year.

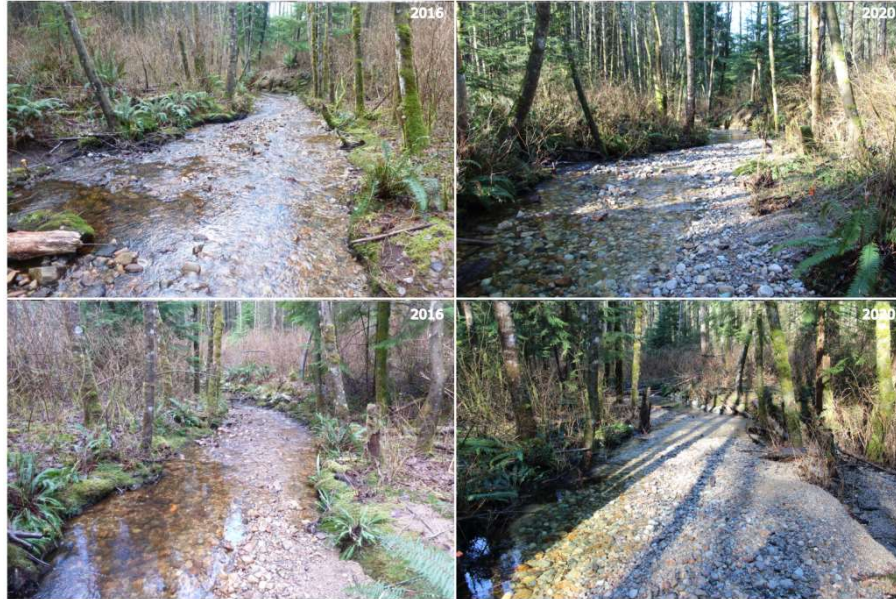
3. Channel features remained despite sediment supply 100x greater than average

Still despite 100x the normal upstream supply, and a logjam, the channel features remained mostly the same. Photos on the left were taken upstream of the logjam from before the bridge installation, photos on the right were from the same places 2 years after.

You can see that storage features like bars enlarged, and the bed became looser, but there was little or no rearrangement of channel features
