# Preliminary Analysis on Multi-Devices Monitoring of Potential Deep-Seated Landslide in Xinzhuang, Southern Taiwan

**Speaker : Ph.D. Ji-Shang Wang**  
**rheo.js@gmail.com**

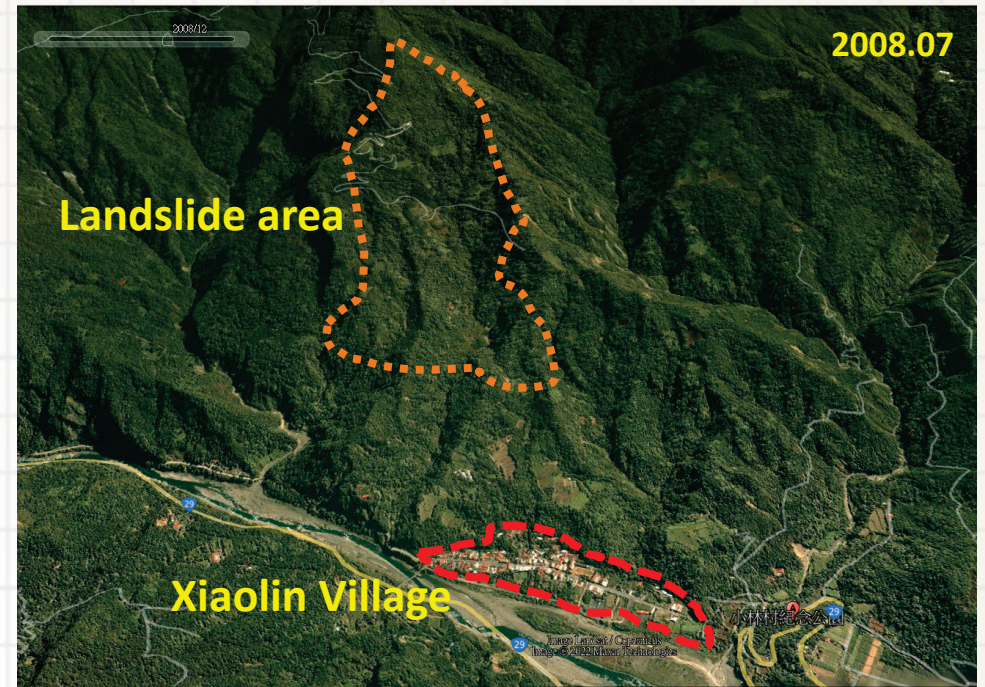
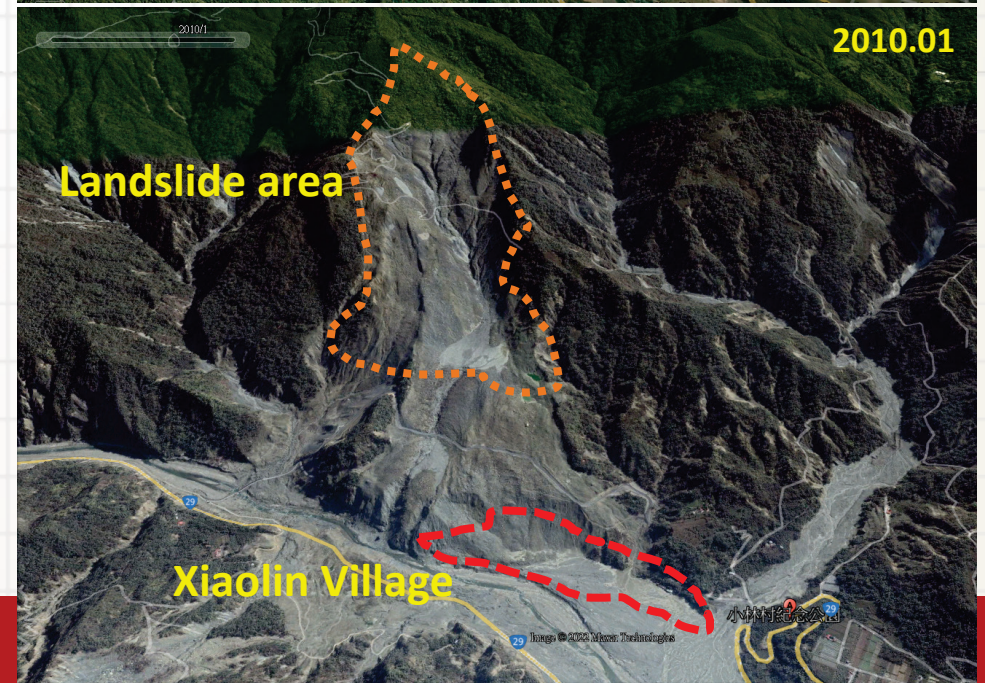
Xiaolin village was buried by a large scale landslide event in 2009 induced by Typhoon Morak. There were 490 casualties and 200 buildings destroyed.

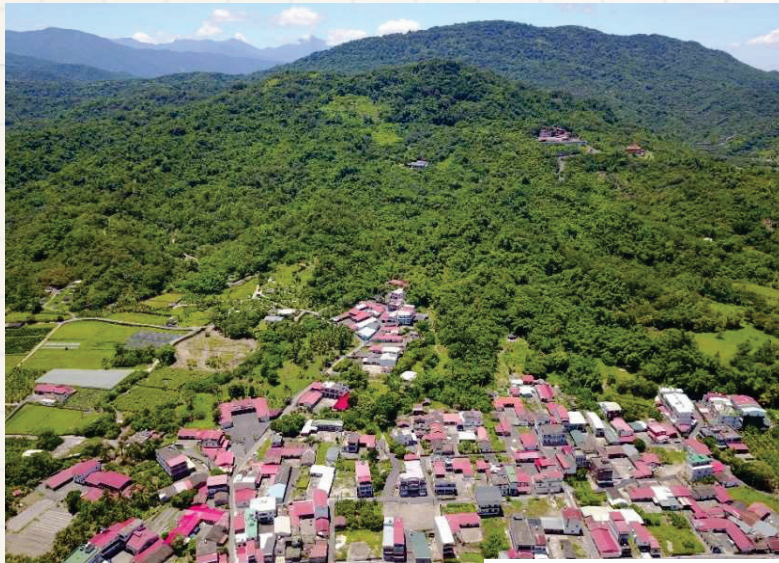
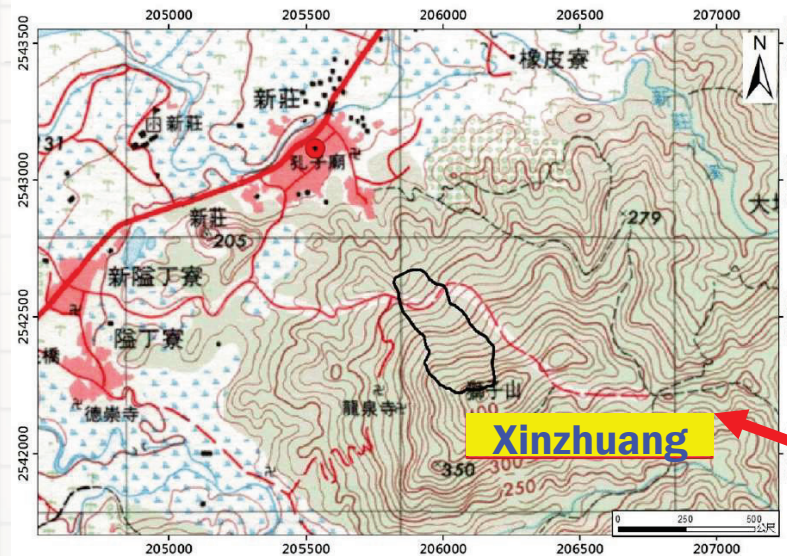
Xinzhuang potential deep-seated landslide area has been identified by Taiwan authority where is located in Kaohsiung City, southern Taiwan, it covers a 10.3 hectares' area and 20 buildings with an average slope of 22.8 degrees. The elevation is from 200m to 430m.
