Restoring urban river habitats. Lessons learned for monitoring, appraisal and management from the River Wandle, South London, UK.

Giuditta Trinci¹, Geraldene Wharton¹, Nicola Bartoletti²

1: School of Geography, Queen Mary University of London, UK 2: School of Environment and Civil Engineering, University of Florence, Italy

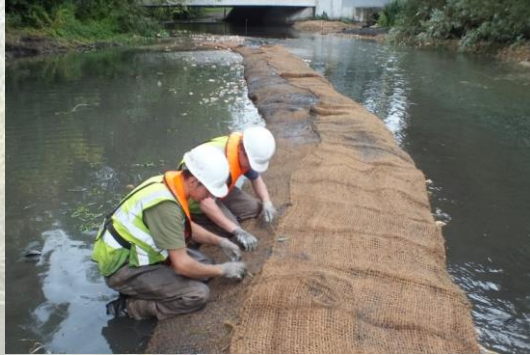
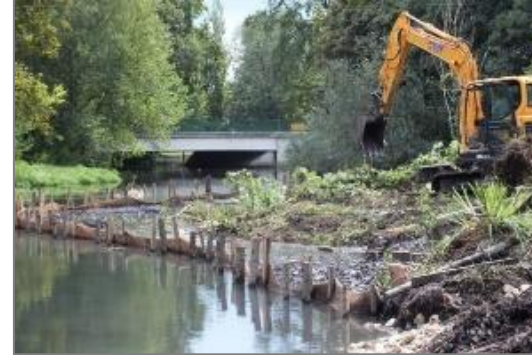
Removal/ modification of concrete structures (weirs, fish pass)

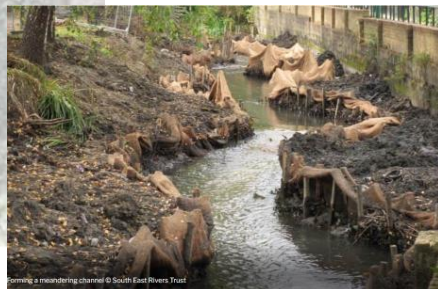
Geomorphological improvements (large woods, channel narrowing)
