LIVING ON LANDSLIDES IN GANGTOK

JOHN DEHLS, GEOLOGICAL
SURVEY OF NORWAY

RAJINDER BHASIN,
NORWEGIAN GEOTECHNICAL
INSTITUTE

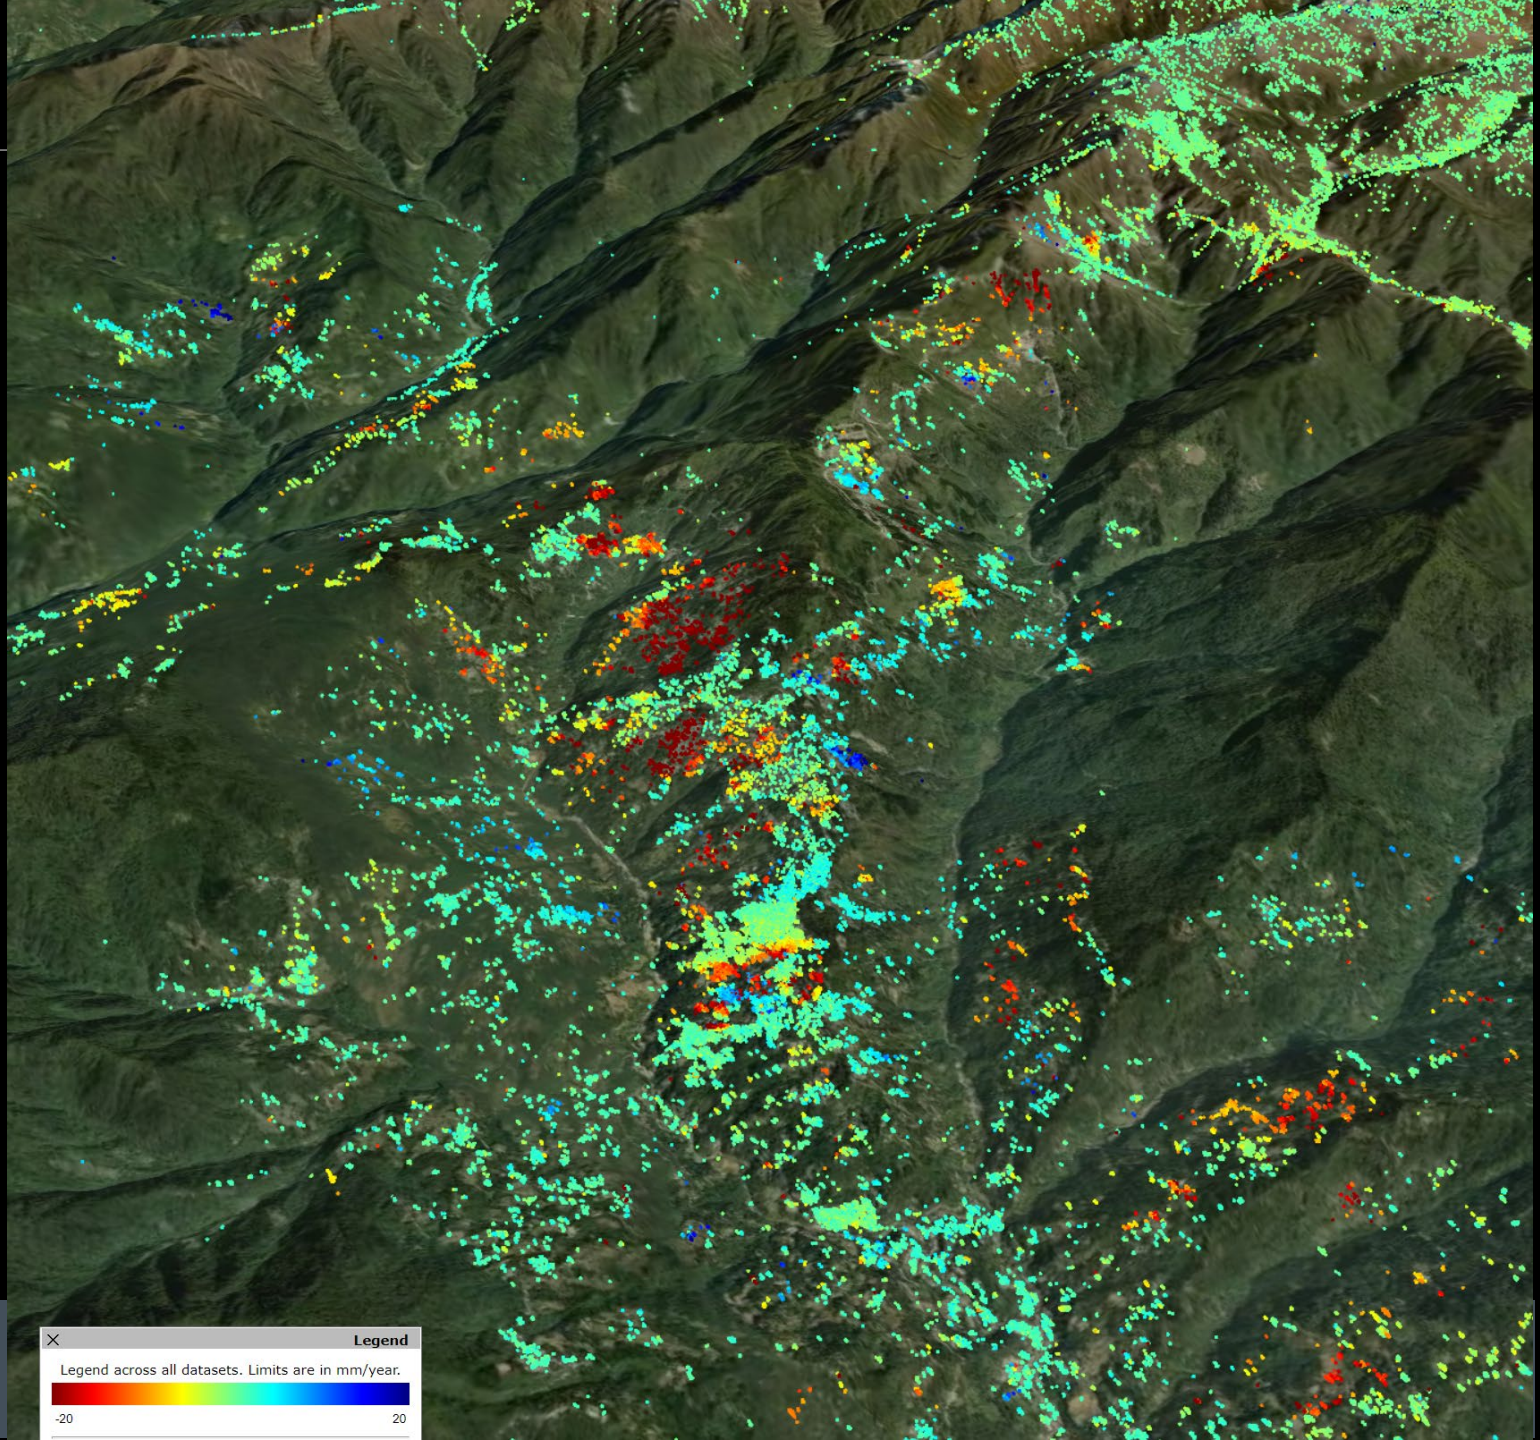
Urban landslide

- Numerous areas of the city moving up to 10's of cm/year.
- Even if the risk of catastrophic landslide in some of these areas is minimal, the ongoing ground movement causes great accumulated destruction of property.
- InSAR can be used to measure the ground movement and monitor it to see if mitigation efforts are successful.

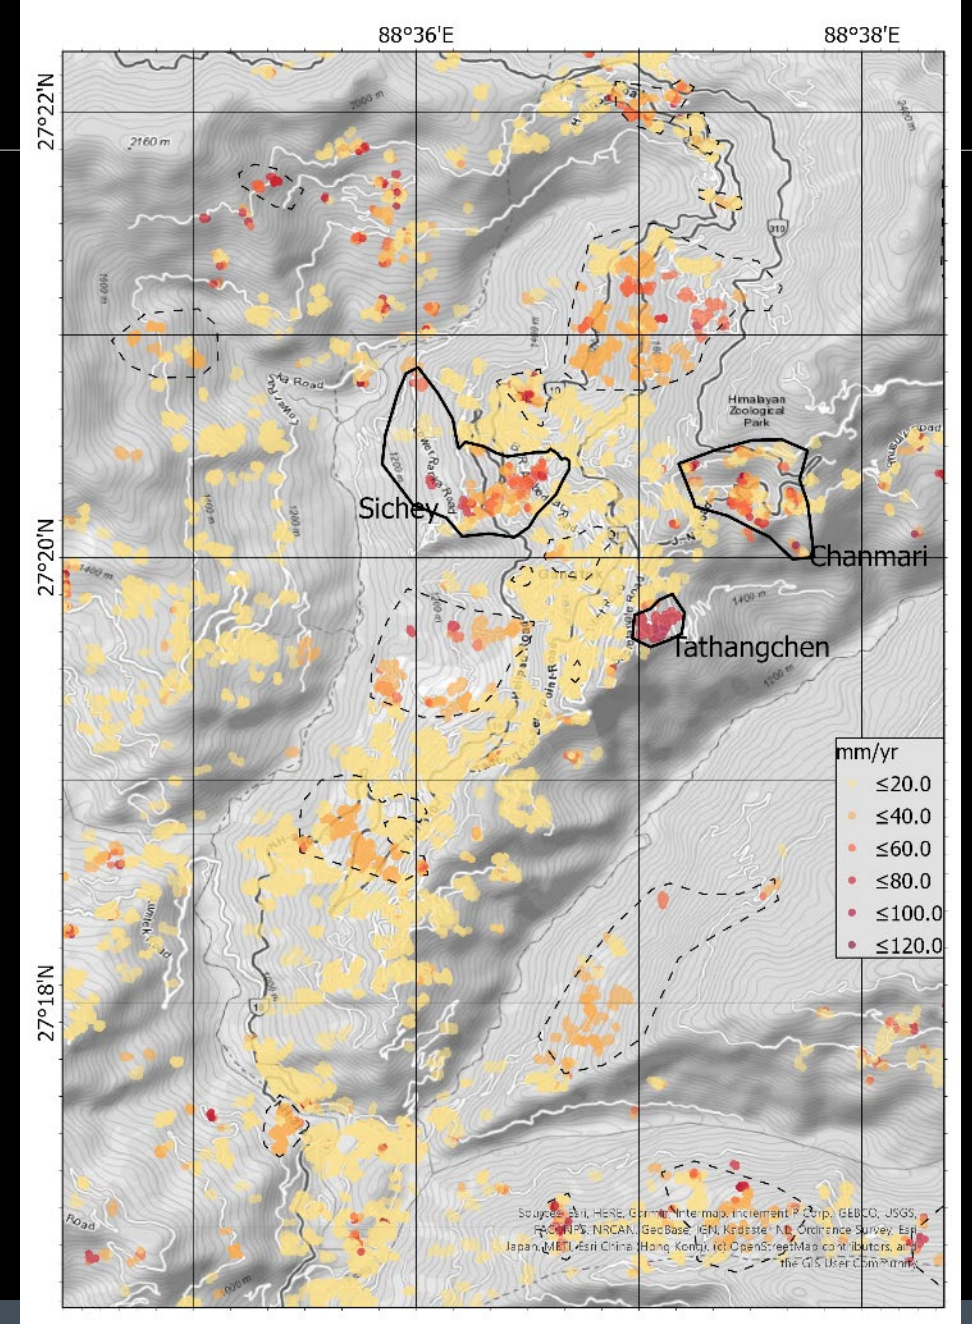
Chanmari

- There have been at least nine landslides, including one in 1997 that resulted in eight fatalities and damaged several buildings and vehicles.

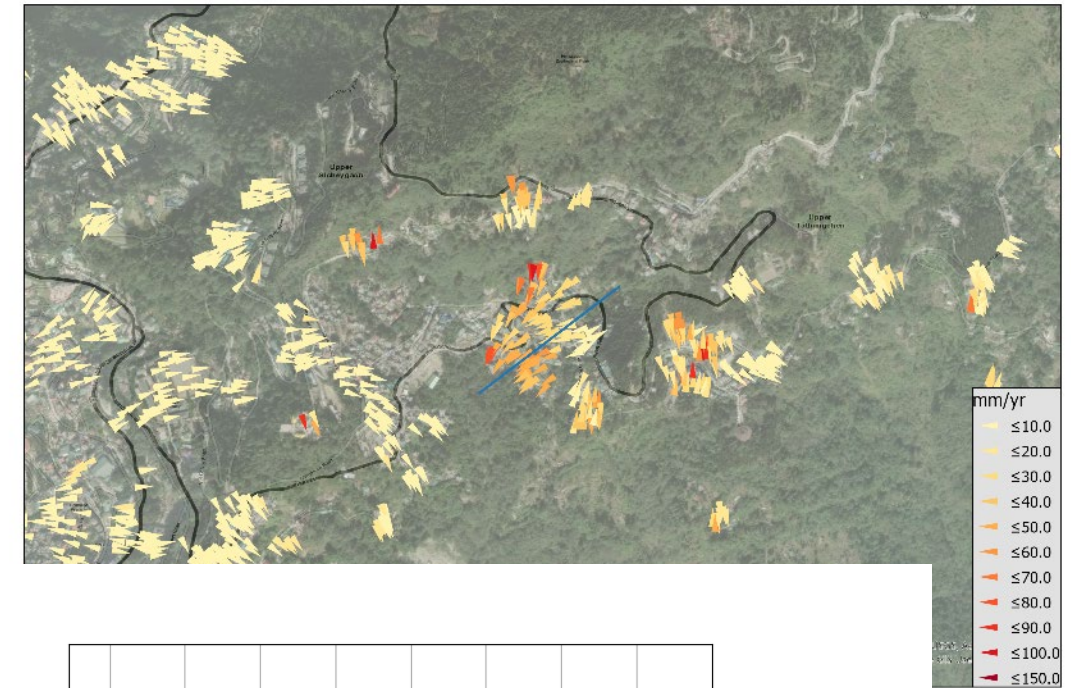
Upper and Lower Sichey

- Another location with a history of landslides.
- One woman killed in 2021.
- Here we can clearly see a pattern of movement consistent with the damage we see in the field.

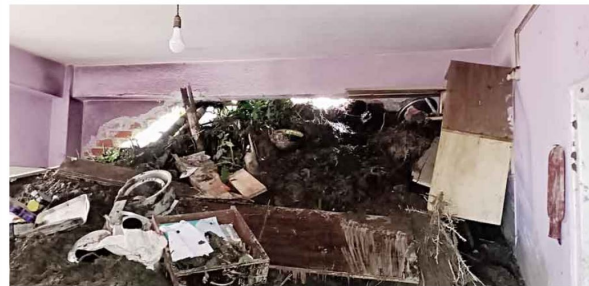
A building hit by a landslide at Sichey in Gangtok on Wednesday
Telegraph picture

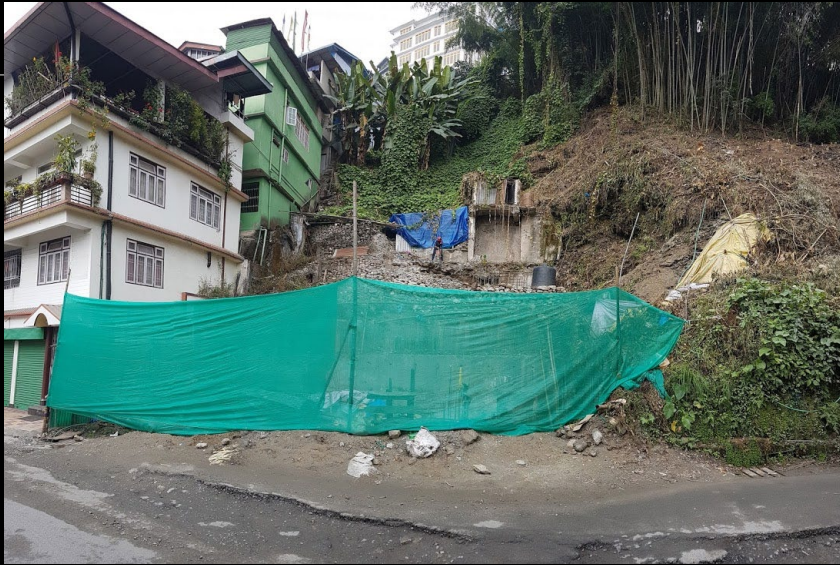
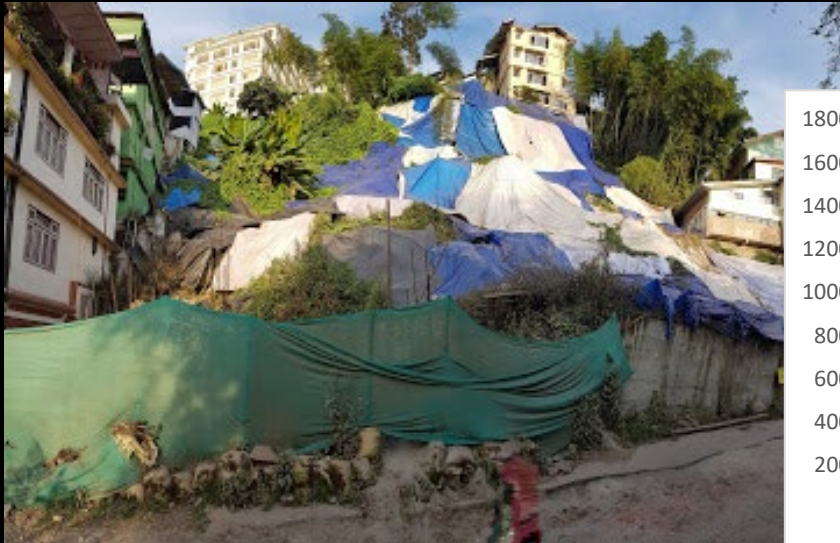
- During 2017, we found the beginning of a construction project, replacing a house destroyed by movement.
- In 2019, the site had been condemned by the city.
- Although catastrophic landslides occur, much of the movement is continuous over many years.

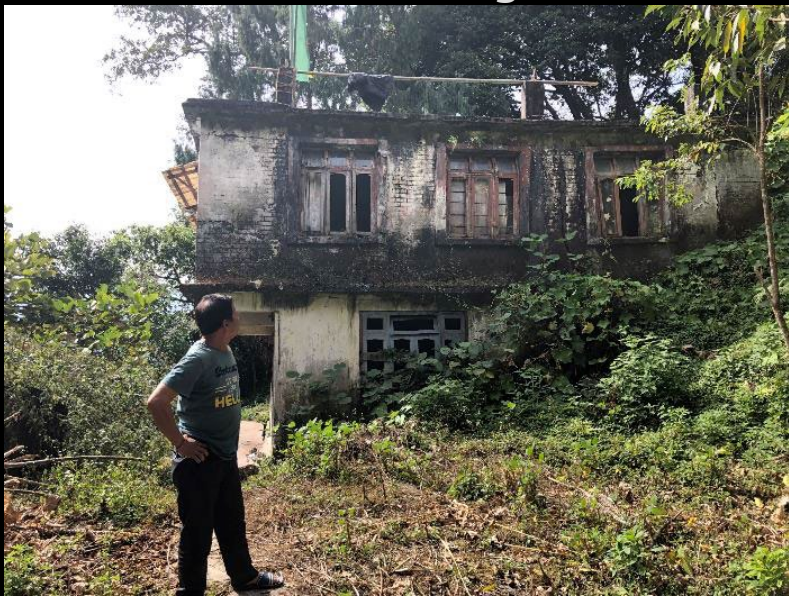
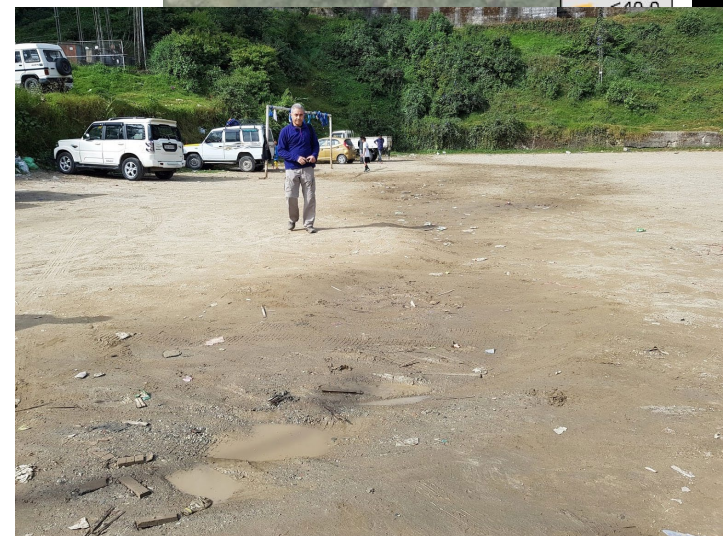
- Perhaps the most dramatic movement we see is in the Tathangchen area.
- Throughout the city we see many examples of fresh and wastewater continuously entering the slopes.
- The clear correlation between rainfall and velocity suggests that mitigation measures include better management of water.
