# Study and Comparison of Solid Bricks Used by Merinids and those For Restoration Within the Chellah Historical Site

Siham Belhaj, Omaima Essaad Belhaj

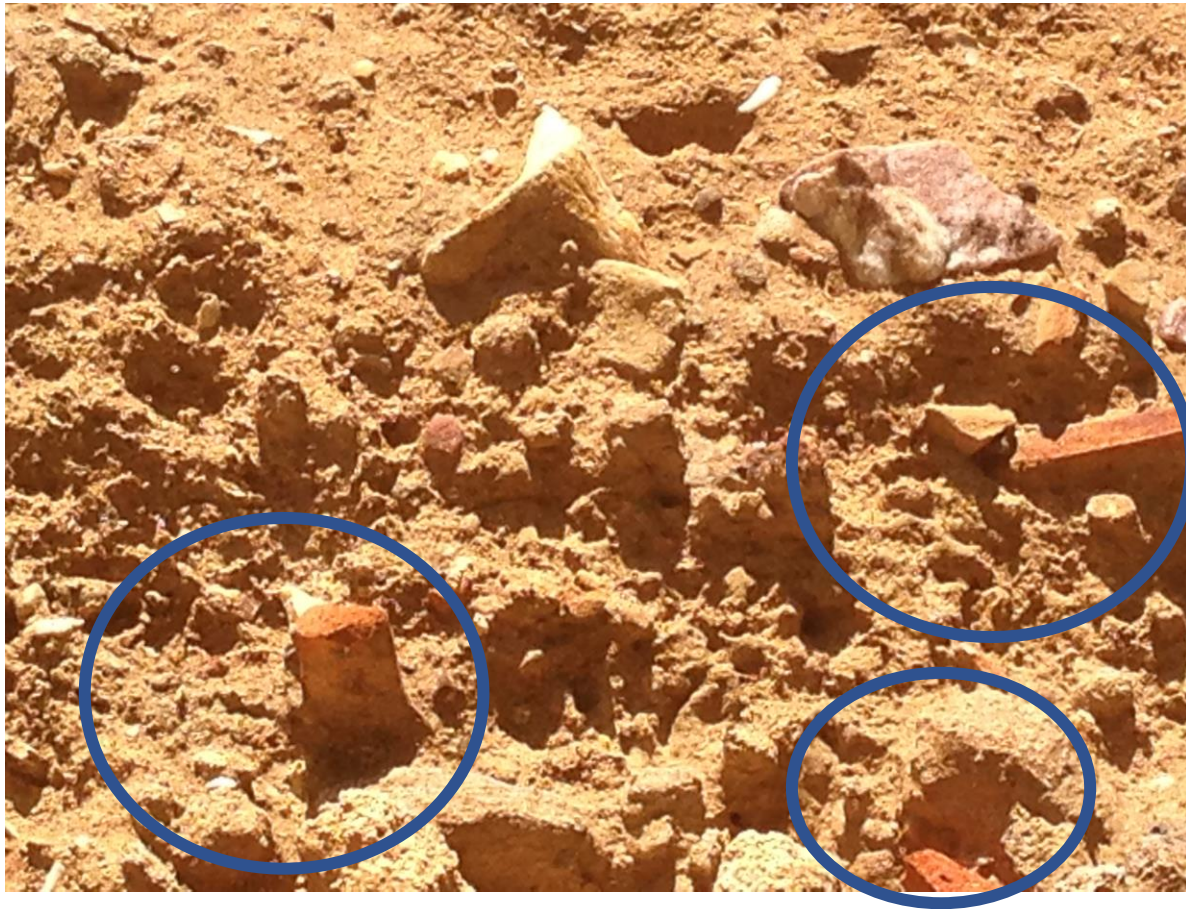
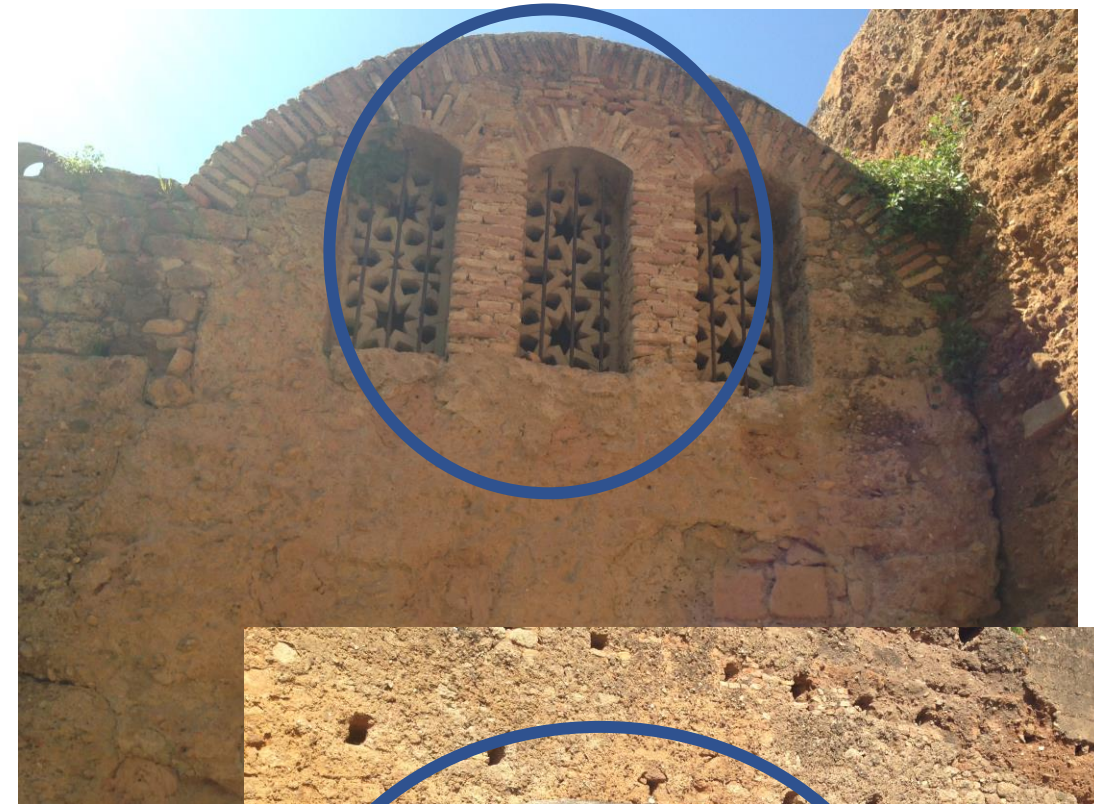
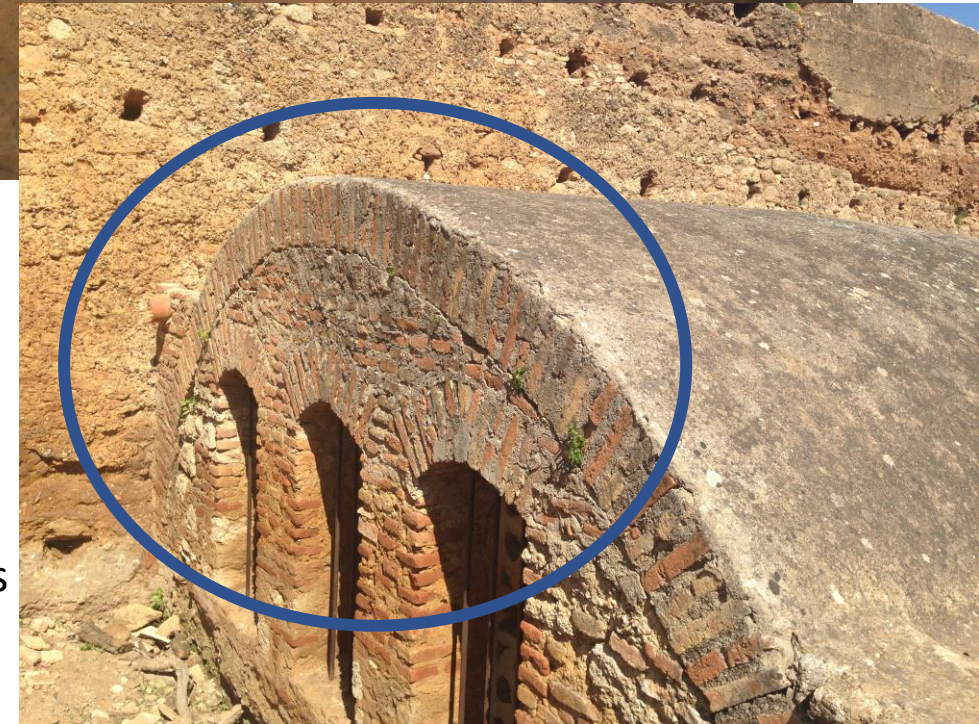
Bricks: solid with regular dimensions:

0.12m wide,

0.26m long ,

0.04m thick ,

joints of 0.03m - change with the equipment-

Bricks are encountered at the level of the merlons of the towers, arches and as well as on localities of the wall which are products of later restorations

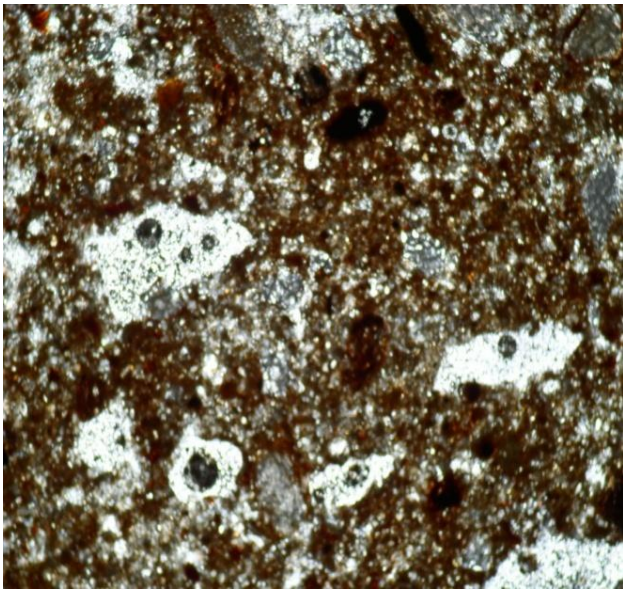
The merinid brick under white and polarized light under 4X objective

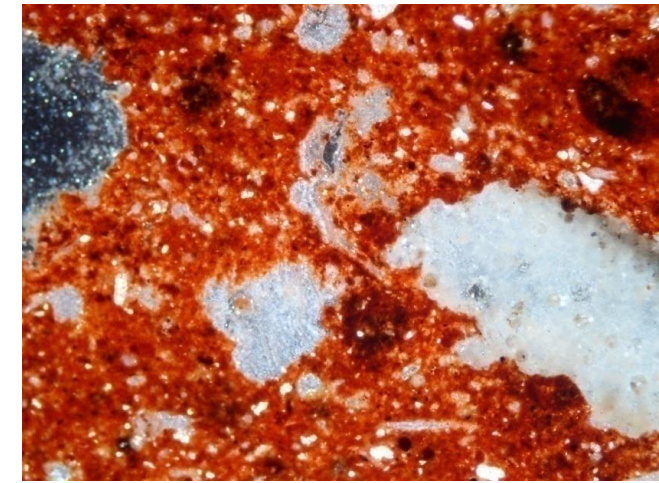
The restoration brick seen under a microscope is a slightly silty clay. It is a Triassic red clay, with sharp grains of quartz 50 to 80  $\mu\text{m}$  in diameter coming from the river, with finer marine deposits of minimal grains. The matrix is clayey

Chellah site restoration brick under polarized and white light, 10x objective.

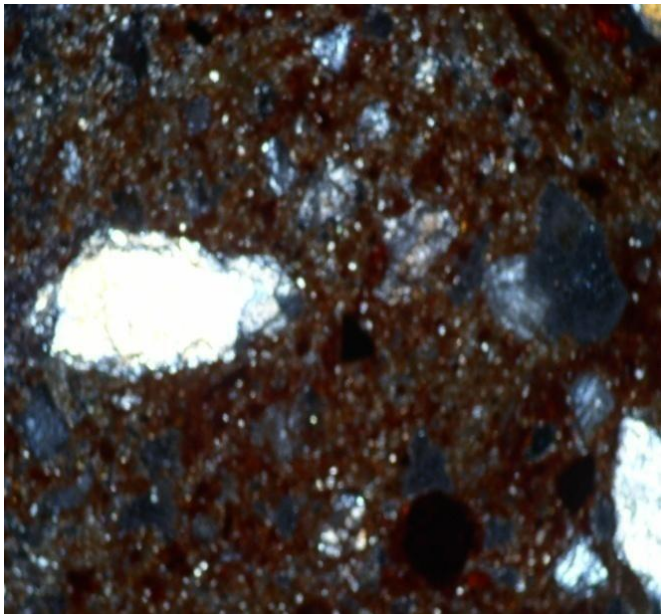
It is weakly carbonated sandstone clay with large grains, sandy with sea or wadi sand, the dispersion of the grains shows a mediocre dosage of elements and therefore a poor quality.

Composed of 10 to 15% quartz 50 to 100  $\mu\text{m}$  in diameter, sub-rounded in shape, 5% of the contiguous quartz is 0.5 to 1 mm in diameter.

The matrix is essentially clayey with the presence of calcite slots.

The original construction brick consists of coarse quartz grains with 10 to 15% dosage therein, while the restoration bricks are of good quality with minimal quartz grains of accepted diameters.

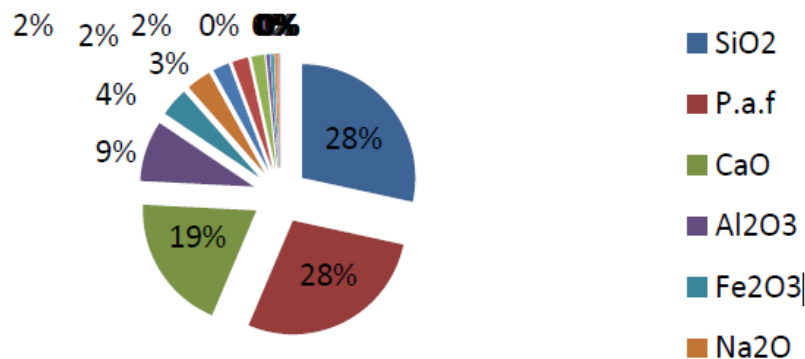
## Merinid brick X-ray fluorescence result

The composition of the merinide brick is more siliceous than carbonated with percentages of 28% for silica and 19% of calcium oxide and 28% loss of fire the percentages of the other oxides are similar to those of the earth found on site. And so the origin of the component materials of these bricks comes from the site of Chellah. The major elements are oxygen, calcium and silica.

Good quality bricks must imperatively have a chemical composition of 50% to 80% silica, 0 to 30%  $\text{Al}_2\text{O}_3$  with almost 30% for the others oxides which is not verified by the building brick of Merinid origin.
