# Mortar damage to heritage

# Heritage in the Crossfire project

# Mortar damage study

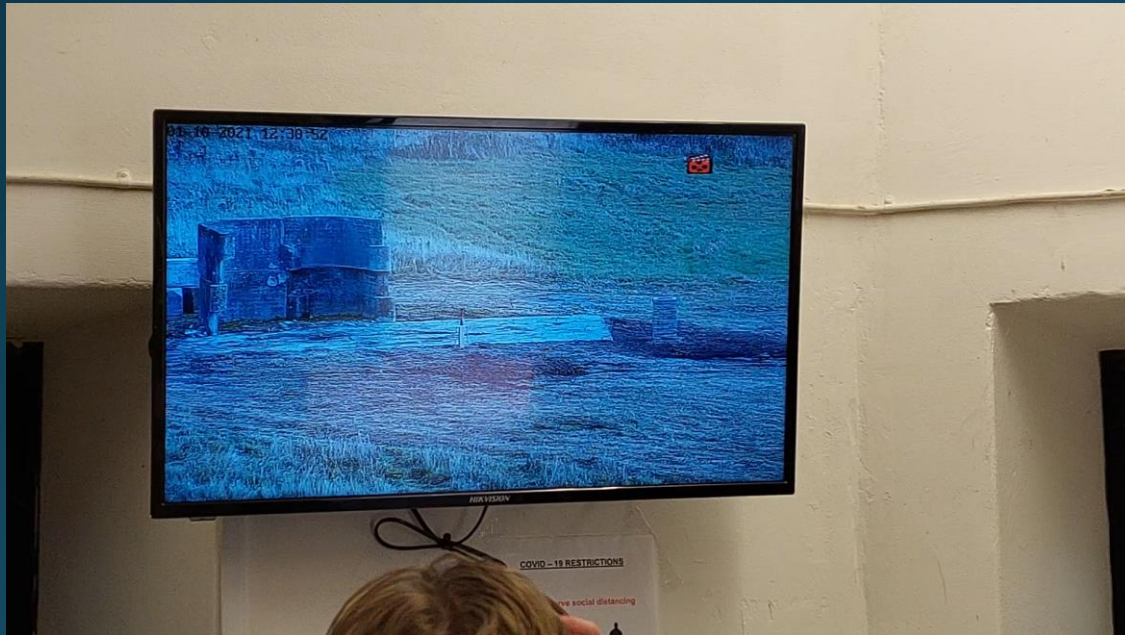
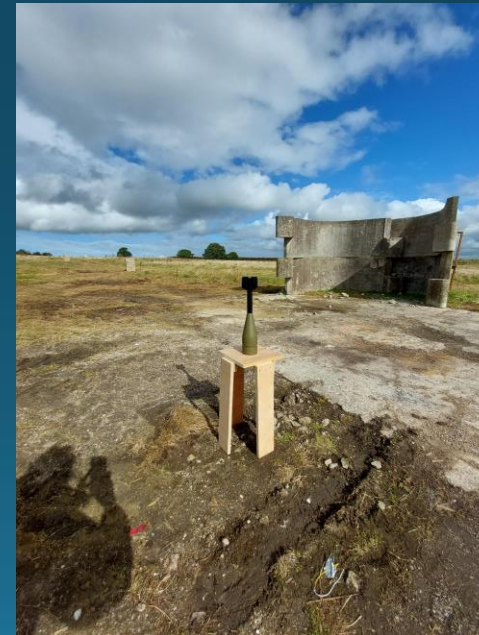
- Explosives arena trials at COTEC
- 3 Pennant Sandstone structures, chimney shaped
- Situated at 5m, 20m and 50m from the blast centre
- Mortar bomb 81mm HE L41A1 fused L127A3
- Effective kill radius 35m – expected damage zone

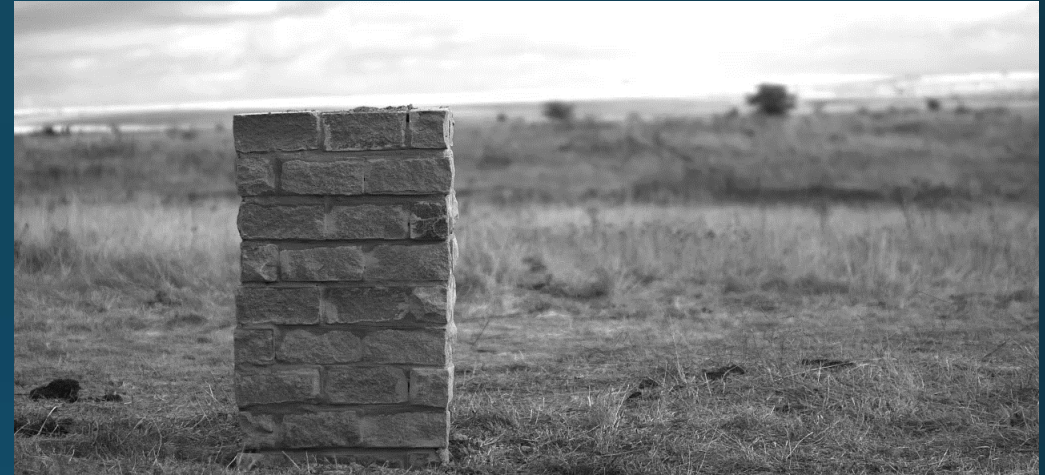
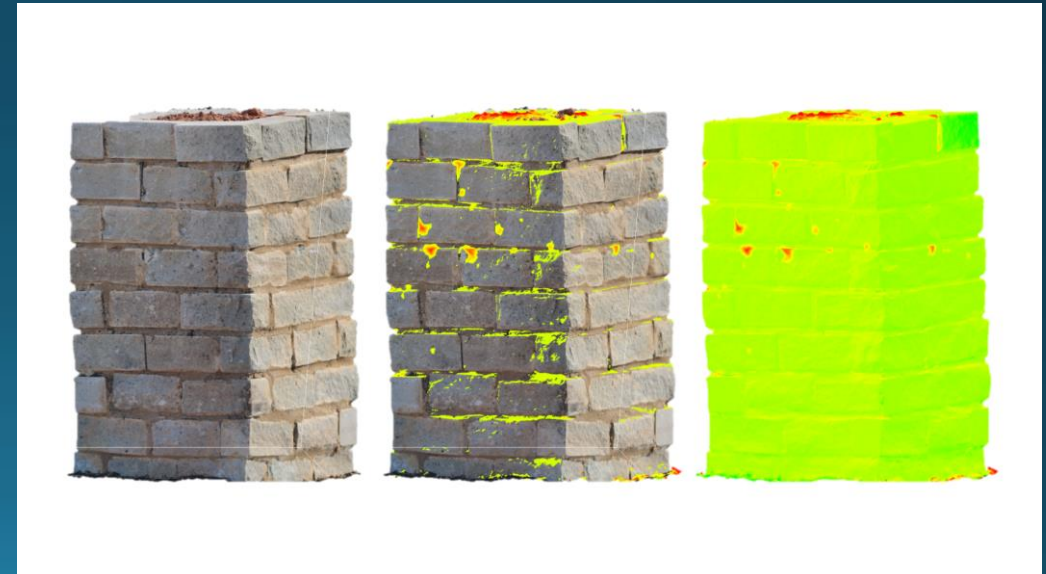
- Relatively few changes detected visually after the detonation
- Photogrammetry confirmed relatively few shrapnel impacts
  - Shrapnel impacts estimated to be at 219-284m/s
- Dstl blast modelling confirmed high pressure blast hit front face, then deforms and progresses

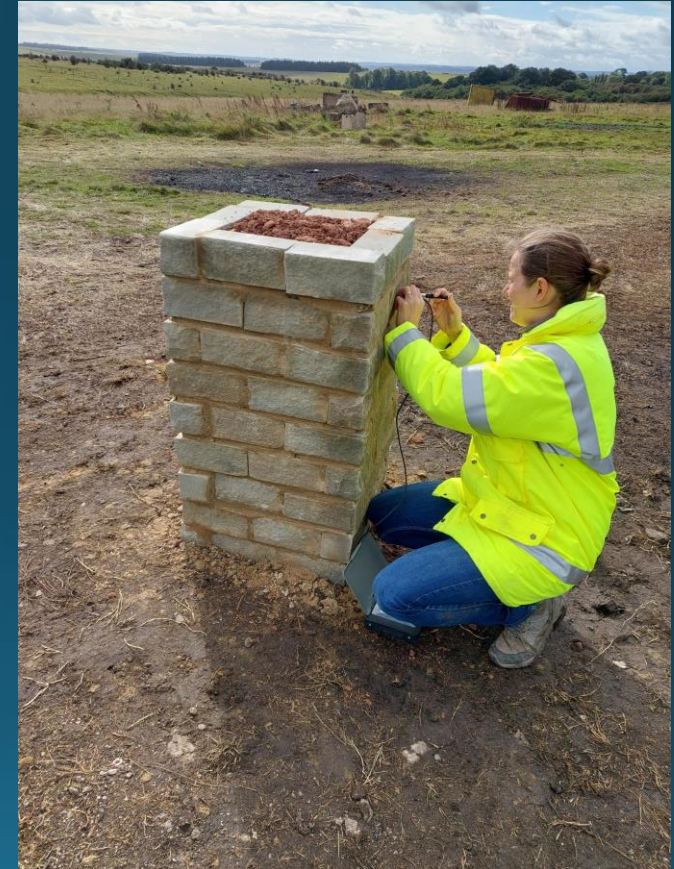
- 2160 equotip measurements on wall 1 (4 faces x 27 bricks per face x 10 measurements per brick x before/after damage)
- **Delta** values calculated as post blast equotip values – pre blast values on a 'per brick' basis
- Hypothesis:
  - Bricks initially characterized by **high** values of hardness will experience -ve delta i.e. become less hard

Our hypothesis would predict negative slopes i.e. harder regions show brittle failure behaviour and become less hard after blast, softer regions show plastic failure behaviour, becoming compacted (harder) after a blast)

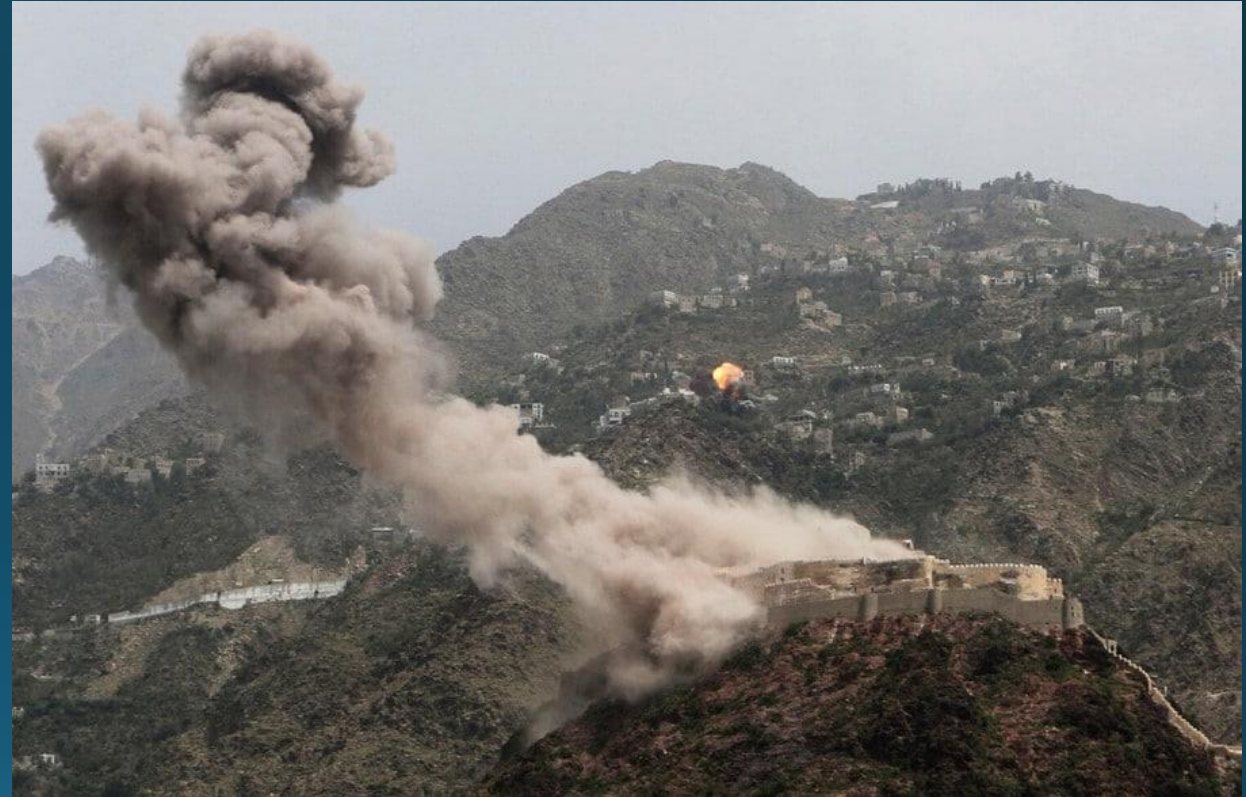
Al-Qahira Castle, Taiz, Yemen 5 June 2015  
Source: Washington Post
