Localized coastal subsidence in Miami Beach and Surfside, Florida

Shimon Wdowinski¹ and Simone Fiaschi²

Local land subsidence in Miami Beach

Questions following the Surfside building collapse

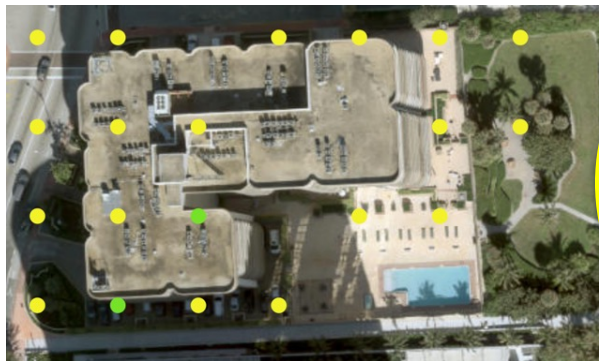
1 mm/yr interval

No noticeable differential component

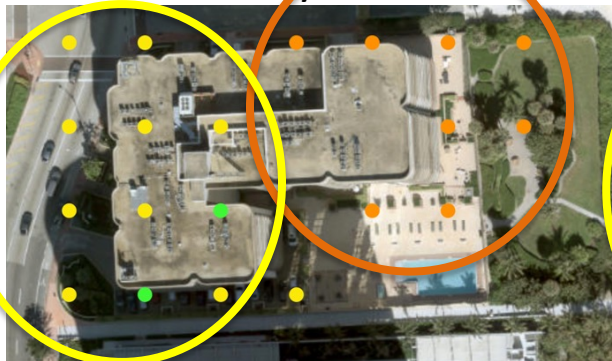
0.5 mm/yr interval

Noticeable differential component of 0.5 mm/yr

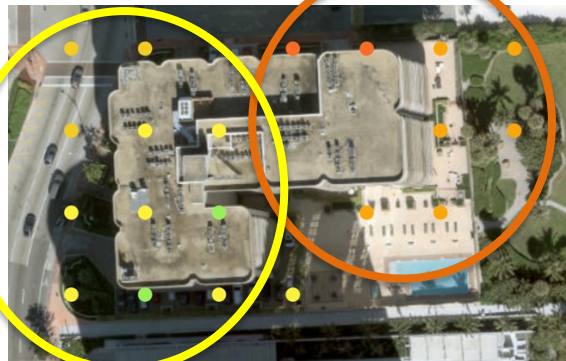
0.25 mm/yr interval

Noticeable differential component of 0.5 mm/yr

Differential subsidence: 0.5 mm/yr

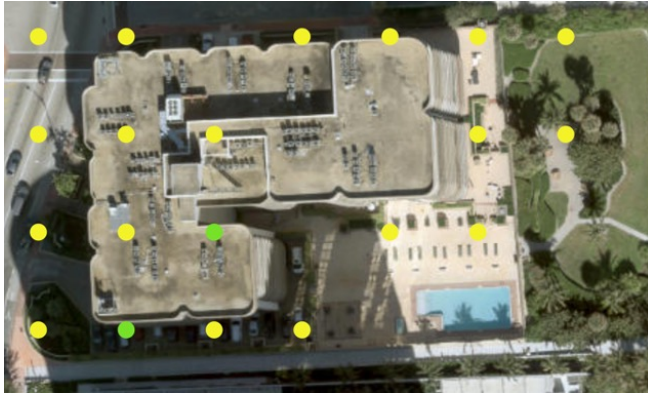
ERS-1/2 (1993-1999)

Questions 2: Did the building continue subsiding after 1999?

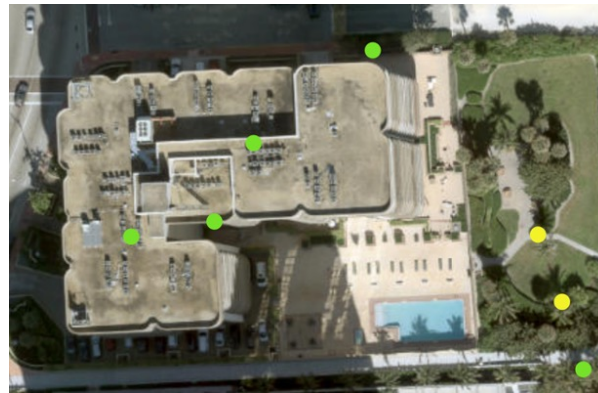
Sentinel-1 (2016-2021)

Answer: No noticeable movement in the Sentinel-1 dataset.

| 2) Did the building continue subsiding after 1999? | Not during

2016-2021 |

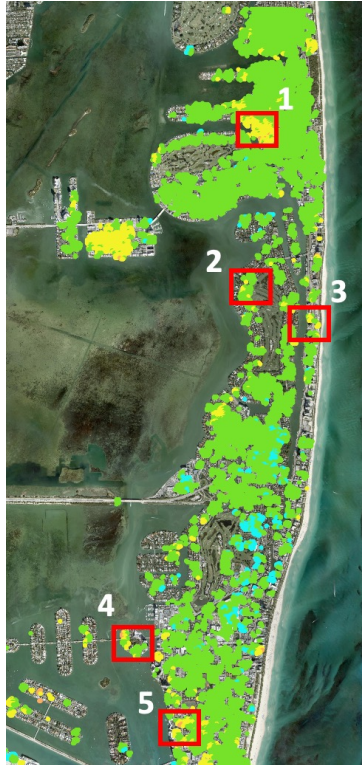
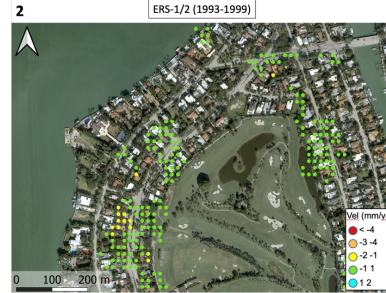
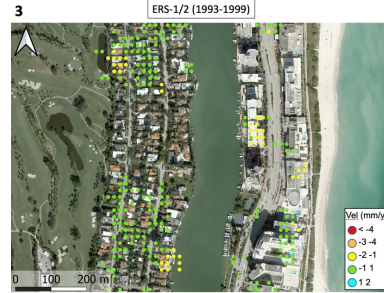
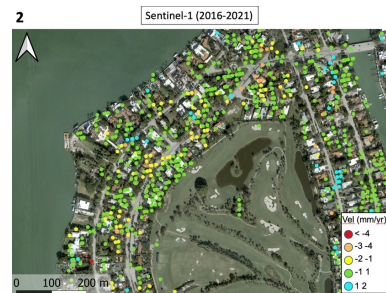
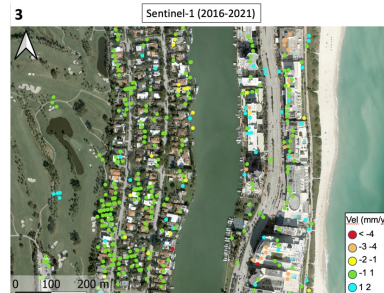
Questions 3: Did other subsiding areas in Miami Beach continue subsiding after 1999?

No

Yes

| 3) Did other subsiding areas in Miami Beach continue subsiding after 1999? | Mostly not |

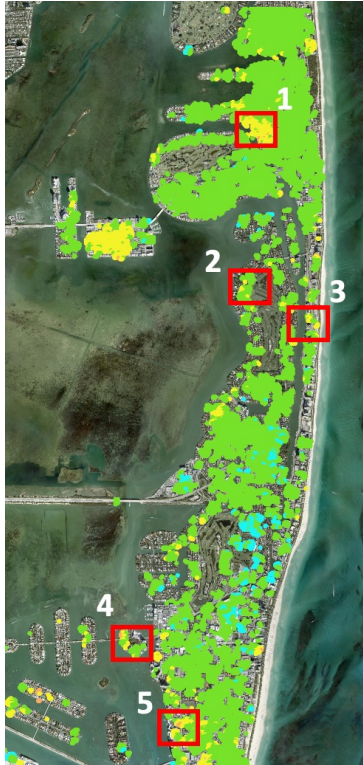
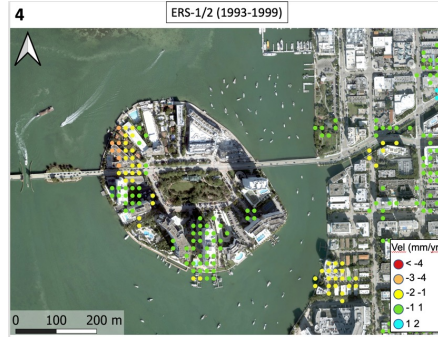
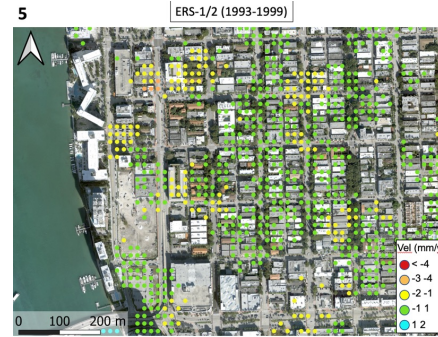
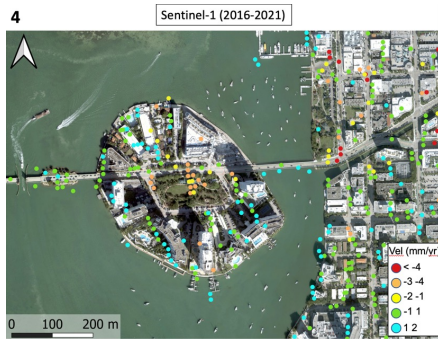
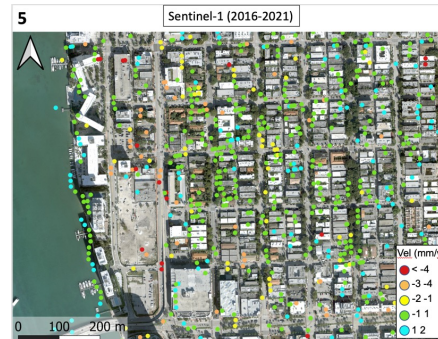
Questions 3: Did other subsiding areas in Miami Beach continue subsiding after 1999?

No

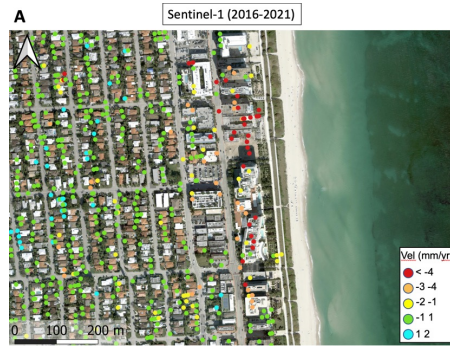
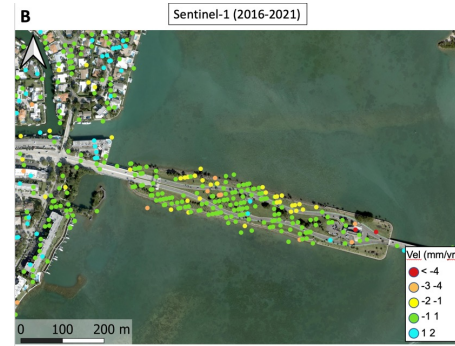
Questions 4: Did other areas in Miami Beach start subsiding after 1999?

- Rapid subsidence in Sentinel-1 (4-5 mm/yr)
 - Primary consolidation
 - Newly constructed buildings.

| 4) Did other areas in Miami Beach start subsiding after 1999? | Yes. Mainly new constructions. |
