SVEUČILIŠTE U SPLITU
FAKULTET GRAĐEVINARSTVA,
ARHITEKTURE I GEODEZIJE

Long term stability of an abandoned construction pit in Eocene flysch rock mass: case study of Bračka street construction site (Split, Croatia)

Goran Vlastelica, Ana Duhović, Marija Relota

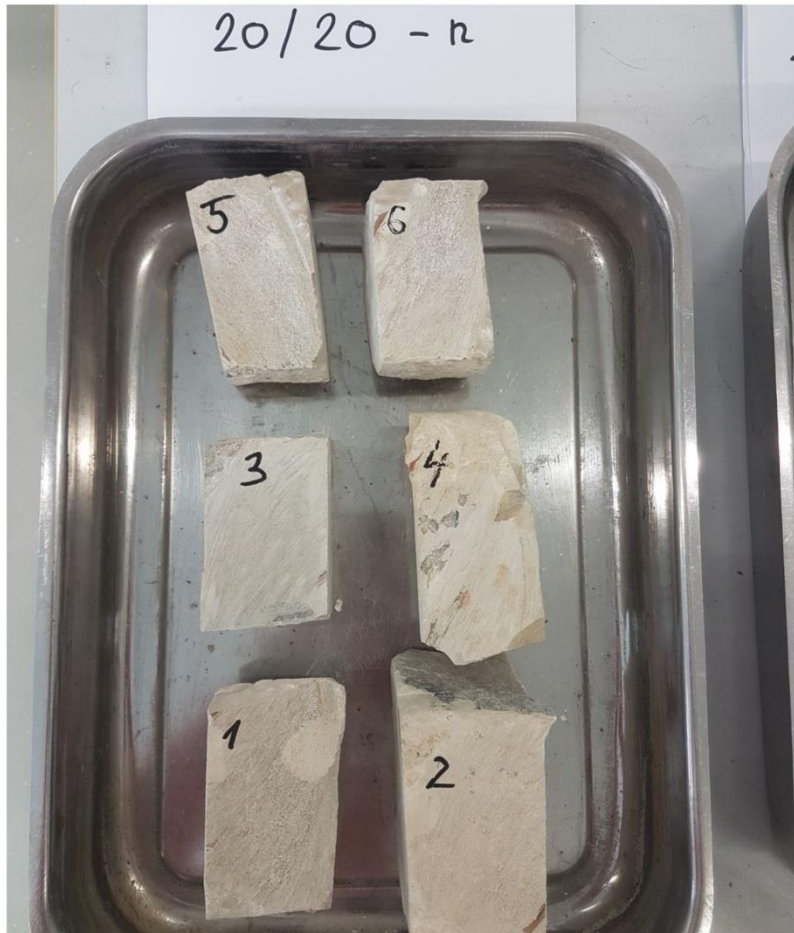
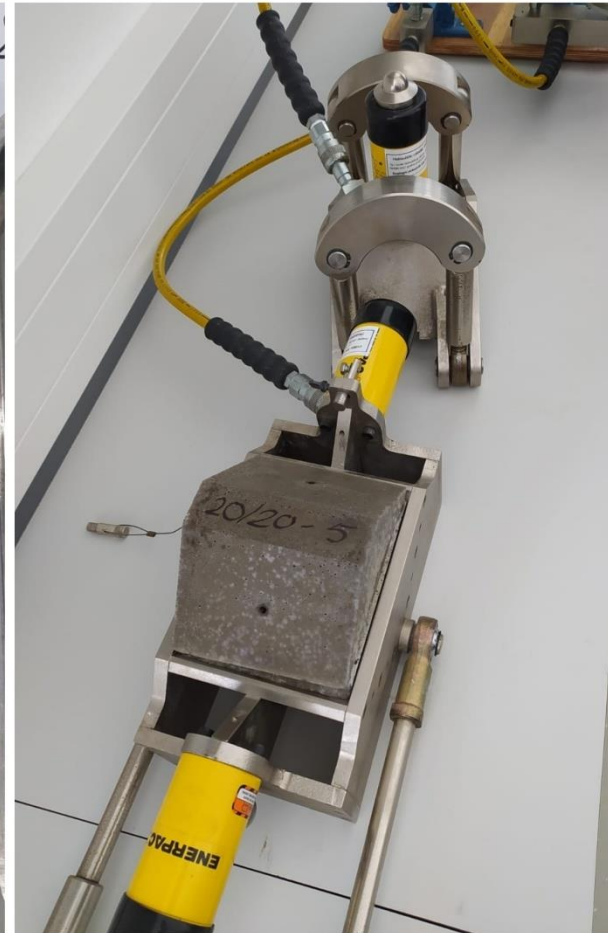
Intact rock – shear strength – portable shear apparatus

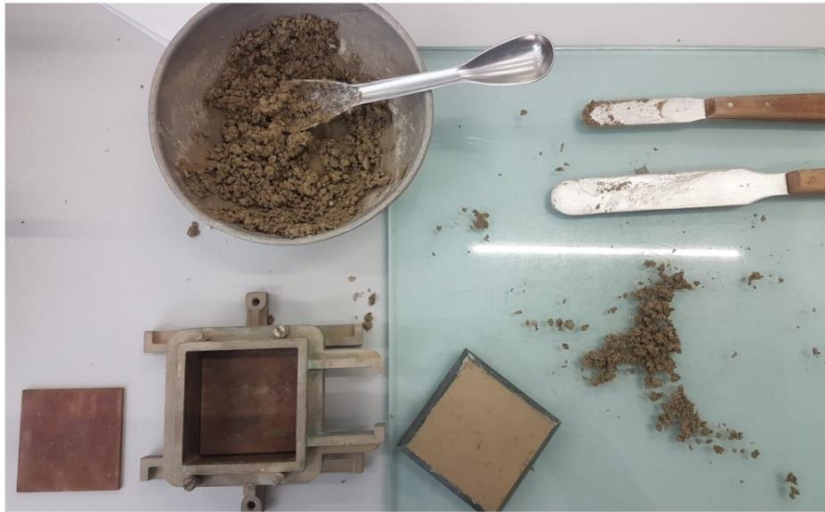
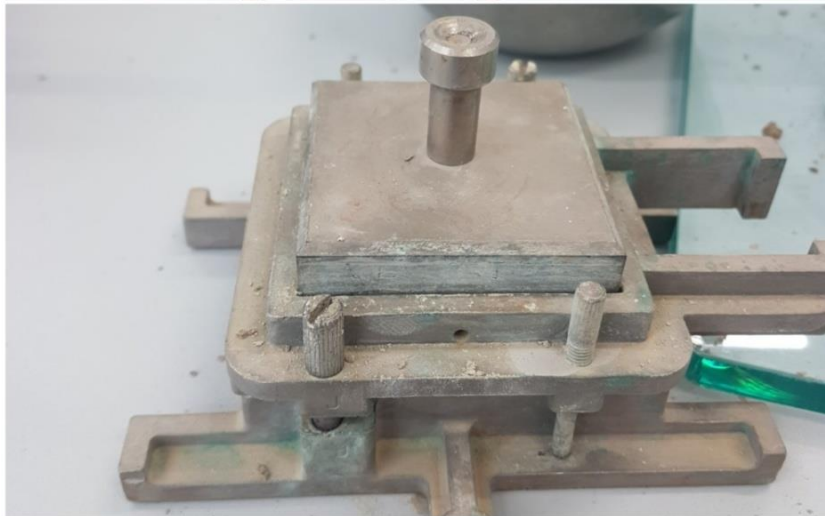
Residual properties – shear strength – direct shear for soil

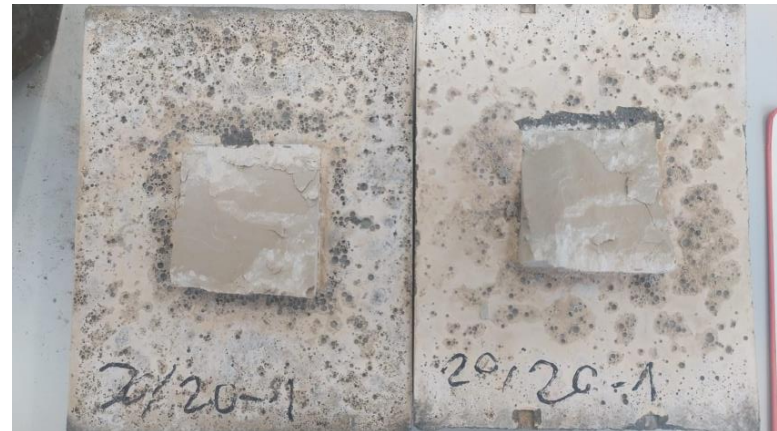
Results for intact material

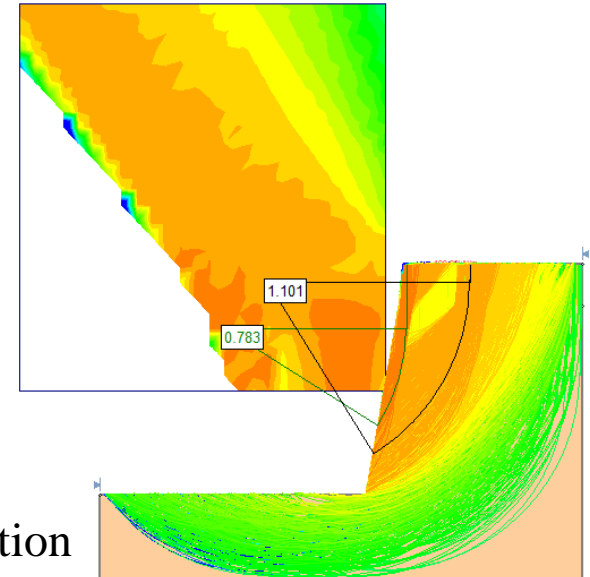
Usual load combination

Vrijeme ΔT	Fs- globalna stabilnost Osnovna komb.	Fs (talus) Osnovna komb.	Fs (kritični dio zasjeka) Osnovna komb.	Fs- globalna stabilnost Potresna komb.	Fs (talus) Potresna komb.	Fs (kritični dio) Potresna komb.
0 god.	1,330	1,427	0,921	1,281	1,491	0,908
0 god.(bez talusa)	1,101	-	0,783	1,078	-	0,734
20 god.	1,485	2,60	0,854	1,385	2,158	0,845
20god.(bez talusa)	1,321	-	0,788	1,278	-	0,781

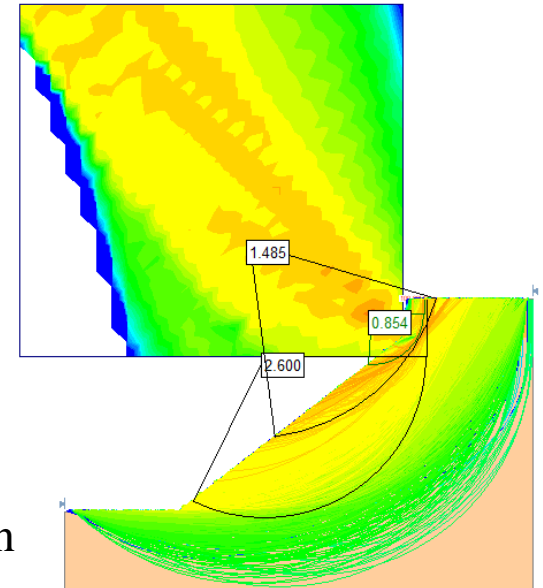
Usual load combination
