Natural hazards evolution in a context of climate evolution and infrastructure development: the Kali Gandaki valley case, West-Central Nepal.

The Middle Kali Gandaki valley and its tributaries: Which factors control geomorphic evolution?

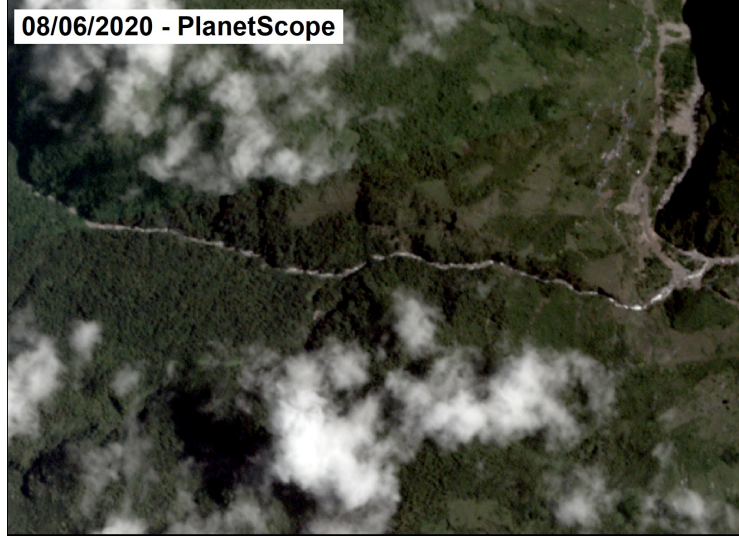
08/06/2020 - PlanetScope

PlanetScope images: apparently no landslide movement since late monsoon 2020 => stability?

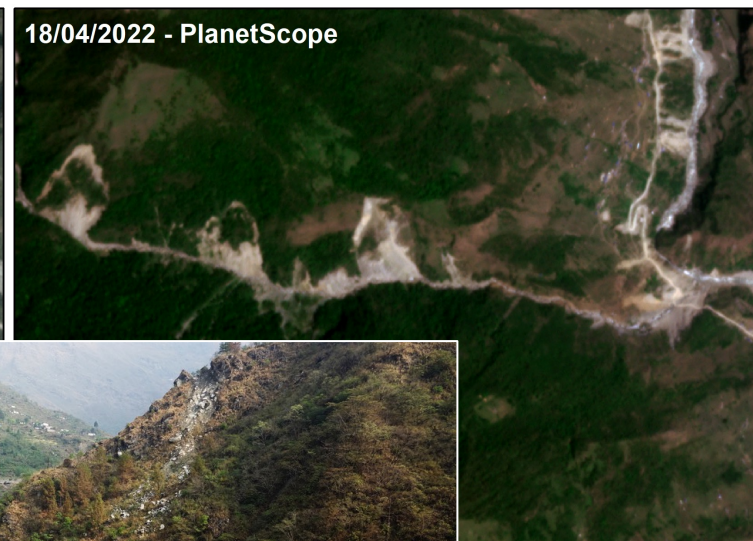
18/04/2022 - PlanetScope

Re-opening and cleaning of the road:
=> continuous lower hillslope instability
=> loose sediment transfer to the KG

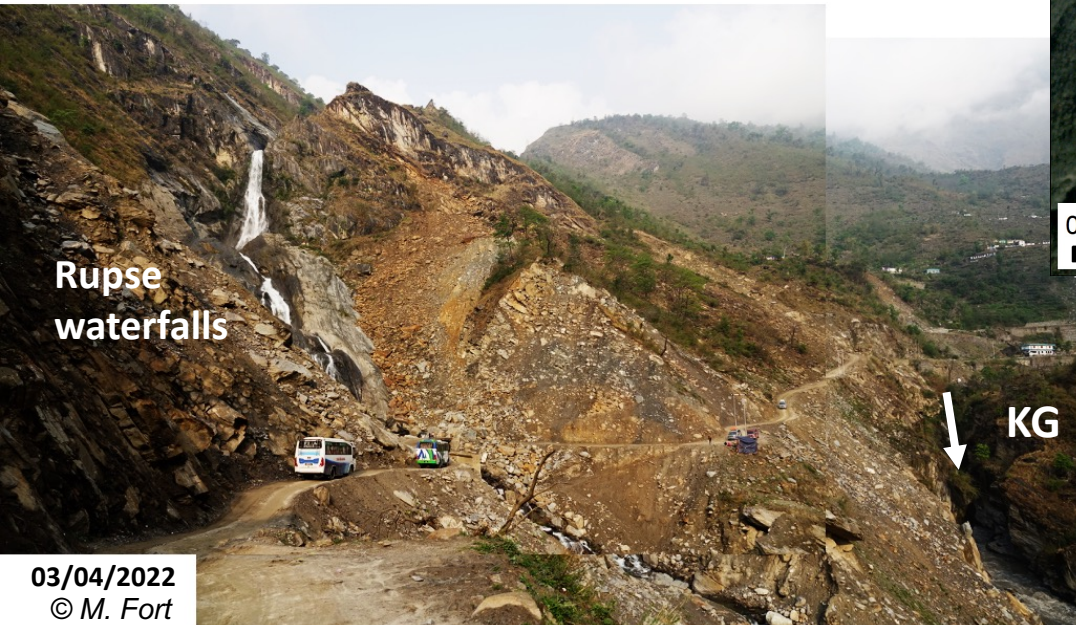
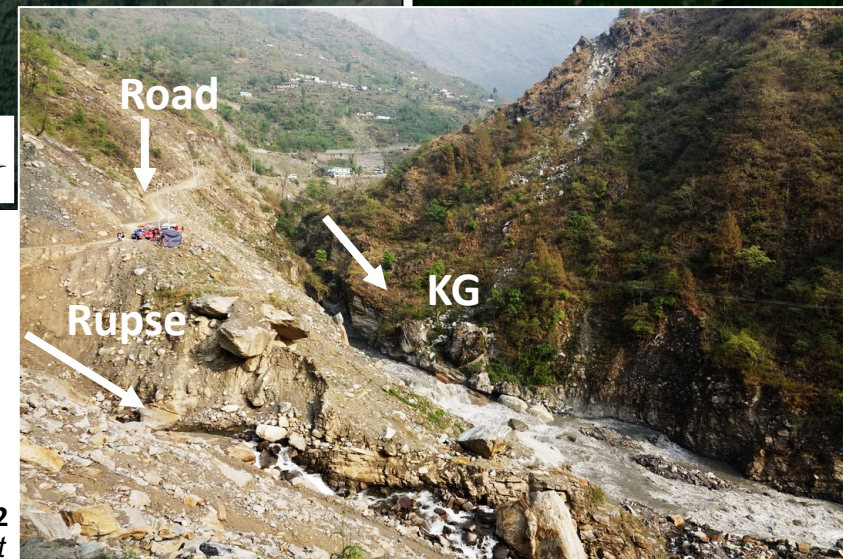
03/04/2022
© M. Fort

Many loose sediments at the junction KG and Rupse khola

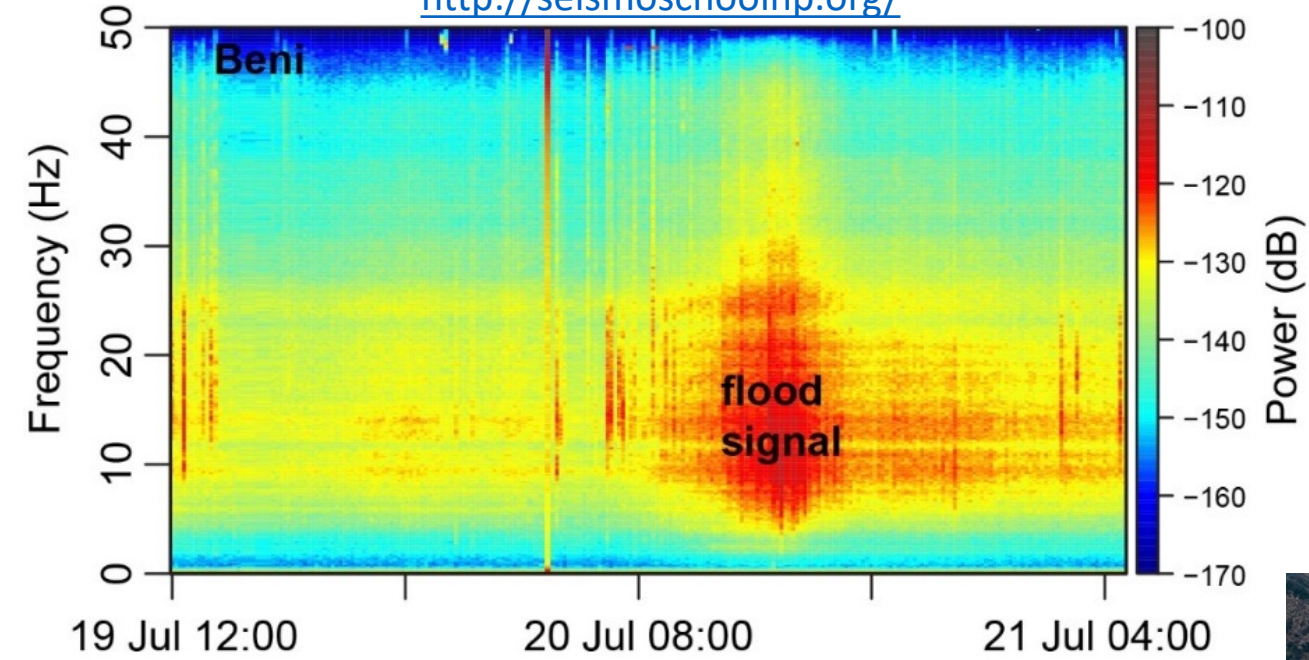
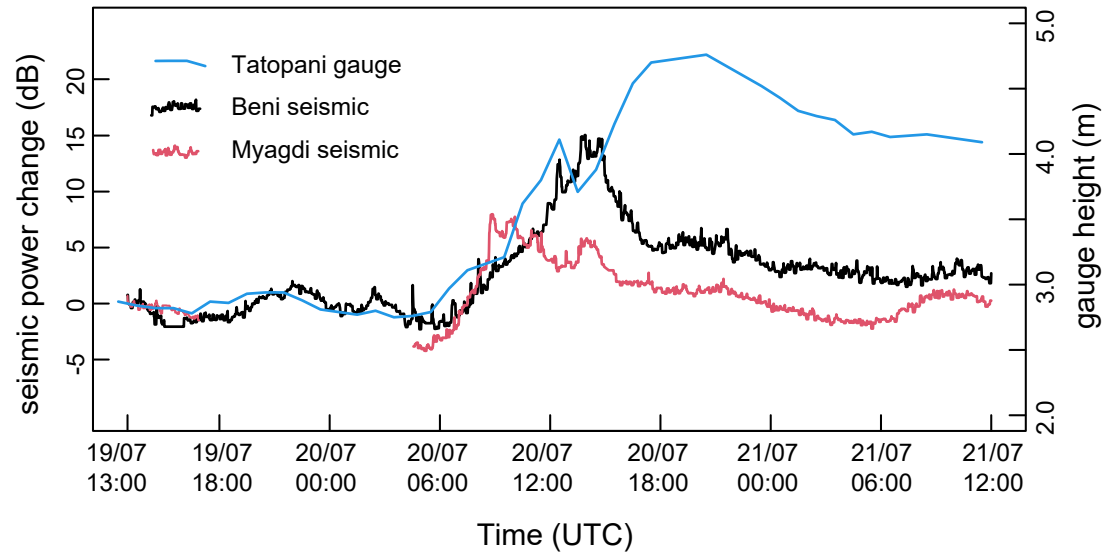
Signal of the flood recorded at Beni seismic station

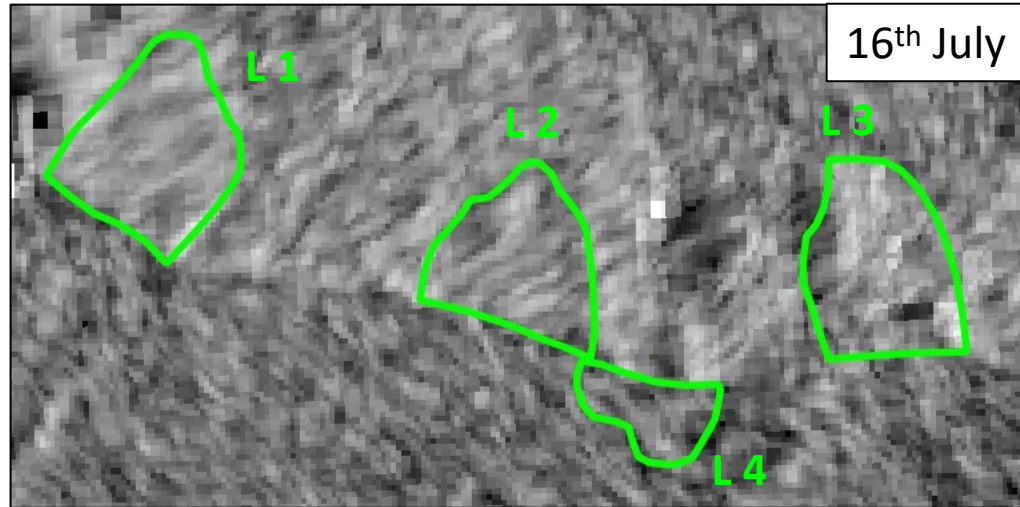
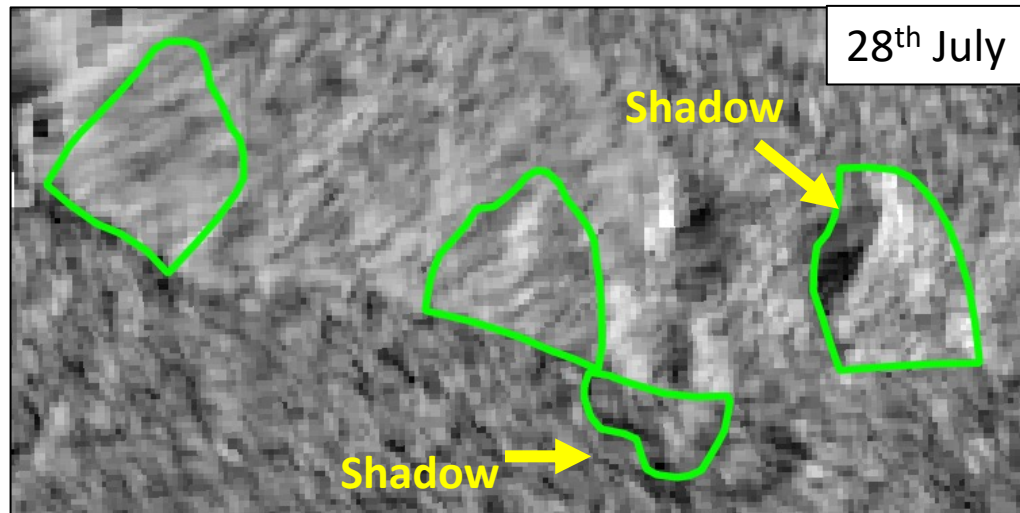
Ascending track SAR

Timing of landslides:

L2: in between 7-31 July 2020

L3 and L4: in between 16-28 July 2020

L1: in between 14-17 Sept 2020

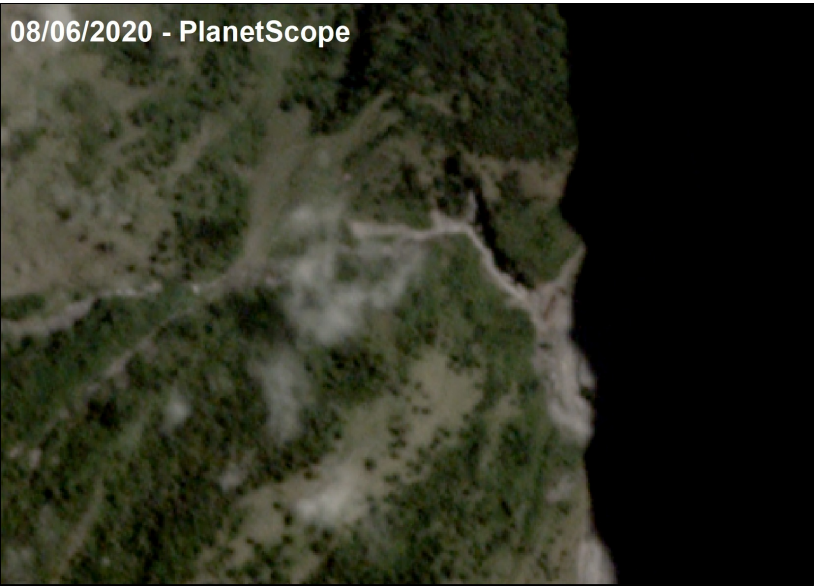
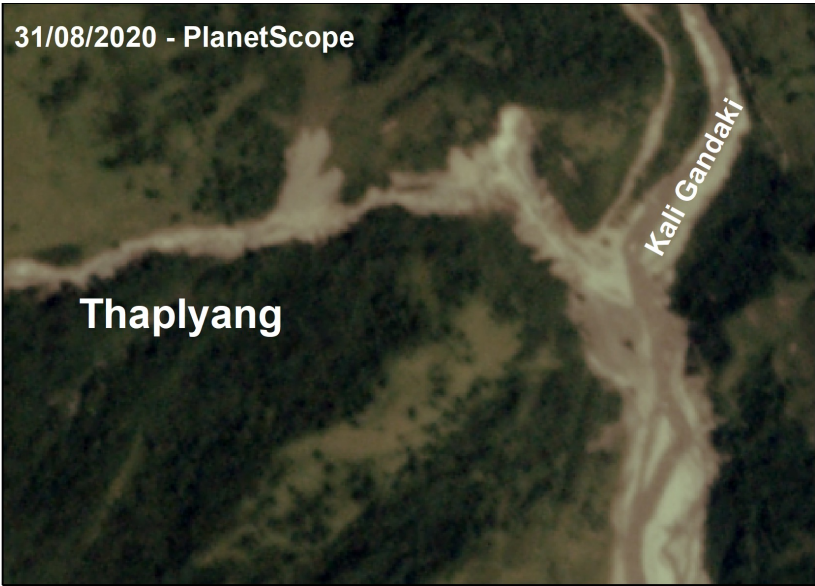
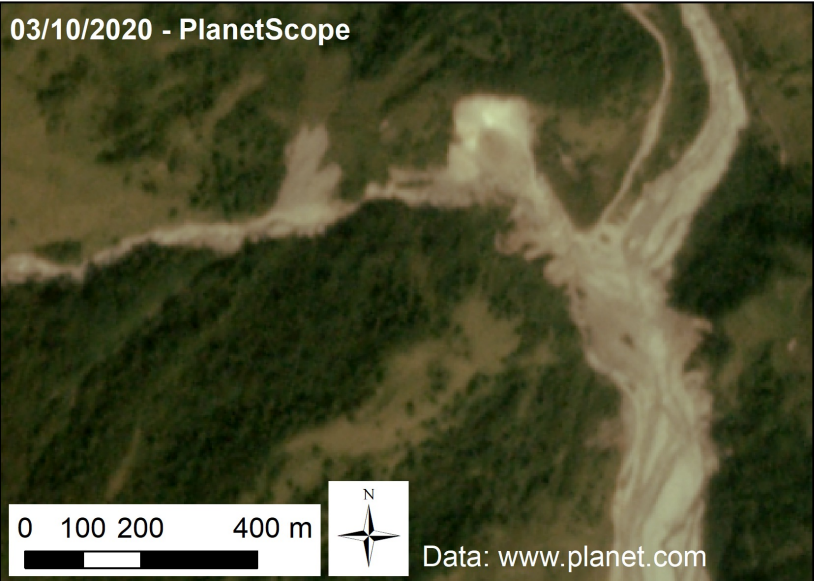
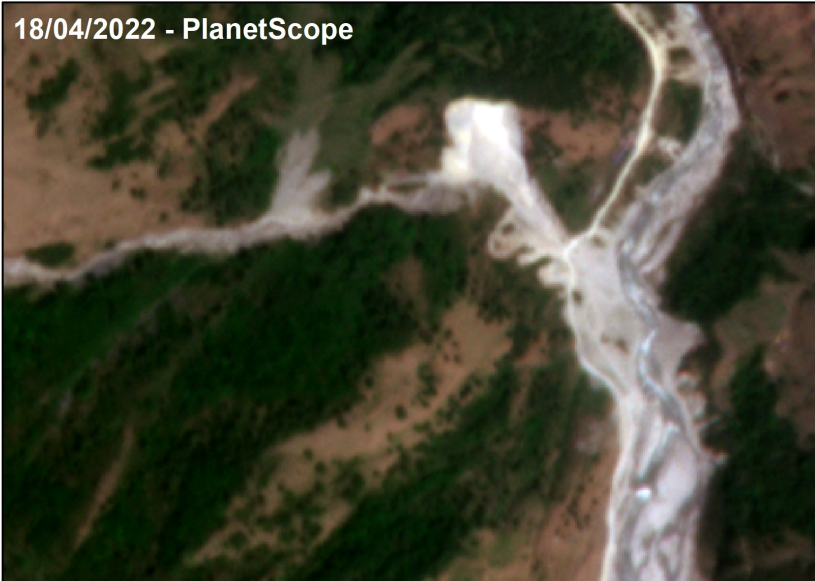
PlanetScope images showing clearly the rapid collapse of the left slope of Thaplyang khola

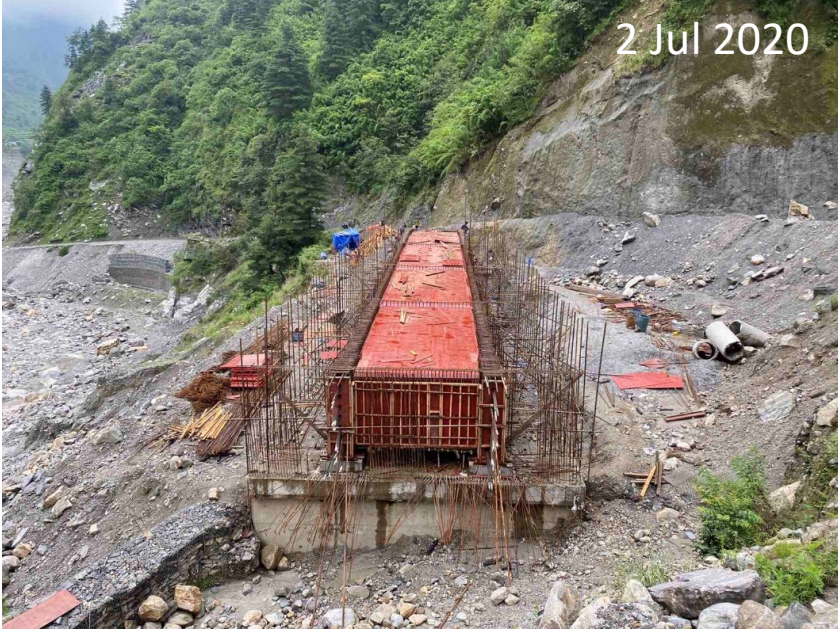
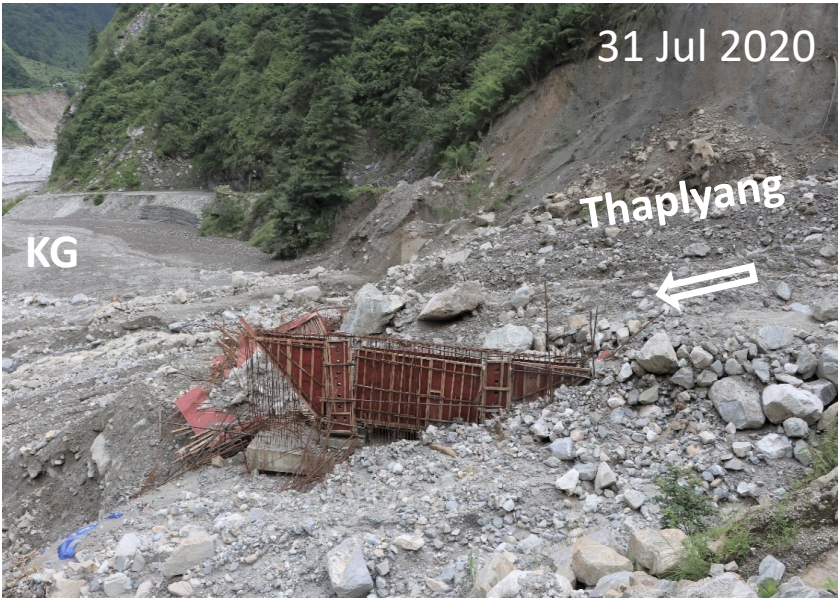
Bridge at the junction Thaplyang/KG

Clearly two events during monsoon, which caused:
-Bridge destruction
-Blocking of the road during several days

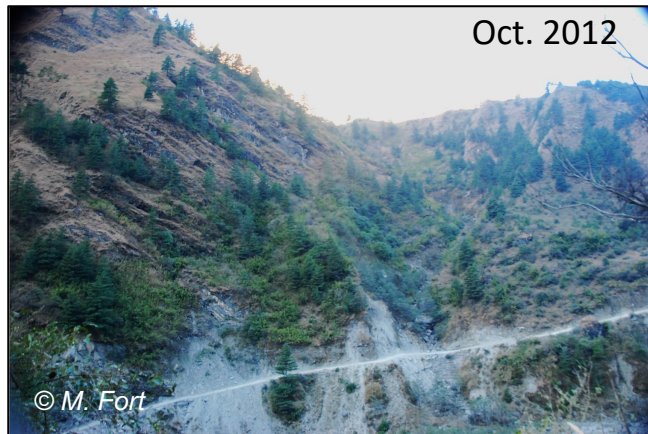
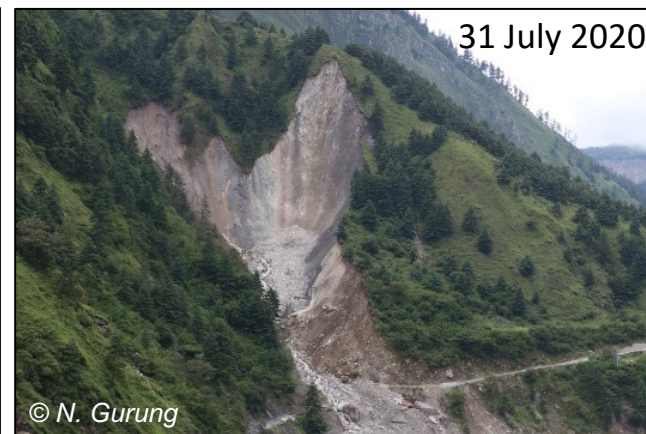
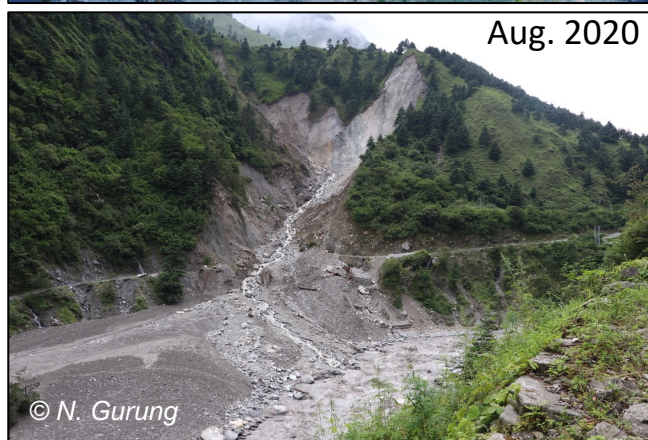
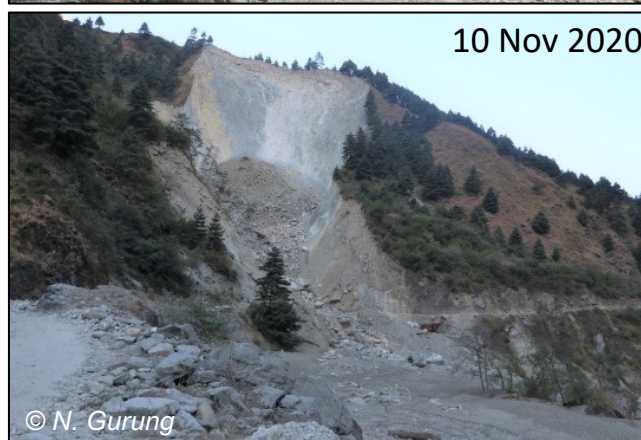
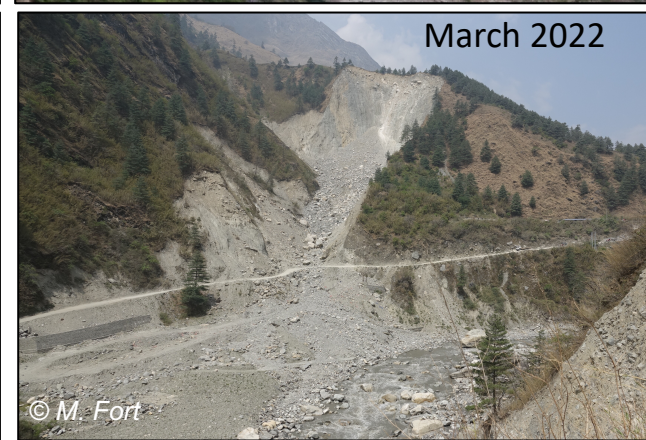
The active area increased from:
9100 m² (March 2018)
to **9600 m²** (Oct. 2018)
then **32300 m²** (Nov 2020)

2020: two more successive collapses in July and Sept/Oct

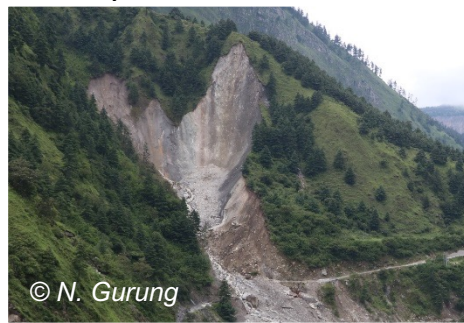
31 July 2020

1st
Failure

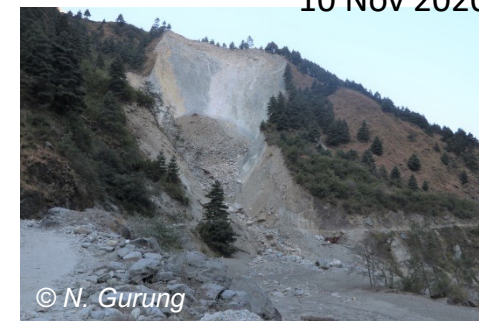
10 Nov 2020

2nd
Failure
