Detecting infiltration pathways by means of multi-method geophysical interpretation: an urban case study

Objectives and setting

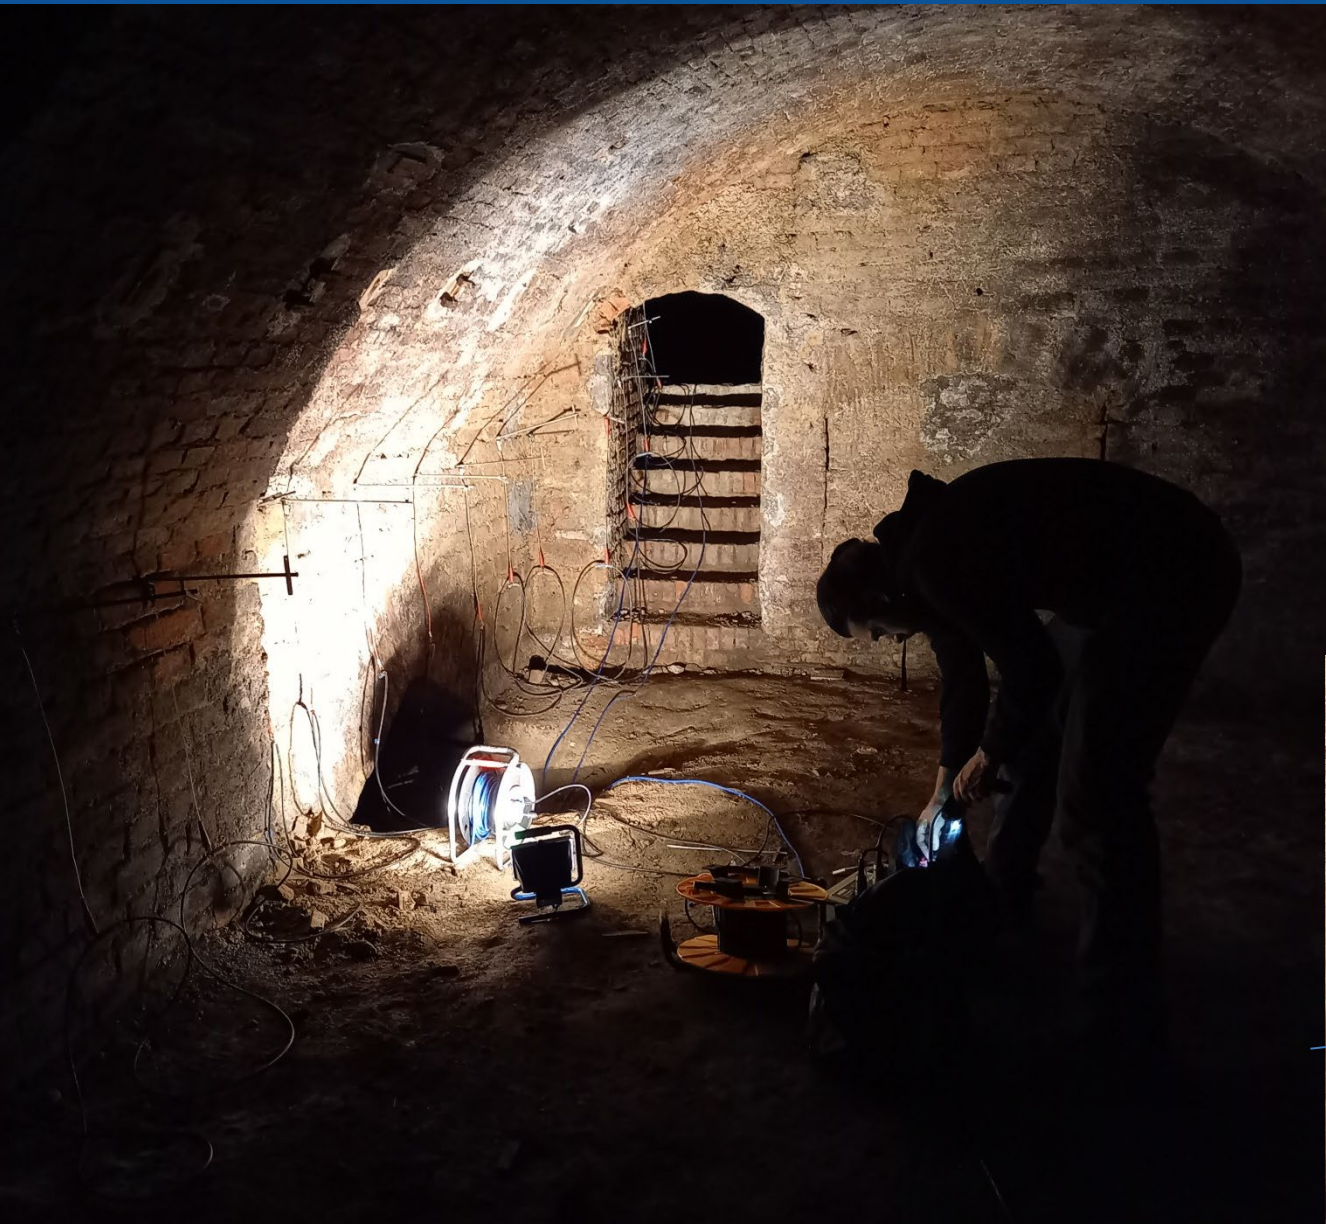
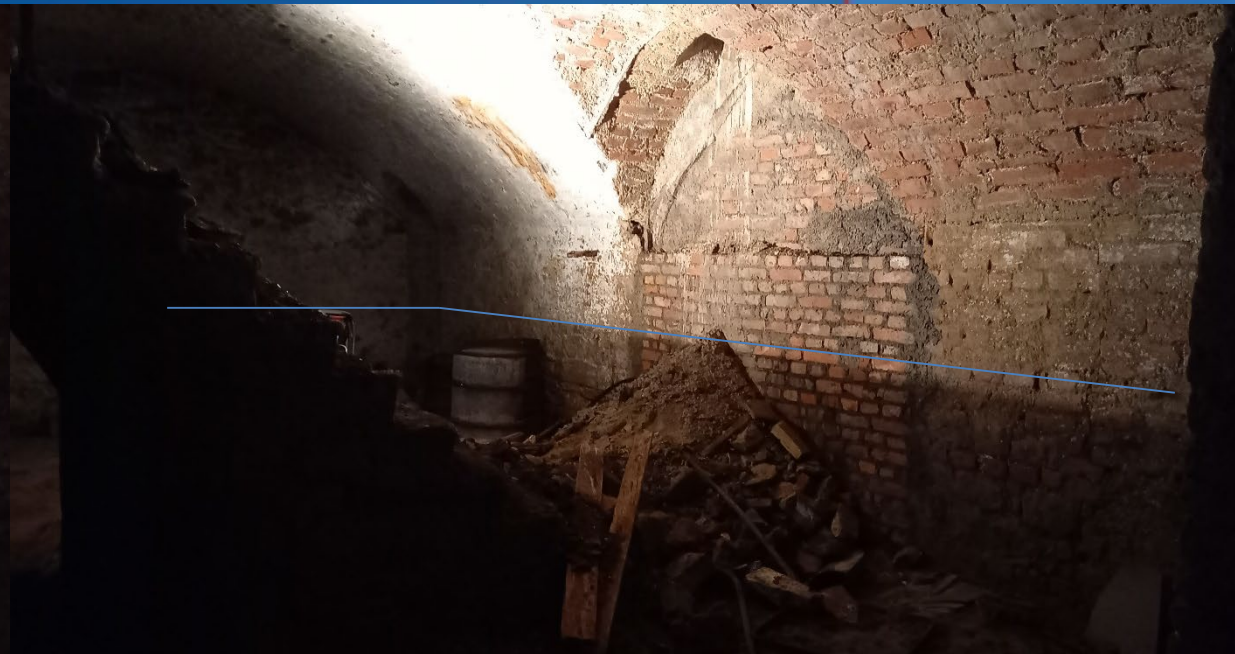
- Low and high frequency ground penetration radar (GPR) measurements:
 - 80 and 160 MHz on street
 - 500 and 1000 MHz on cellar walls
- Electrical resistivity tomography (ERT):
 - Street: 72 electrodes with 1 m spacing
 - Cellar: 60 electrodes with 0.5 m spacing
- Seismic measurements collected with 24x 4.5 Hz geophones streamer with 2 m spacing:
 - Refraction seismic tomography (RST)
 - Multichannel analysis of surface waves (MASW)

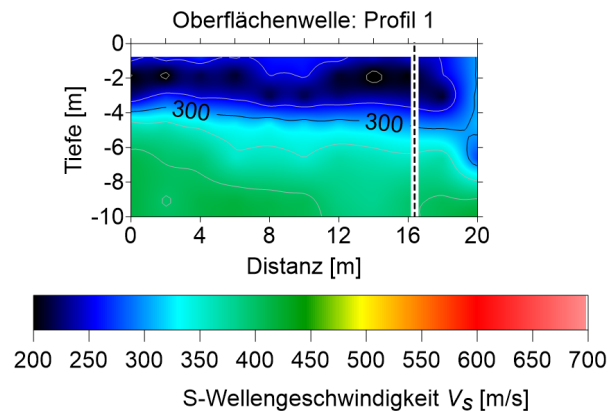
Results – Street: ERT, RST and MASW along profile Tuchlauben 1

Shearwave velocity [m/s]

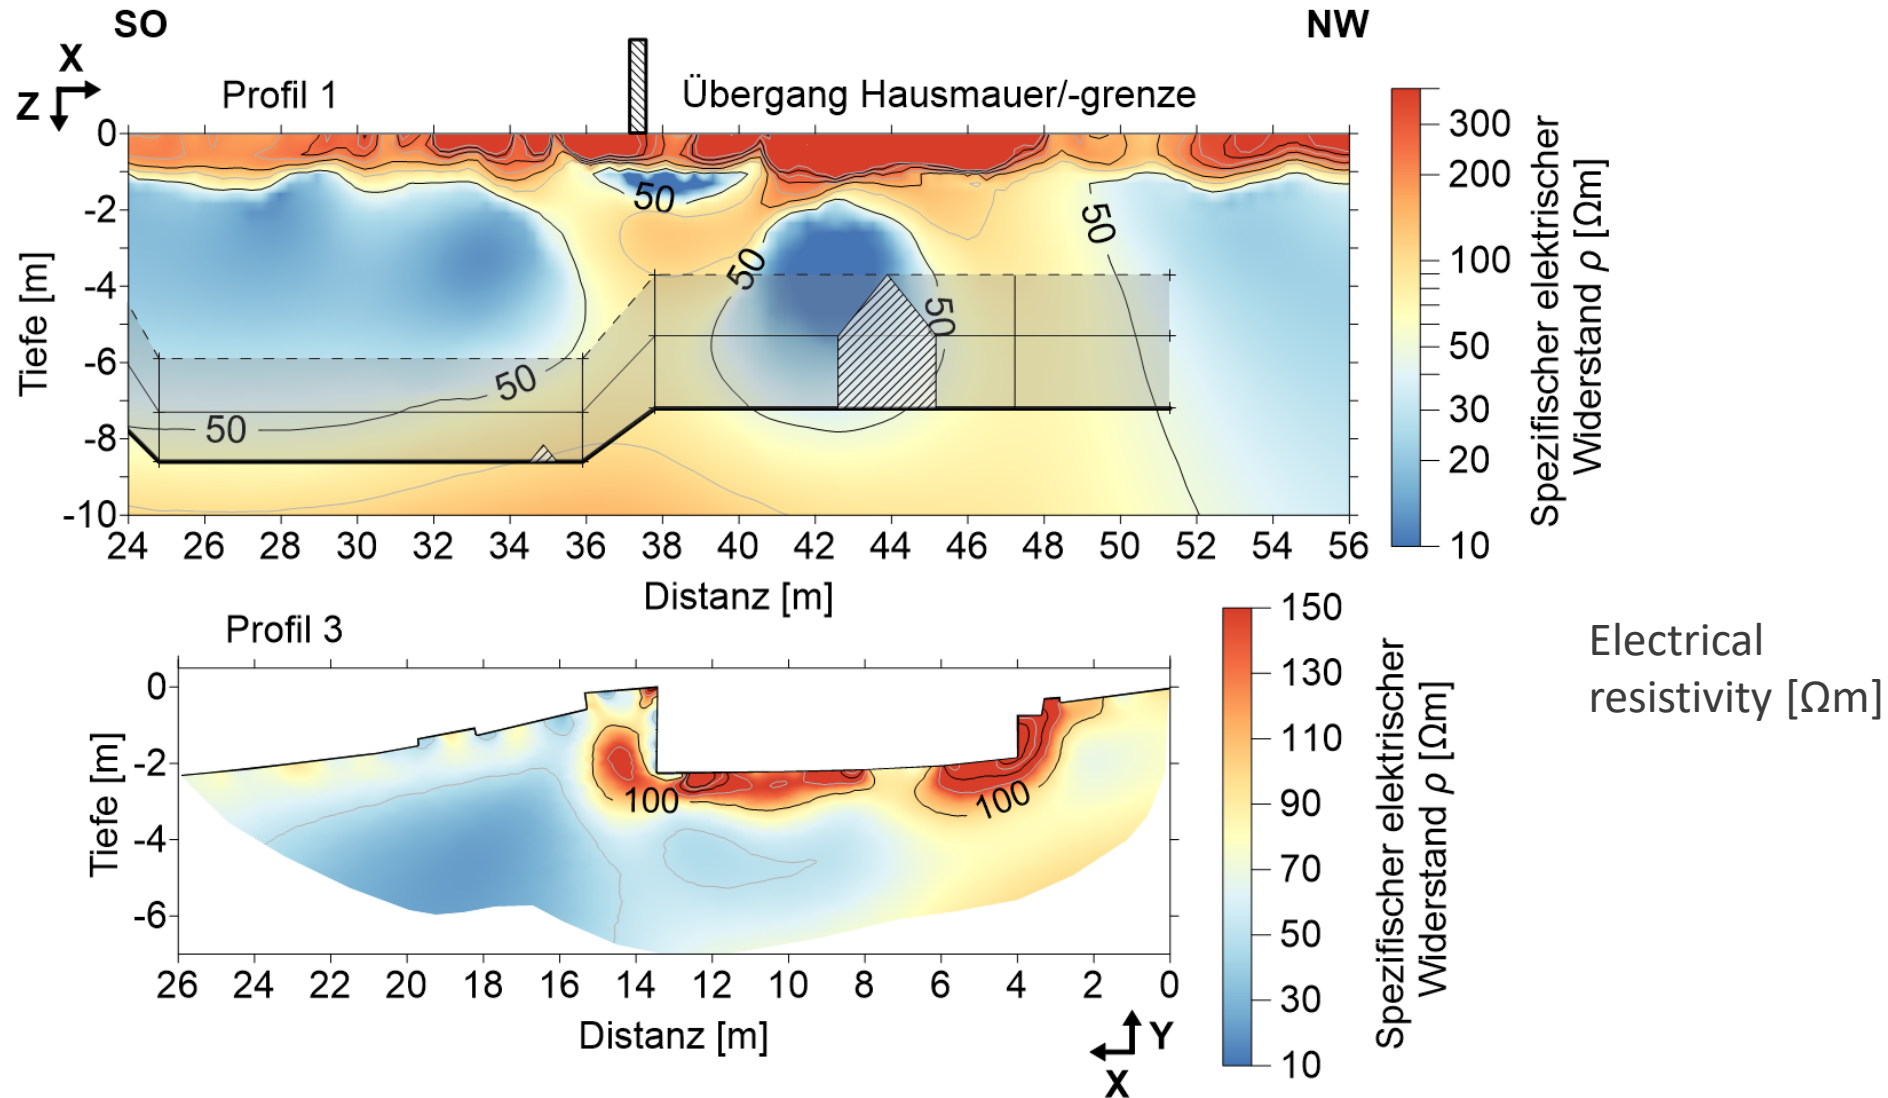
Results – Cellar and street: ERT

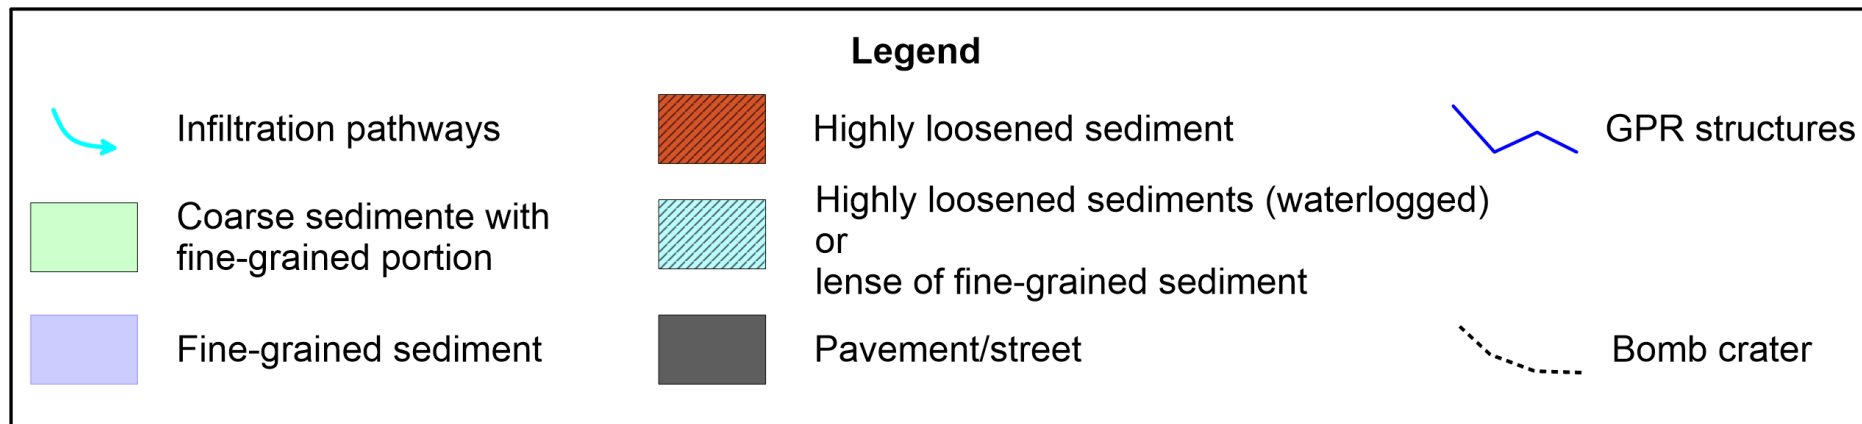
Interpretation: imaging infiltration pathways (1)
