LAB AND MODELLING TESTS TO DEVELOP A GEOELECTRIC MONITORING SYSTEM FOR MUNICIPAL SOLID WASTE LANDFILLS

Lorenzo Panzeri ¹ , Monica Papini ¹ , Luca Formaggia ² , Anna Scotti ² , Alessio Fumagalli ² , Diego Arosio³,
Laura Longoni¹

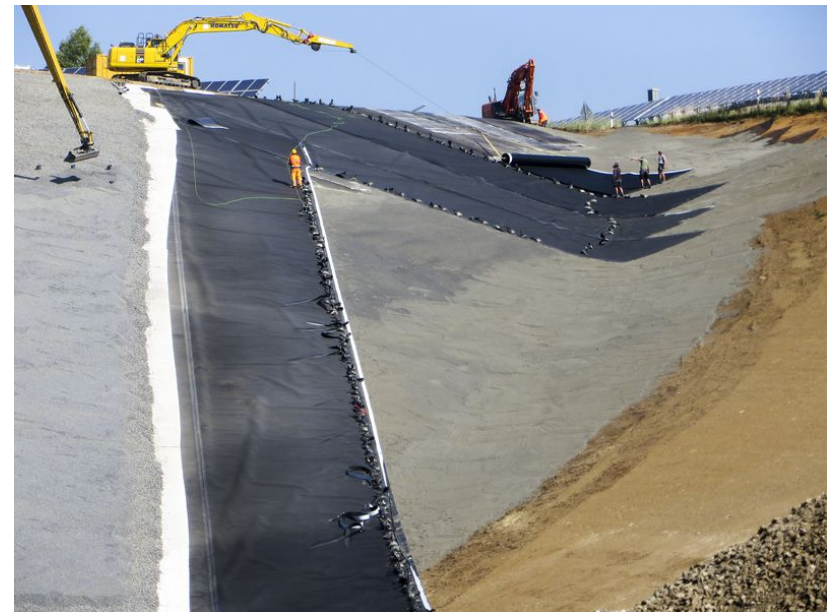
Installation of the HDPE liner by using a long arm excavator [<https://www.agru.at/>]

- **Damage to the HDPE** membrane would lead to the diffusion of highly polluting **leachate** into the **aquifer**.
- **Alterations in the liner** covered by the waste are difficult to detect.

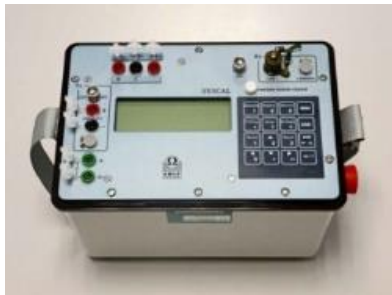
■ GEOPHYSICAL DC METHODS

Resistivity ρ [Ωm]

Induced polarization (IP)
Chargeability M [$\frac{mV}{V}$]
