Vegetation as nature-based solution for mitigating hydro-meteorological geohazards on slopes and streambanks

Vegetation as a remedial measure against erosion and shallow landslides in steep soil slopes

Swedish Civil Contingencies Agency
Swedish Geotechnical Institute
Swedish Transport Administration
Swedish University of Agricultural Science
Lundström, K., Andersson, M., Ånäs, M., Rolf, K.

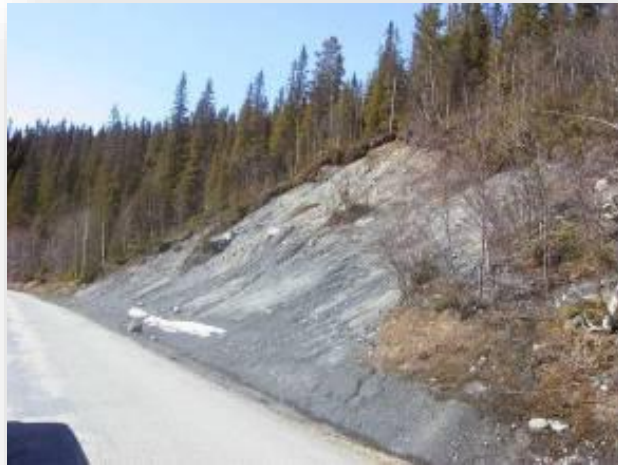
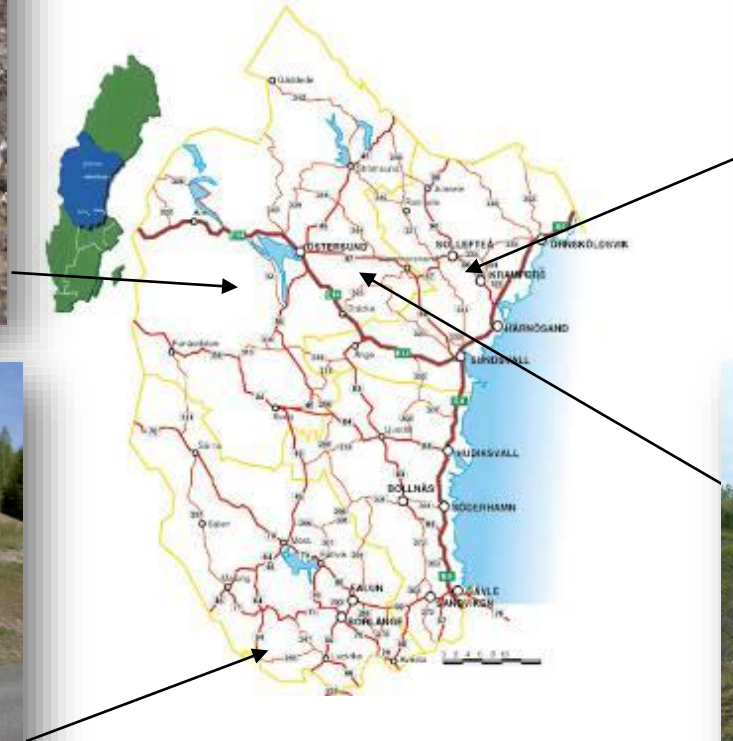
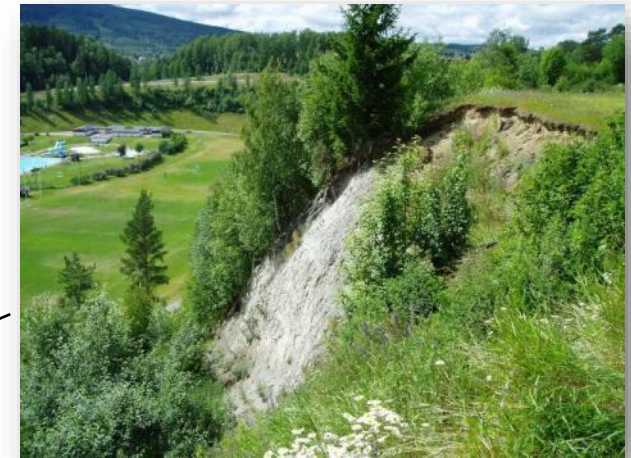
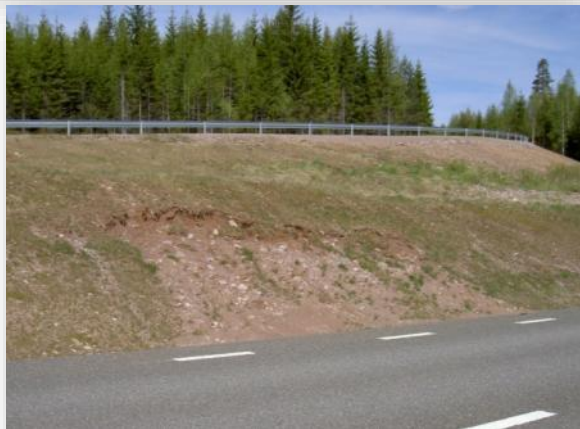
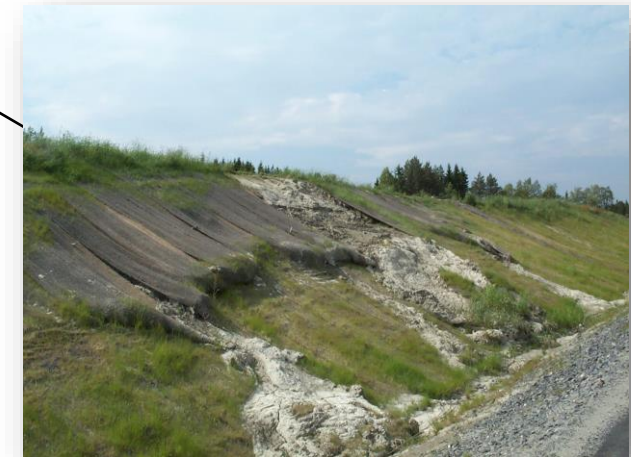
Erosion and stability problems in Norrland, Sweden

- Shallow landslides, 1 – 2 m
- Thaw effects
- Porewater pressure and several groundwater pressures
- Water from the road surface

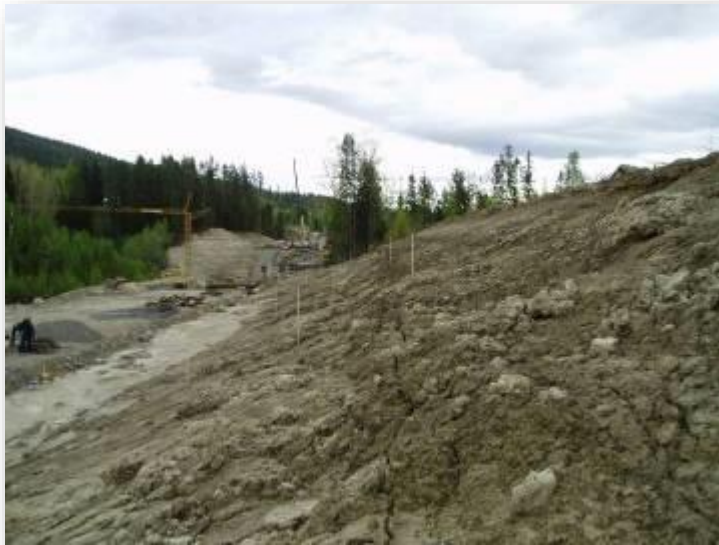
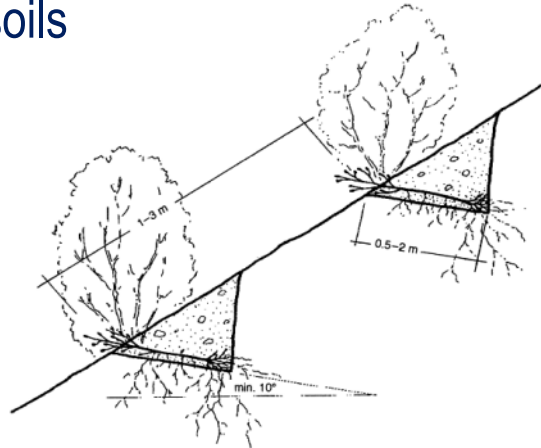
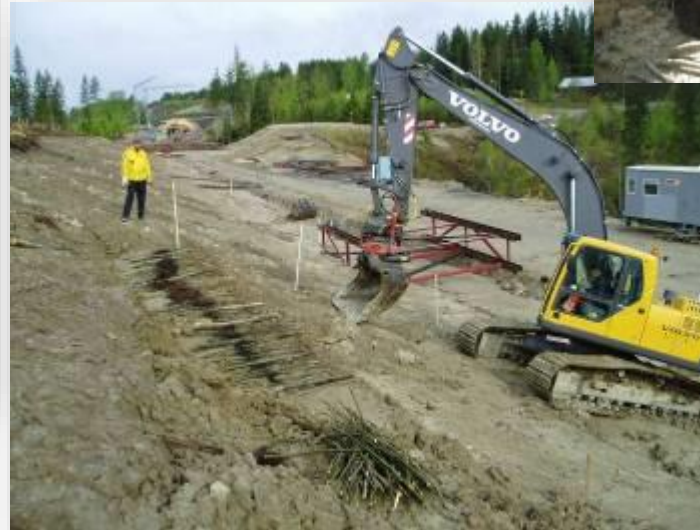
Test site - Bispgården

Problems:
Erosion, frost heaving, thawing,
layered soils

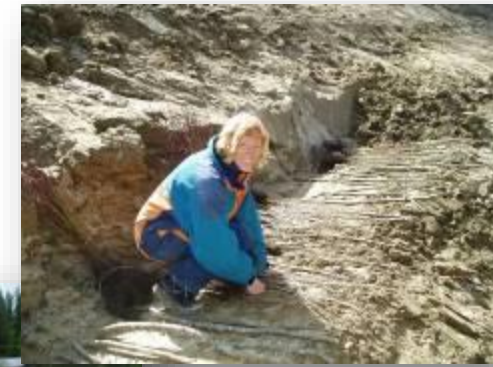
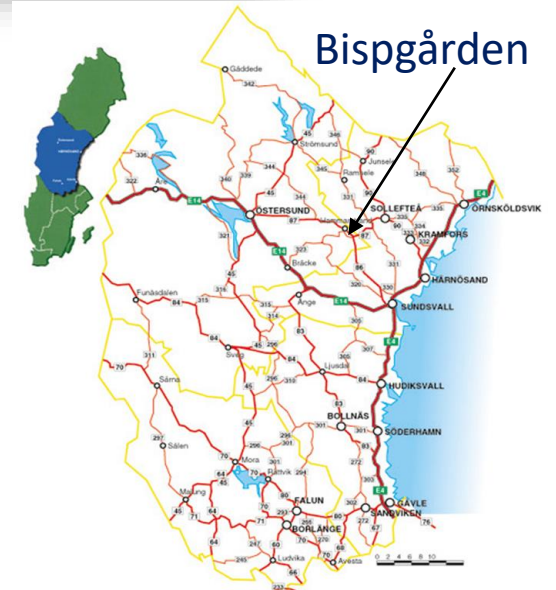
Preventive measures:
Hedge- and brush layers, grass

Plant name, Latin	Plant name, English	Amount of plants (%)
<i>Alnus incana</i>	Grey elder	20
<i>Cornus sanguinea</i>	Dogwood	20
<i>Lonicera xylosteum</i>	Fly honeysuckle	20
<i>Prunus padus</i>	Bird cherry	12
<i>Sorbus aucuparia</i>	Rowan	28

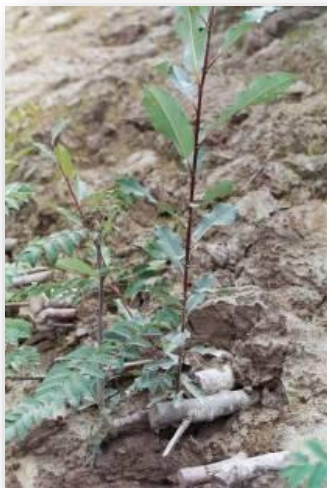
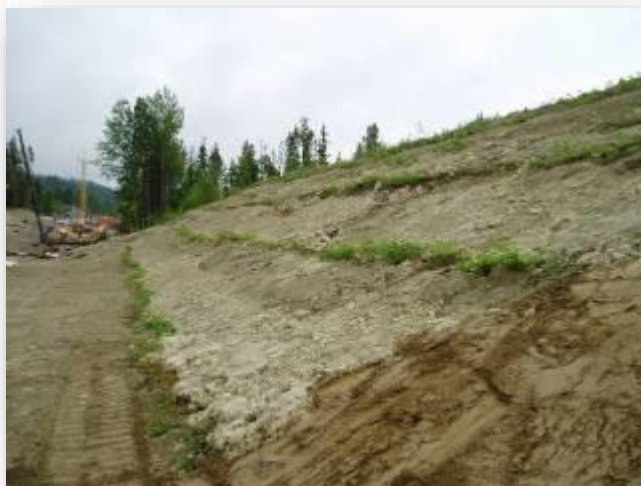
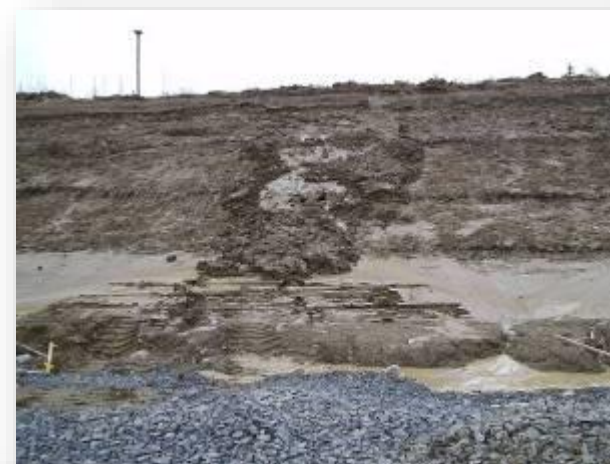
Experiences from Bispgården

First year (2004):

- Bare-rooted plants flourished
- Thick cuttings >5 cm flourished
- Thinner cuttings dried out
- Grass did not successfully sprout

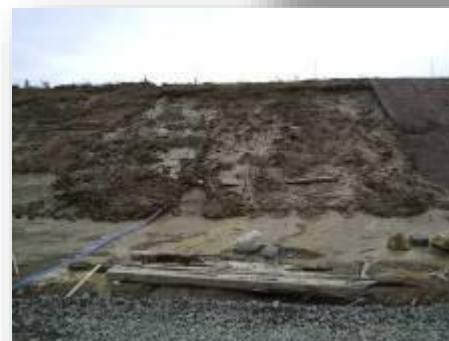
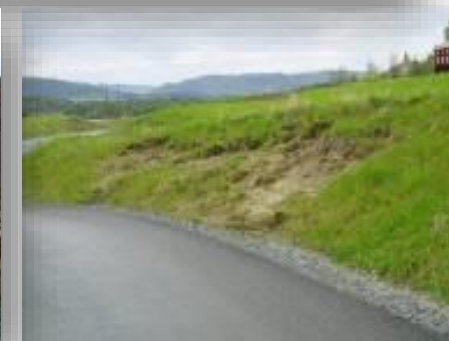
May 2006:

- Solifluction from thawing and rainfall
- Hedge/brush layers slid , some buried
- Test site was terminated
- Slope covered with crushed stones

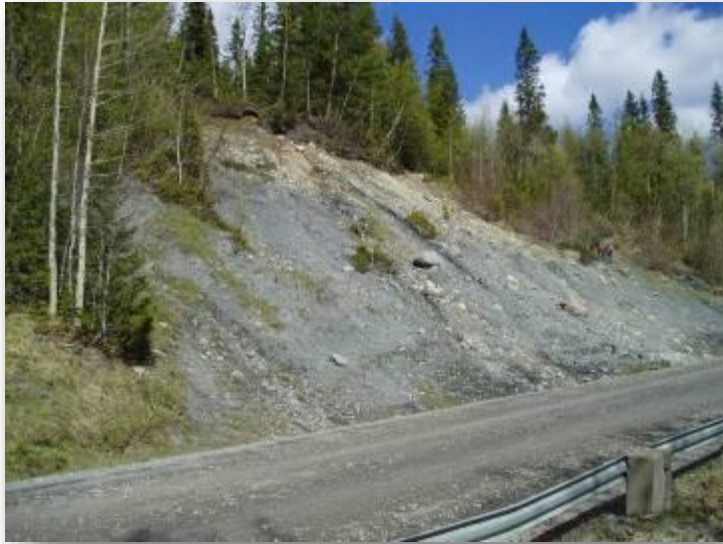
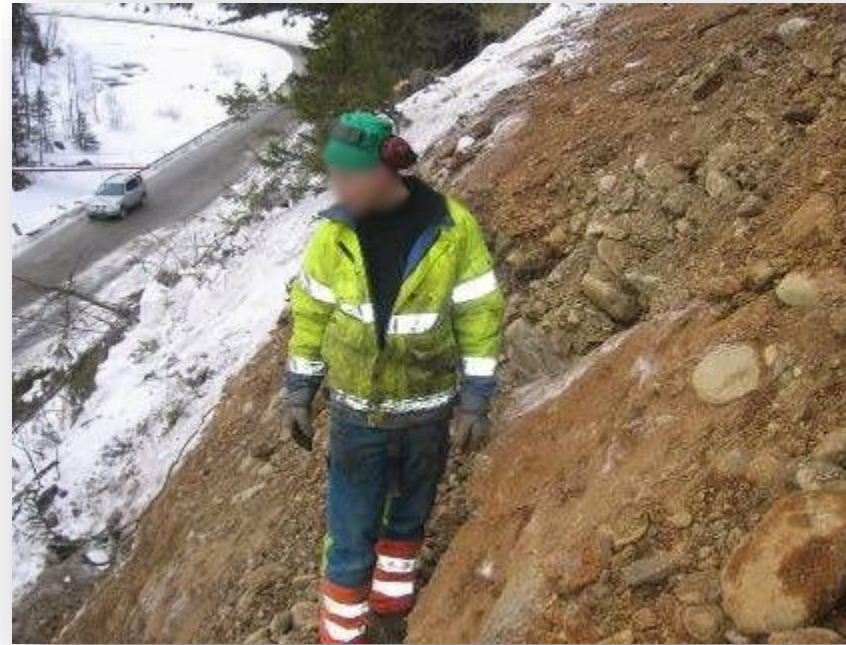
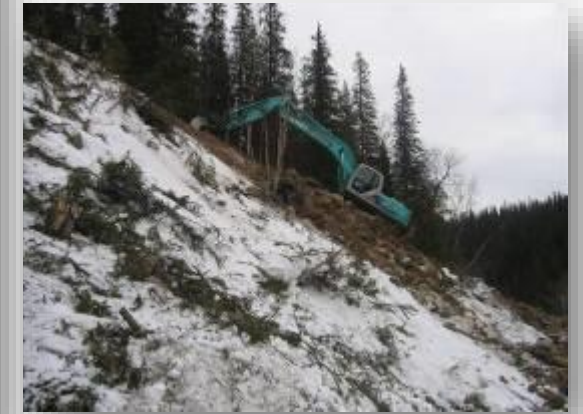
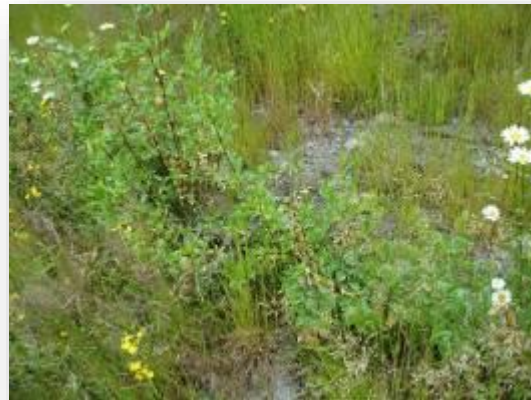
Test site - Bydalen

Problems:

- groundwater
- frost heaving
- erosion

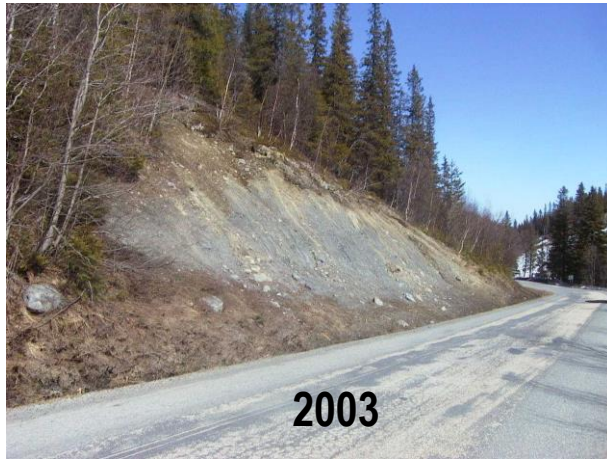
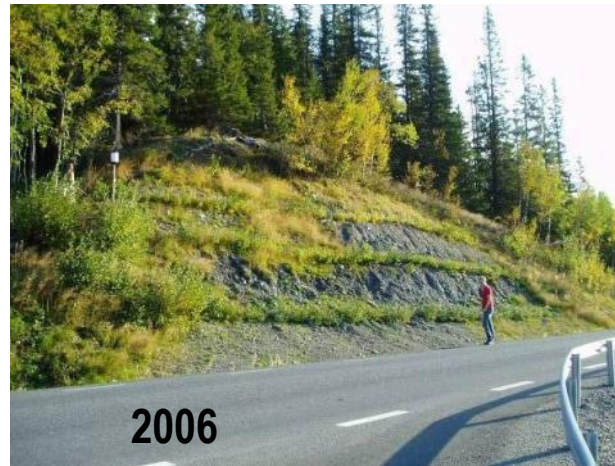
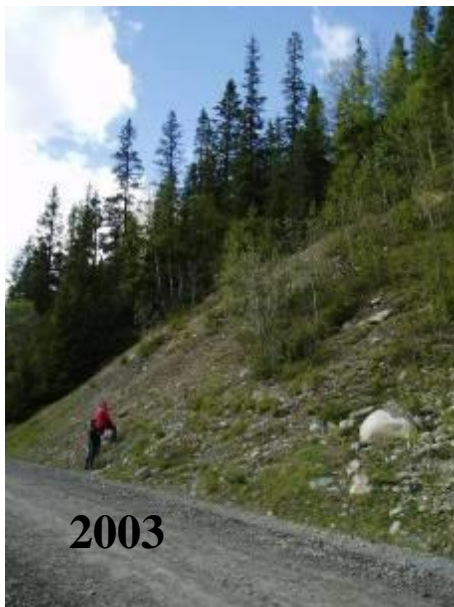
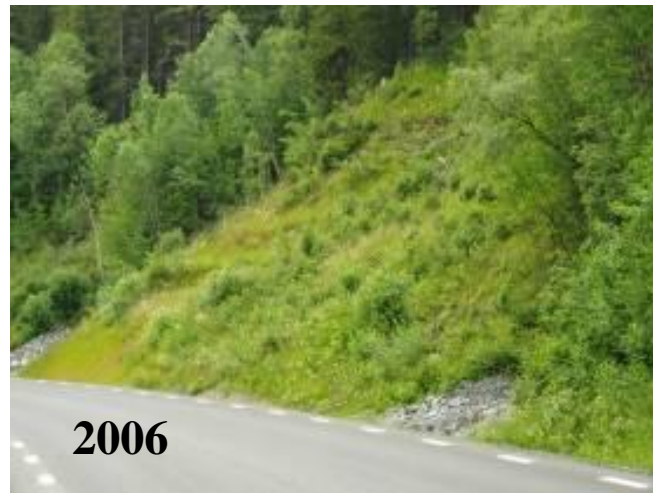
Experiences from Bydalen

- Very marginal signs of solifluction during in thawing or rainy periods
- Deciduous trees which were previously cut sprouted nicely
- Good growth of plants in hedge layers
- Grass grew well, especially when seeded below coconut mat

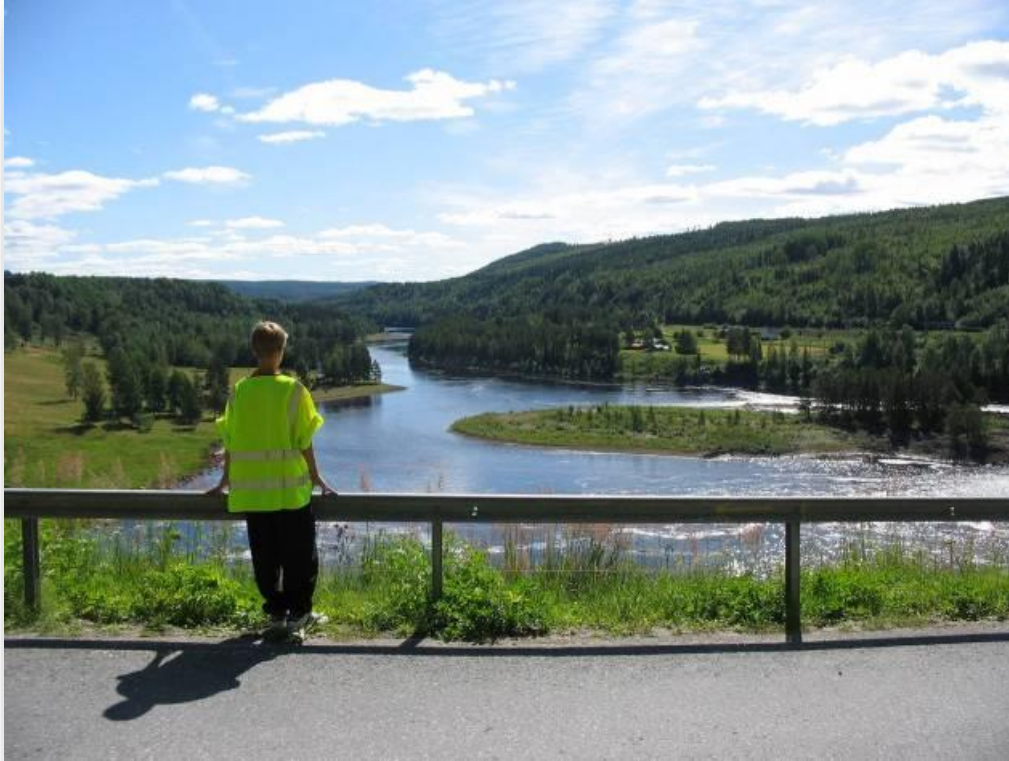
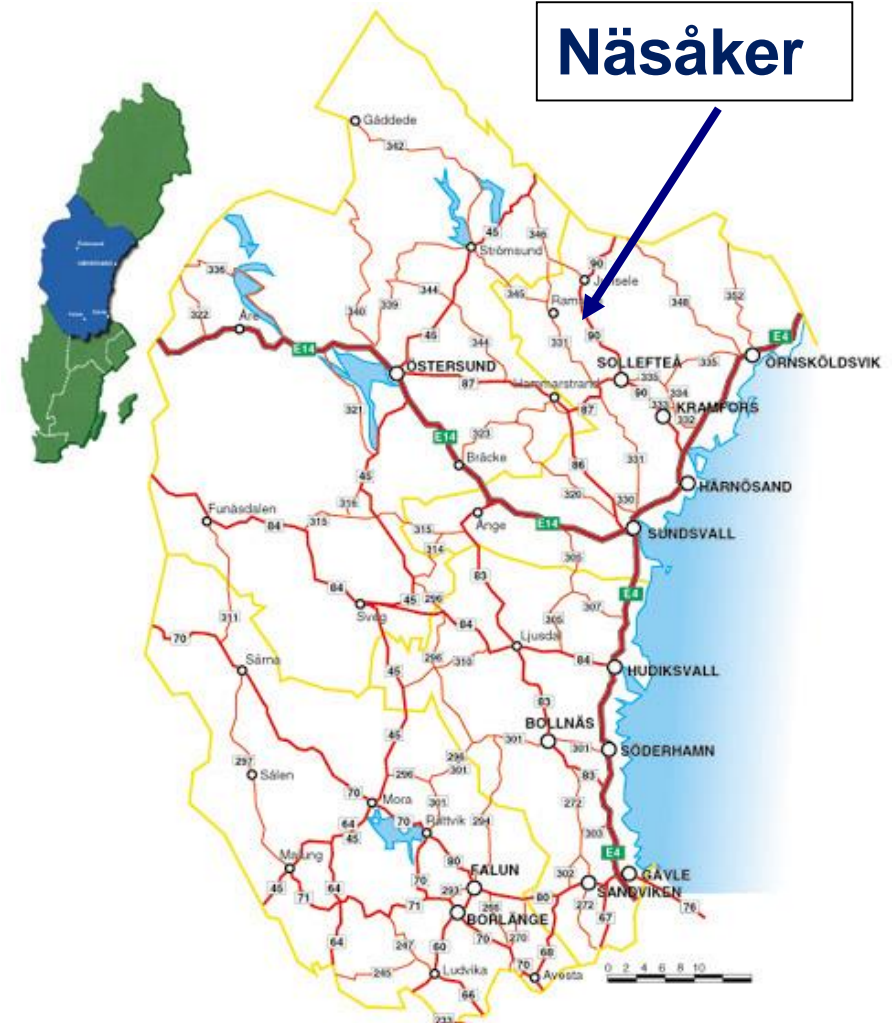
Road 975 in Näsåker

- The road is situated in a steep slope 30-60 m above a river
- The soil consist mainly of silt, with layers of sand and clay
- In this part of Sweden a steep soil-slope is called a "Nipa"
- Existing slope inclination varies between 1:1 – 1:1,5
- Stability without reinforcement, $F_{cf} \approx 1,0 - 1,1$

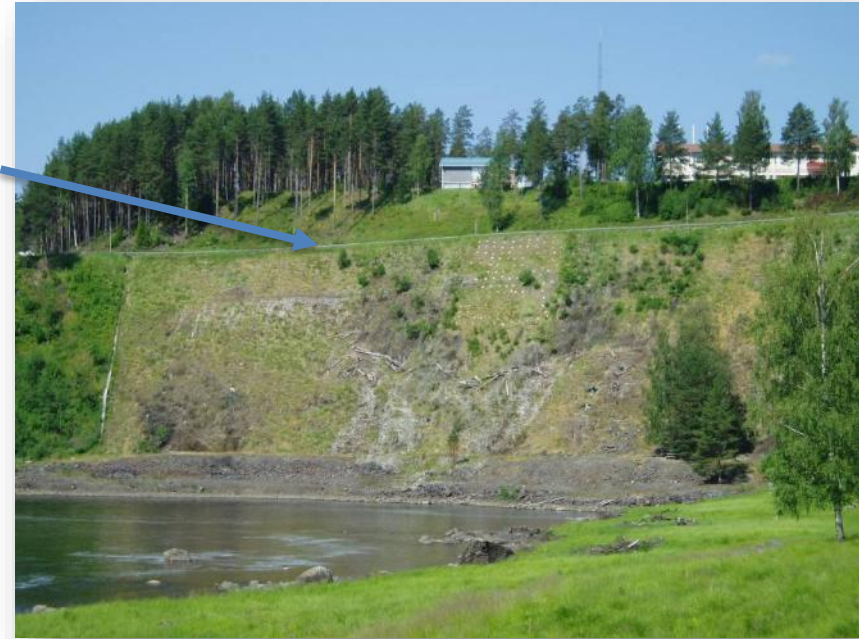
Road 975

- 1918 Road installed
- 1946 Landslides, repaired with crushed rock
- 1946-1983 Gabion walls are constructed
- 1983 Drainage measures installed
- 1987 Reinforcement with thaw-isolation, displacement of the road and new drainage measures
- 1994 Soil nailing
- 2000 Repair of the soil nailing
- 2001-2002 New soil nailing
- 2005 Landslides, again!
- 2005-2006 Planning of new ideas and measures
- 2006-2008 Reinforcement with vegetation and soil nailing

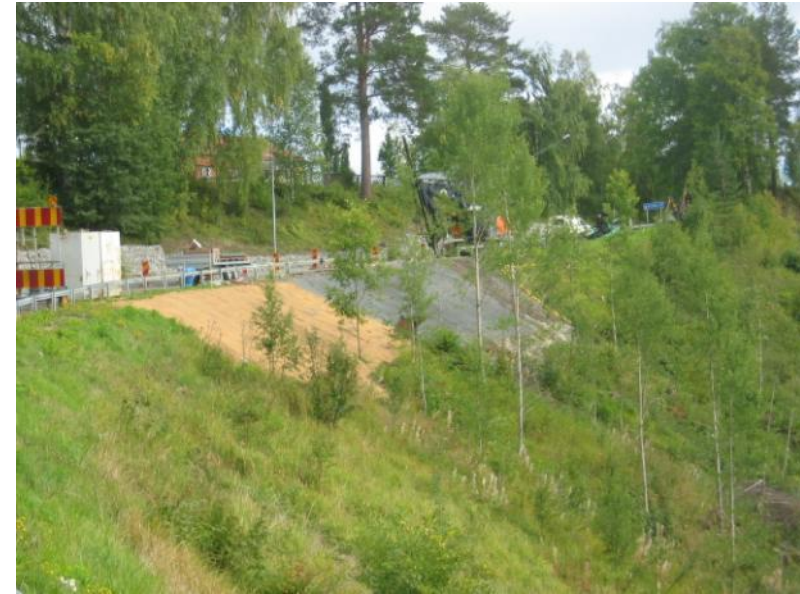
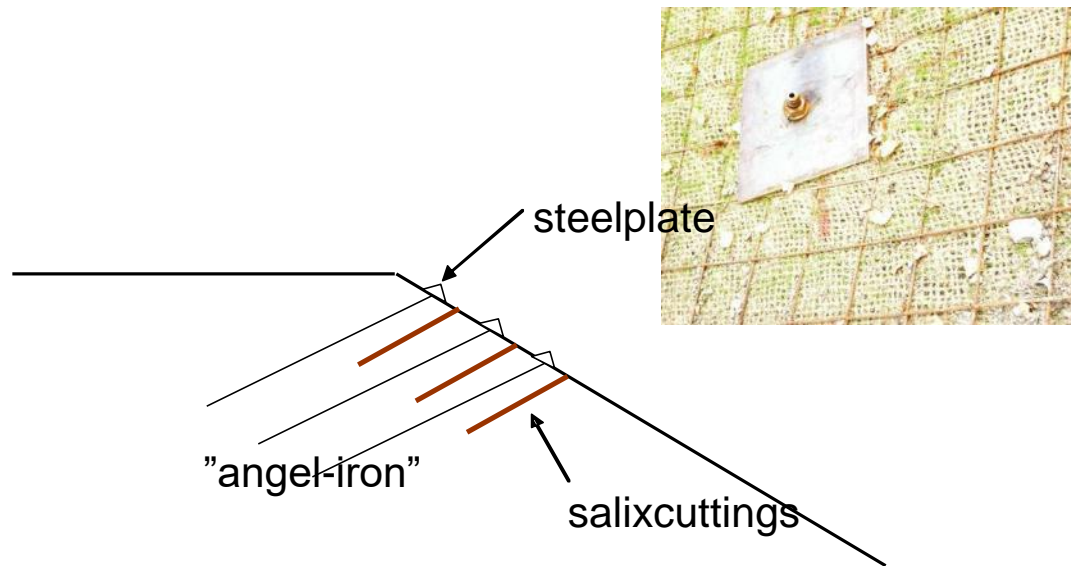
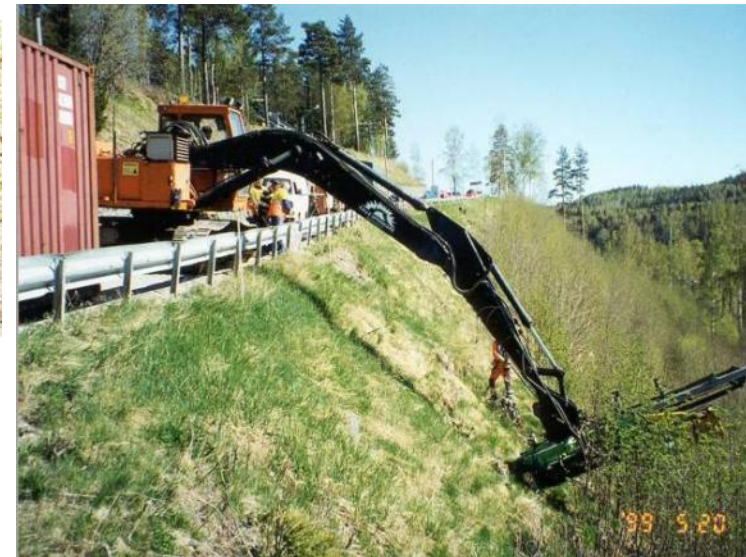
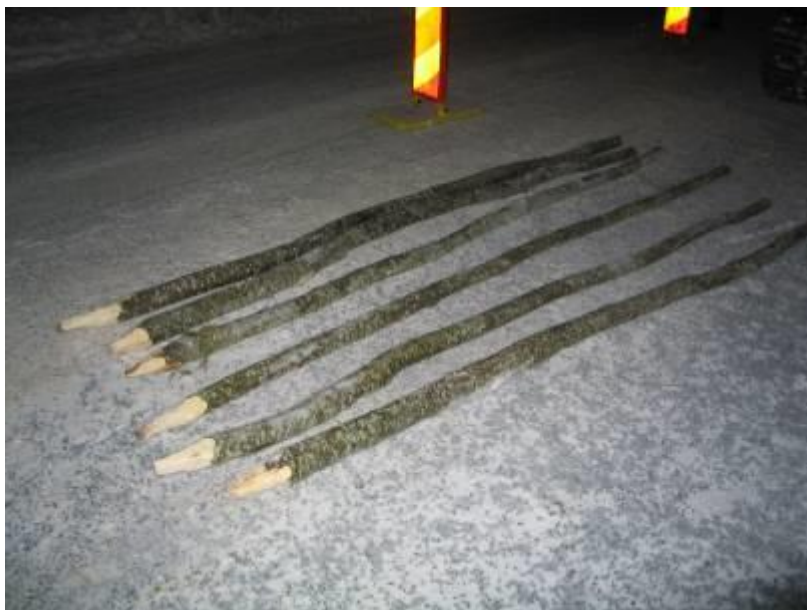
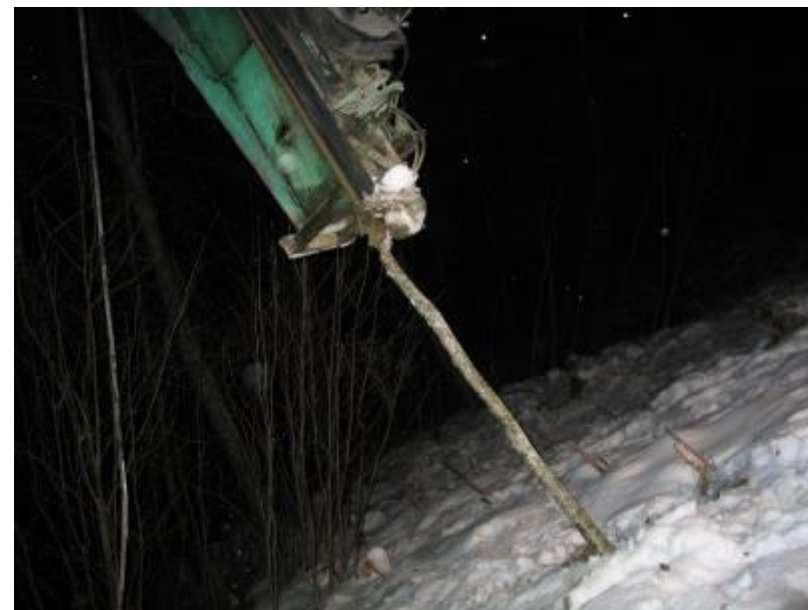
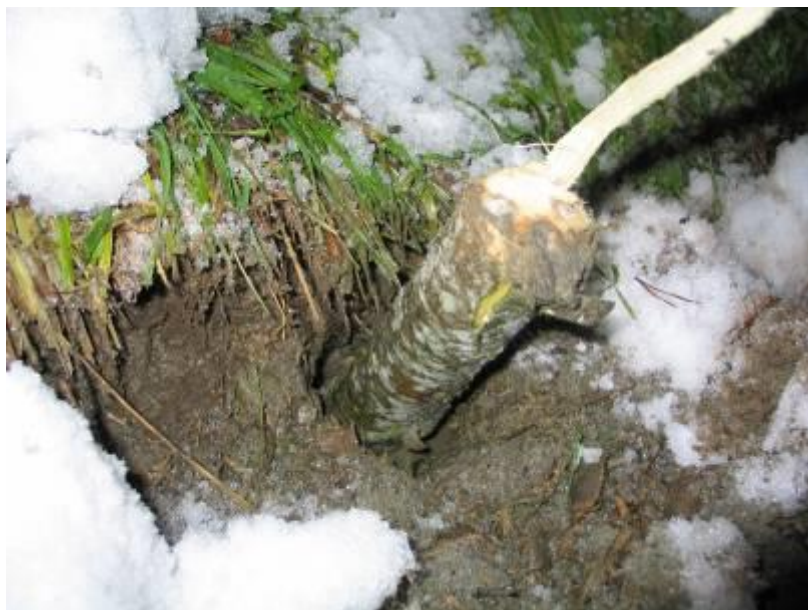
Reinforcement measures

- Hydraulically pounded angel bars, 6 m, 3 rows
- 2,5–3 m long salix-cuttings, 3 rows
- Nailing and pounding from the road
- Steel net and -plates
- Grass-seeding with coconut mat

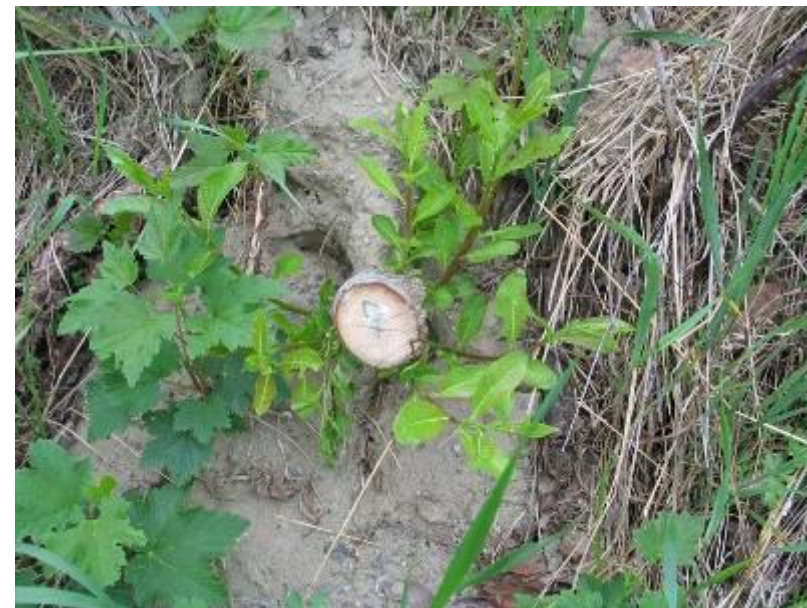
Long salix cuttings

Growth of roots on an extracted ~2,5 m salix cutting

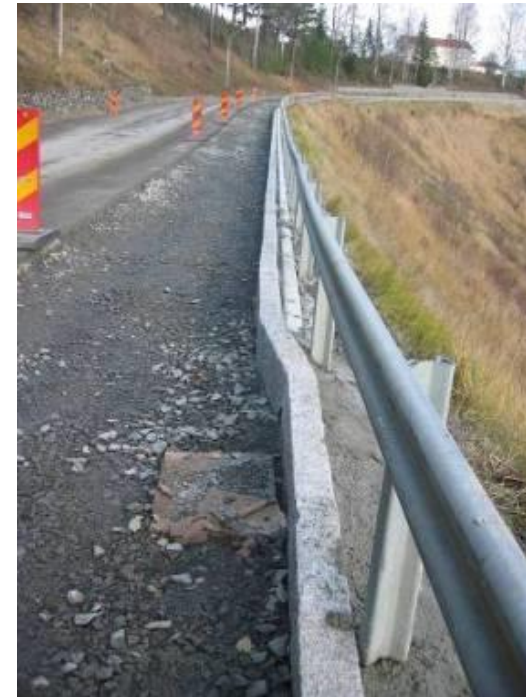
Other measures

- A plan for maintenance of vegetation and soil nails
- Kerbstones and drainage wells
- Monitoring measurements
- Weather stations

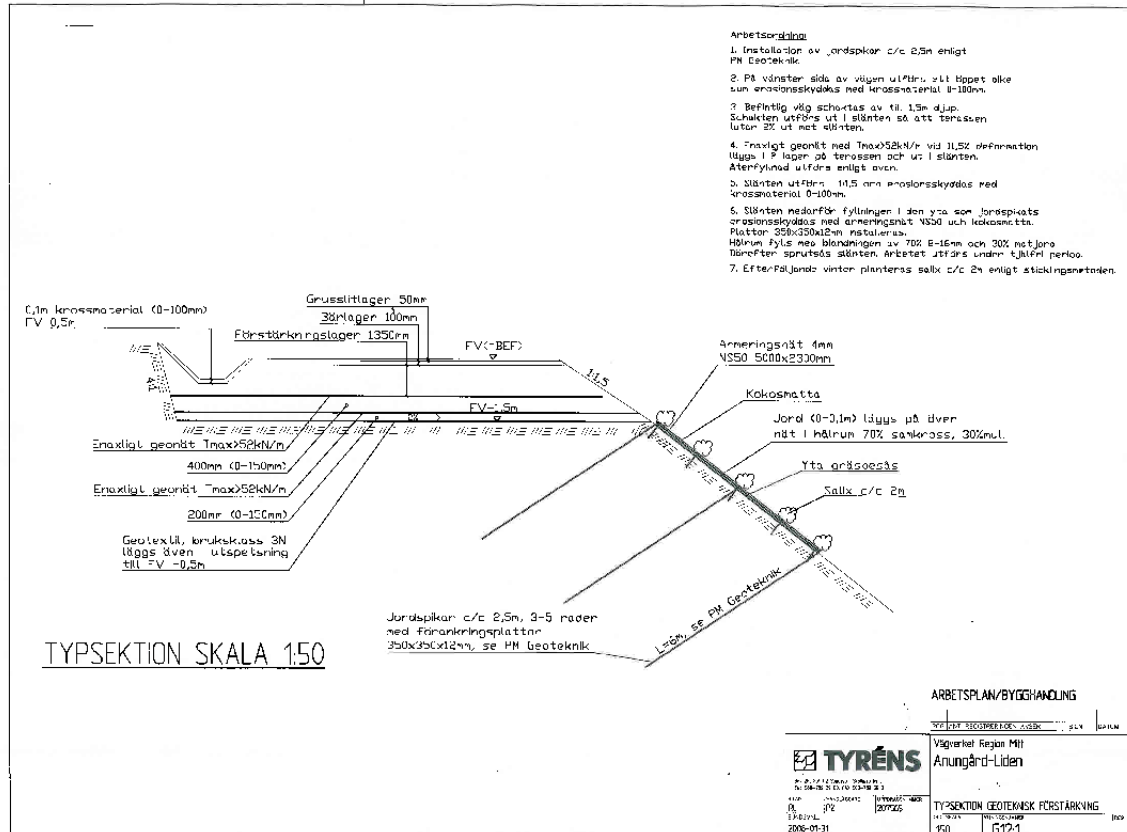
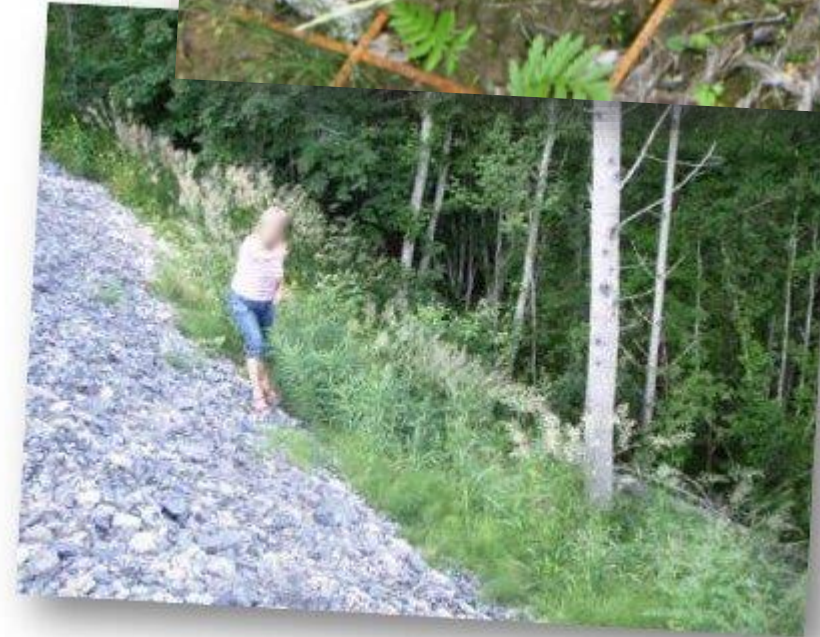
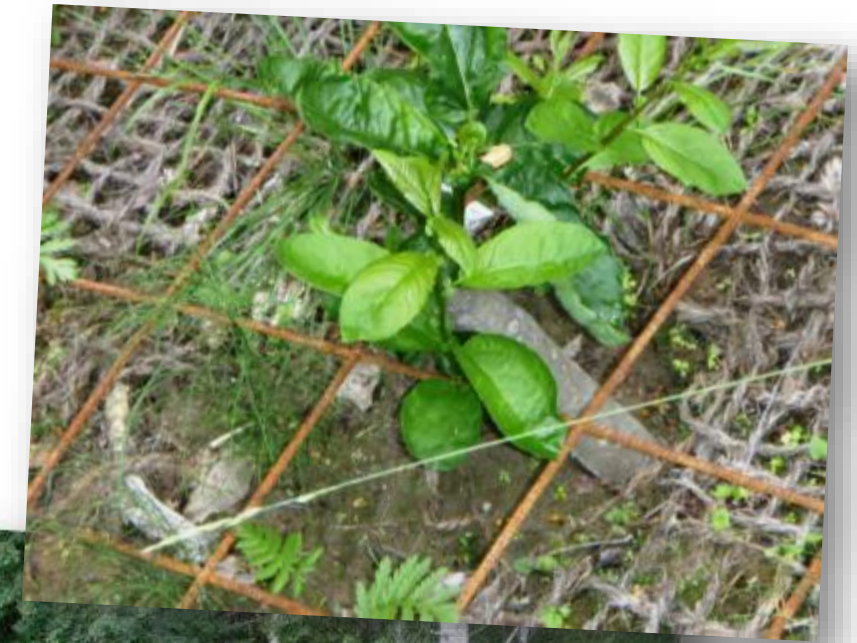
Road 638 Liden

The methods are used in other slopes
