Multi-disciplinary approach for assessing the impact of a flood event in a shallow karst cavity (Pindal Cave, Spain)

Pindal Cave (Asturias, Spain) and its Paleolithic art have been part of the UNESCO World Heritage List since 2008. Since 2017, a multidisciplinary team have been carrying out research focused on deciphering the relationships between environmental conditions and microbial activity to the design of conservation strategies. On October 23, 2019, the cave was flooded. After the flood, a specific study was performed to evaluate the environmental changes caused in the underground ecosystem. This study revealed a massive entry of material from a cattle farm located vertically in the cavity. Thereafter, in 2021, the livestock activity in the vicinity of the cave was stopped.

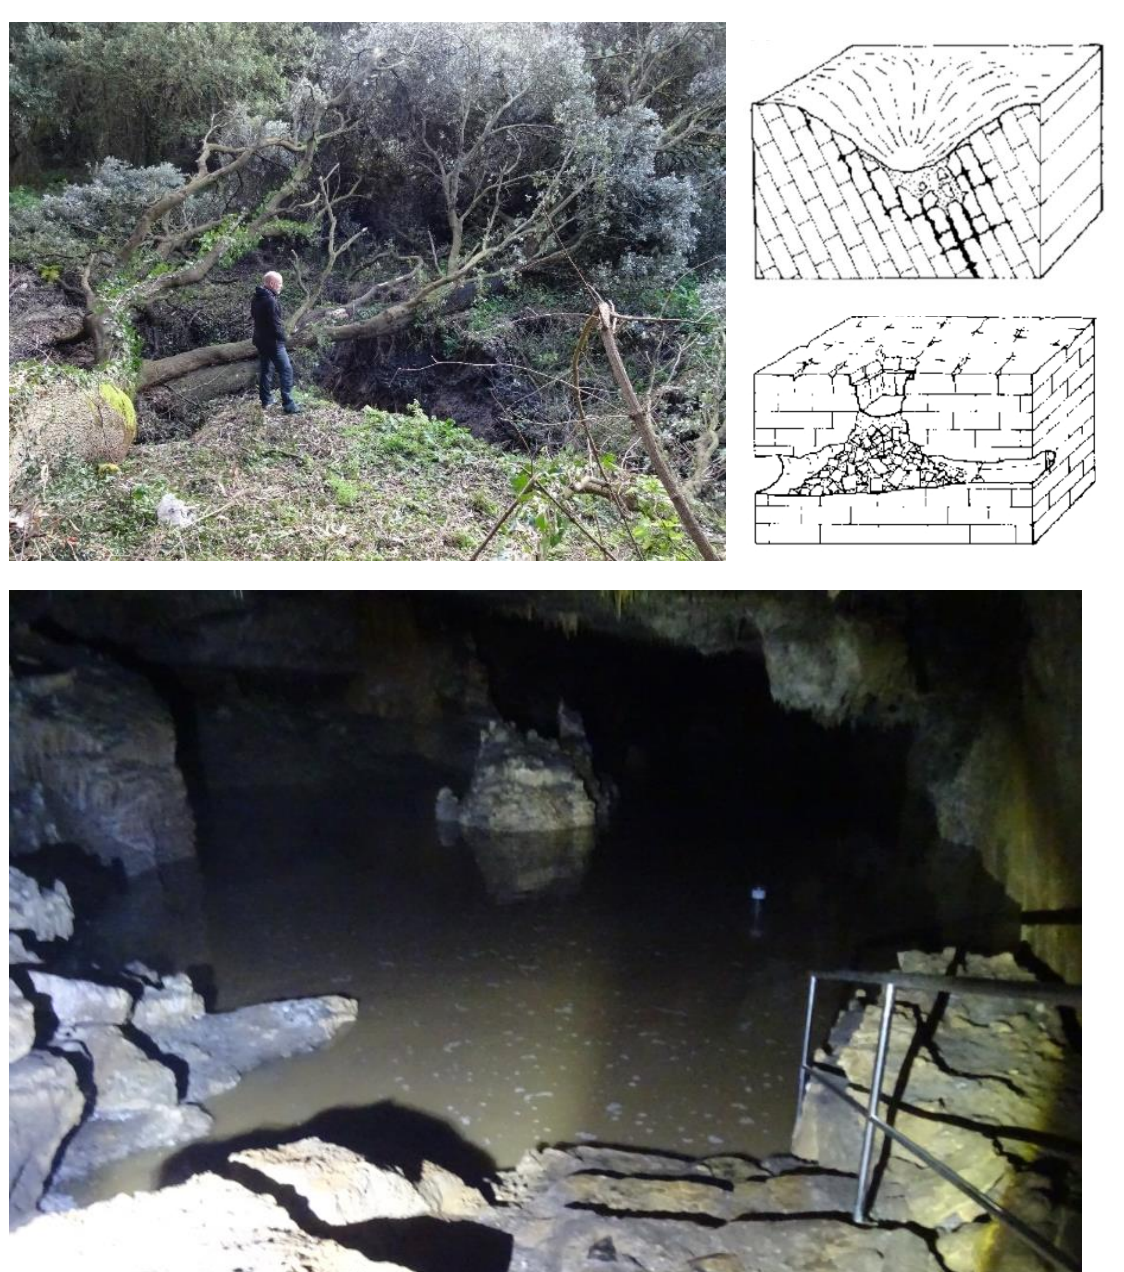
Fig. 3. Collapsed sinkhole (top) and flooded cave (bottom).

Between October 19 and 23, 2019, an extreme episode of rainfall occurred in the area with a cumulative total of 209 l/m². This event caused a strong accumulation of water in the sinkhole that finally collapsed, flooding the cave for several days (Fig. 3).

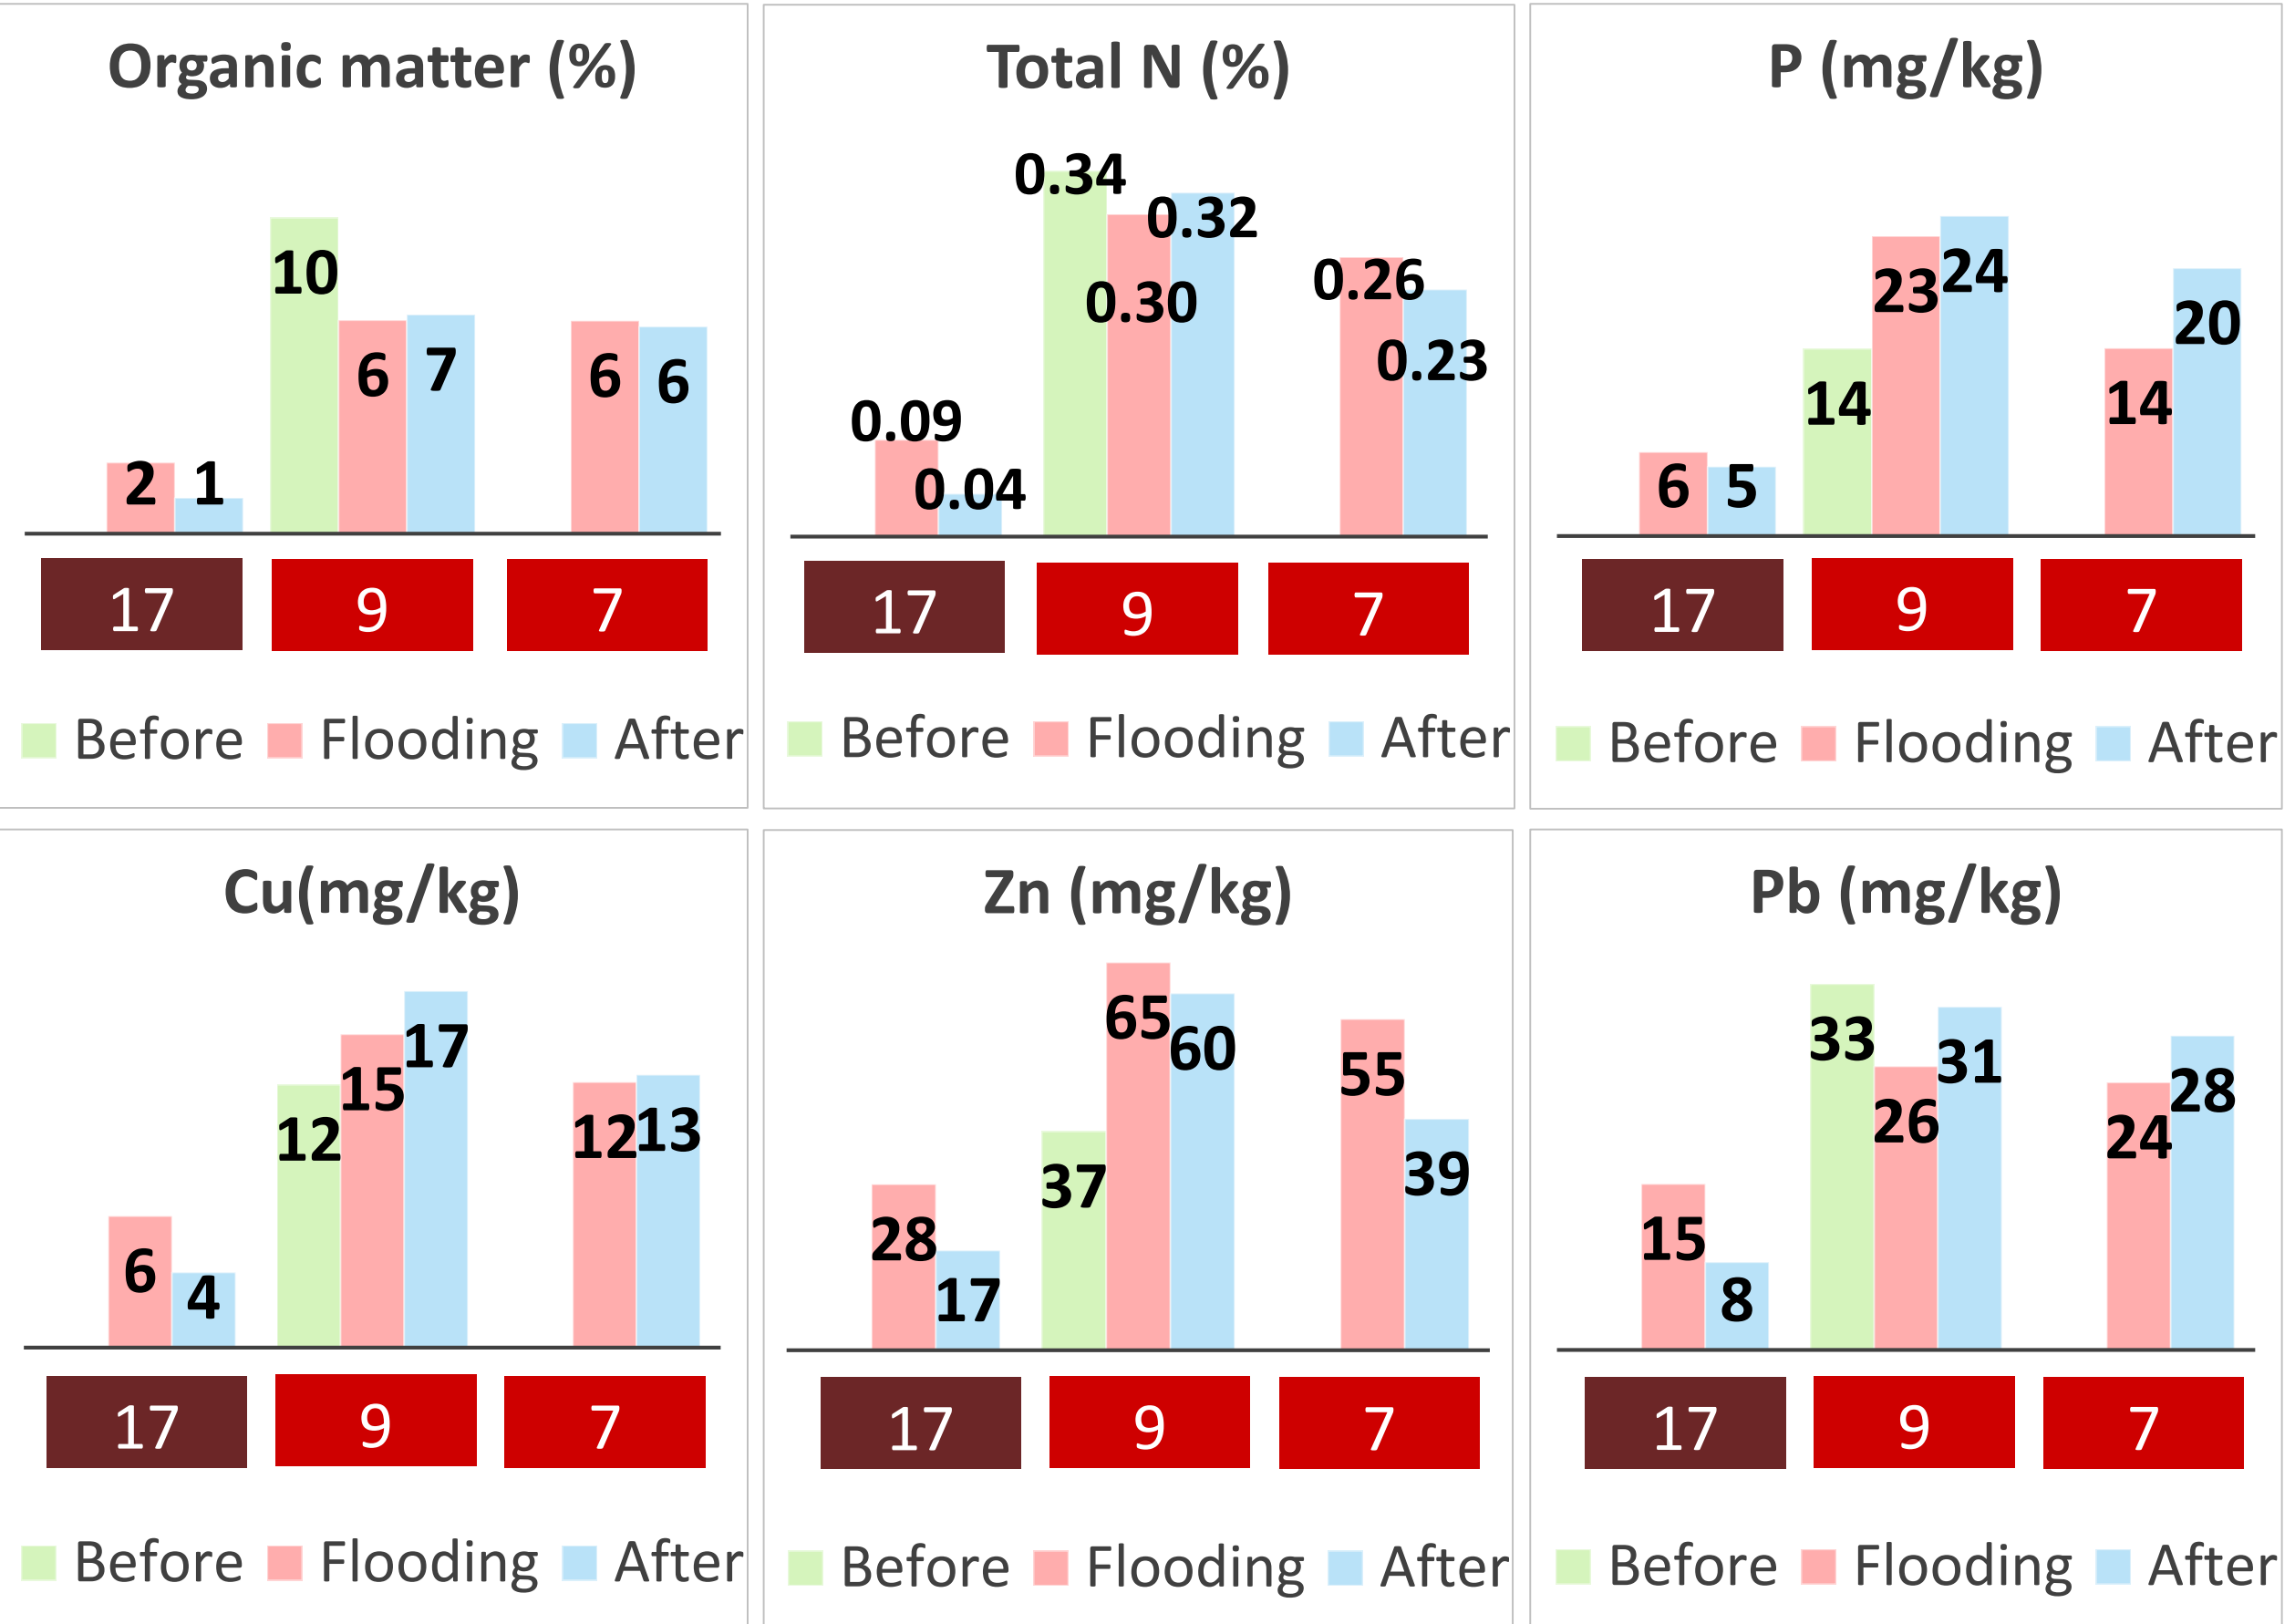
Fig. 6. Results of the geochemical analysis. Before: before the flooding, Flooding: one week after the flooding, After: one year after the flooding. Red: sediments contaminated with slurry (sites 9 and 7). Maroon: uncontaminated sediments (site 17).

The cave sediments and exogenous sediments of sites 7 and 9 showed high values of organic matter, nitrogen phosphorus and metals. These values were higher than those of the innermost sites (17) that were not directly affected by the collapse of the sinkhole and the entry of water contaminated with slurry.
