Assessment of terrigenous sediment input into Plastiras lake (Greece) as deduced from UAS and multibeam surveys: insights from the "IANOS" Medigane effect

Vassilakis Emm.¹, Konsolaki A.¹, Maroulakis S.², Anastasakis G.¹, Lekkas E.¹

¹ Faculty of Geology and Geo-environment, National and Kapodistrian University of Athens, Greece | ² TerraMarine Consulting Geologists, 73, Machis Analatou str, 11745, Athens, Greece

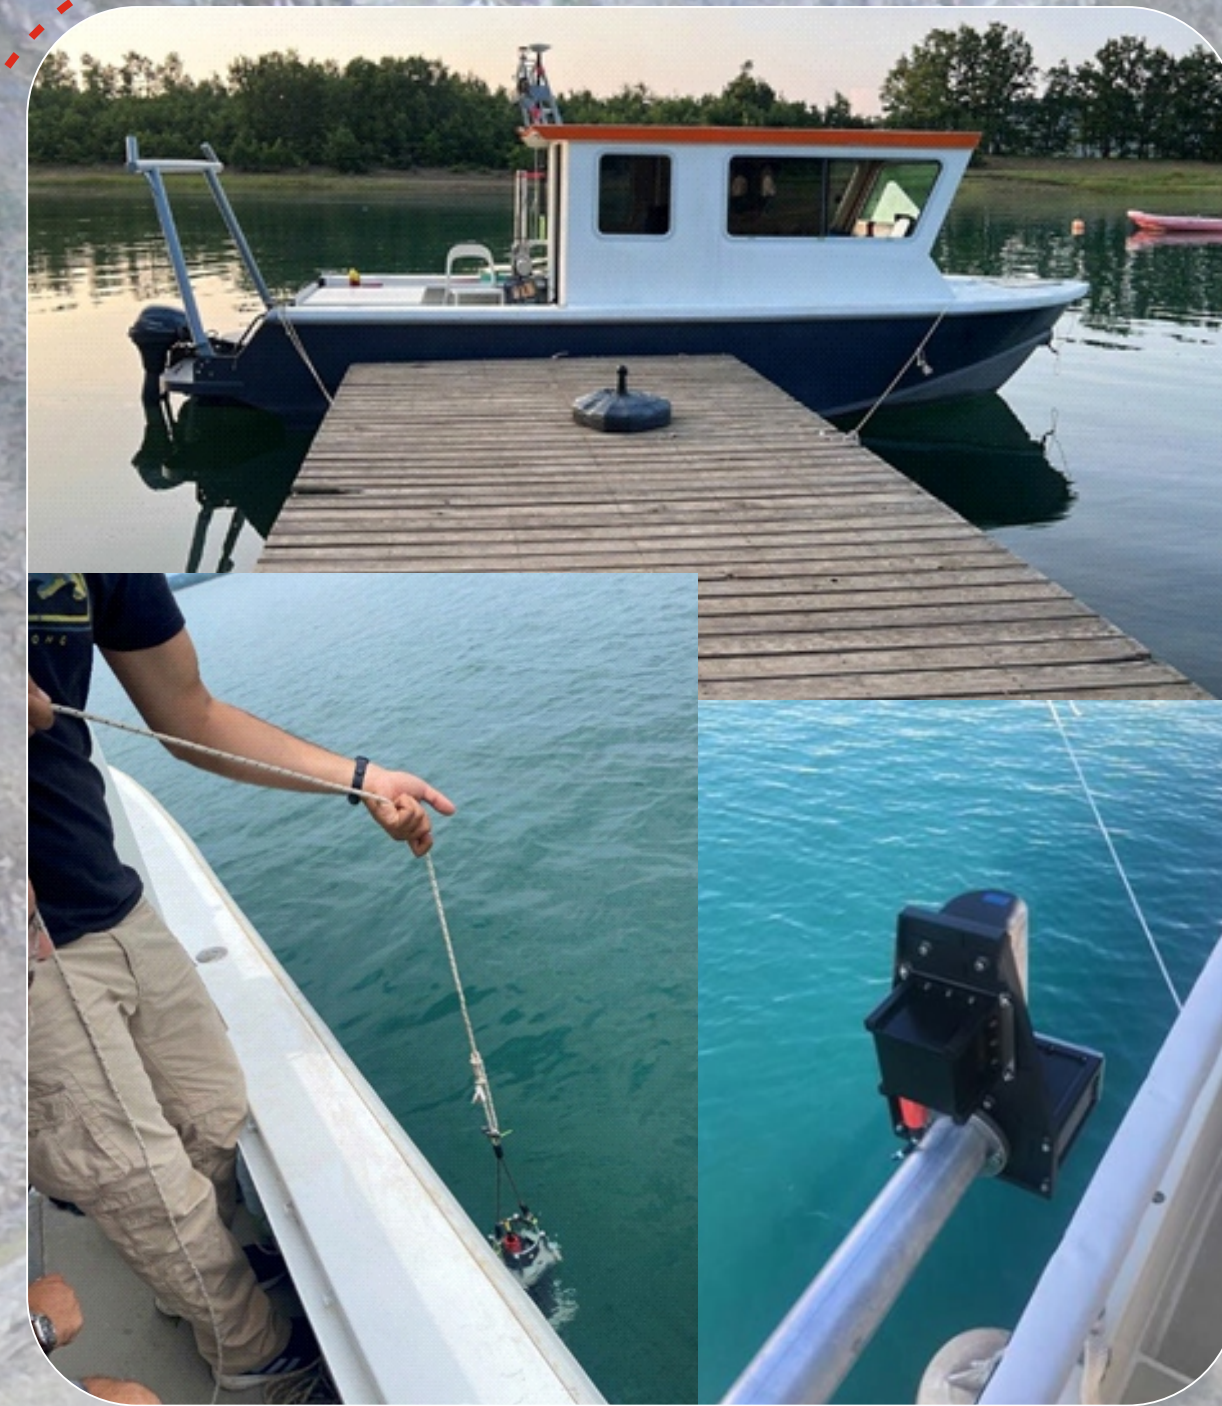
The equipment for the offshore, lake bottom data collection, included a multi-beam sounding device carried by a vessel, conducting transects parallel to the main lake axis (right inset).

The deeper parts of the lake bottom morphology were mapped, based on the point cloud, which was created after processing the multi-beam survey data. A high detail map was generated (right inset) and used for detecting lake bottom changes for the last decade.

The high-resolution offshore data processing revealed -among others- a submerged bridge and buildings as well as the underwater part of the dam, which could be visualized in 3D oblique views (inset below).
