Measures to mitigate torrential hazards in a typical alpine catchment area in Slovenia

Introduction – about our case study

Conceptual design (mitigation) – 3 phases

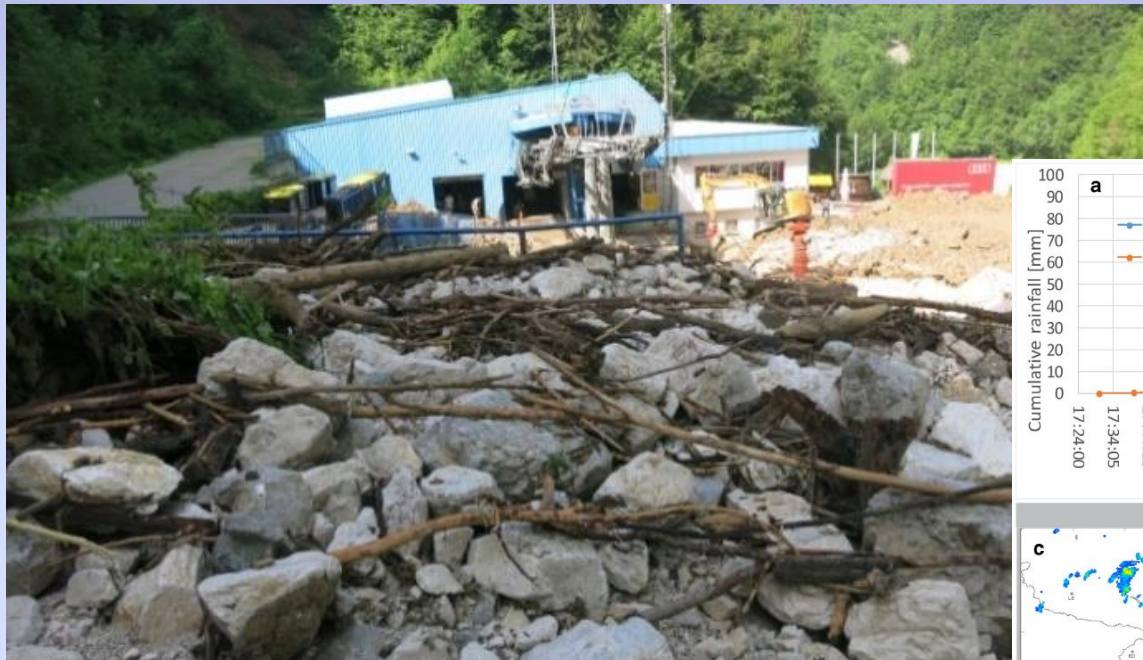
- 50 mm precipitation in 30 minutes \approx 50 year return period
- Numerous landslides in the catchment area turned into mass flows – 10.000 m³ of deposition + 10.000 m³ in the channel

Fig. 3 Rainfall during the May 2018 event measured/estimated using the pluviograph and the optical disdrometer (a) and the rainfall radar (b) from 17:00 until 18:00, (c) from 18:00 until 19:00, and (d) from 19:00 until 20:00

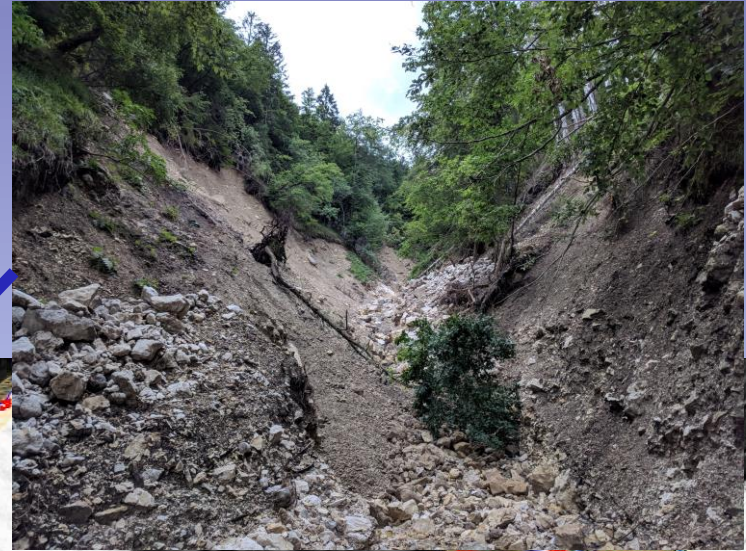
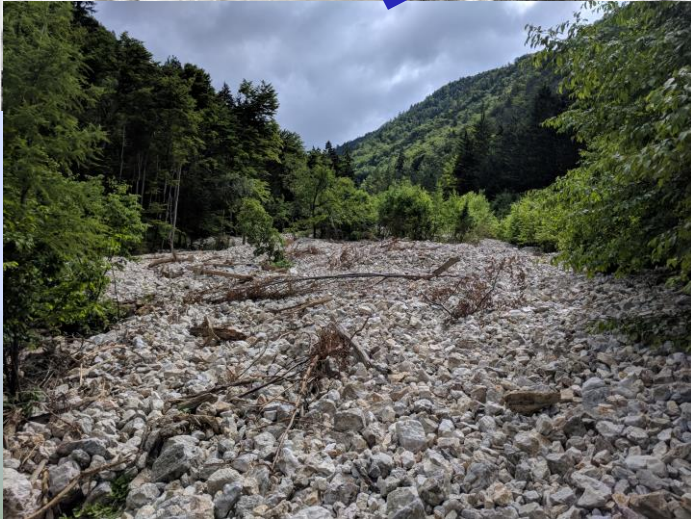
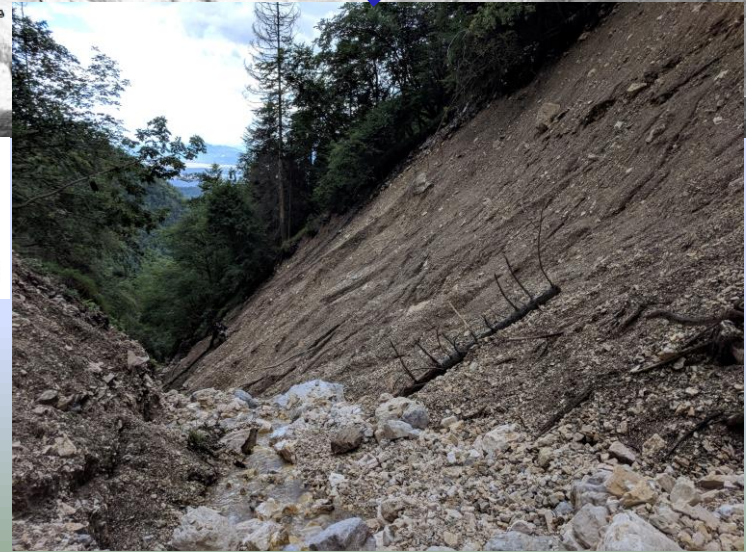
Geological settings of the catchment area

torrential sediment (coarse-grained gravel)
-

scree deposits
-

solid basement, dolomite prevails

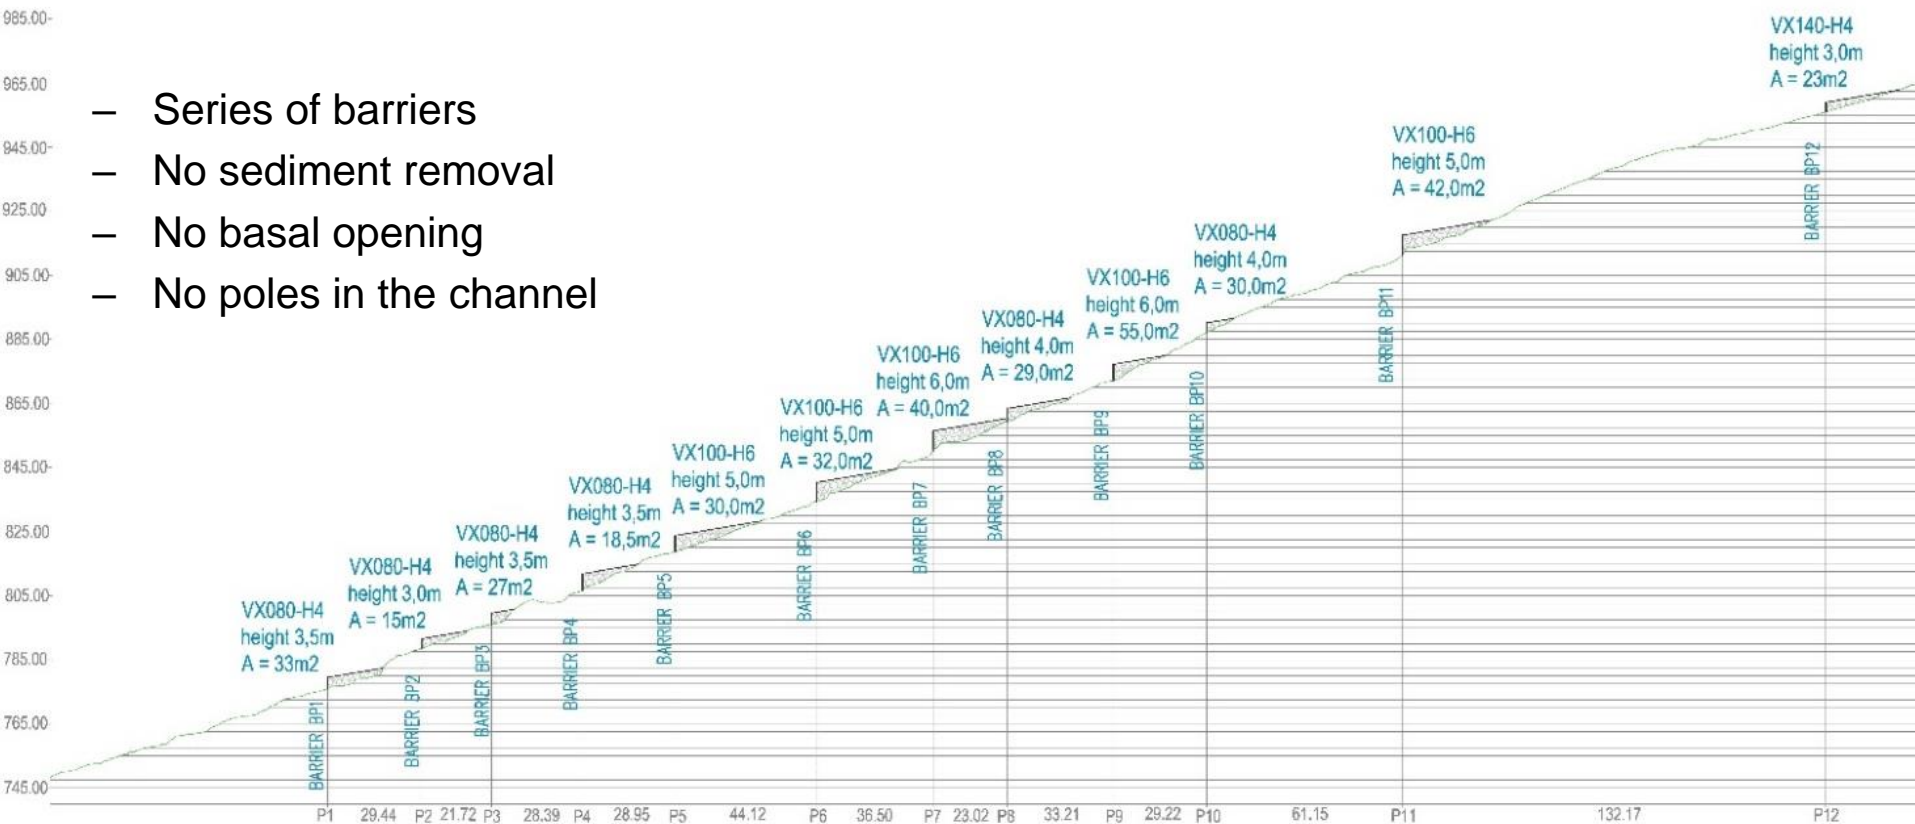
Phase 3 – dimensioning process

DEBFLOW ONLINE TOOL

Dimensioning of the flexible Debris Flow Protection System GEOBRUGG VX/UX - DEBFLOW

- Series of barriers
- No sediment removal
- No basal opening
- No poles in the channel

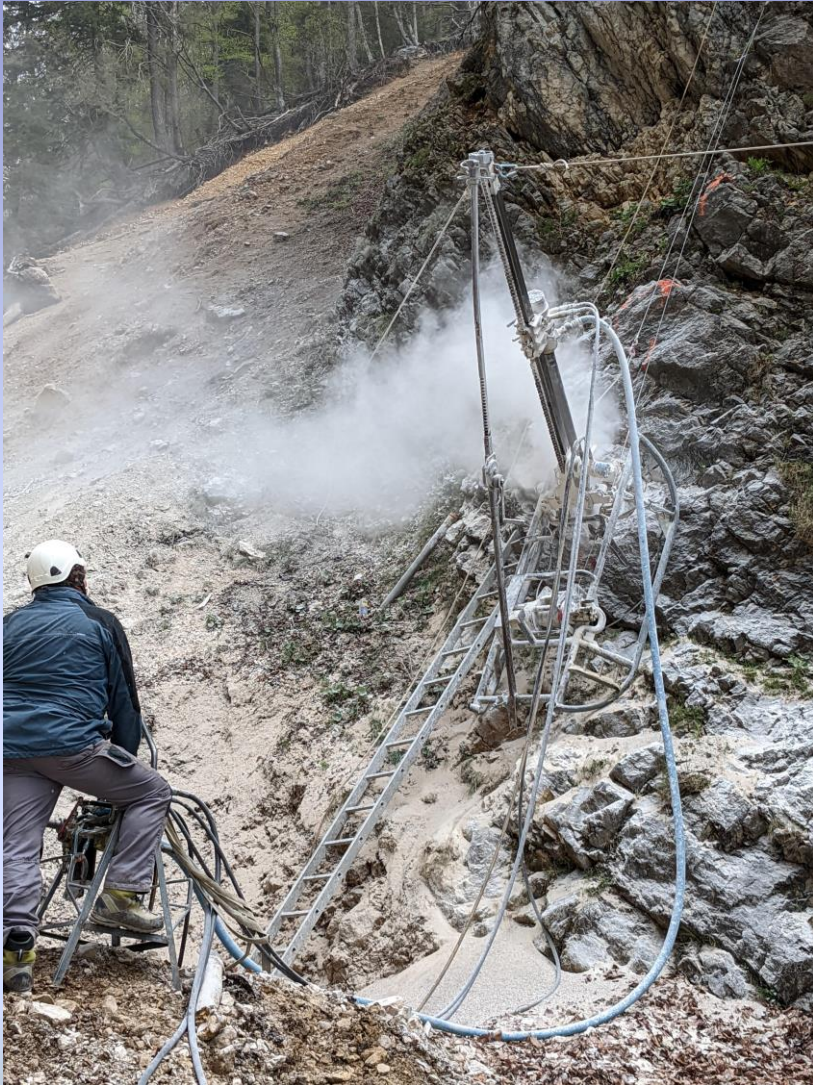
Phase 3 – Brezovški graben

Contractor: Hidrotehnik d.o.o. & Kaskader d.o.o. 13

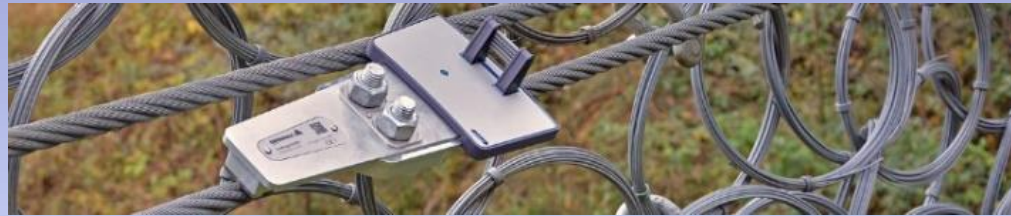
– A field debris flow / mass flow observatory

– Geobrugg GUARD

- Corrosion of the nets
- Measurement of the debris flow impacts and forces in barrier ropes

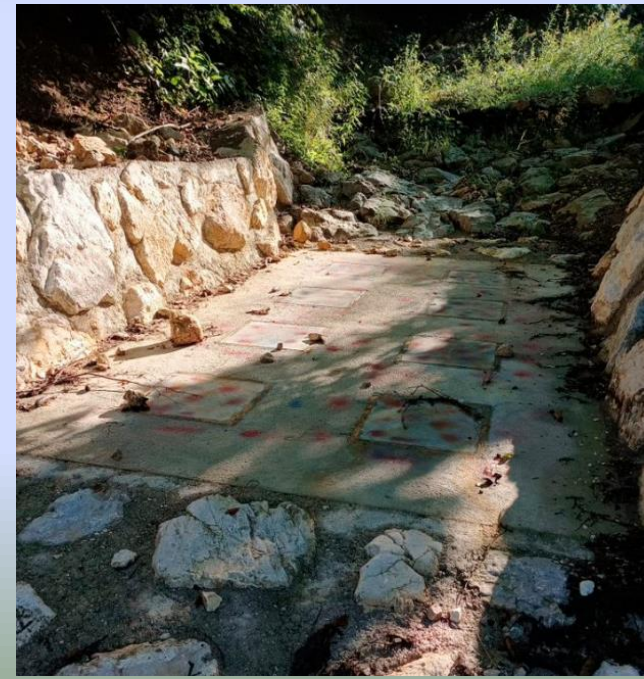
– Concrete abrasion monitoring

- Plates 50cm/50cm with 4 different types of concrete
- Upgrade of the research on The Lower Sava River

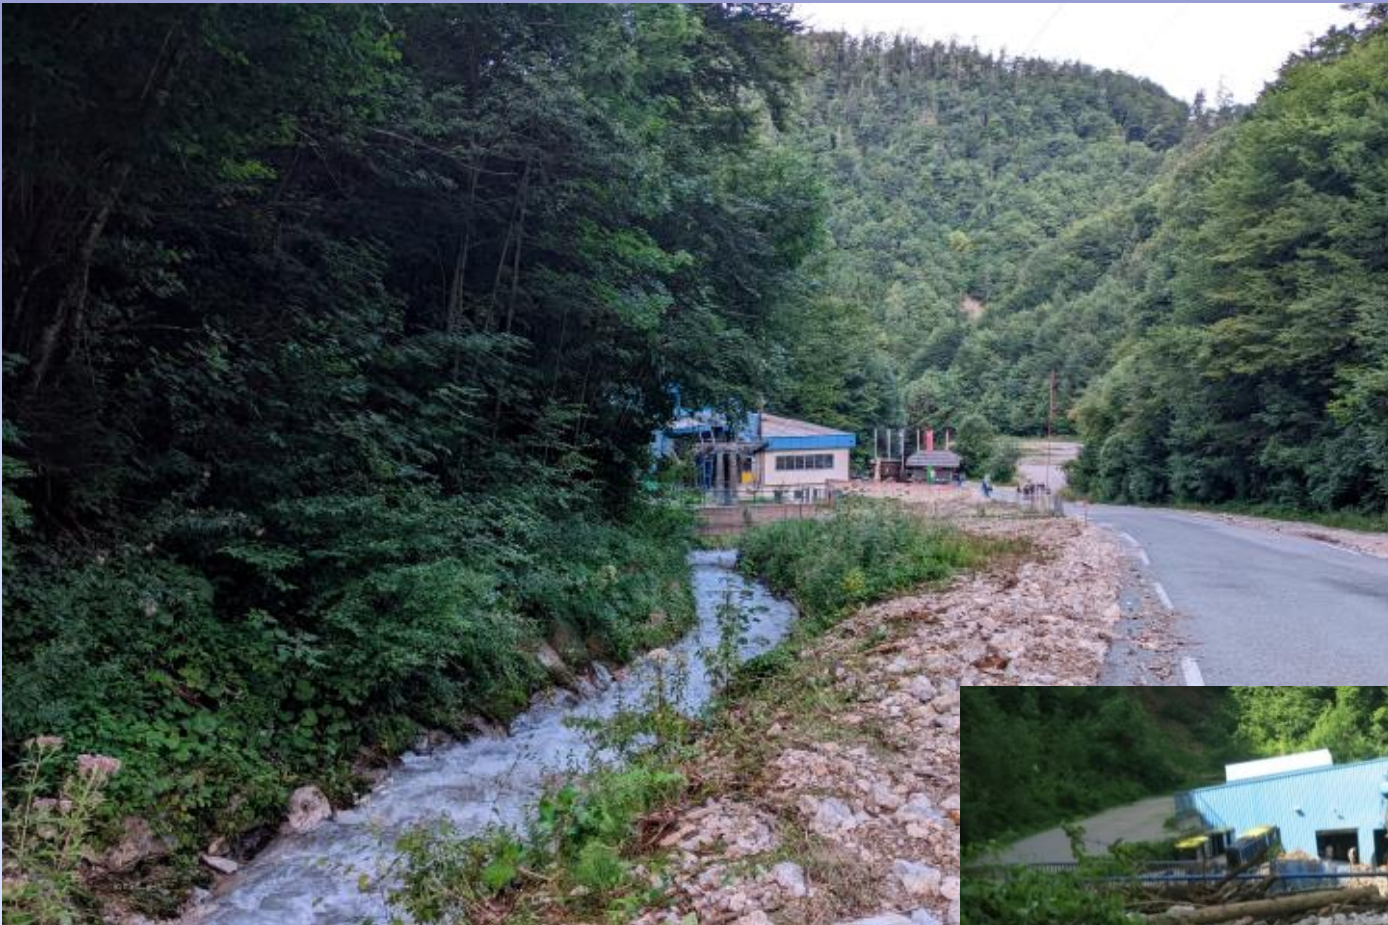
August 2023 flood event

- 30 mm in 30 min
 - 165 mm in 12h - over 250 year return period
 - 196 mm in 24h
- Numerous new landslides and intensive erosion process
 - Drone survey showed that 19.000m³ of material was trapped by the barriers + additional aprox. 30.000m³ was not eroded

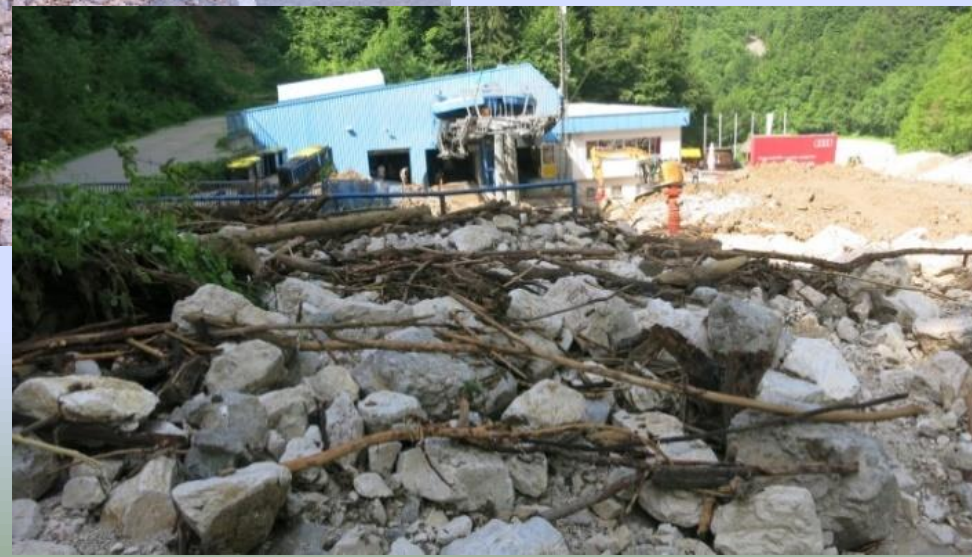
May 2018

August 2023

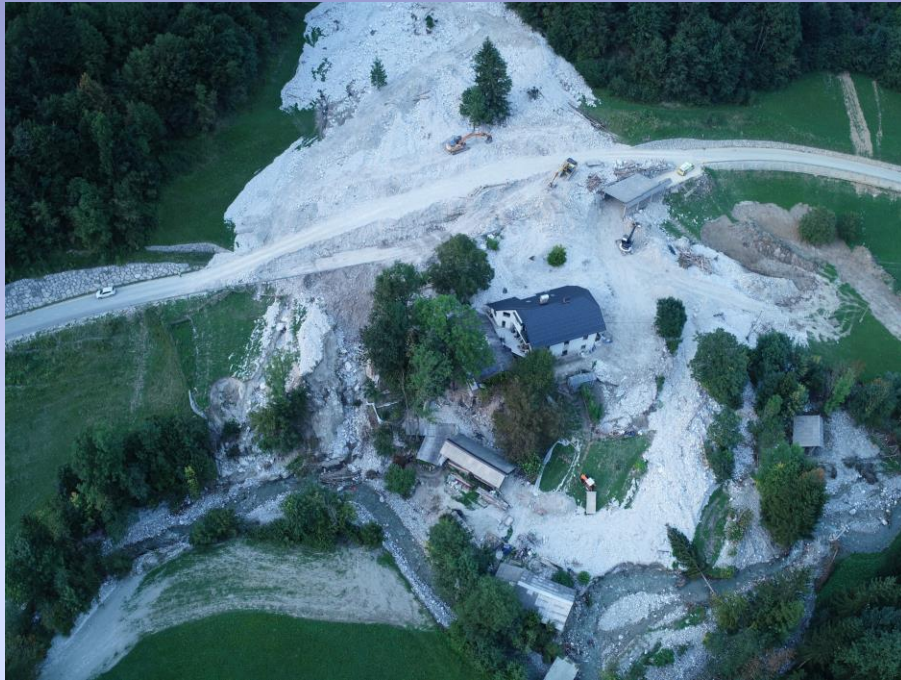
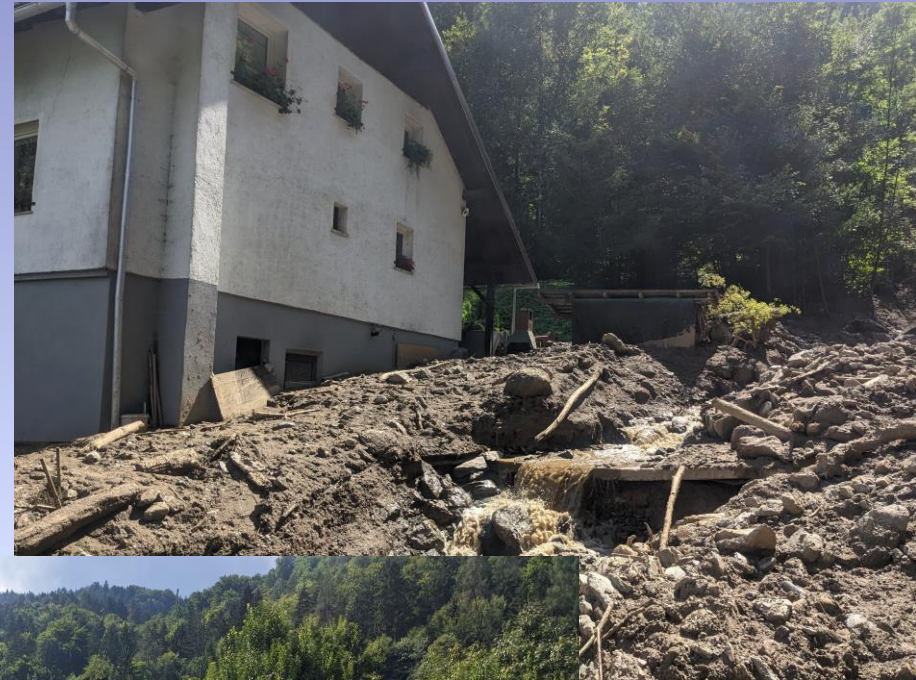
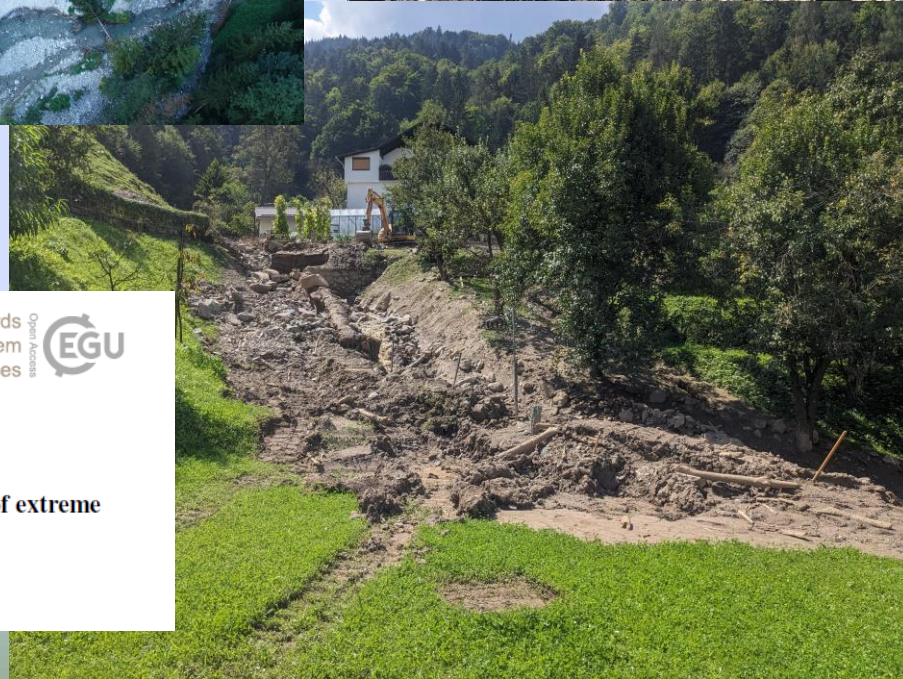
August 2023 flood event – other areas

- 25-35% of Slovenia affected
- 500+ year return period discharges in some areas
- Aprox. 10.000 new landslides
- 10 billion € estimated damage (17% of GDP)
