ABSTRACT

This case study focuses on the hydraulic-integrated environmental restoration of the Rio Santa Croce stream, encompassed within a Natura 2000 site (code IT6040024), located in Latina, Italy (Lat. 41.27°N, Long 13.71°E WGS 84). It serves as an illustrative example of how the Natura 2000 network, often perceived merely as a restriction by authorities, technicians and local communities, can be transformed into a valuable tool for steering hydraulic risk management towards nature-based solutions (NbS). This transformation could be achieved through the appropriate assessment (AA) regulated by Article 3 of the European Council Directive 92/43/EEC.

A multidisciplinary team, comprising professional foresters from the Società Cooperativa Trifolium a.r.l., along with professional engineers and a professional geologist, on behalf of the Province of Latina, conceived a green gabion wall to stabilize the banks of a section of the Rio Santa Croce while creating habitats for aquatic vertebrates. These retaining structures are considered environmental-friendly, offering a more sustainable option compared to traditional earth-retaining walls. By integrating vegetation and implementing sp

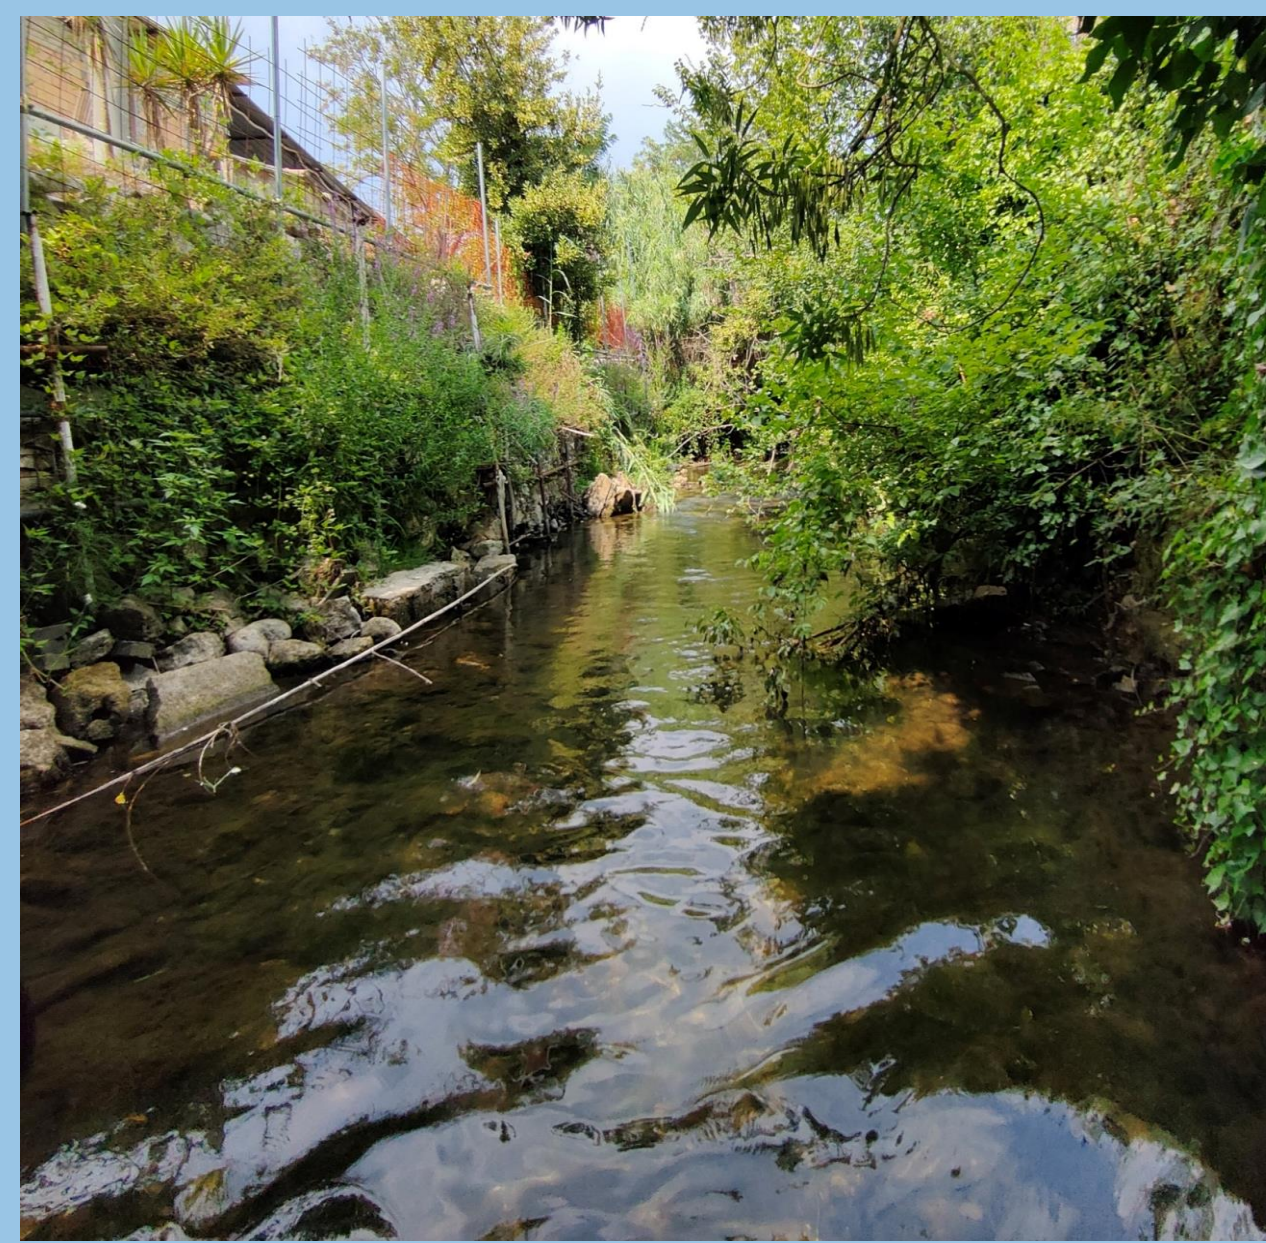
Figure 1 – Reach of the Rio Santa Croce

The Rio Santa Croce is a stream located in Latina, Italy (41.27°N, 13.71°E). Its main stem extends 1.2 km, flowing north-southwest from Capodacqua di Spigno source into the Tyrrhenian Sea, where it forms a narrow estuary at its mouth. The catchment area is approximately 35.3 km², with a diverse topography, including rugged mountainous terrains, as well as an alluvial plain that is heavily urbanized. Elevations range from approximately 0 m amsl to over 1,200 m amsl. In the sector analyzed, the road embankment of the Appia way variant aligns with the stream bank, which has been excavated in alluvial deposits from the valley floor, showing signs of erosion. The riverbed shows moderate incision, with steep banks that terminate in sub-vertical escarpments. The study area is encompassed within a Natura 2000 site (code IT6040024); it features hazard zones classified as A1 (high hazard) by the Appennino Centrale District Basin Authority (Fig. 1).

- a. Hydrology and hydraulic study:** the hydraulic simulation reveals that the stream does not have a sufficient hydraulic section for the considered flood events;
