# Geoelectrical and seismic investigation of a subsidence geohazard zone in Neckendorf, Saxony-Anhalt, Germany

## Supplementary material

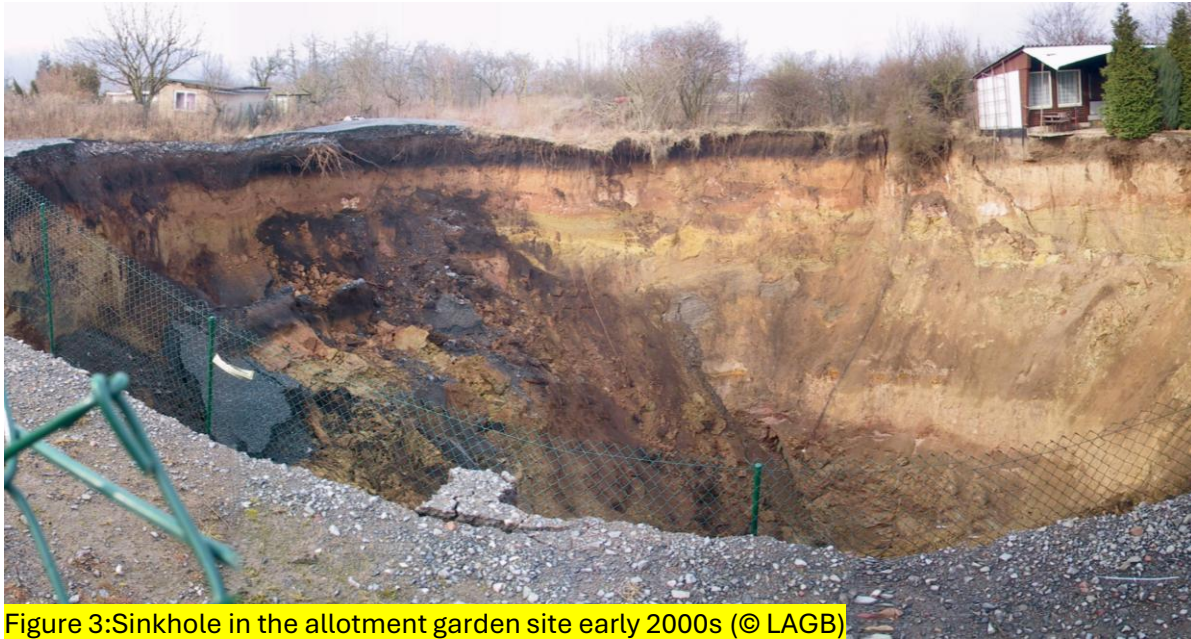
Figure 3: Sinkhole in the allotment garden site early 2000s (© LAGB)

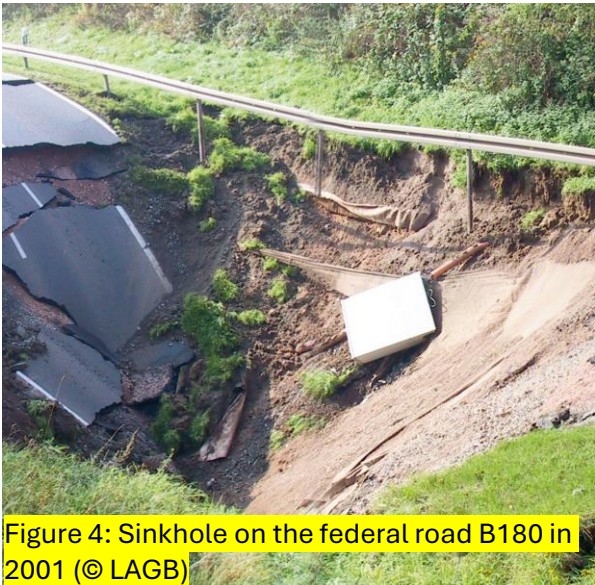
Figure 4: Sinkhole on the federal road B180 in 2001 (© LAGB)

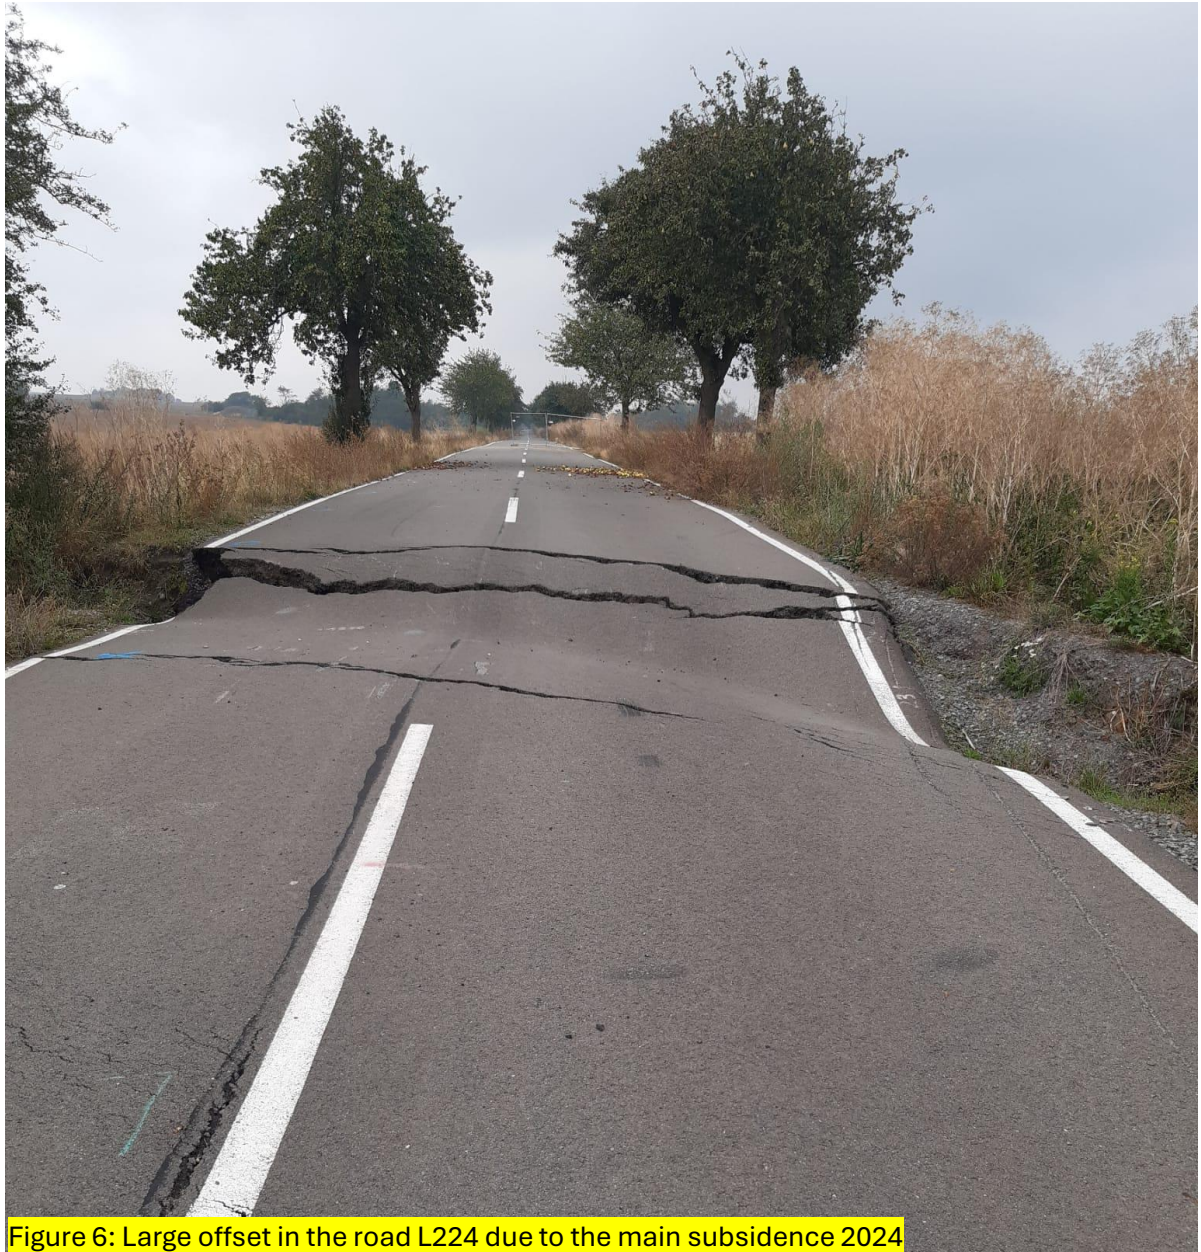
Figure 6: Large offset in the road L224 due to the main subsidence 2024

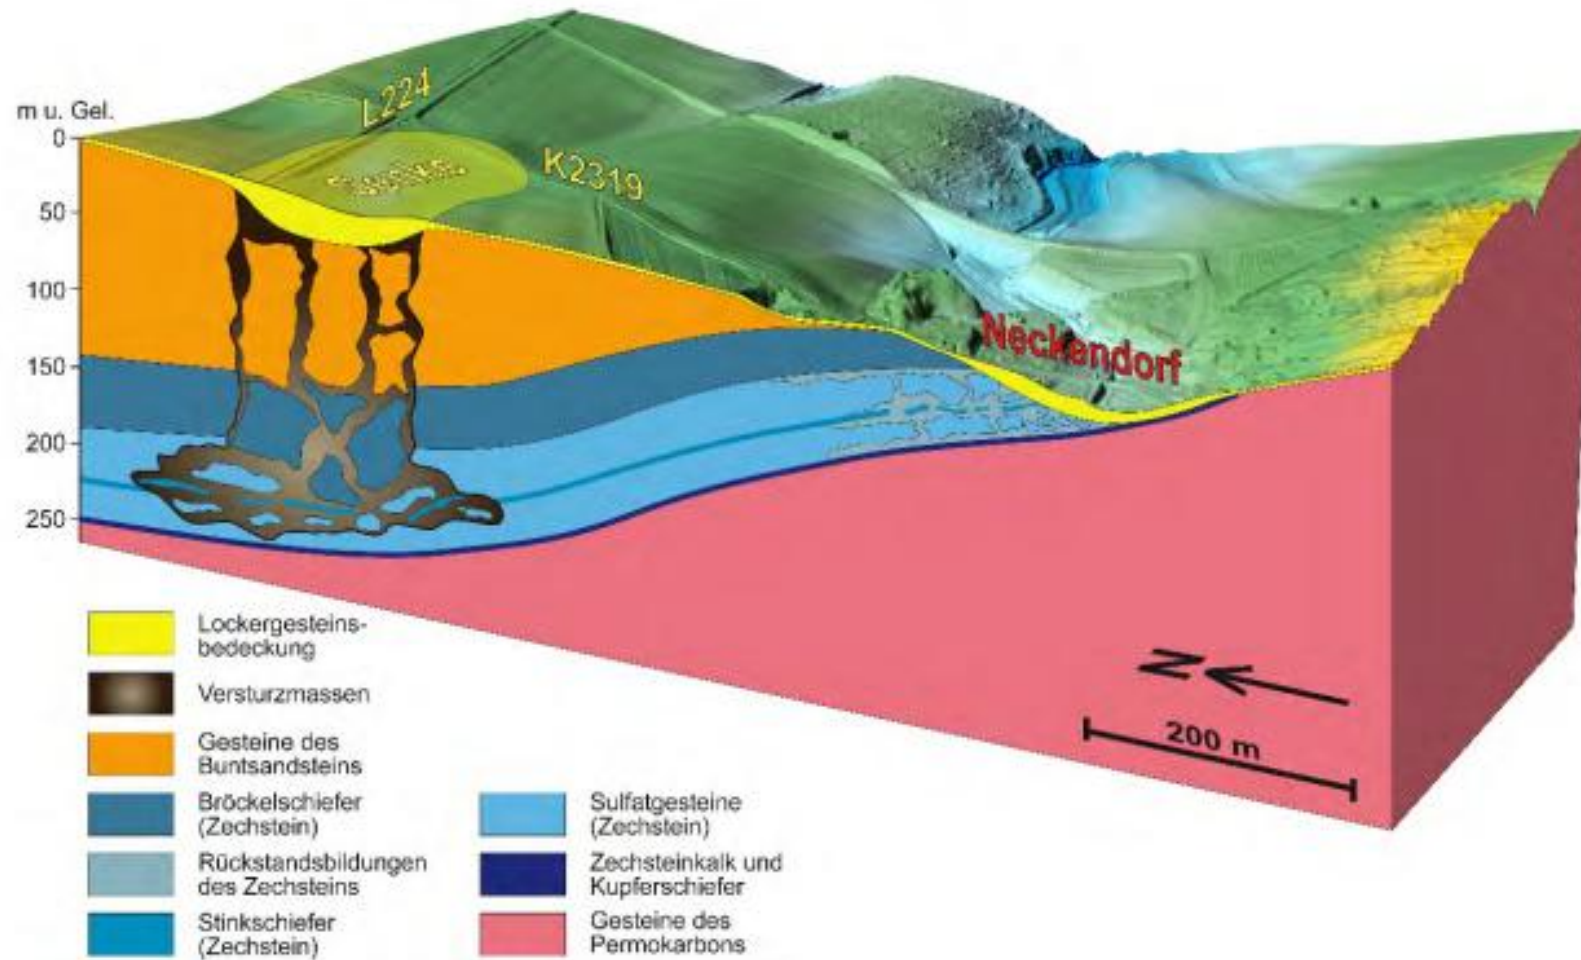
## Model of the geological situation in the subsidence area [LAGB]
