Sediment disasters induced by the 26-28 September 2024 extreme rainfall event in Nallu Khola watershed of Central Nepal

Study area & rainfall event

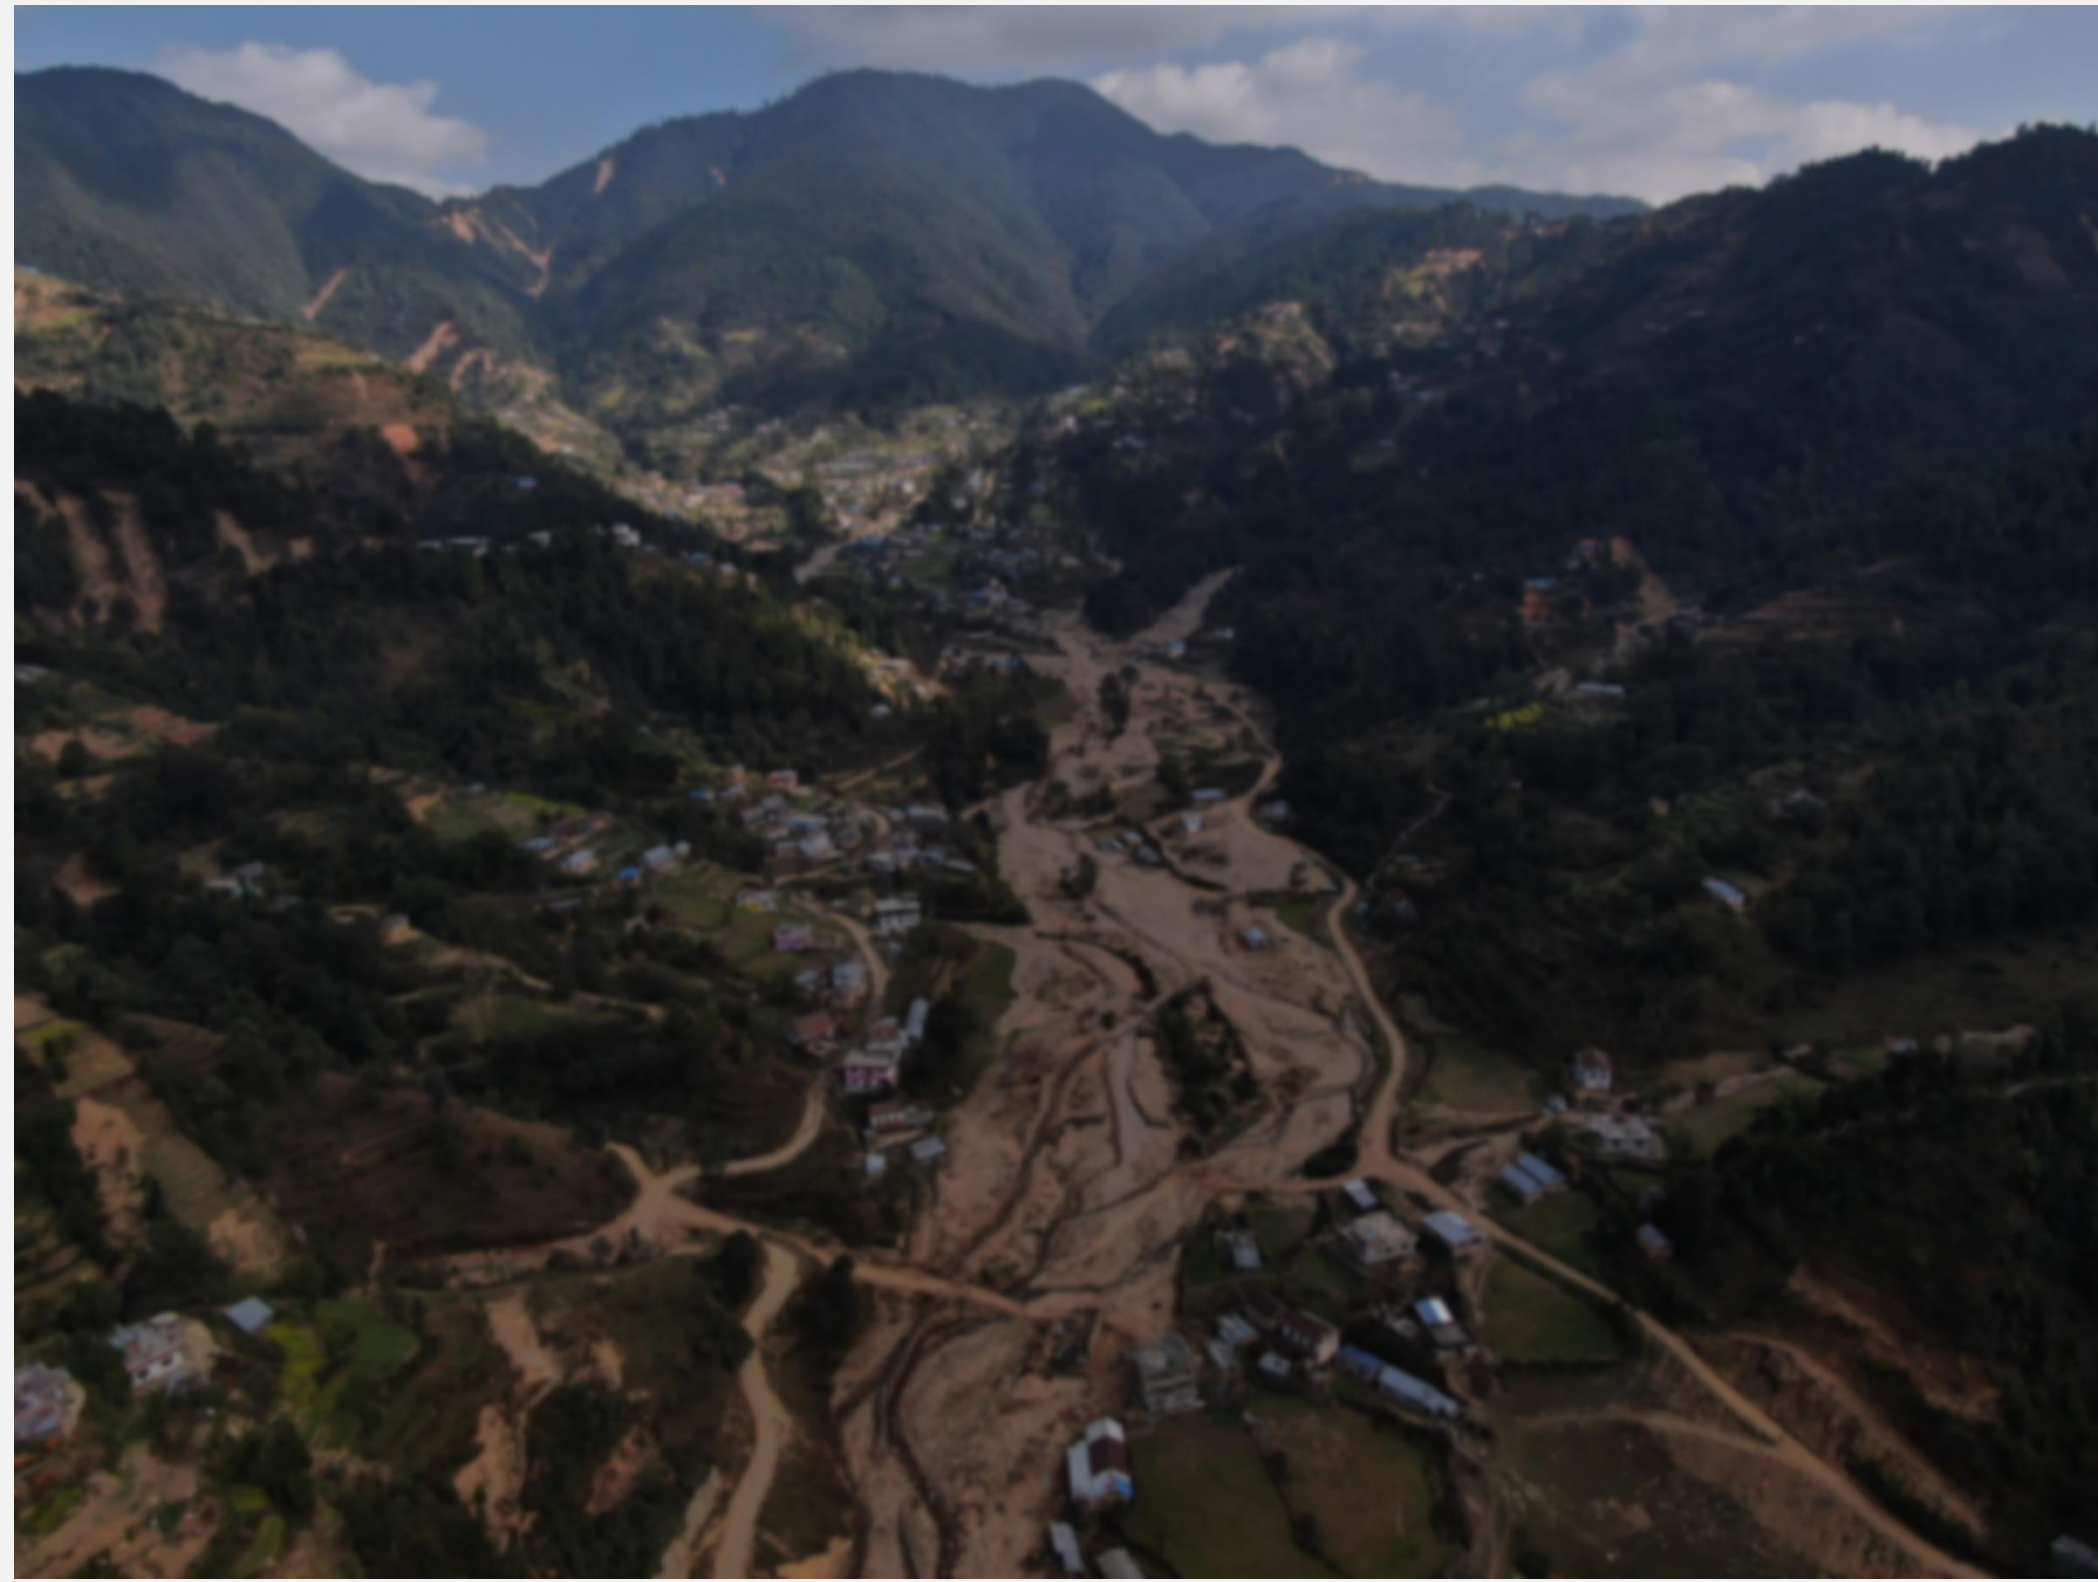
Fig. 3 Rainfall triggered compound sediment disasters, raising the river ~3 m above the riverbed, along with landslides and debris flows. Shallow landslides primarily occur along roads and cultivated land areas.

The rainfall triggered a series of compound sediment disasters, including raising the river level by approximately 3 m above the riverbed, along with numerous landslides and debris flows (Fig. 3).

The landslides predominantly consist of shallow failures, primarily occurring along roads and in areas associated with cultivated land, while areas covered with forest exhibit relatively few failures (Fig. 3).

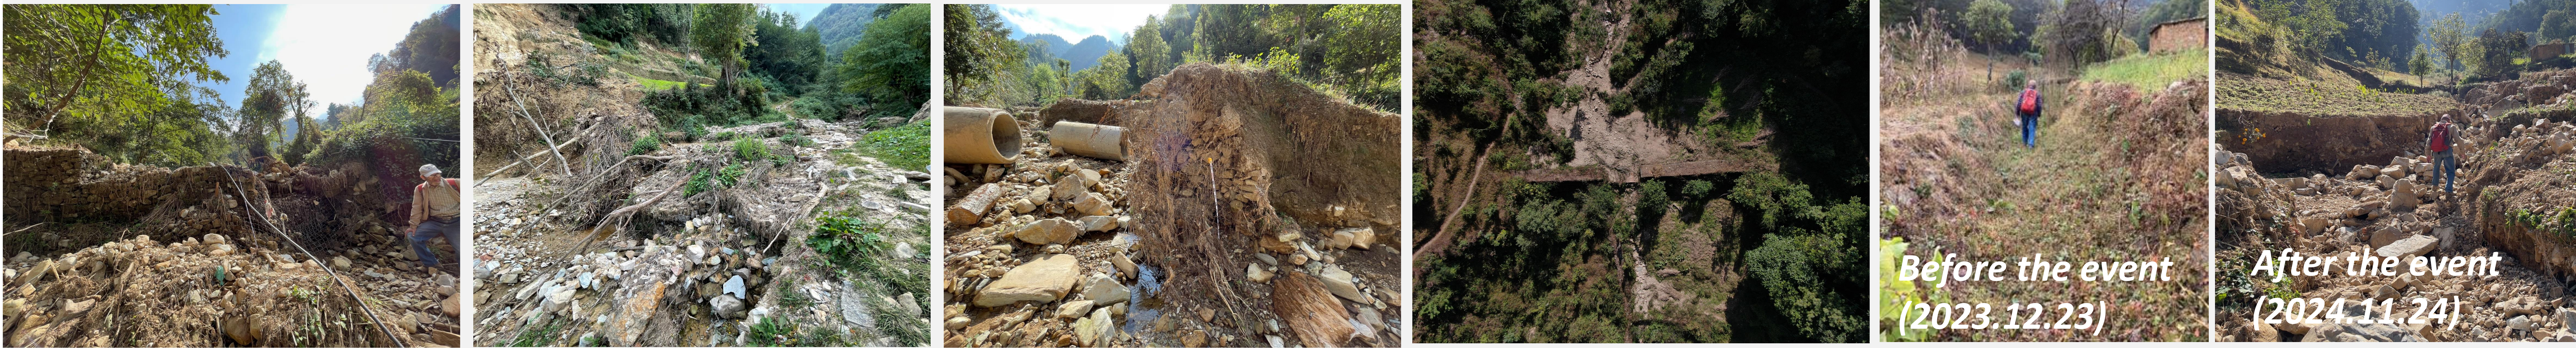
Mitigation measures (gabion check dams and channel works on gullies No. 8 & No. 11)

Debris flows are predominantly concentrated in creeks, with a comparable event having occurred on September 30, 1981. Following that event, debris flow mitigation engineering measures (e.g. gabion check dams and channel works) were implemented in some creeks and the impacts of the 2024 event appear to have been largely confined to these mitigated creeks. This underscores the importance of implementing and maintaining effective mitigation measures to manage debris flow hazards in vulnerable areas.

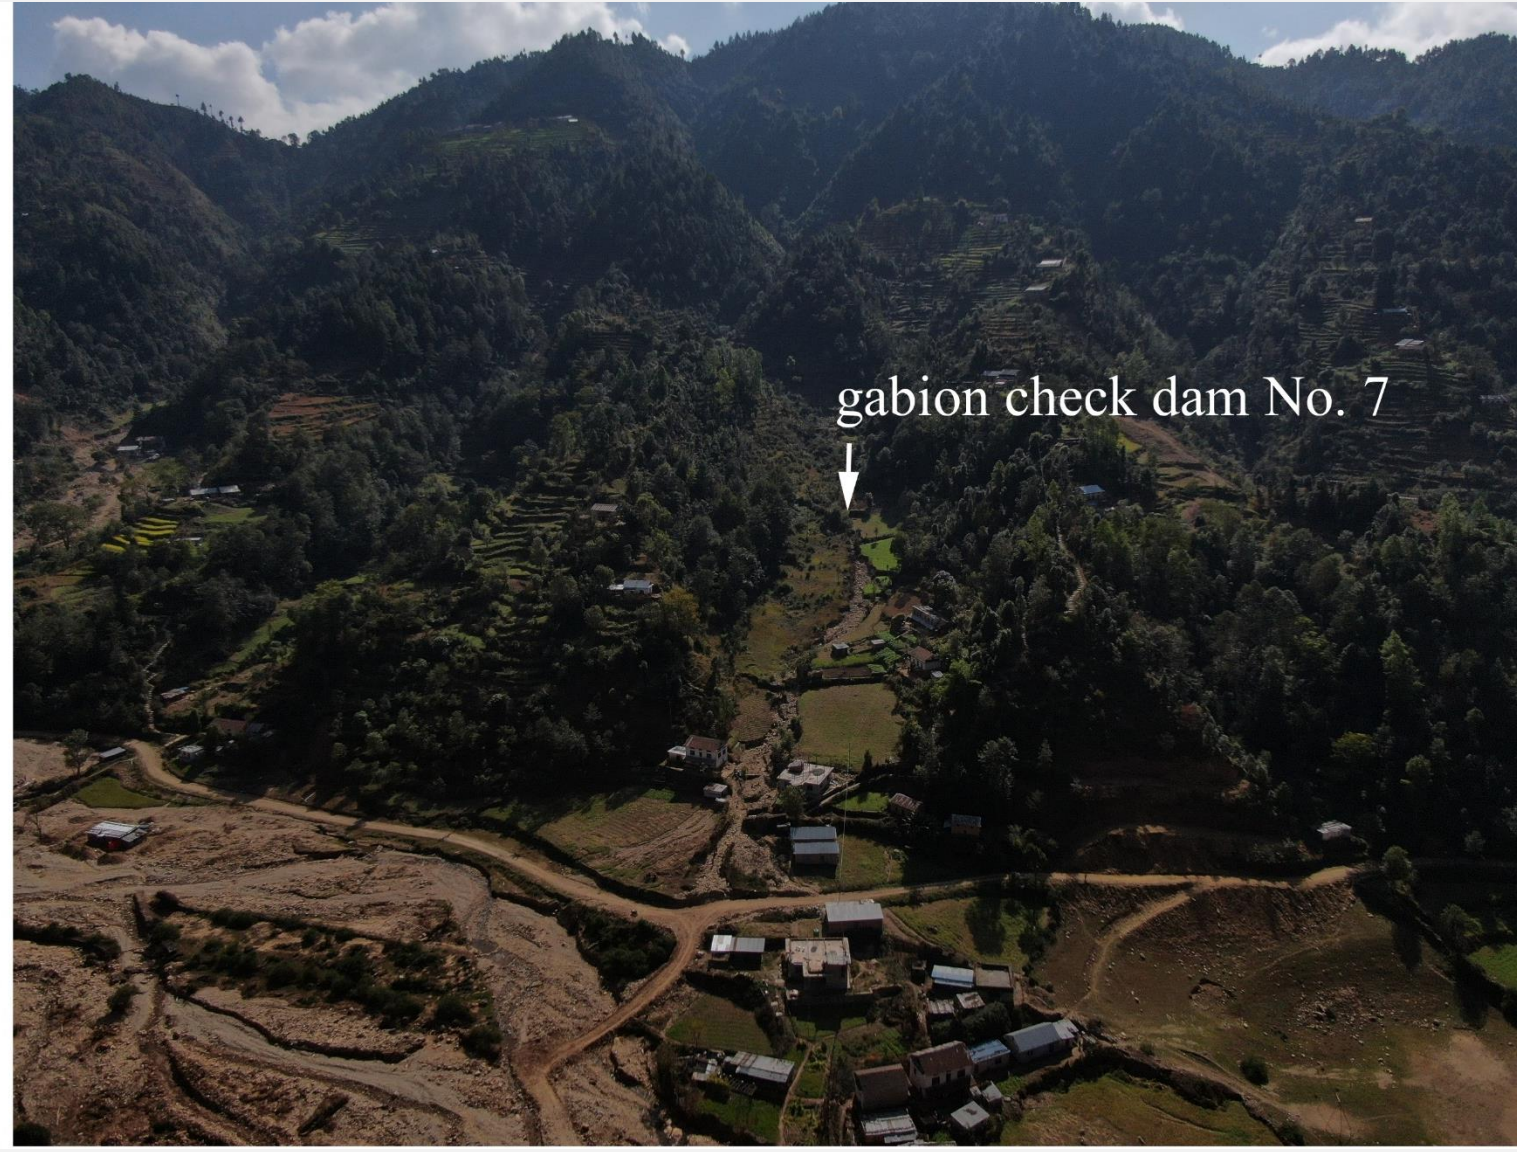
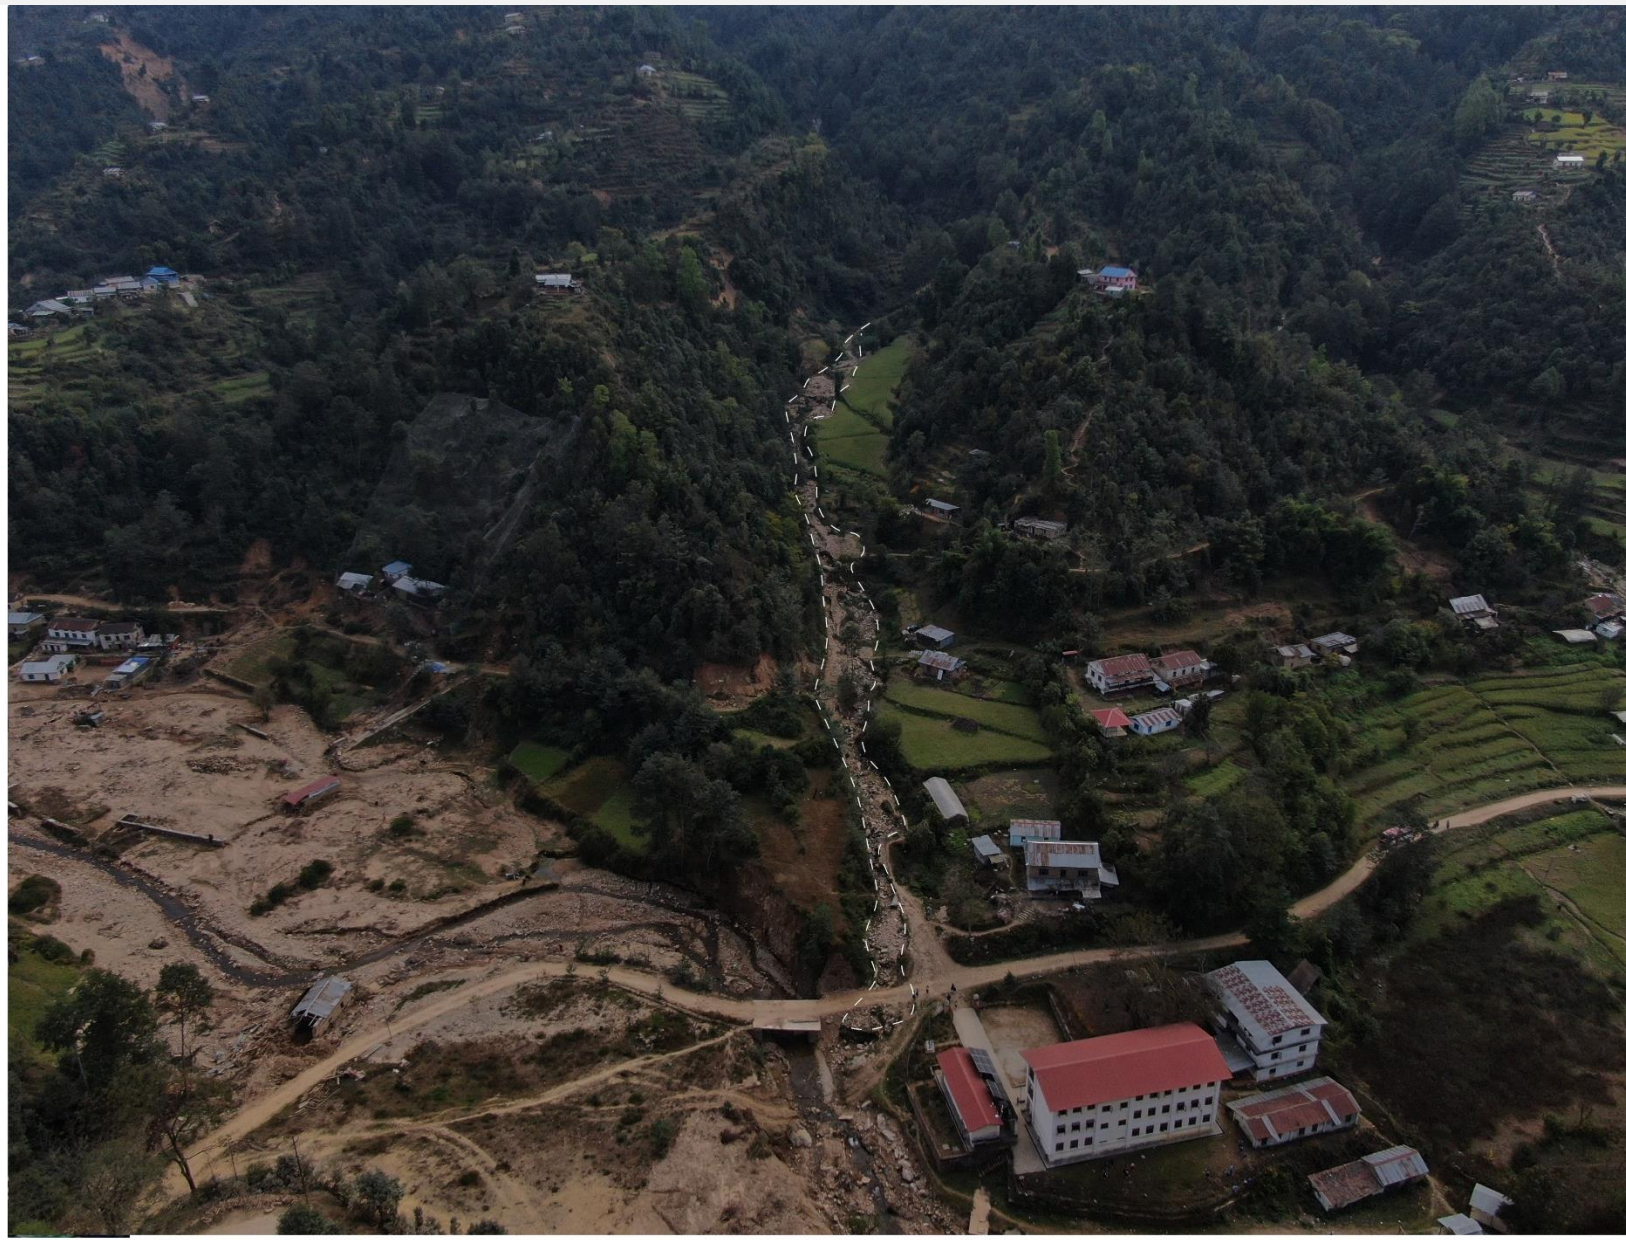
Gullies (No. 8 & No. 11) with mitigation measures

Before the event

Google Earth (2024.9.23)

After the event

(2024.11.24)

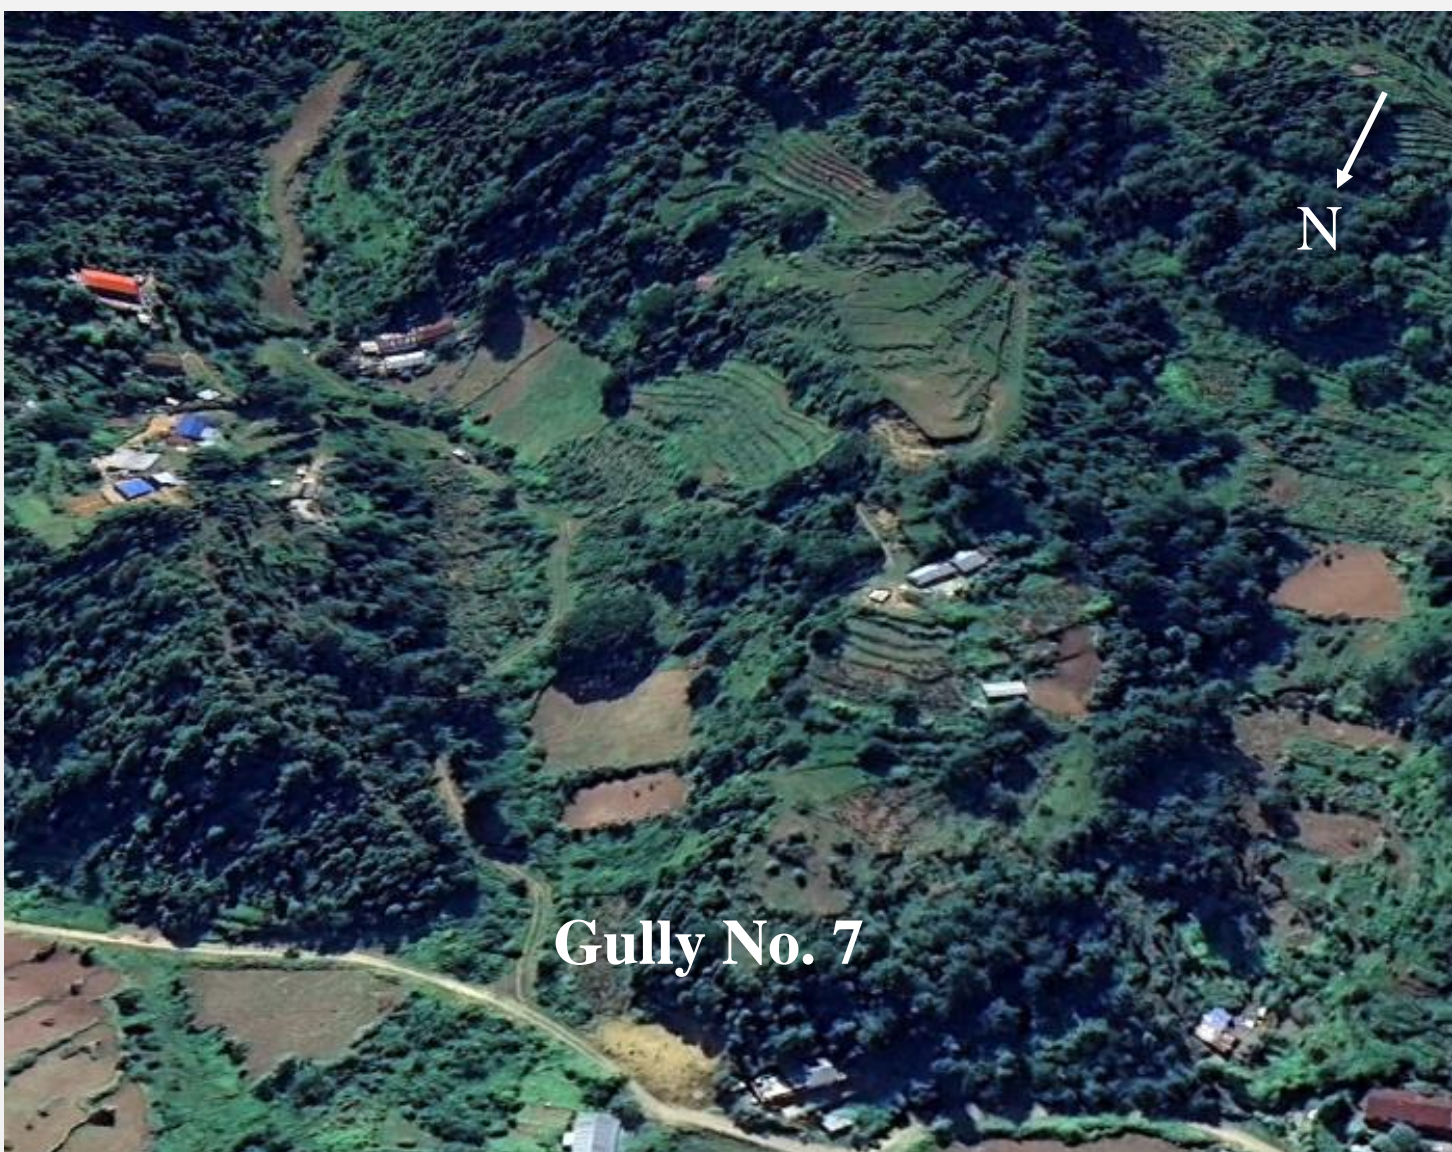
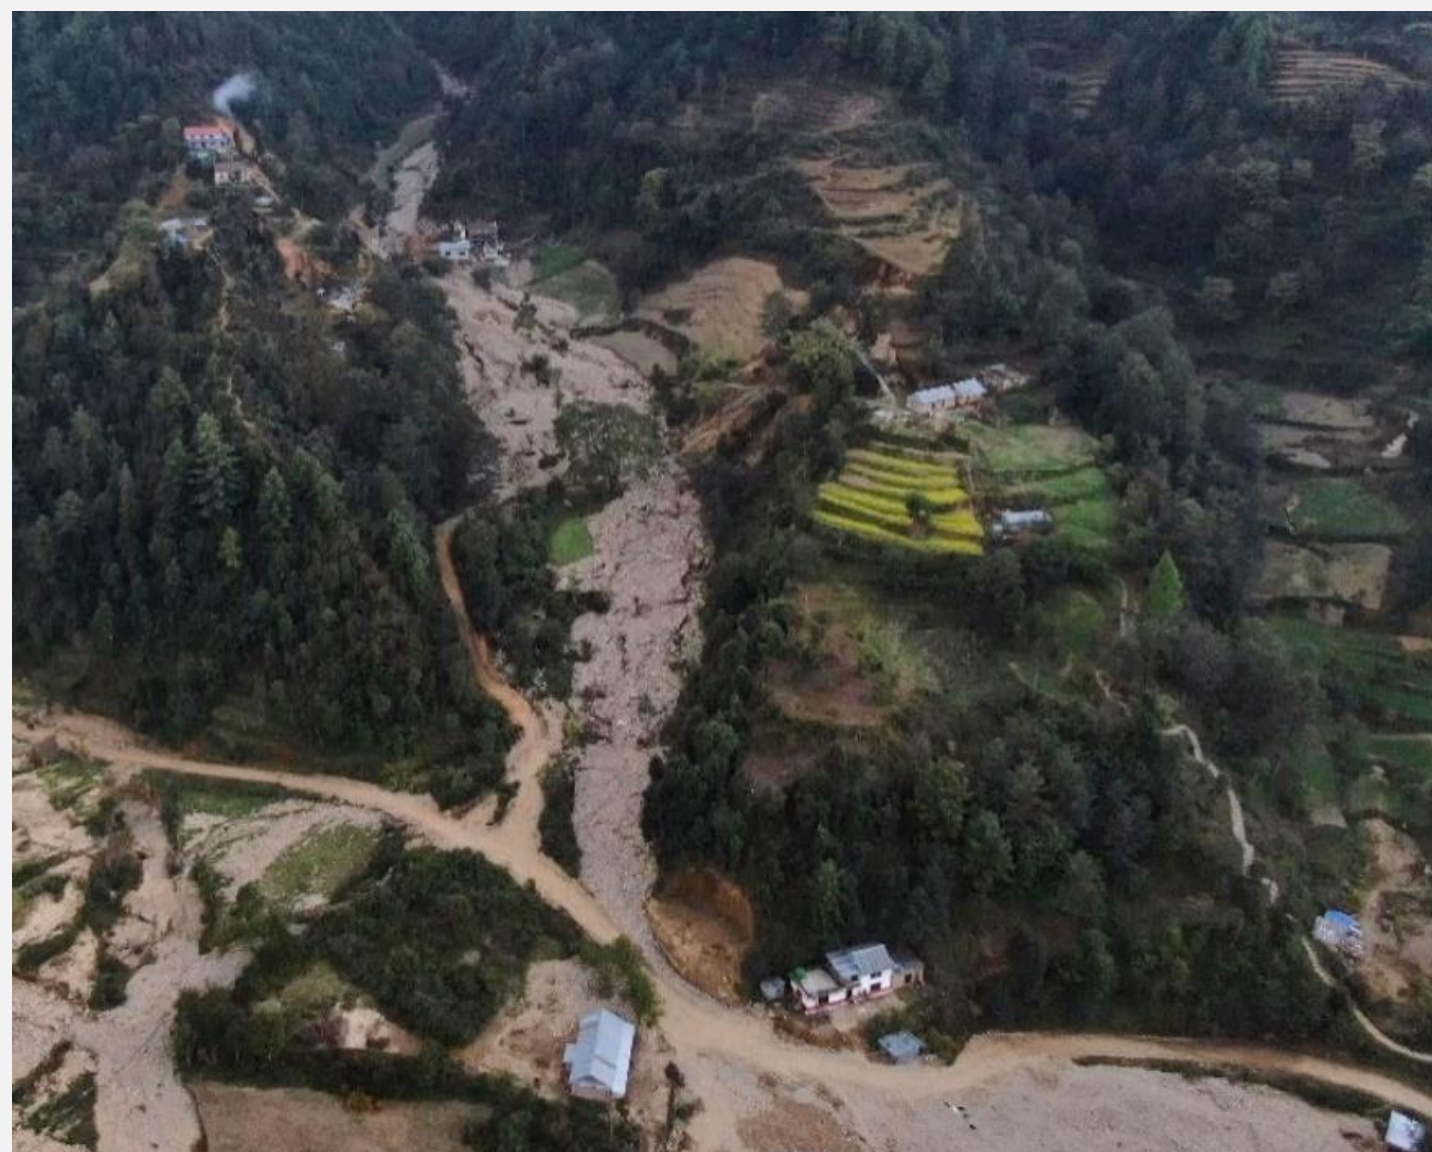
Gullies without mitigation measures

Before the event

Google Earth (2024.9.23)

After the event

(2024.11.24)

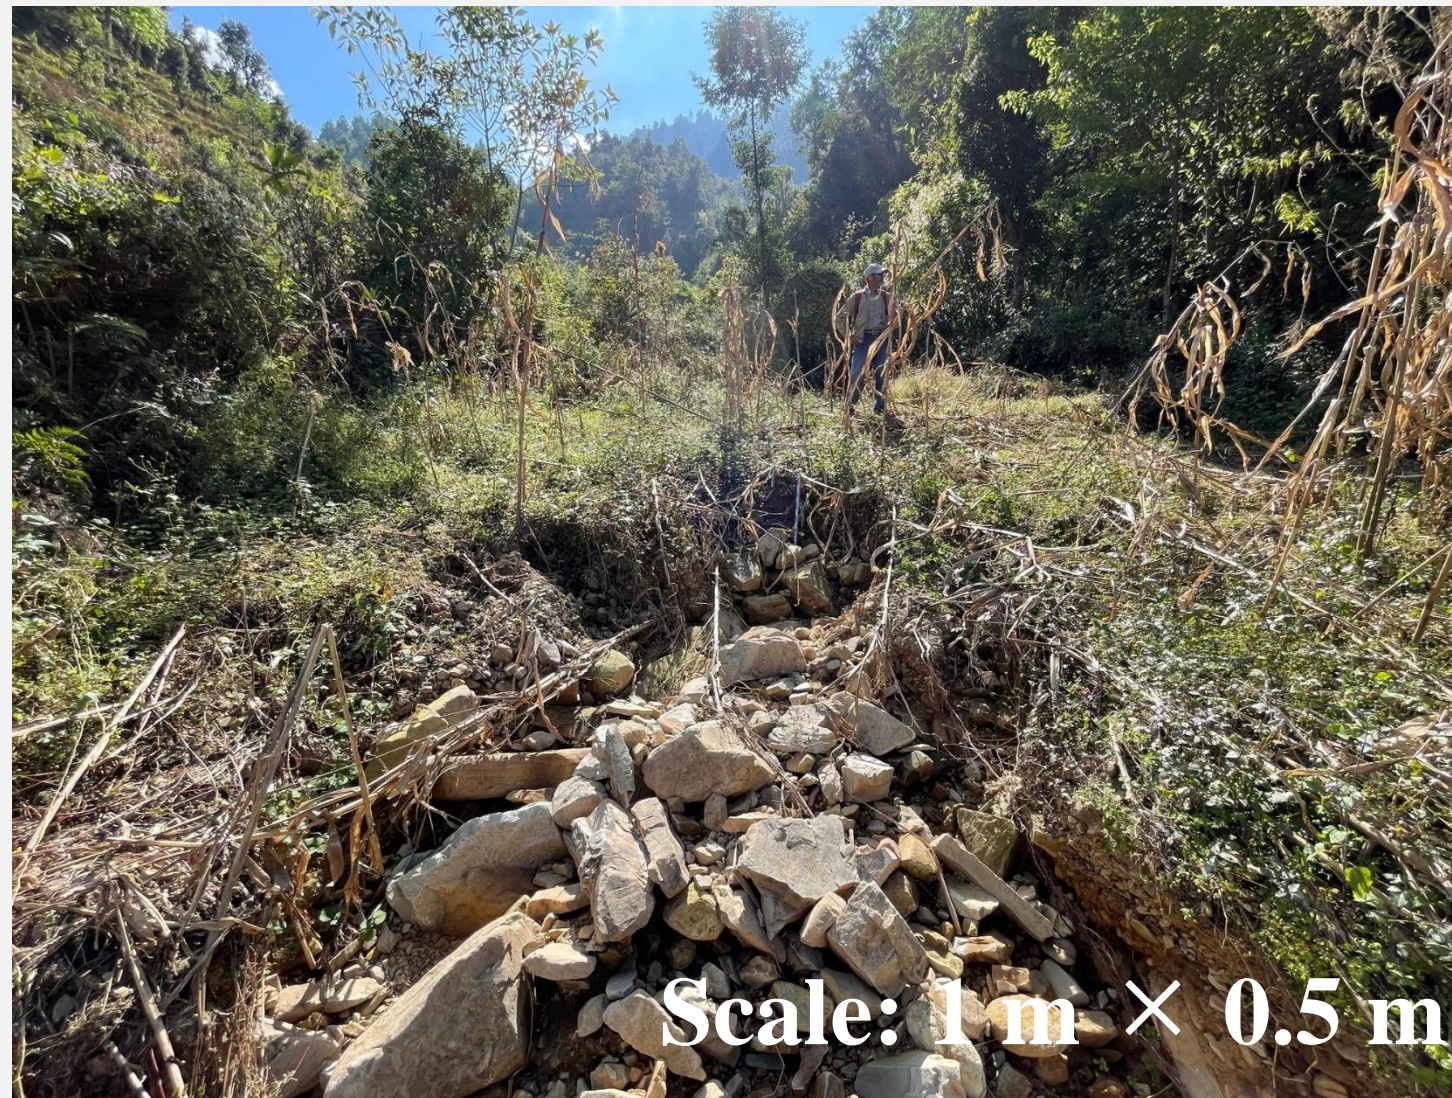
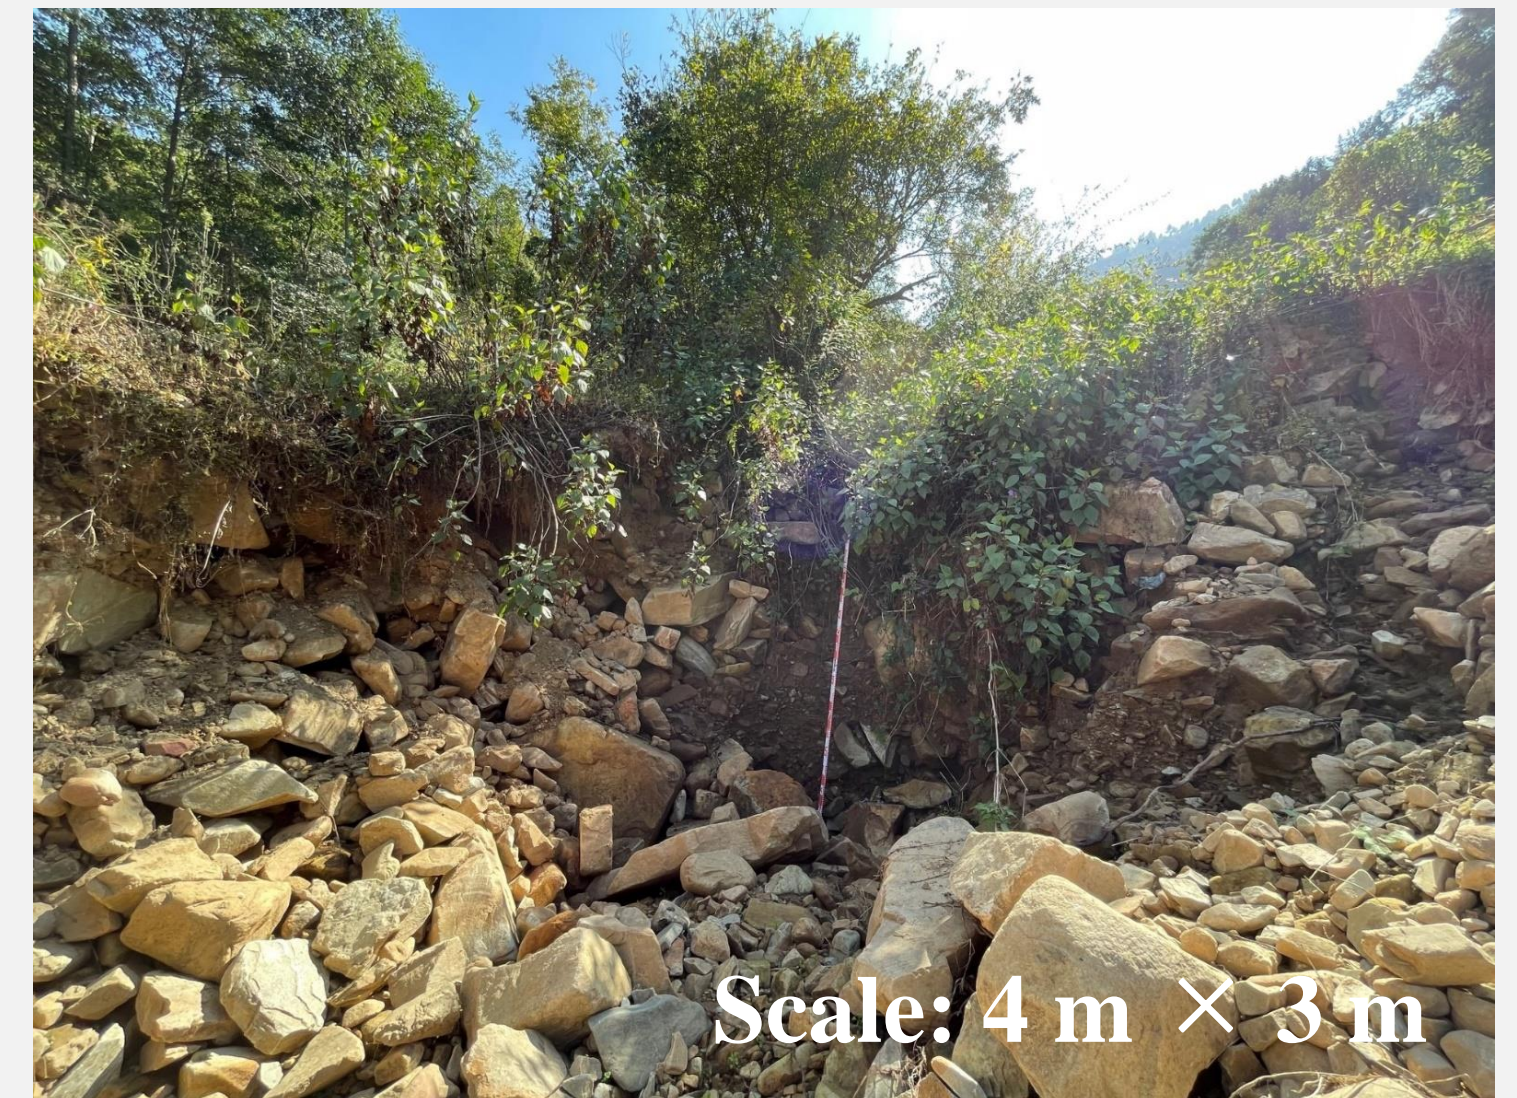
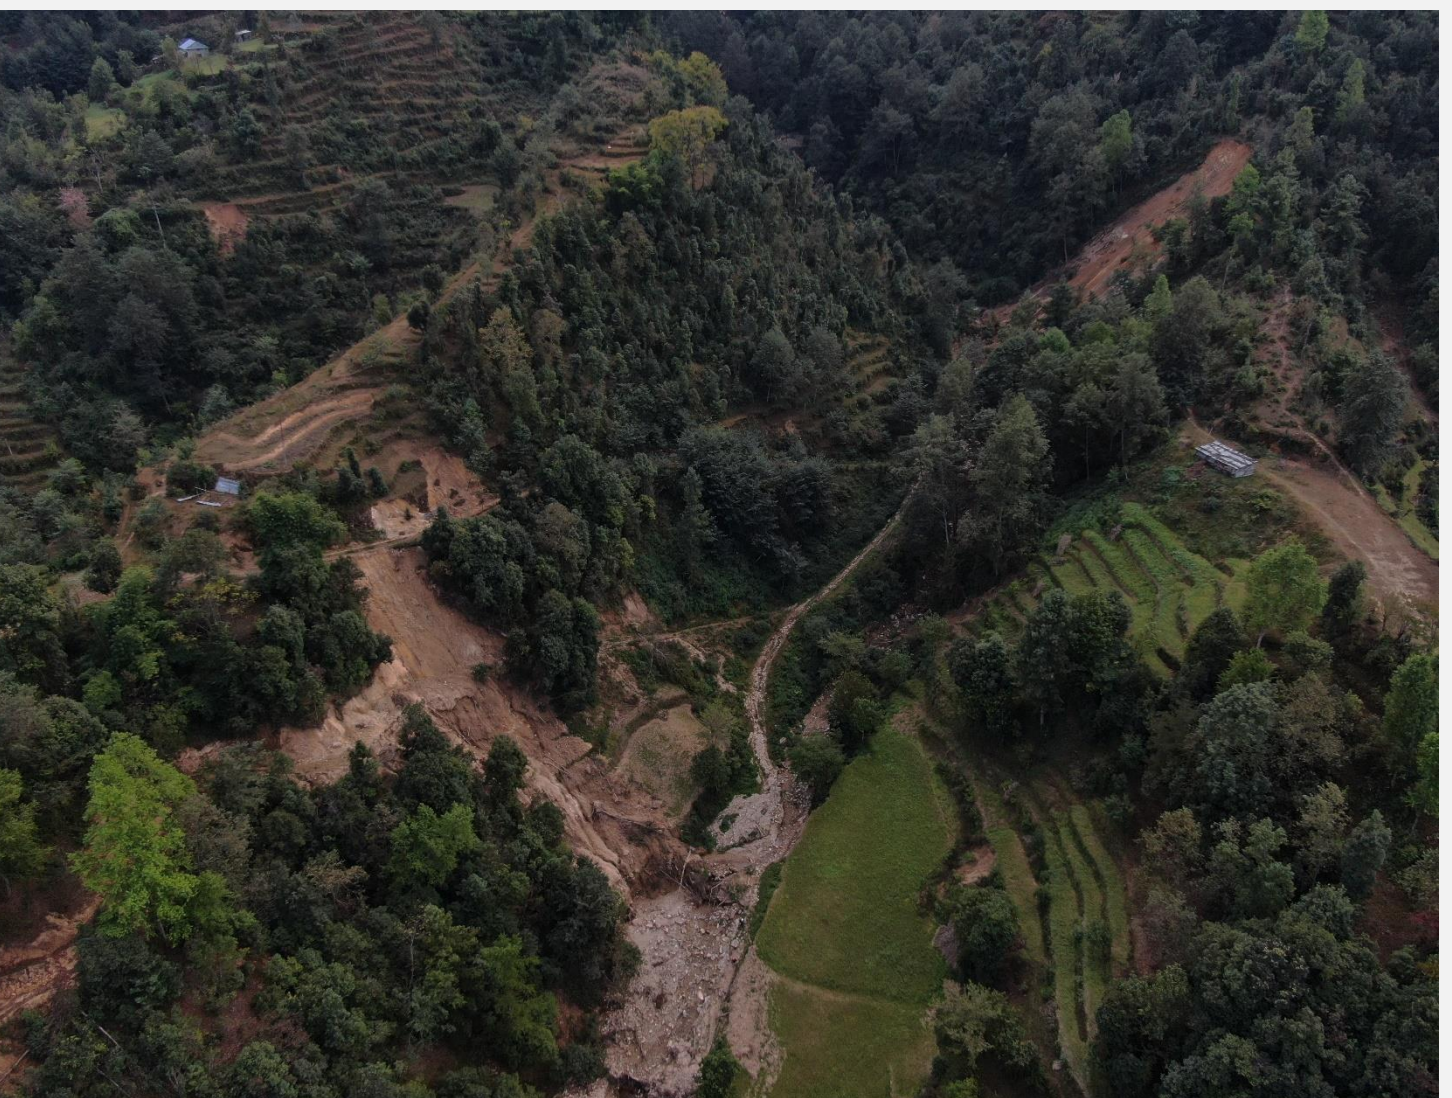
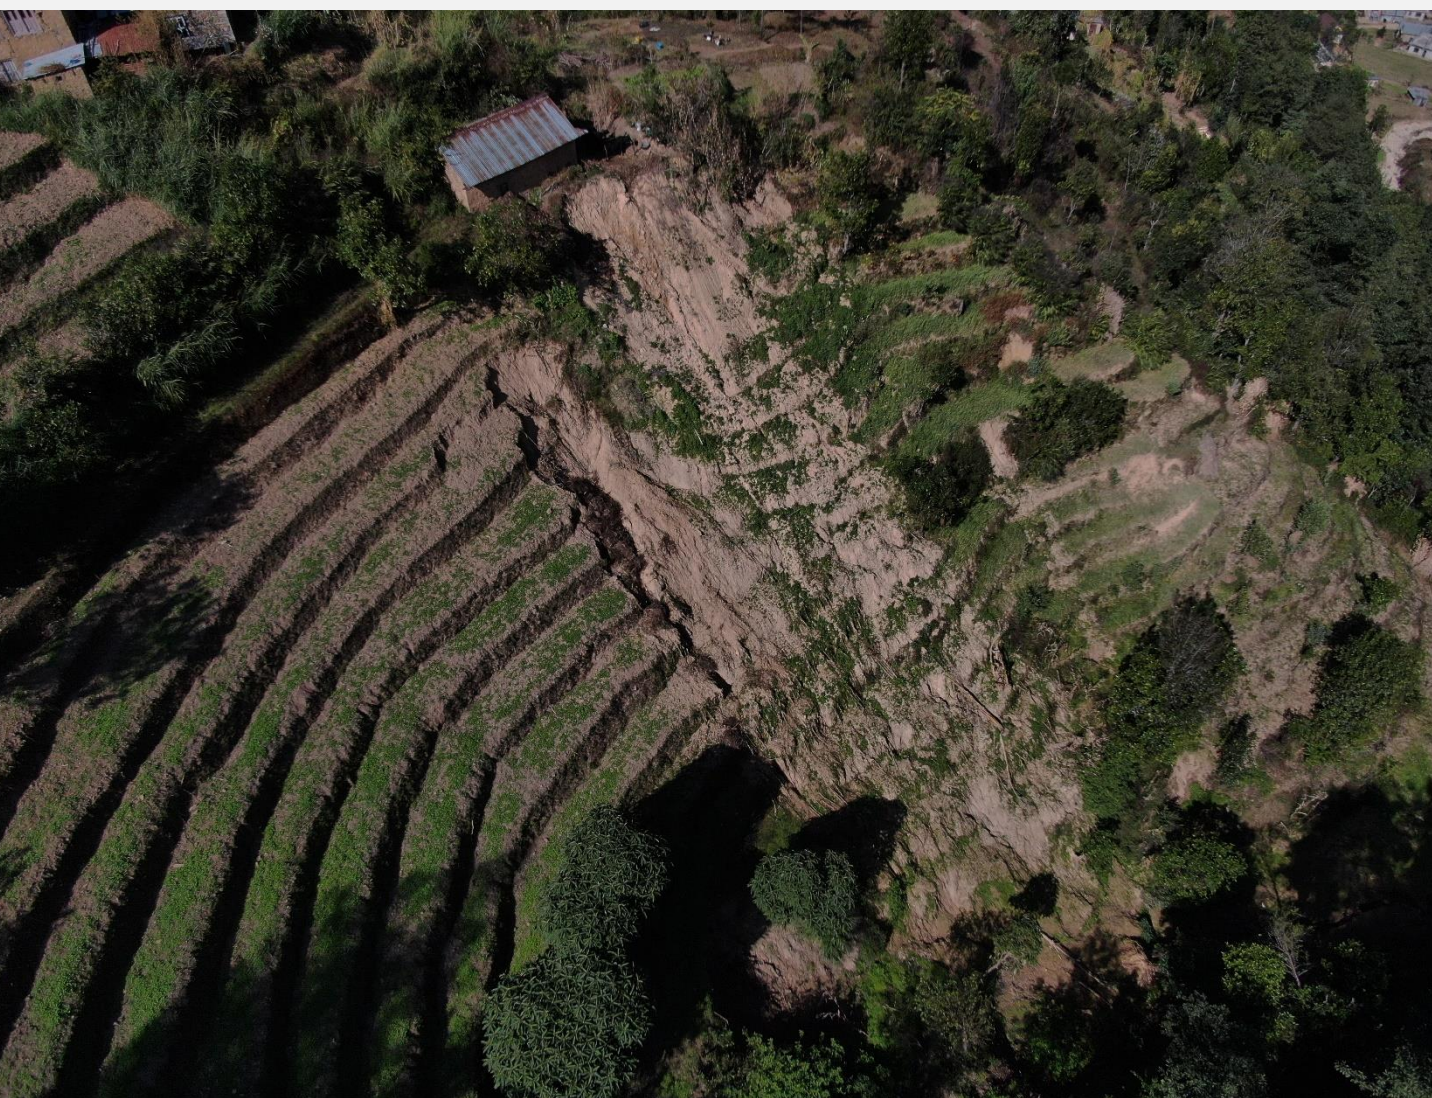
Source areas of debris flows (gullies No. 8 & No. 11) involve remobilization of 1981 debris flow event remnants and shallow landslides
