Flash Flood Events in the North-western Black Sea Region under Climate Change

Valeriya Ovcharuk and Inna Khomenko
Odesa I.I. Mechnikov National University, Ukraine

EGU26-14233

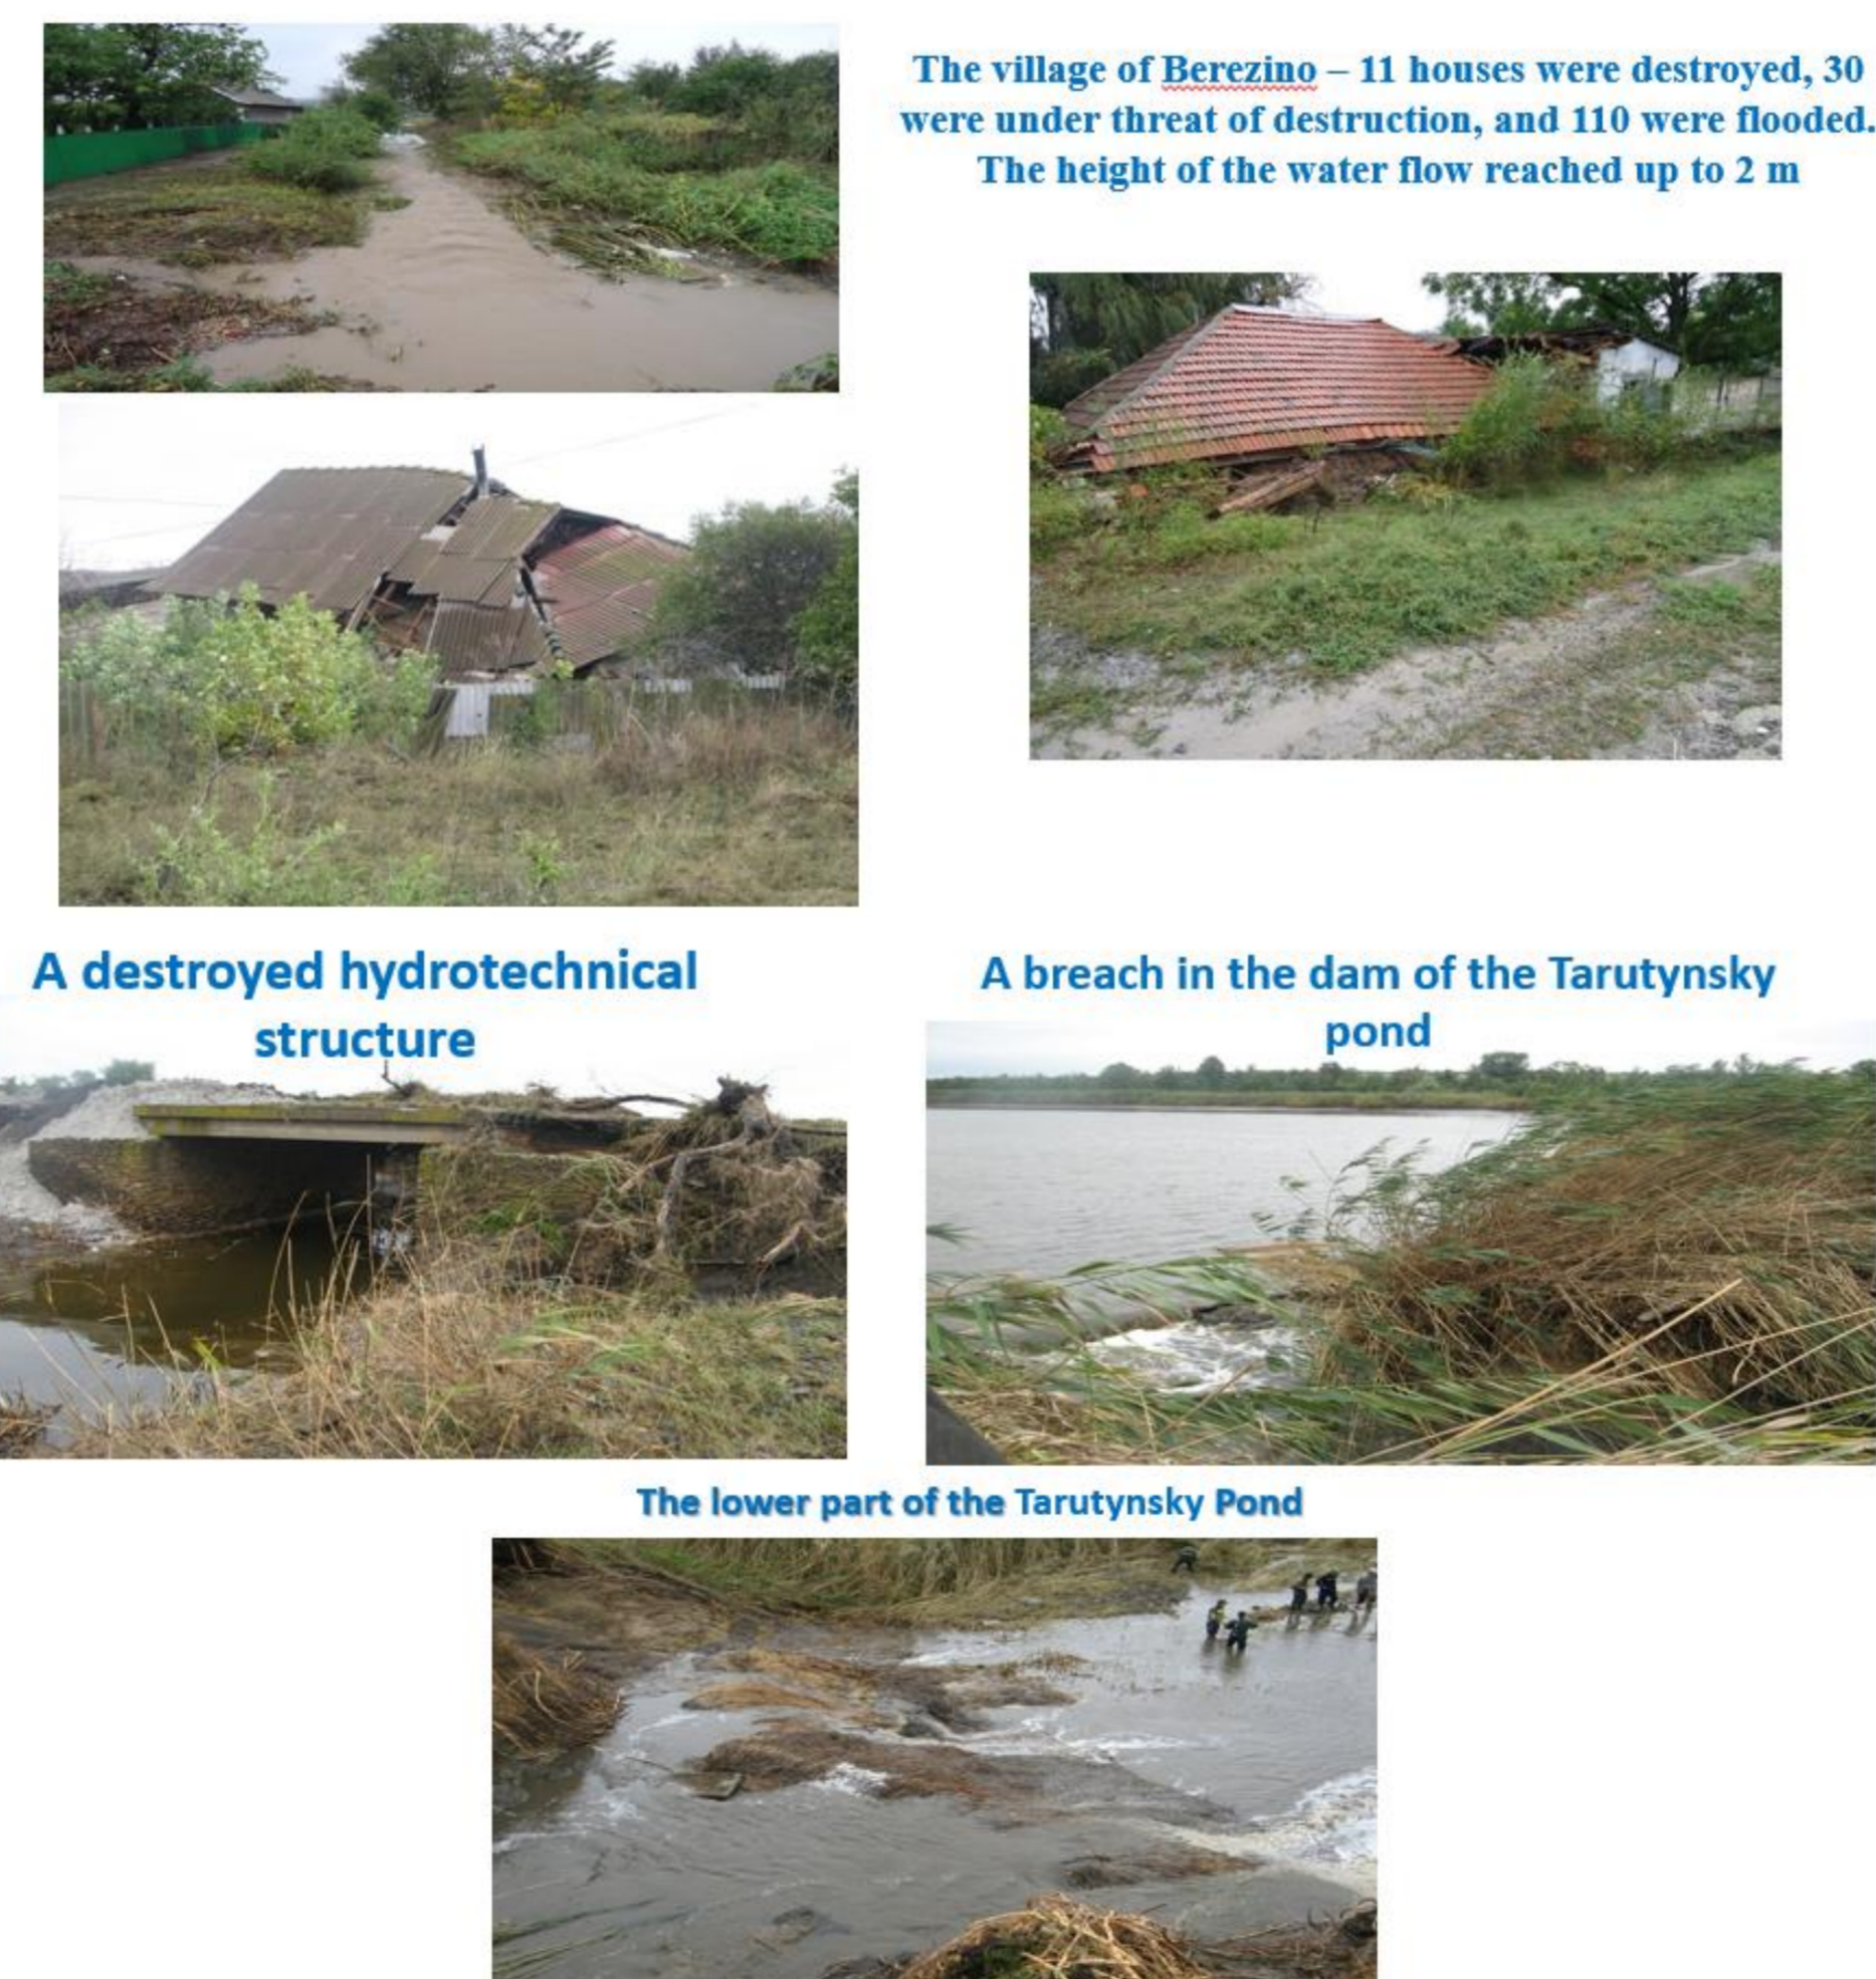
Flooding of the village Berezino

The village of Berezino – 11 houses were destroyed, 30 were under threat of destruction, and 110 were flooded. The height of the water flow reached up to 2 m

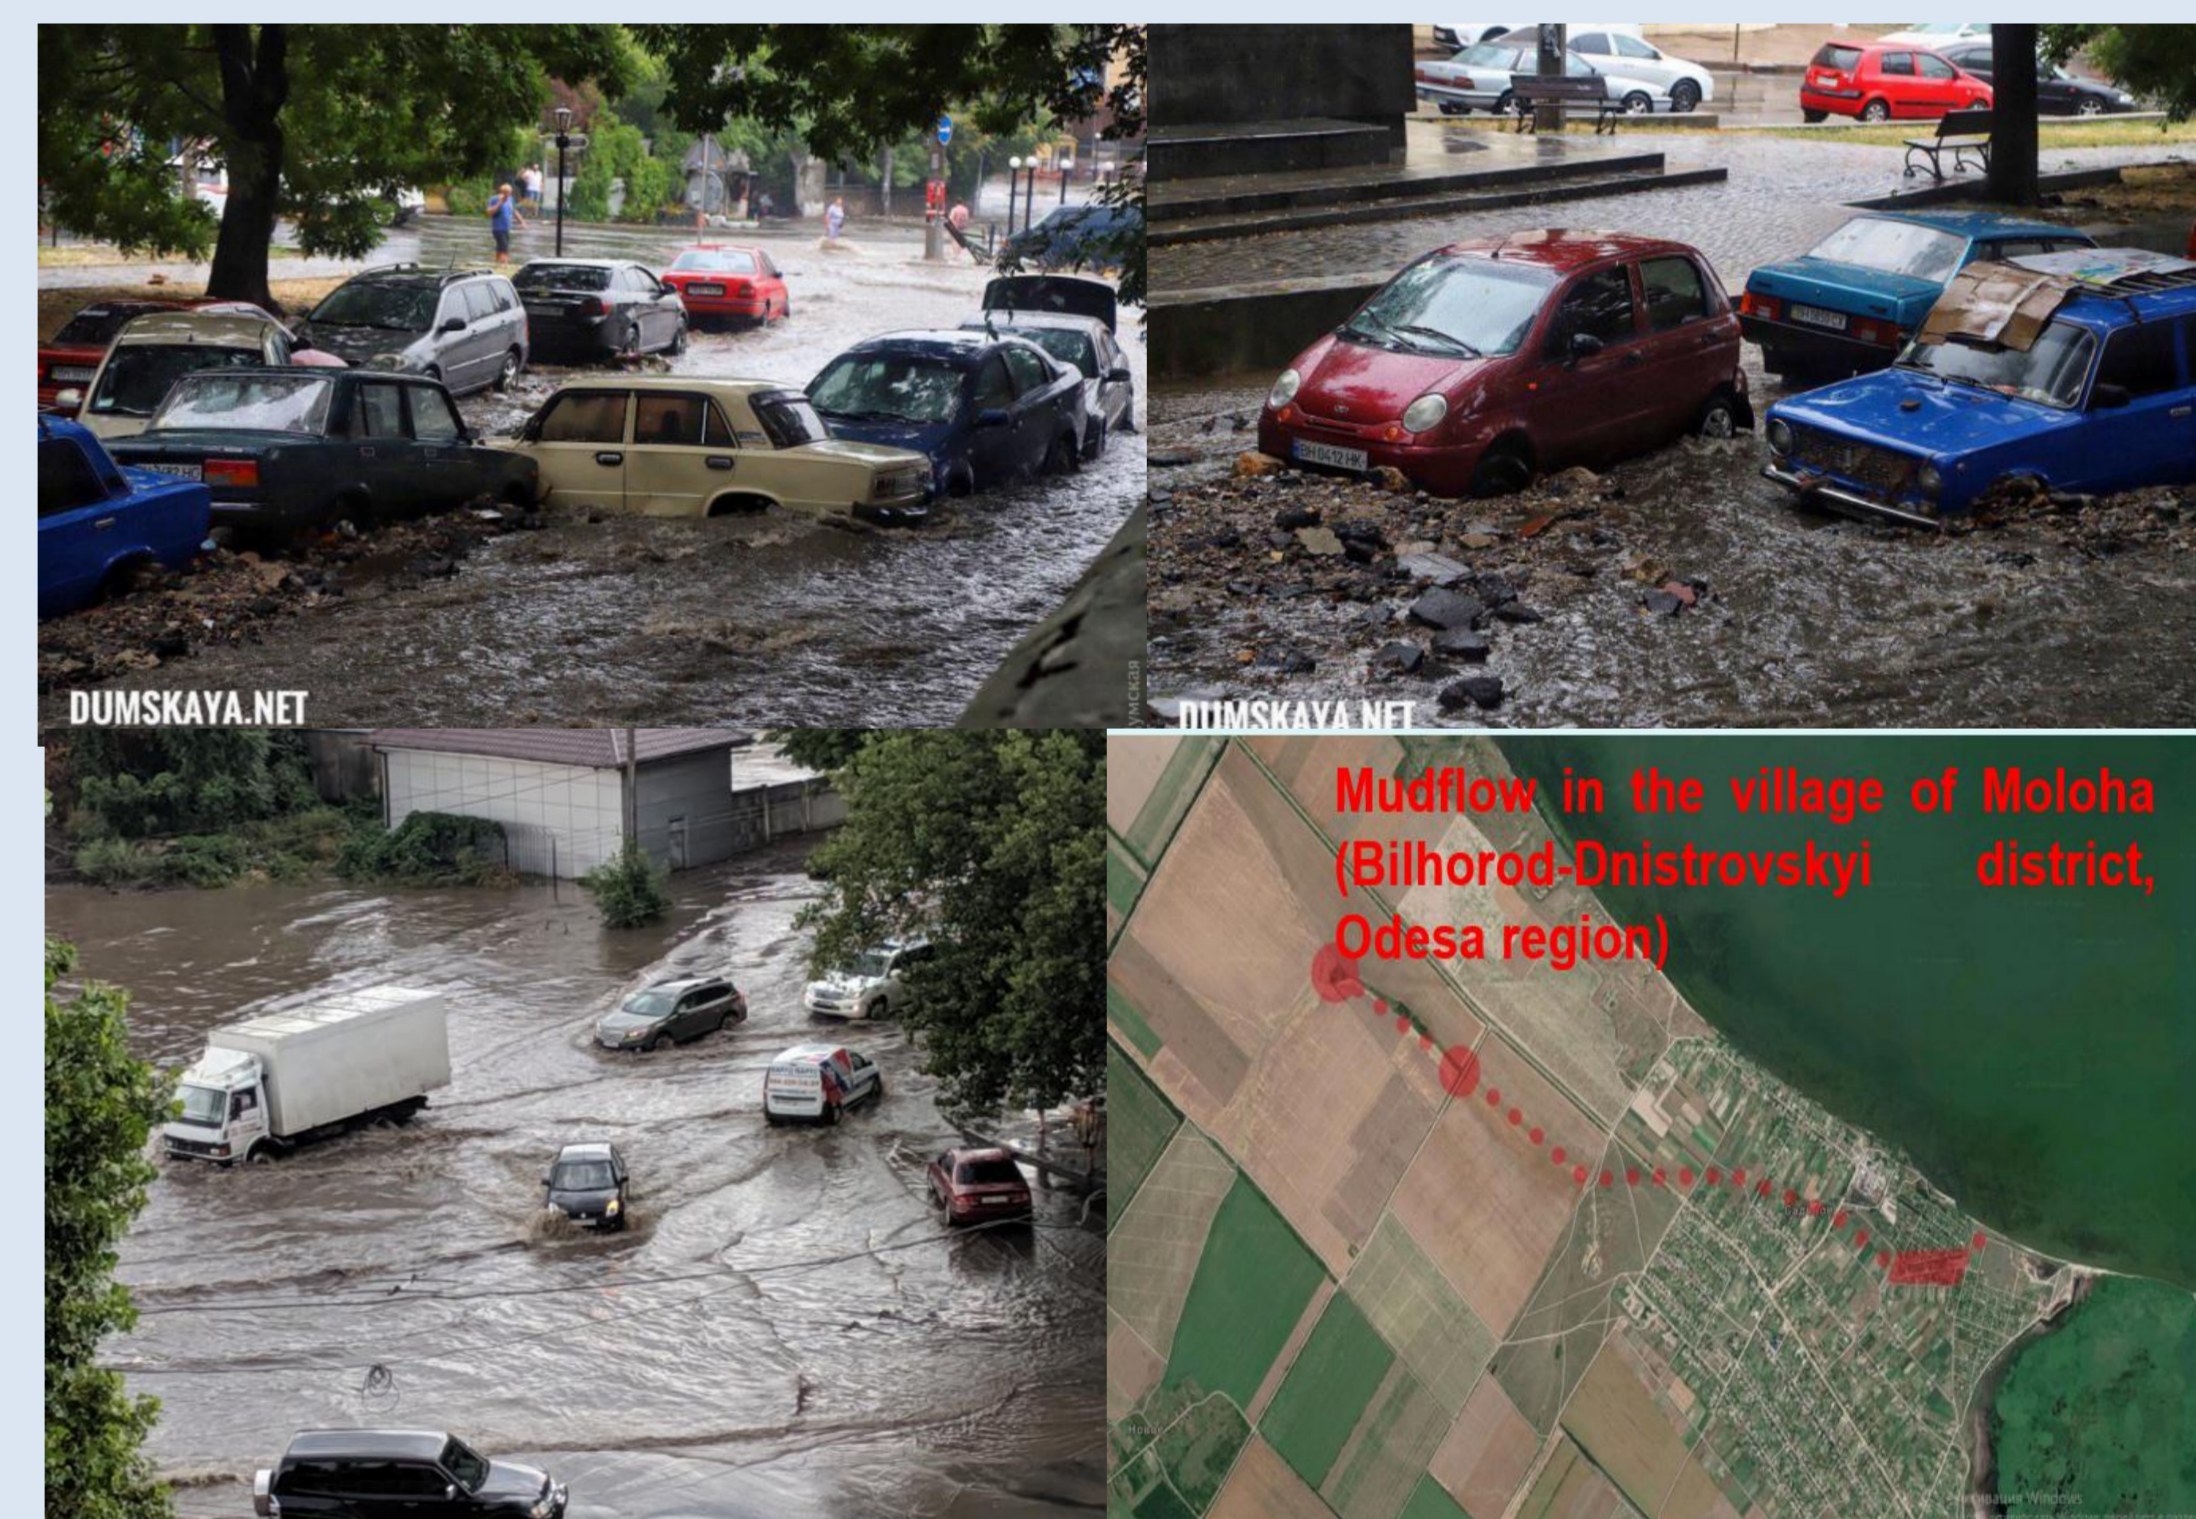
Characteristics of precipitation anomalies in the first ten-day period of August 2019 (based on data from the Ukrainian Hydrometeorological Center www.meteo.gov.ua)

Another notable episode occurred in early August 2019, when unstable atmospheric conditions and the passage of active cyclones led to intense rainfall across southern and eastern Ukraine. On 3–4 August, precipitation amounts reached 130–220% of the monthly norm in several locations. In the Odesa region, rainfall totals of up to 126 mm were recorded, corresponding to nearly three-monthly norms and meeting the criteria for hazardous meteorological phenomena. This event triggered debris flows and localized flash flooding, particularly in the village of Moloha, Bilhorod-Dnistrovskiy district.

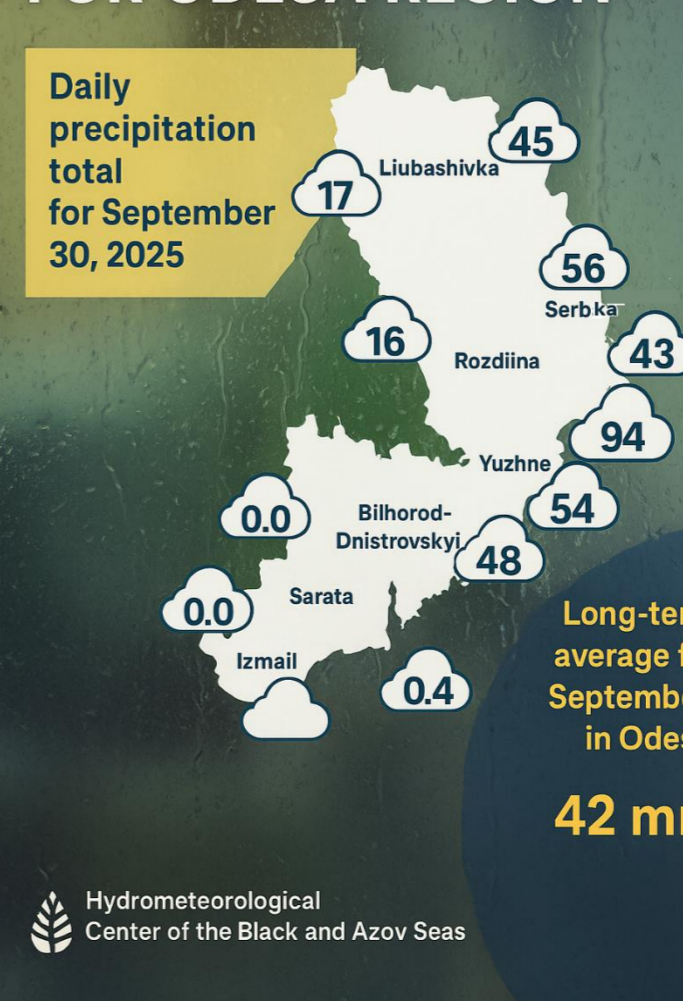
WEATHER SUMMARY FOR ODESA REGION

In Odesa and the Odesa district, rescuers had been working for nearly a day to deal with flooding caused by heavy rains. **Nine** people, including a child, have died. A total of **362** people were rescued and **227** vehicles evacuated with the involvement of **255** rescuers and **68** units of equipment, according to the State Emergency Service of Ukraine.
