Early Warning Systems for Landslides in the urban area of Rome (Italy): an integrated approach

Alessandro Fraccica, Matteo Maggi, Mauro Bonasera, Vittorio Chiessi, Danilo D'Angiò, Daniela Maria Antonia Niceforo, Valerio Ruscito, Gianluca Ferri, and Saverio Romeo

¹Dep. of the Geological Survey of Italy, ISPRA - Italian Institute for Environmental Protection and Research, Rome (Italy)

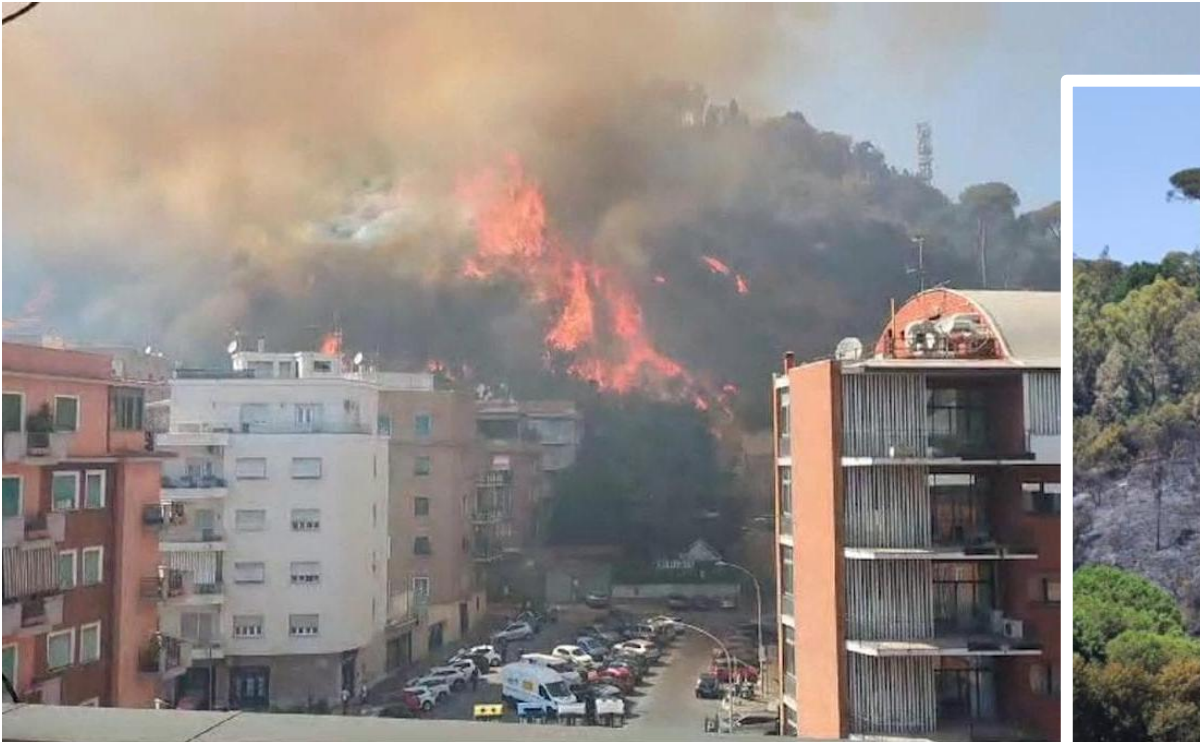
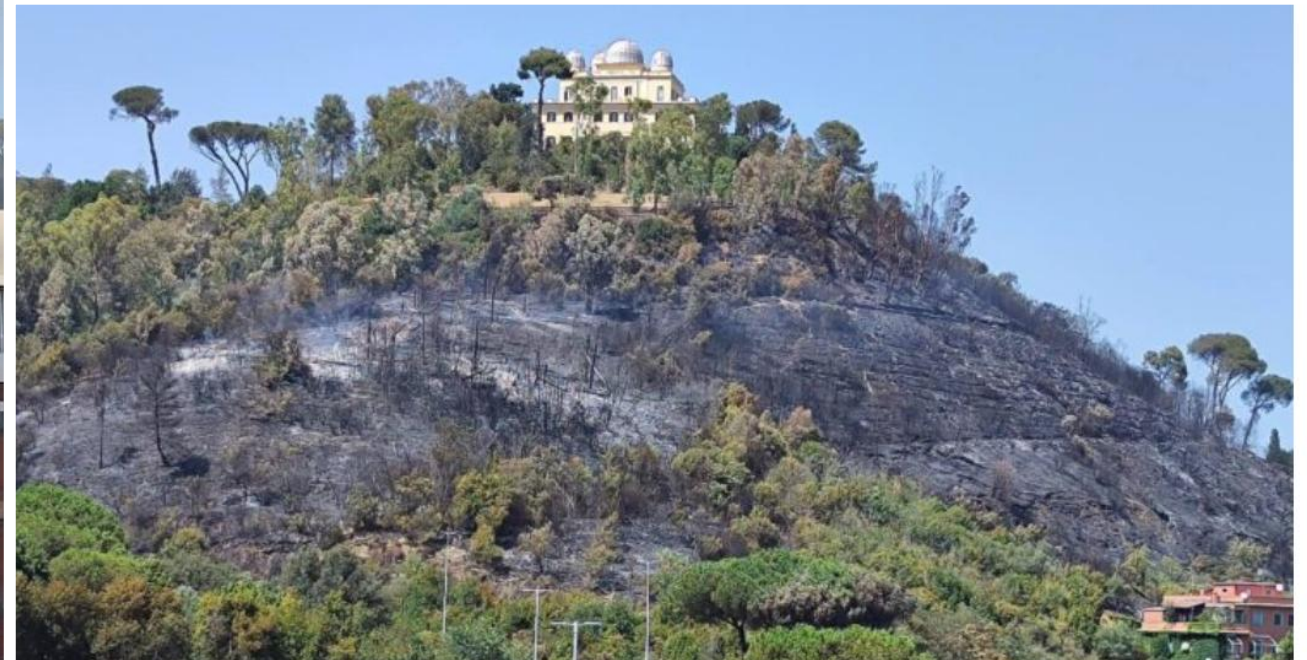
- Severe and persistent **wildfire** (on July 31st, 2024), covering an area of about **12 hectares**.
- **Mt. Mario Regional Protected Urban Park** affected.
- **Burnt vegetation species:** *Holm Oak (tree)*, *Cork Oak (tree)* and *Cistus (shrub)*.

- The reduction of root reinforcement on soil induced by the persistent and severe wildfire is considered a major factor in triggering surface landslides on Mt. Mario Case. The preliminary numerical results reflect in-situ observations.
- Future laboratory results and in-situ monitoring (water content, suction, shallow displacements) will provide deeper understanding of the behaviour of the slope under saturated and unsaturated conditions and will improve the numerical predictions too, in view of developing **digital twins for Early Warning Systems**.
- Re-vegetation of the slope is in progress (**importance of nature-based solutions in urban environments**)

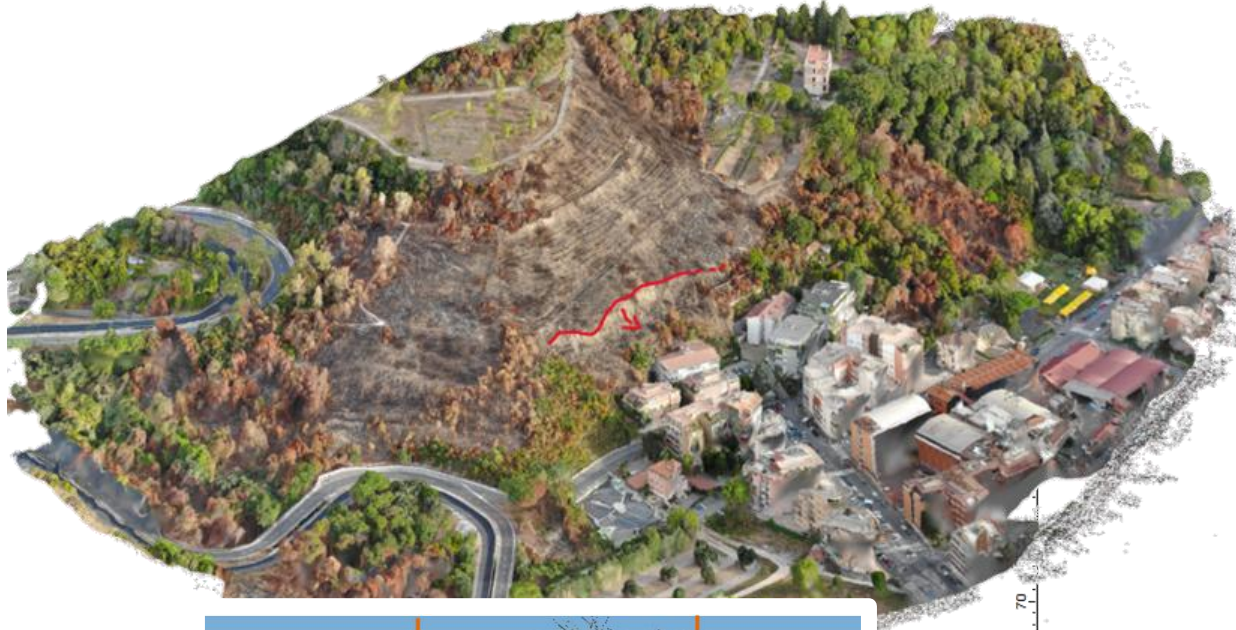
The geological – geotechnical model (FEM)

- A DSM with 5cm resolution (UAS laser scanner) was available for the study site.
- visual observations on the site allowed to individuate trees and shrubs partitions on the slope
- Roots depth given from literature data on vegetation found on the slope (2 m for trees, 0.5 m for shrubs)
- Average **slope angle: 33°**

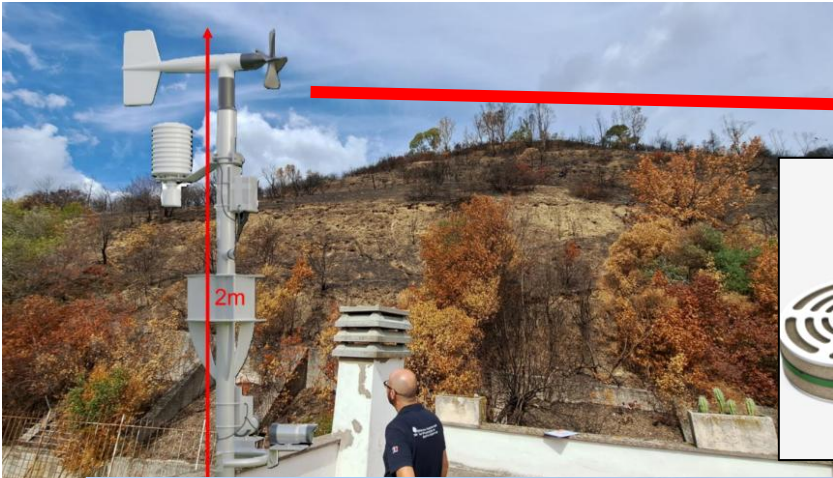
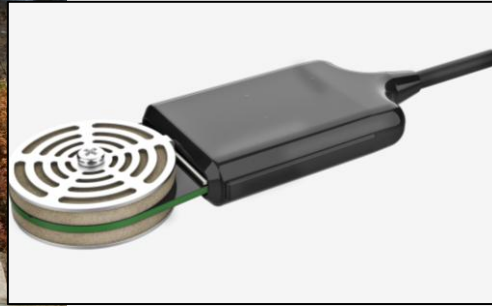
Weather station:

Wind direction and velocity
Rainfall intensity – duration
Air temperature and relative humidity
Data logger and remote transmission
Optical camera

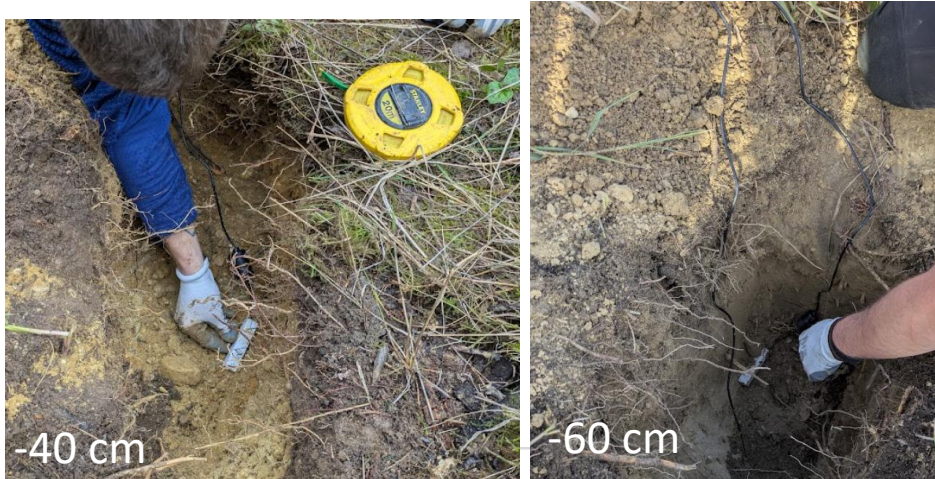
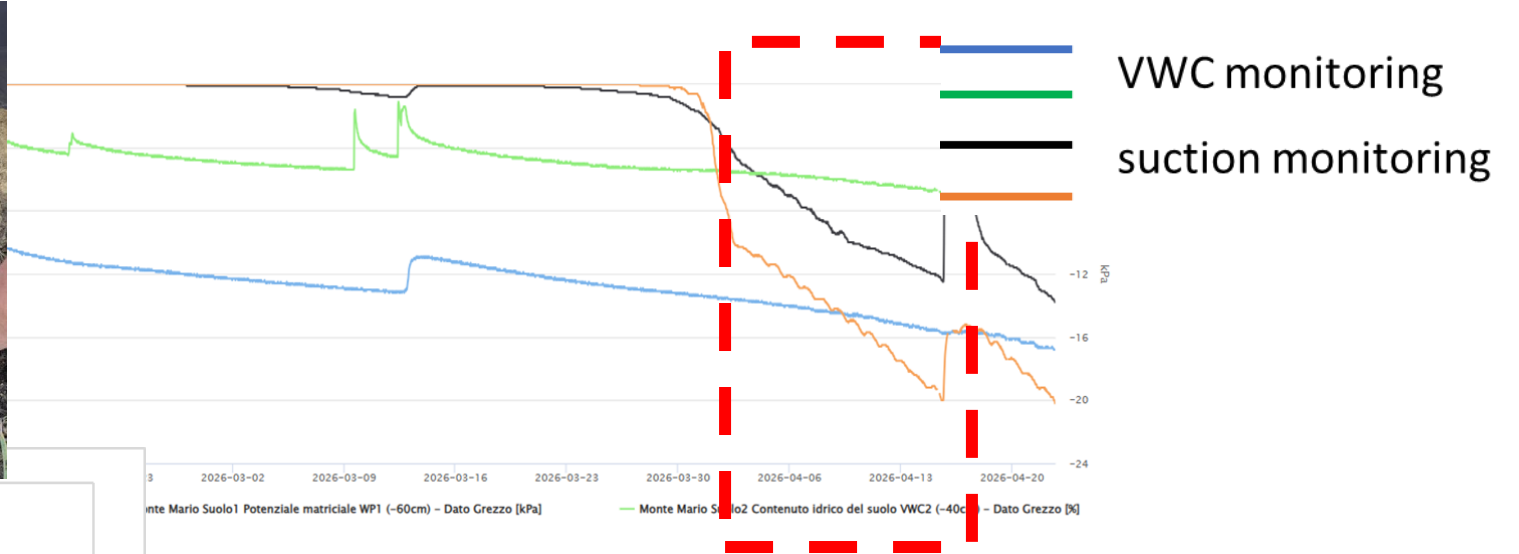
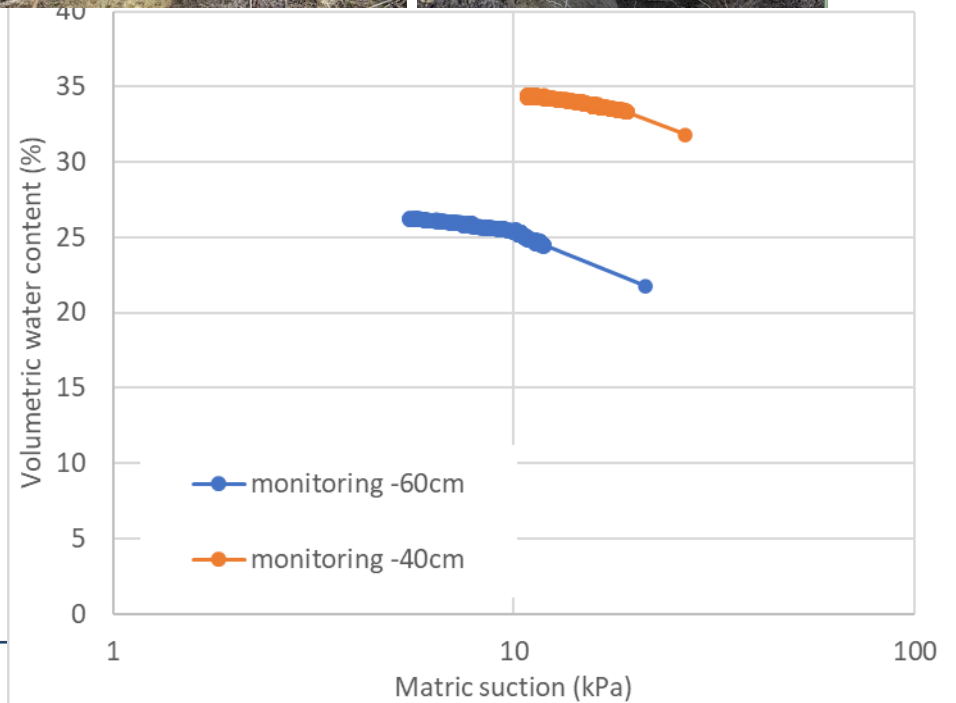
Early Warning monitoring system (installed – first 4 months of data)

- From monitoring data, days without rainfalls were selected to plot jointly VWC and suction correspondent points to obtain a “main drying” SWRC for in-situ soil (to be enhanced in the future, with more data)
- Laboratory SWRC in progress (soil retrieved close to the sensors)
- A SWRC consistent with the nature of the silty soil was adopted in the numerical model (to be enhanced with more data)

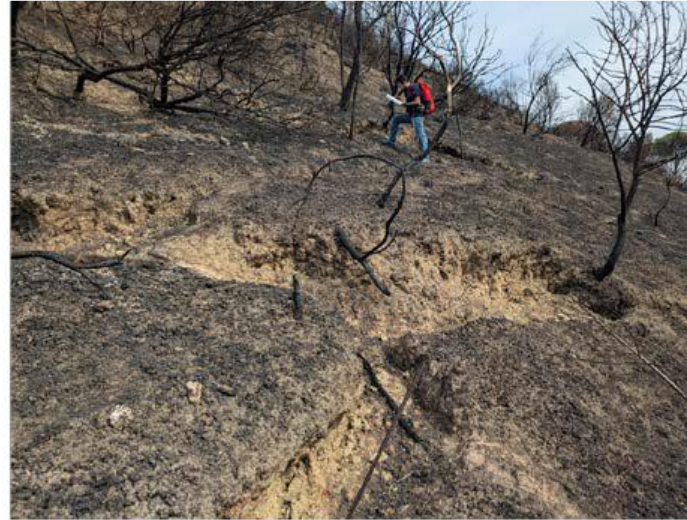
Ash on the slope after the wildfire

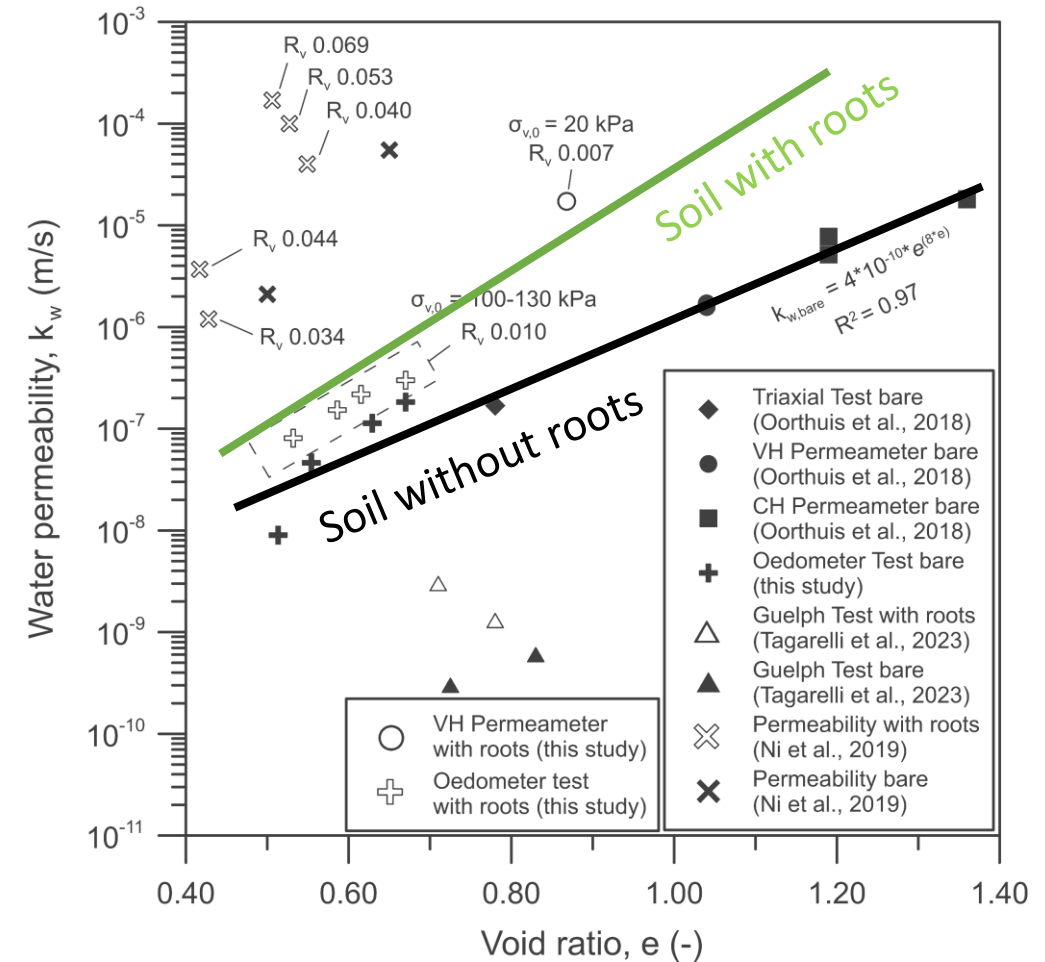
ID	c' kPa	ϕ' °	γ_d kN/m ³	k_w m/s
Sandy silt	0	23	16	3.4×10^{-7}
soil+living shrubs	15 ^d	23	16	3.4×10^{-6}
soil+living trees	19 ^c	23	16	3.4×10^{-6}
soil+burnt vegetation	0	23	16	3.4×10^{-6}

- Increase in soil cohesion and permeability (negligible effects on friction angle)
- Ashes reduce rainfall water infiltration (void clogging by fines)

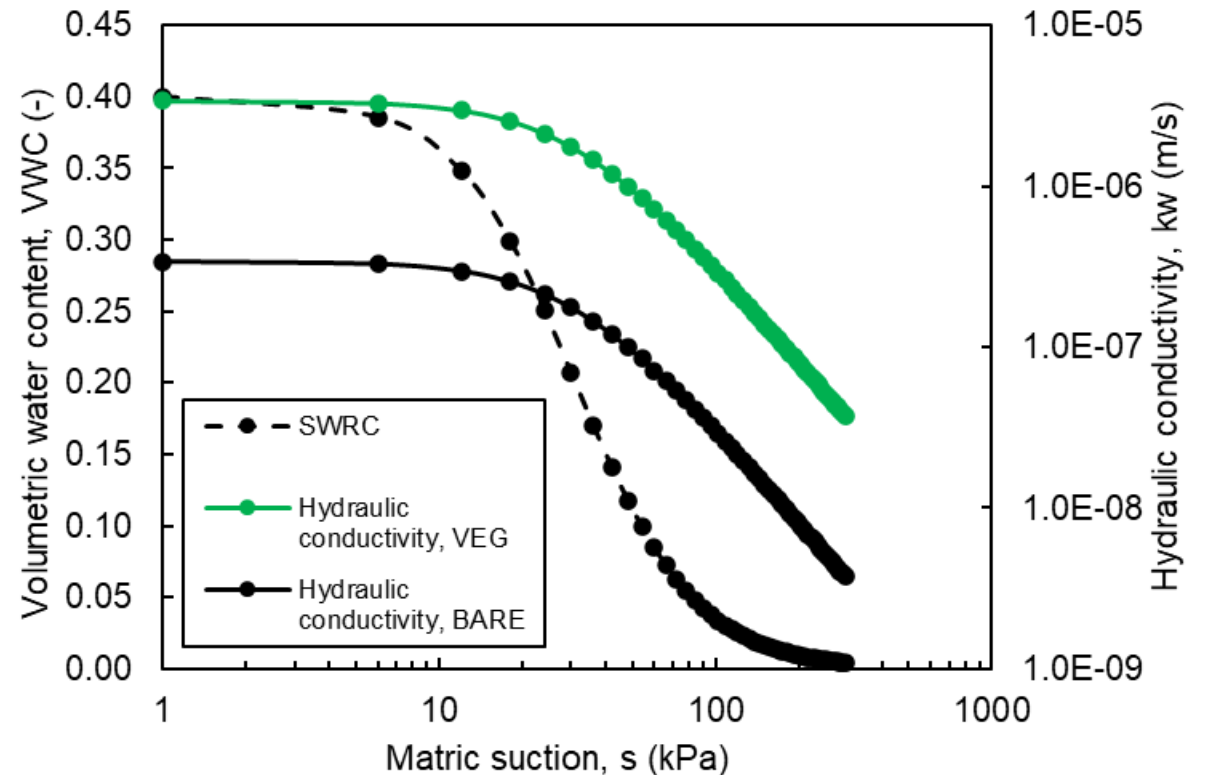
- Soil water content is controlled by soil matric suction (negative pore pressures) and soil physical properties (grain size, porosity, ..)
- Soil permeability decreases as soil gets drier (controlled by matric suction, s)
- Vegetation generates an increase in permeability (with respect to bare soil)

$$k_w = k_{w,s} \left(\frac{1}{1 + a \left(\frac{s}{\gamma_w} \right)^n} \right);$$

$$a = 0.1 \text{ m}^{-1}, n = 2$$

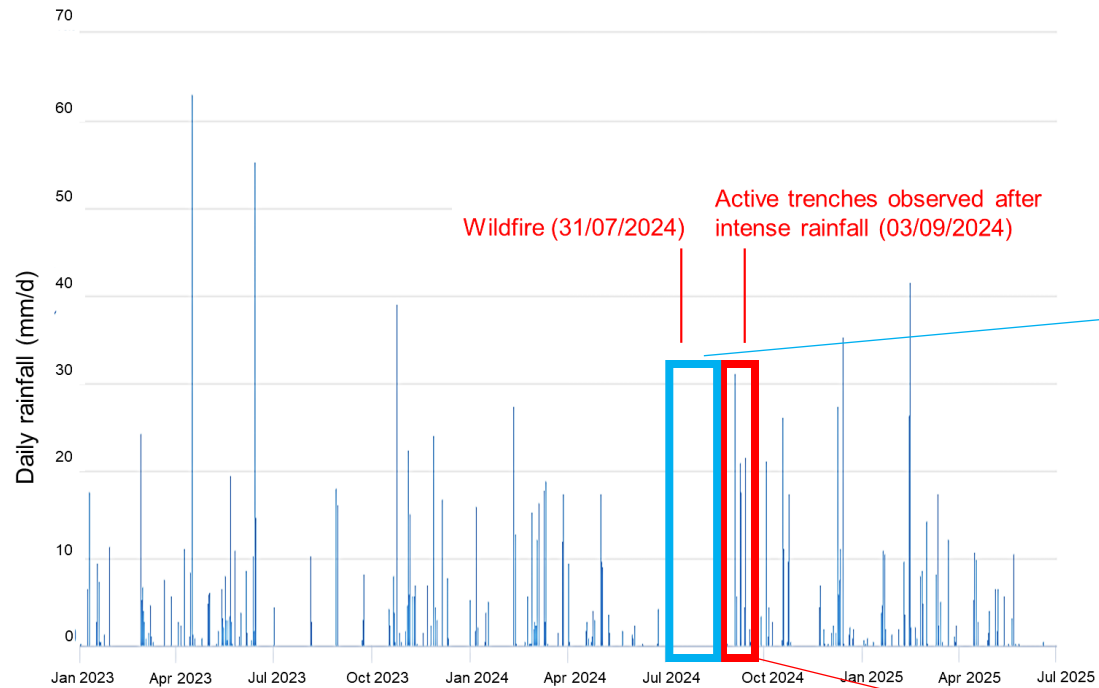
- Steady state and transient hydraulic analyses (heavy rainfalls) were carried out through a Finite Element solver

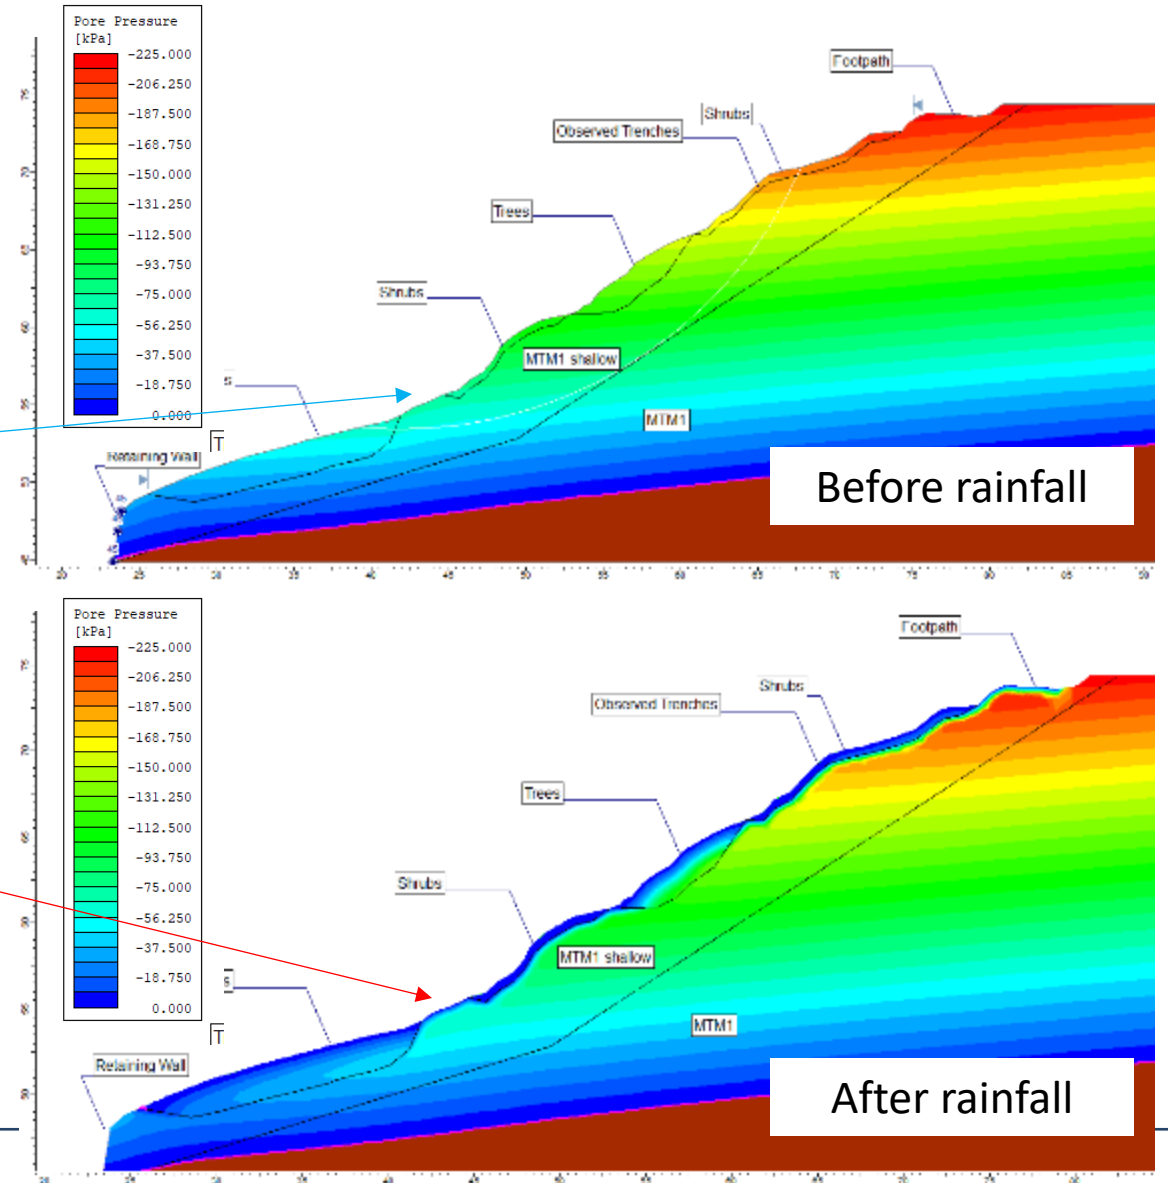
Simulating the effect of **heavy rainfall** (September 3rd, 2024), occurred after the **wildfire**, on slope stability with (hypothetically) living and burnt vegetation
