EGU26-6932, EGU General Assembly 2026
HS10.3 -Peatland hydrology: Groundwater and surface water
from tropical to subarctic latitudes
Room 3.29/30 on Friday, 8 May 2026, 11:45

Tree-ring analysis on the alder tree growth in a river meandering restoration site of the Kushiro Mire, Hokkaido, Japan

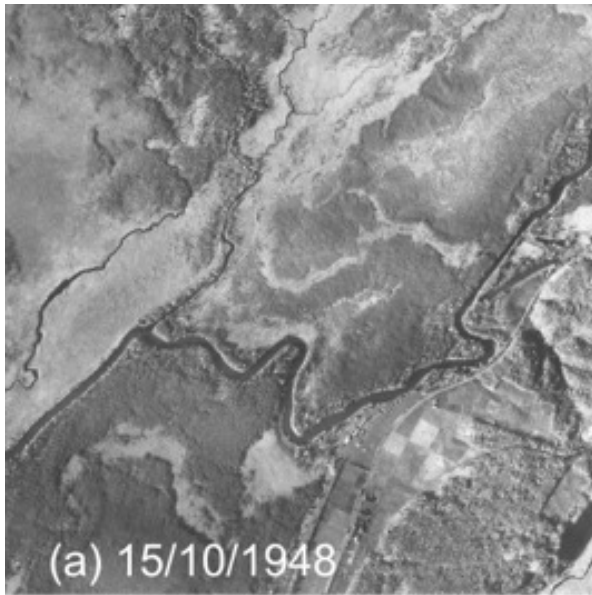
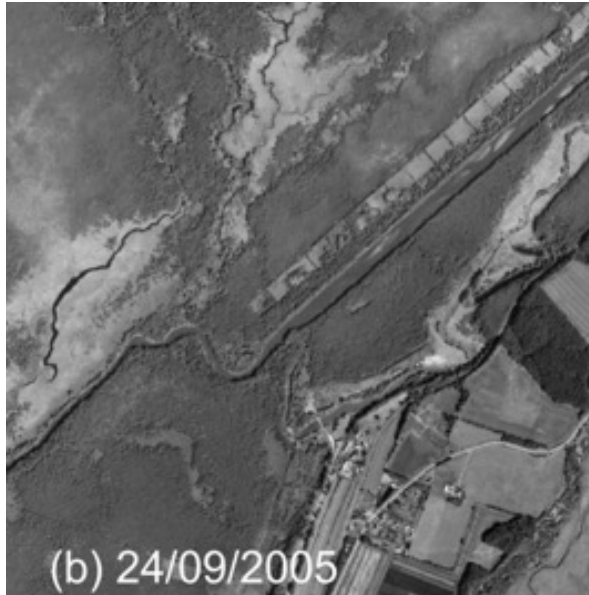
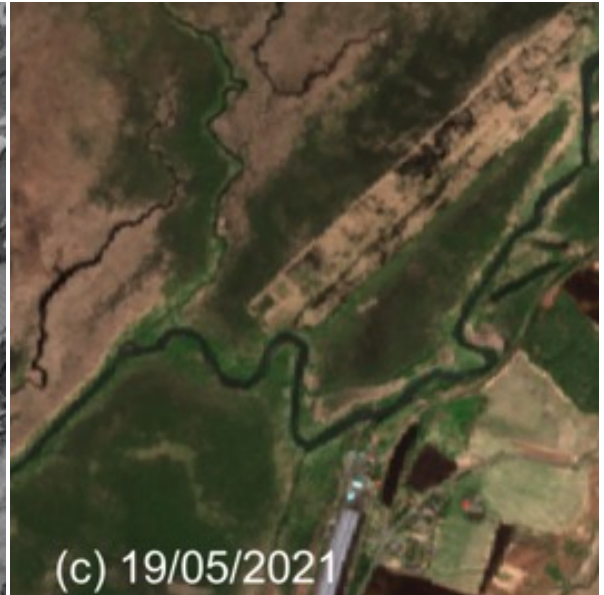
Nature restoration: river re-meandering

Historical changes in the study site of *Kushiro Wetland* from aerial images

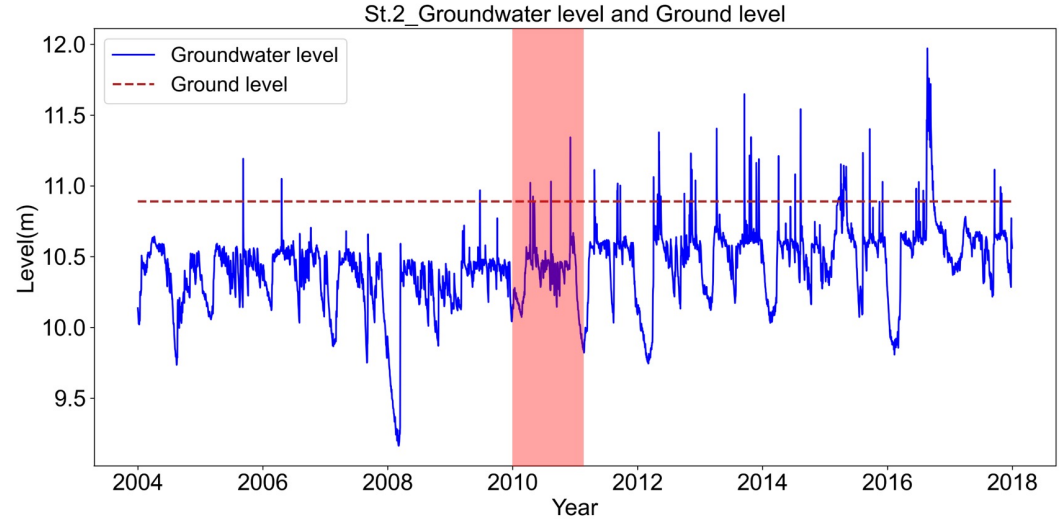
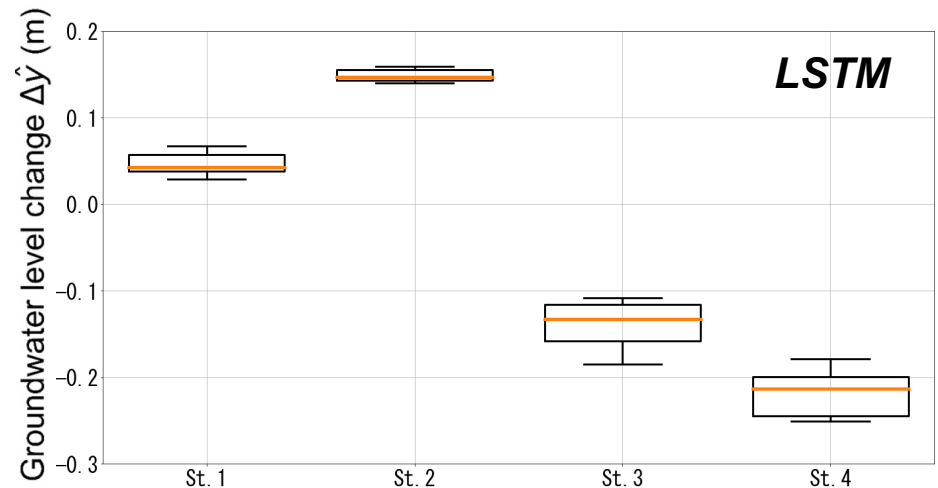
✓ *Groundwater level recovery*

(Yamaguchi et al. *Water*, 2023)

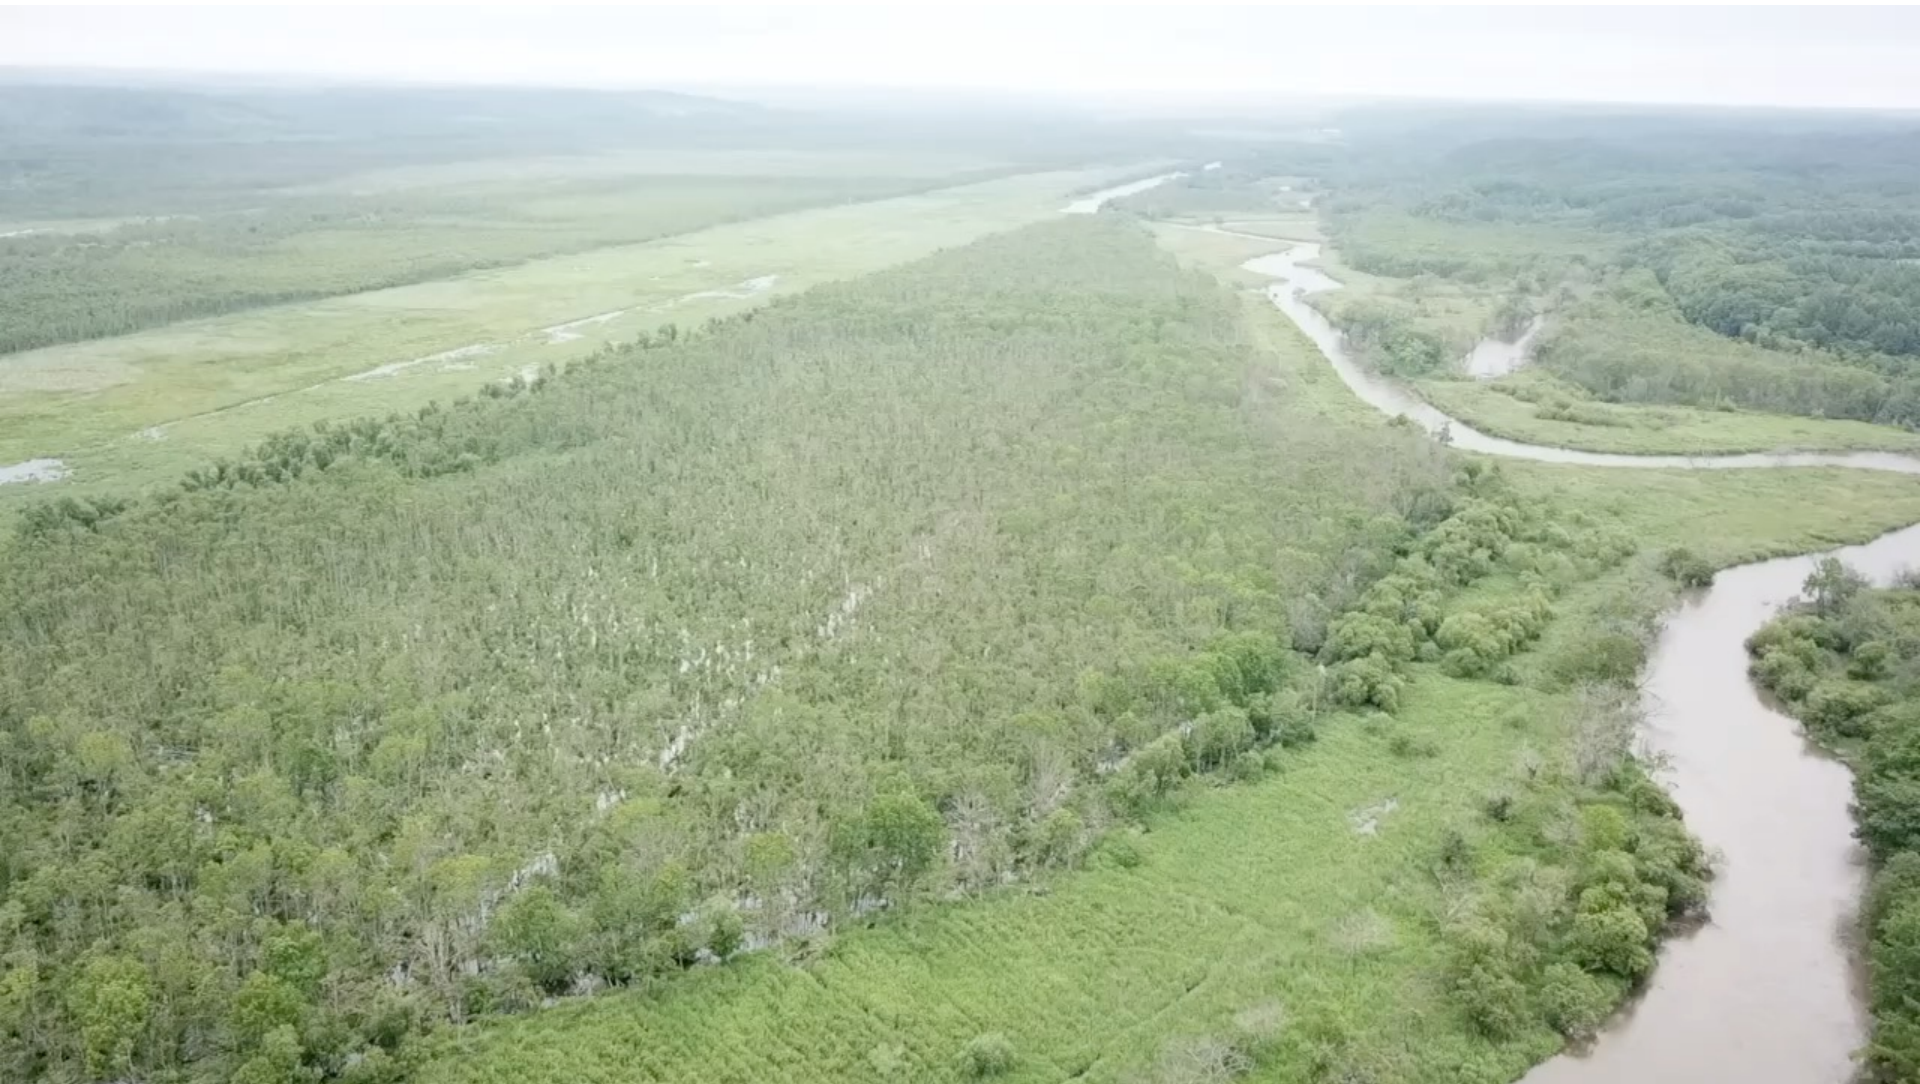
Study site: UAV snapshot in 2018

(UAV Snapshot/Hitoshi Miyamoto, July 12, 2018)

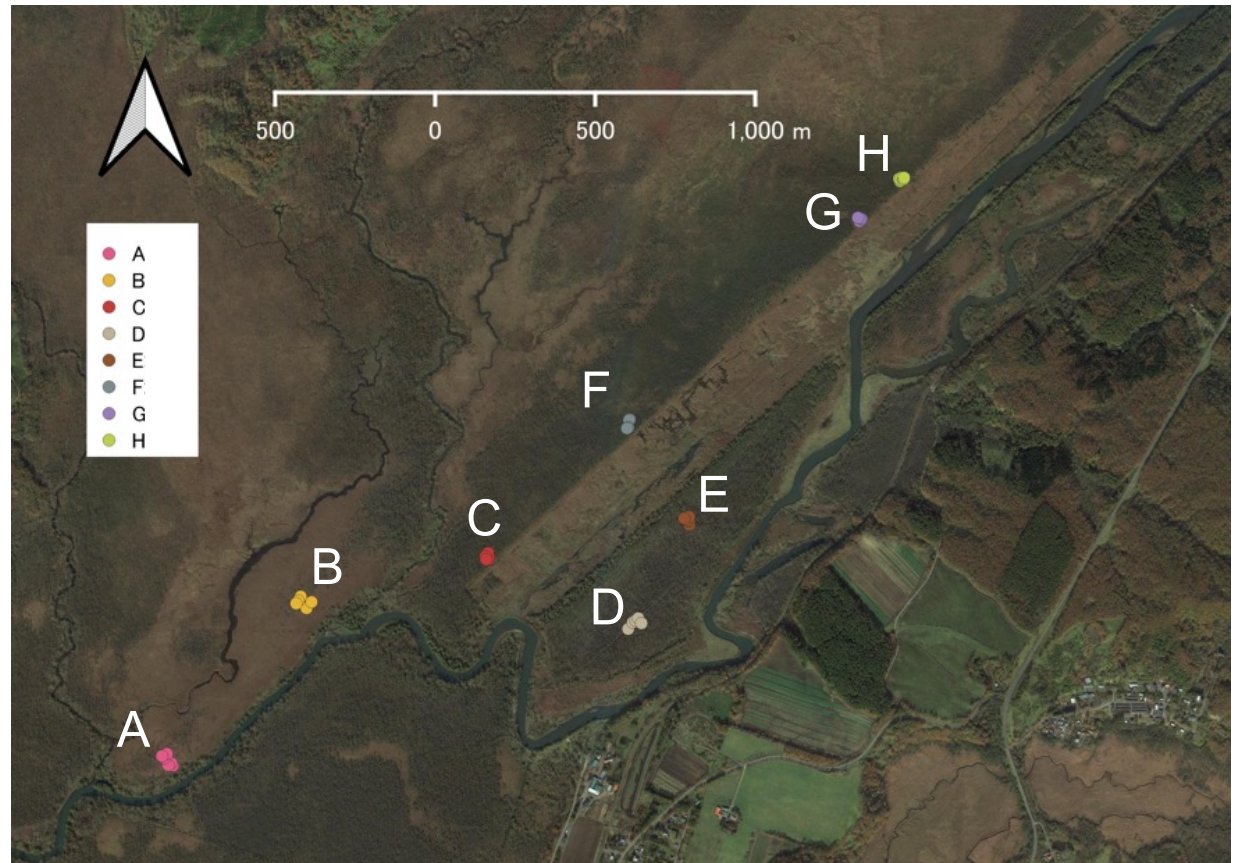
- ✓ *Eight alder tree-ring survey sites with* tree-ring conditions were expected to differ.
- ✓ At each site, *5-6 trees with* a typical growth condition.

(41 points in total: Date : Oct.31-Nov. 2, 2023)

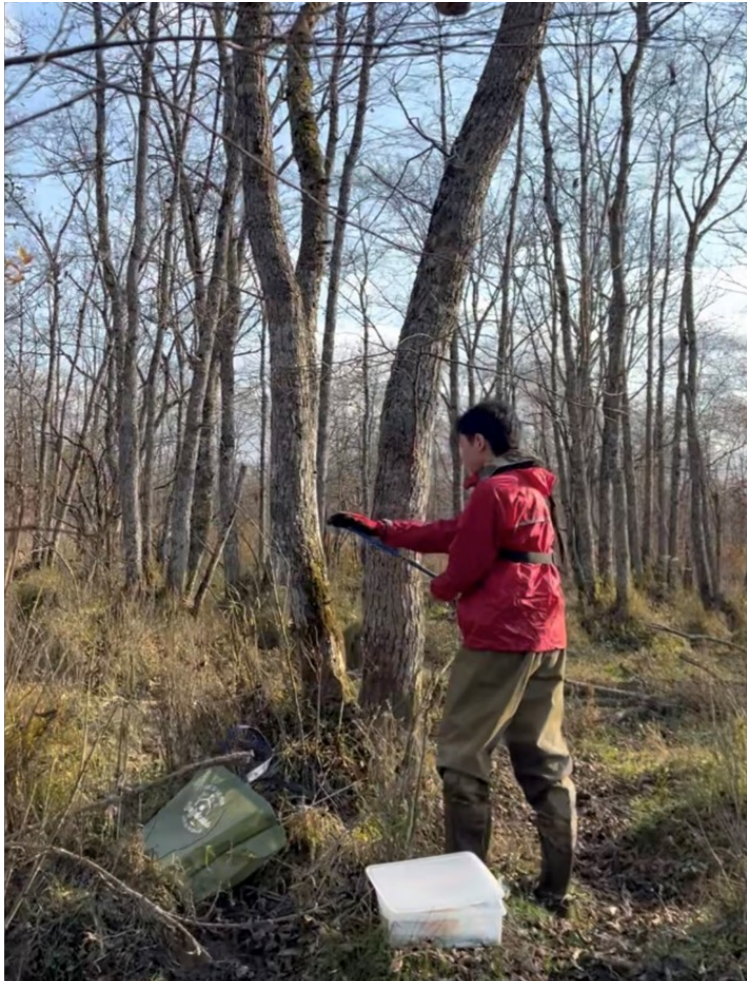
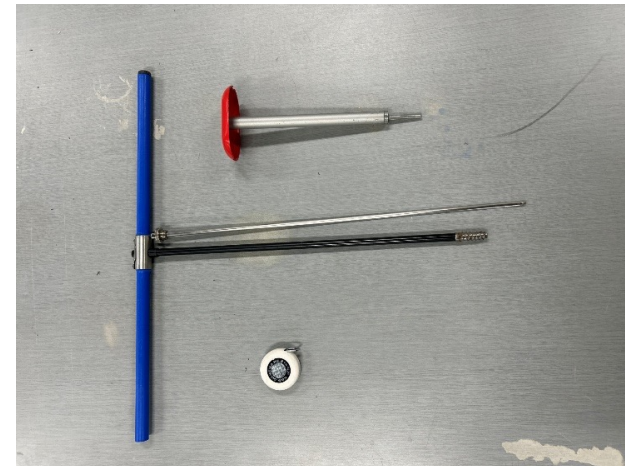
- ✓ Sampling *tree-ring cores* using an increment borer
 - Increment cores at breast height (about 1.3 m)

Increment Borer (Haglöf Sweden AB)

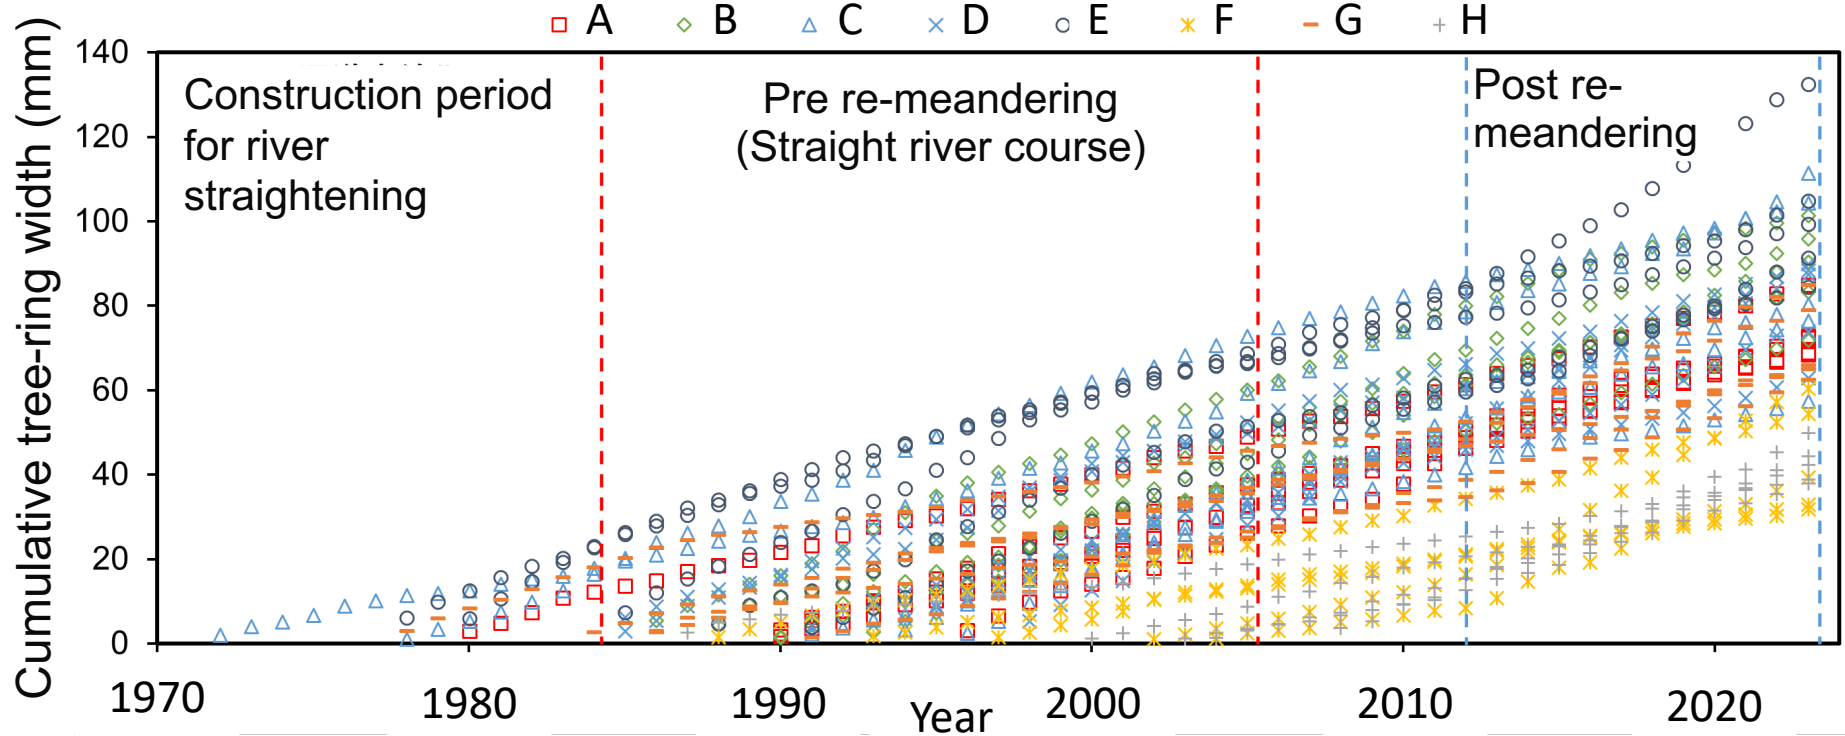
The growth curves of all alder trees in the eight survey sites.

✓ Means and standard deviations of the alder tree age in the eight survey sites.

| | A | B | C | D | E | F | G | H |
|---|---|---|---|---|---|---|---|---|
| Age | 34.8 ± 5.2 | 34.6 ± 2.3 | 37.8 ± 9.5 | 34.4 ± 3.9 | 38.2 ± 4.8 | 27.2 ± 5.8 | 40.0 ± 4.9 | 23.6 ± 7.2 |

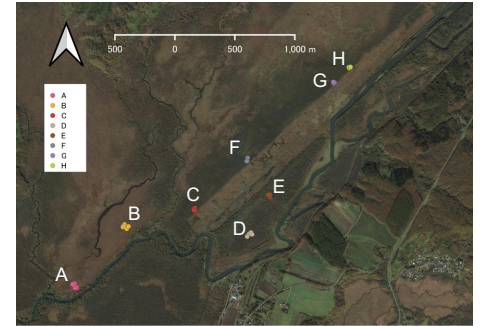
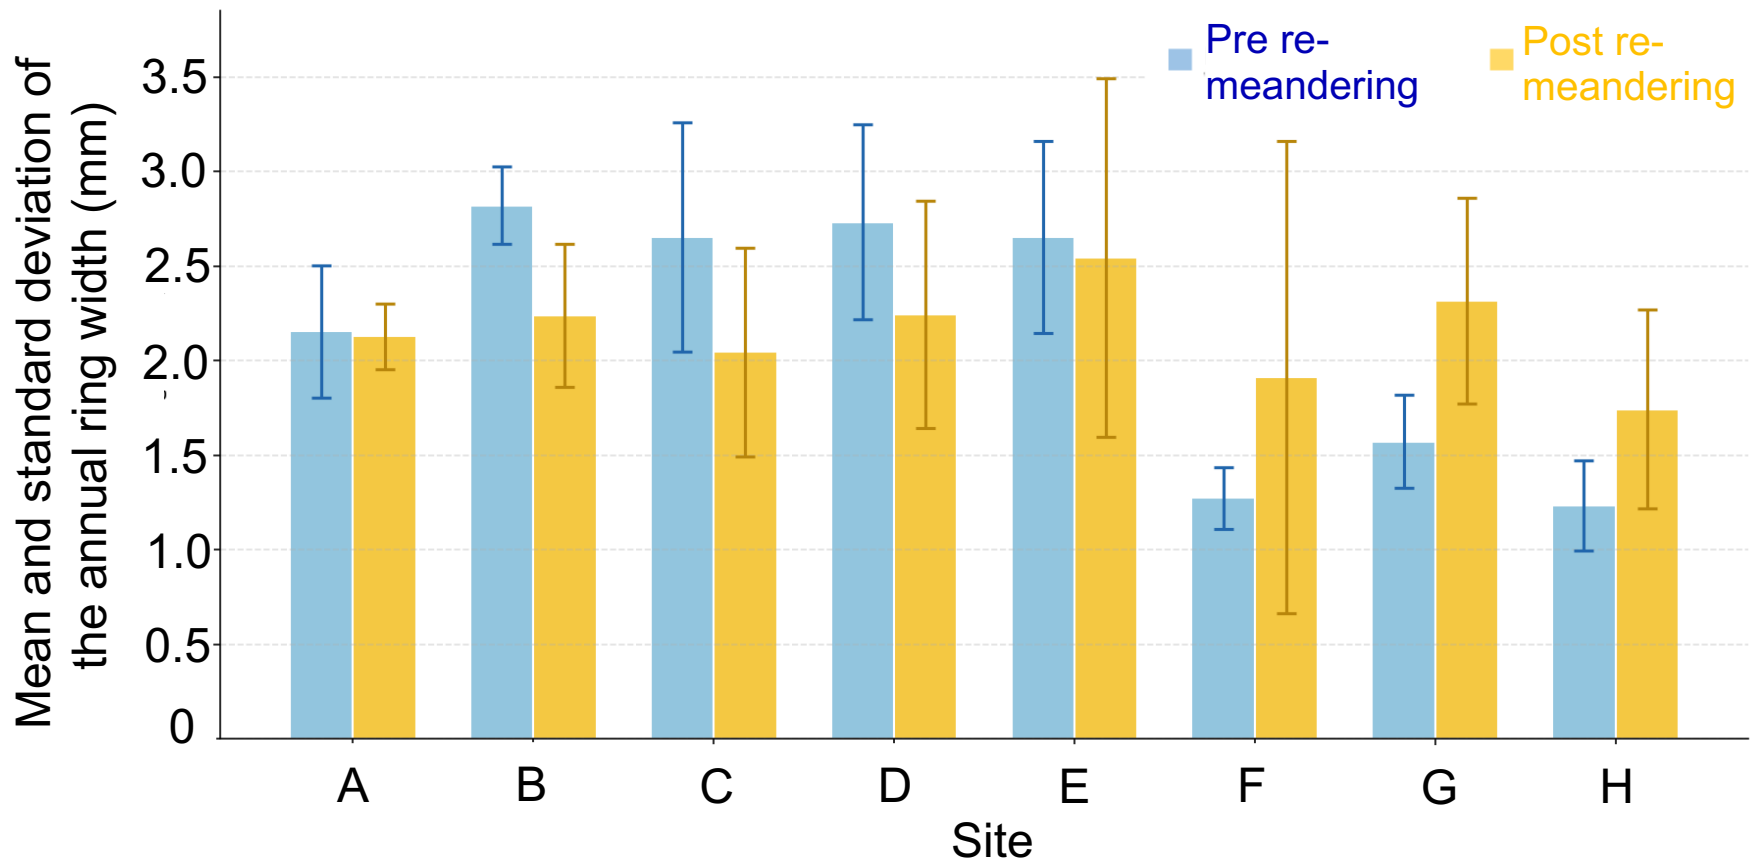
✓ Comparison of the growth rates between pre- and post- river restoration

- Pre re-meandering: 1984-2005
- Post re-meandering: 2011-2023

- ✓ This study examined the effects of river restoration on alder growth in Kushiro Mire, Hokkaido, Japan.
- ✓ Downstream of the restored meandering river channel, *tree-ring growth decreased* following restoration compared with pre-restoration conditions.
- ✓ Near the former straight river channel *upstream, tree-ring growth increased* following restoration.
- ✓ Flood simulations before and after restoration indicated that *flood-induced sediments into the wetland could alter water content & nutrient distribution*, contributing to alder growth.
- ✓ Future studies will examine the effects of factors such as *water content ratio, water levels, and peat/soil characteristics*.

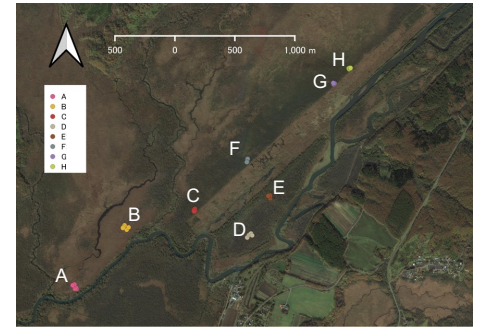
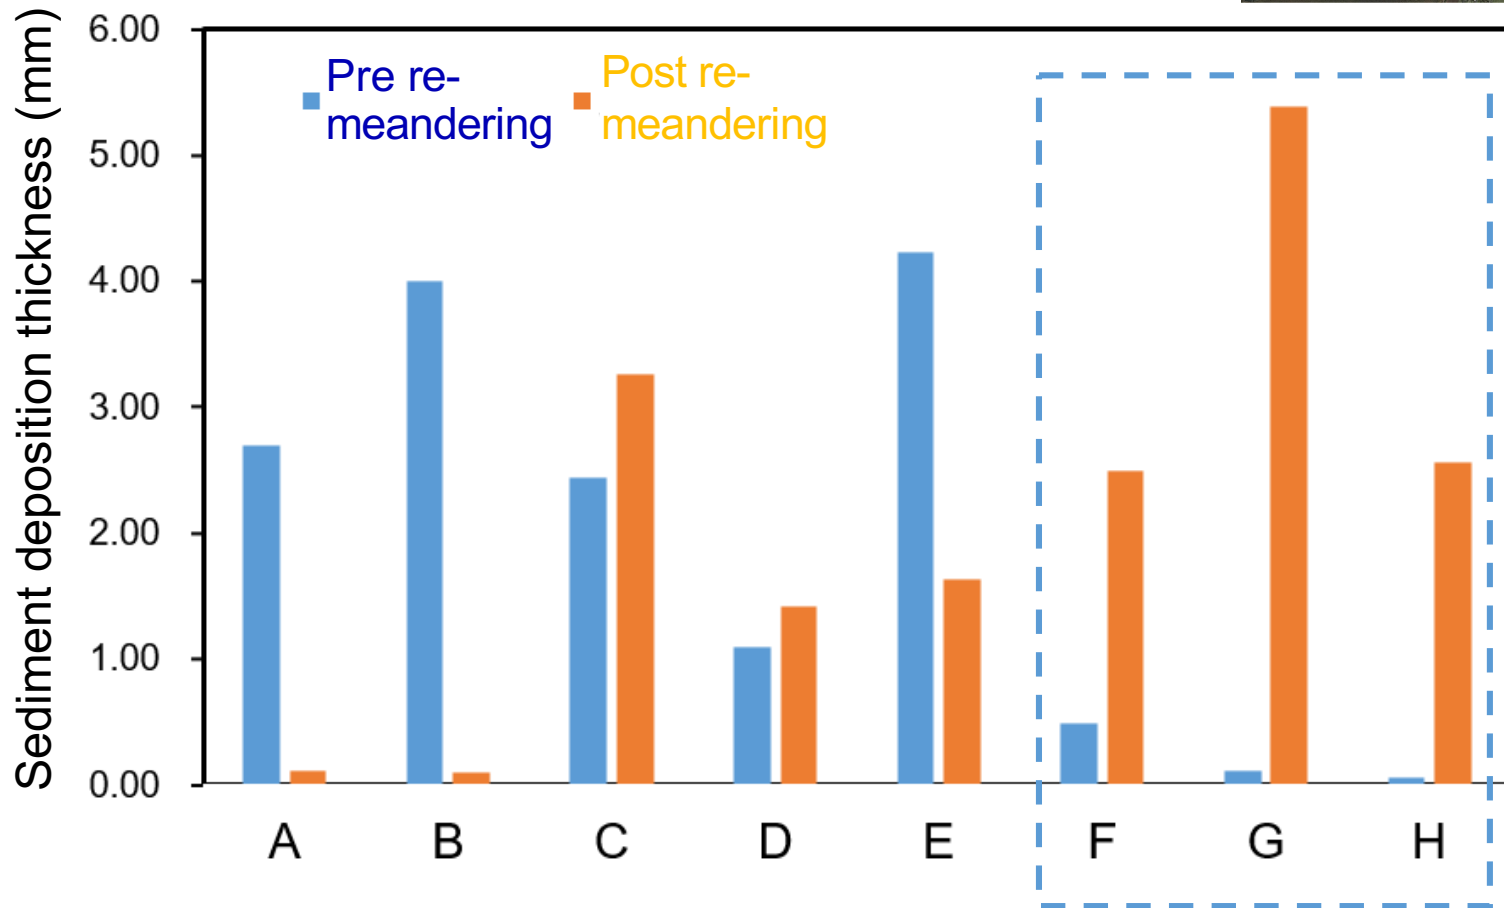
- ✓ Changes in *sediment deposition thickness* before and after meandering restoration.

Study on quantifying the reduction of sediment load into the Kushiro Wetland via Meander Restoration (Ishida et al., 2018)
